**Zuni Bowl and One Rock Check Dam Research –
Phase 1**

Final Report

December 2024

Rio Grande Return for the New Mexico Department of Transportation Research Bureau

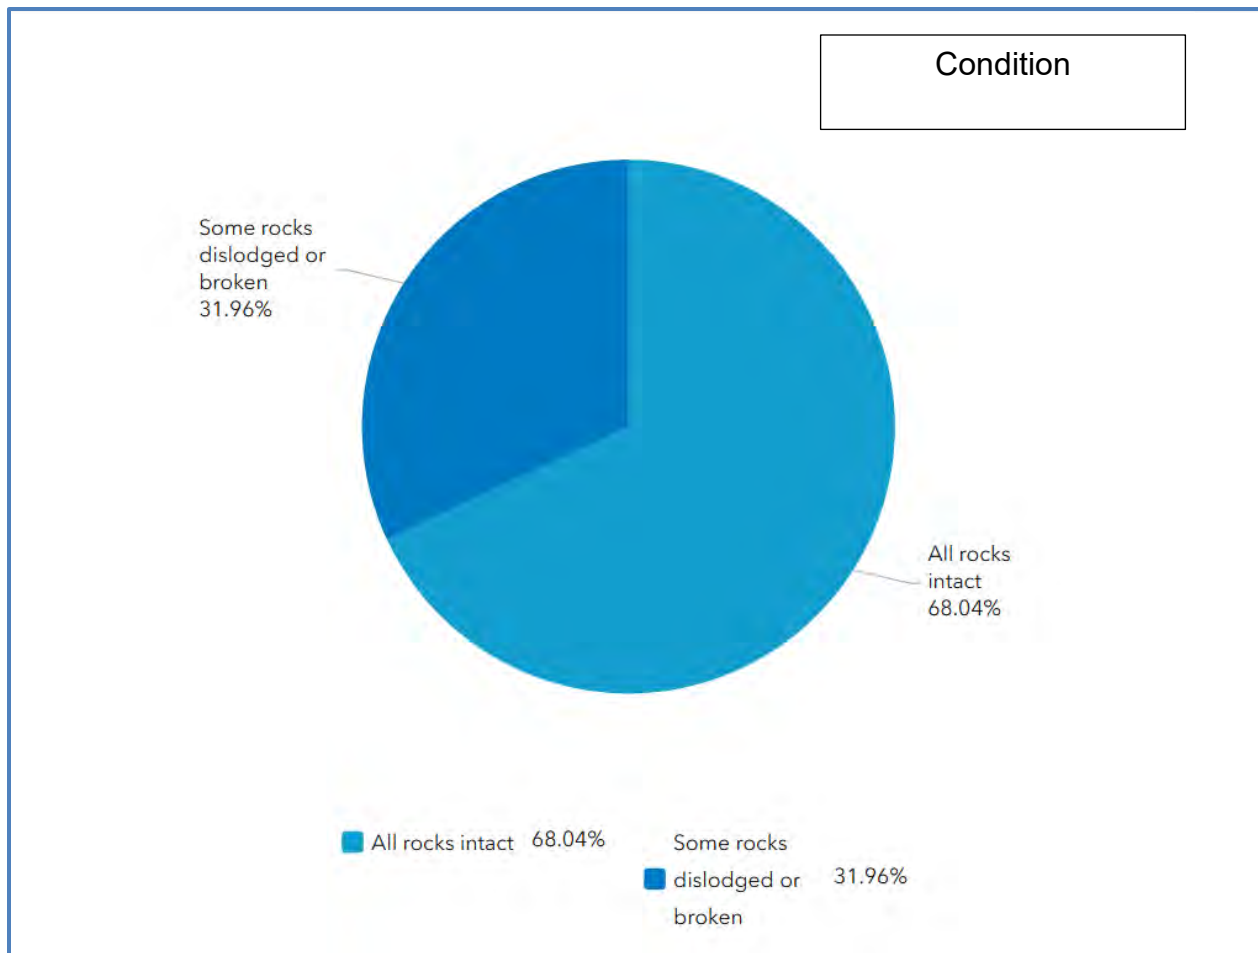
Figure 3-3. Condition (all rocks intact, some rocks dislodged or broken).

The majority of structures surveyed (68%) were entirely intact, whereas the remainder (32%) had at least one rock dislodged or broken. This is shown in Figure 3-3. This means that most of the structures have become integrated with the landscape and are likely functioning to arrest erosion. Dislodged rocks were deemed to be caused by water in all cases except one that was identified as human interference. RGR did not identify or survey any significantly deteriorated structures. Figure 3-4 shows a structure where some rocks were dislodged by water.

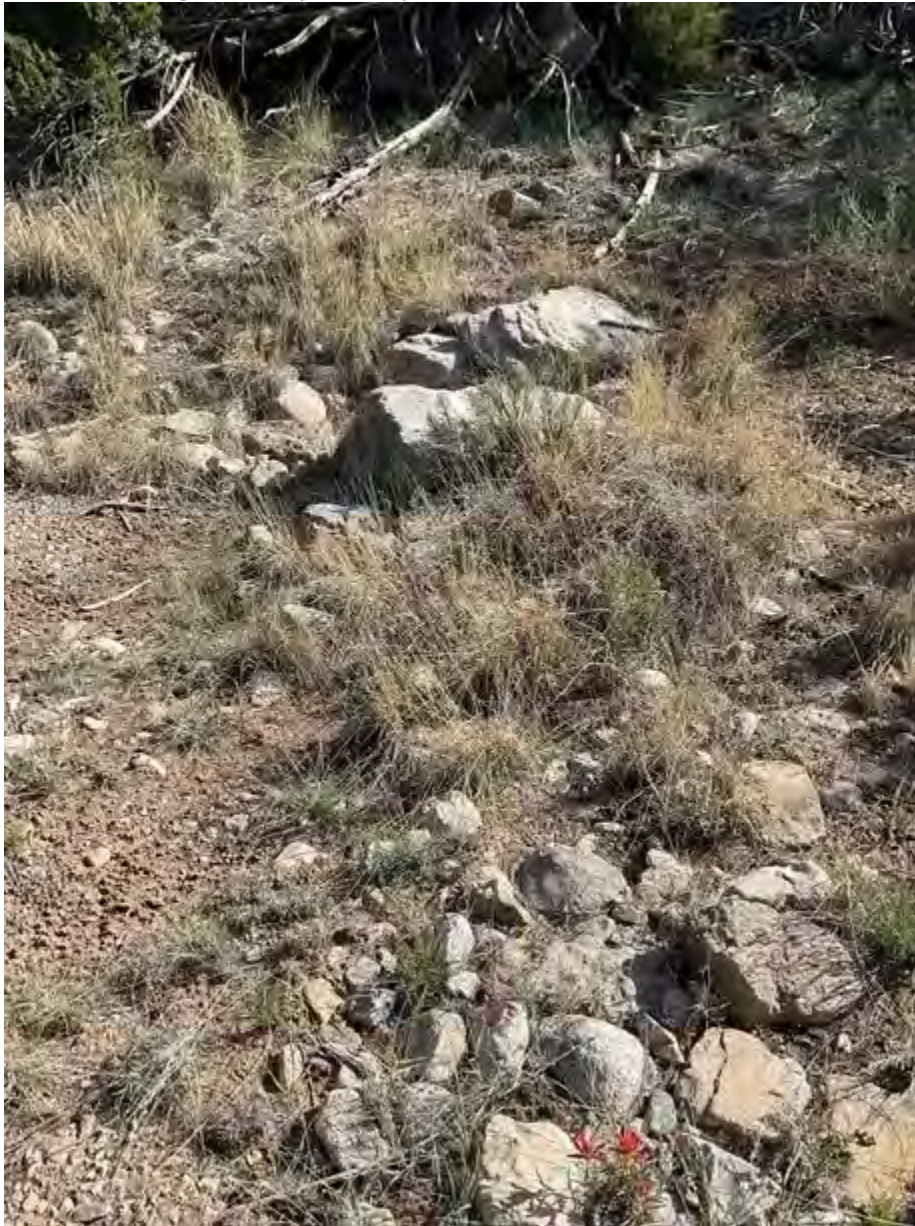
Photo 4 looking cross slope (valley left)

Some rocks dislodged or broken

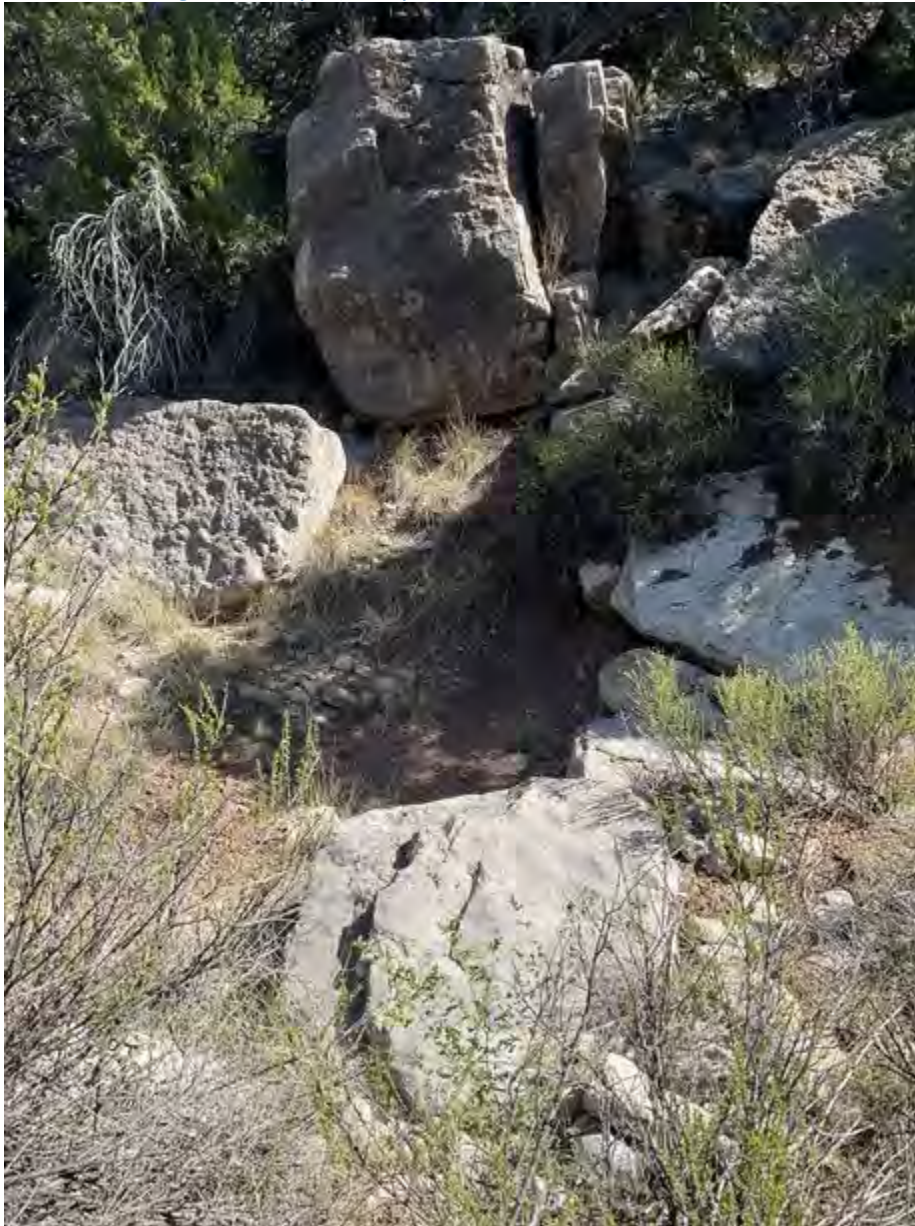
Photo 4 looking cross slope (valley left)

Some rocks dislodged or broken

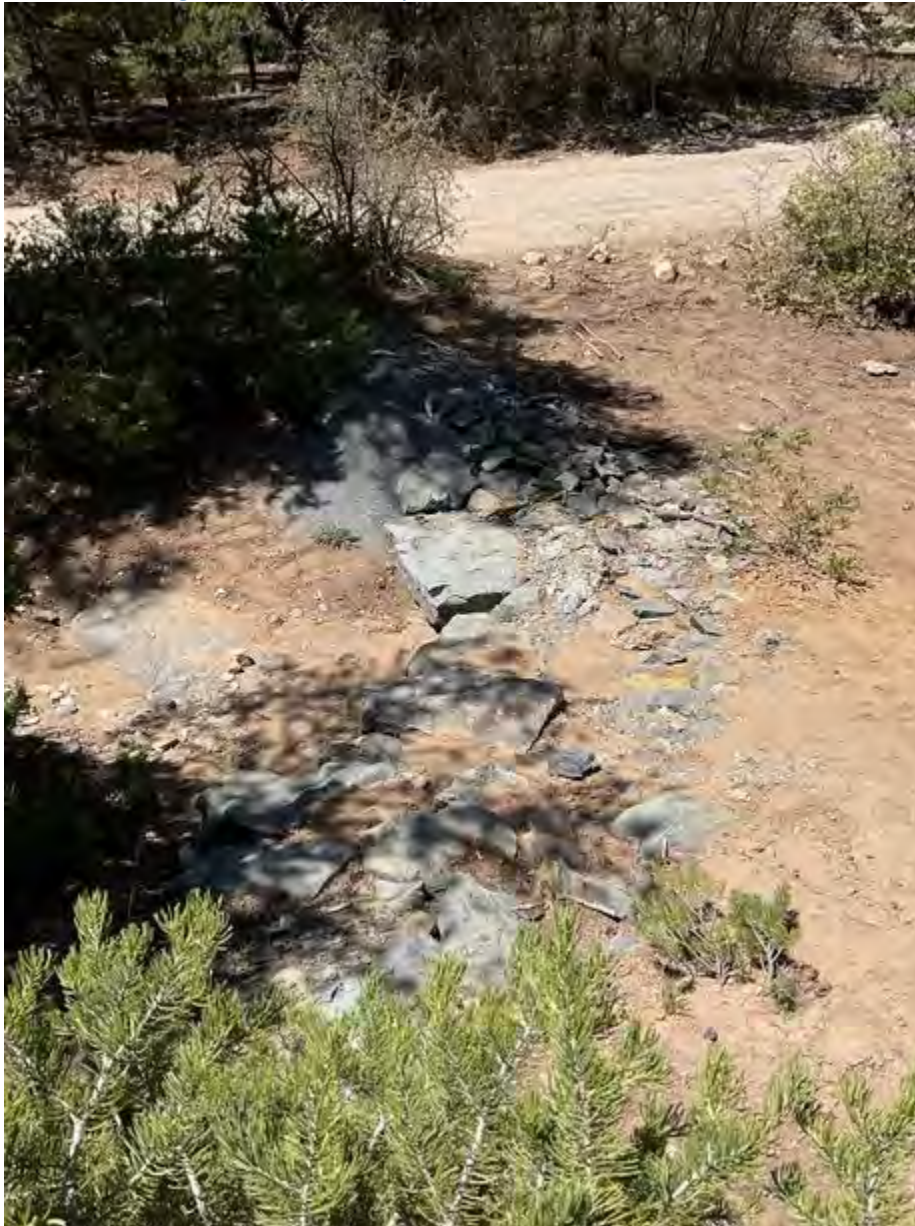
Photo 4 looking cross slope (valley left)

Some rocks dislodged or broken

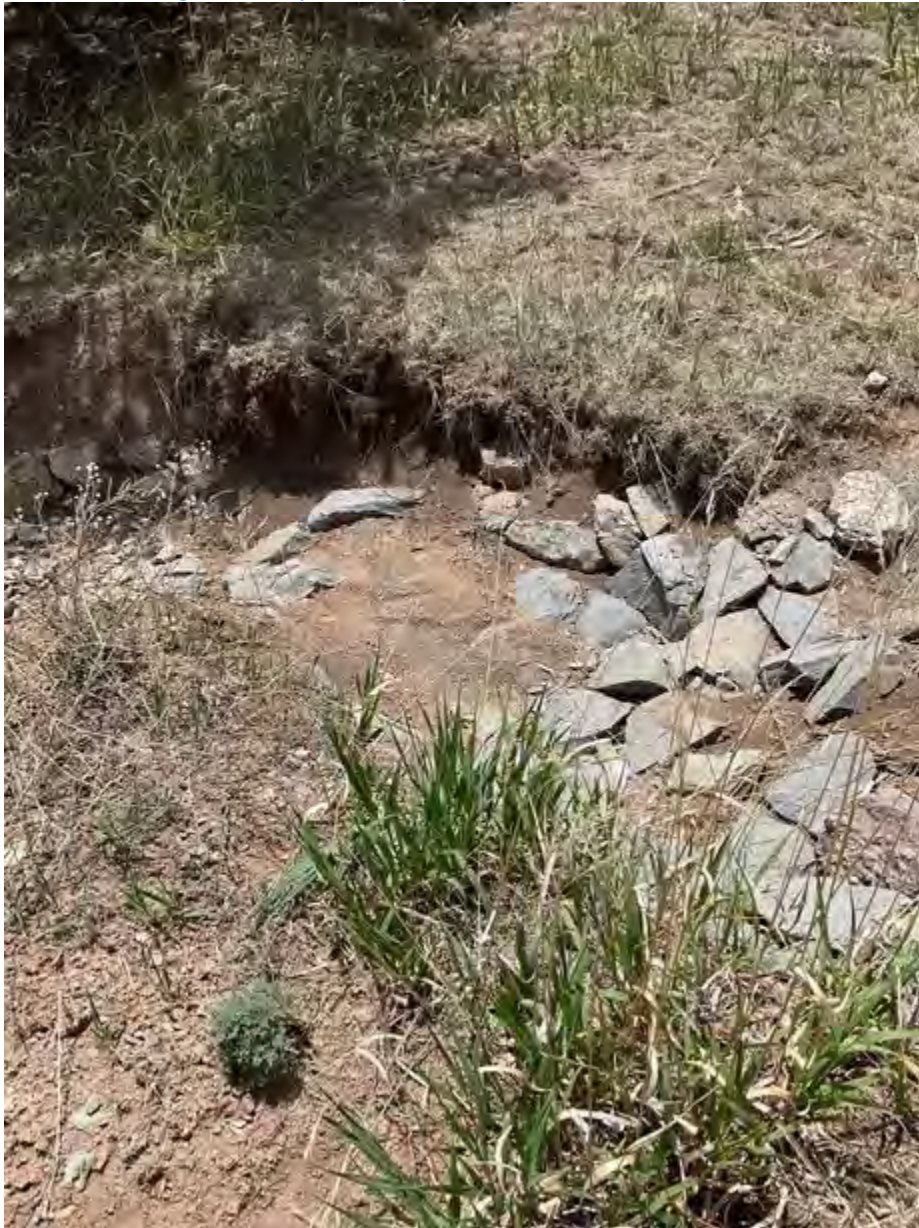
Photo 4 looking cross slope (valley left)

Some rocks dislodged or broken

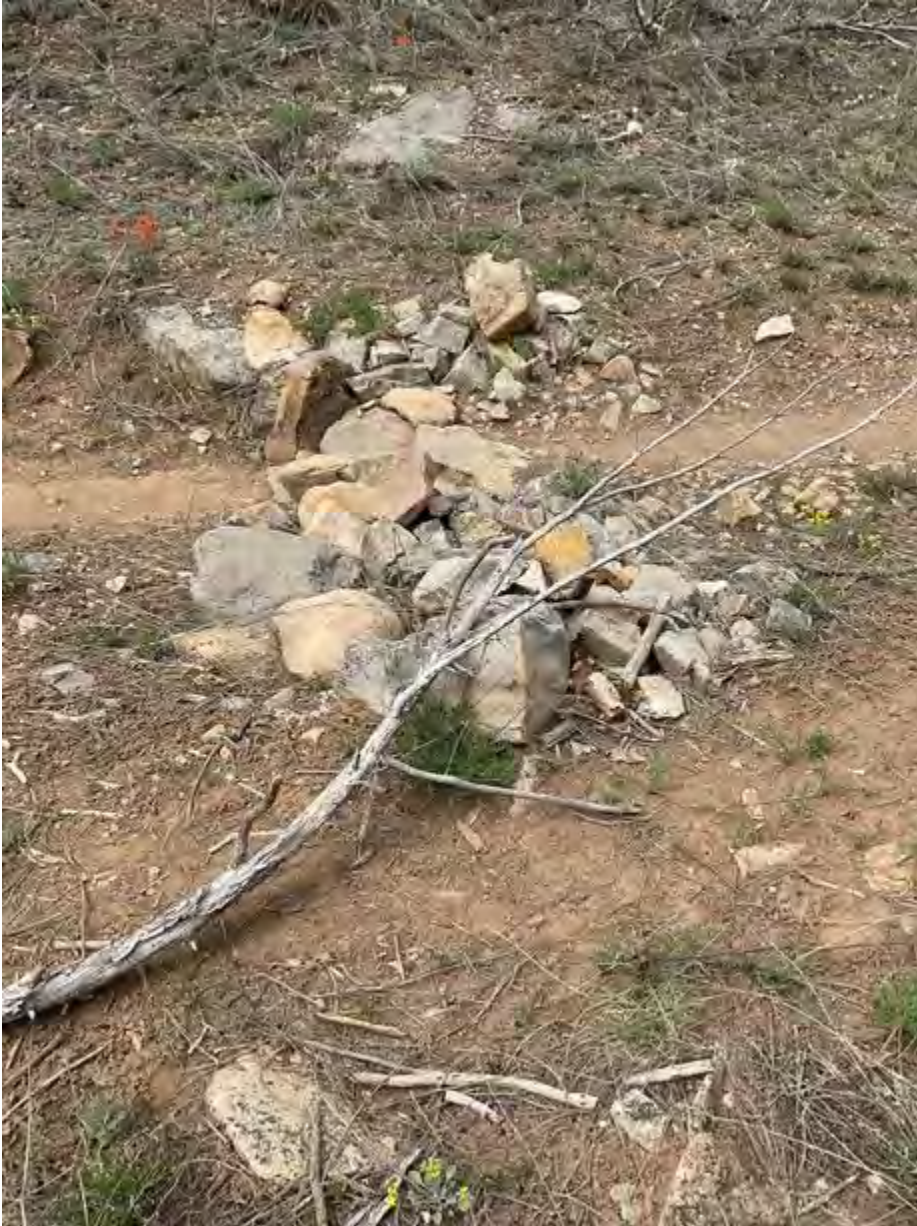
Photo 4 looking cross slope (valley left)

Some rocks dislodged or broken

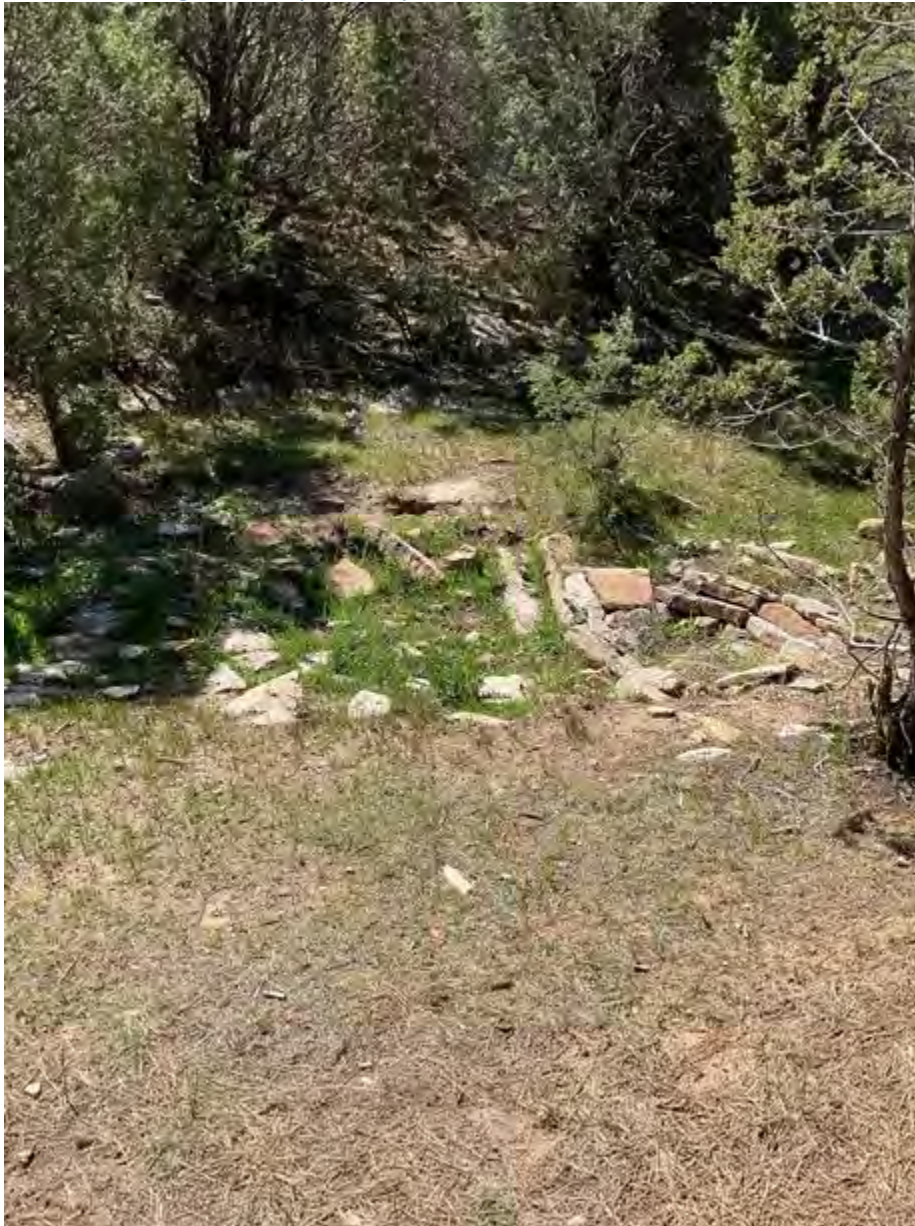
Photo 4 looking cross slope (valley left)

Some rocks dislodged or broken

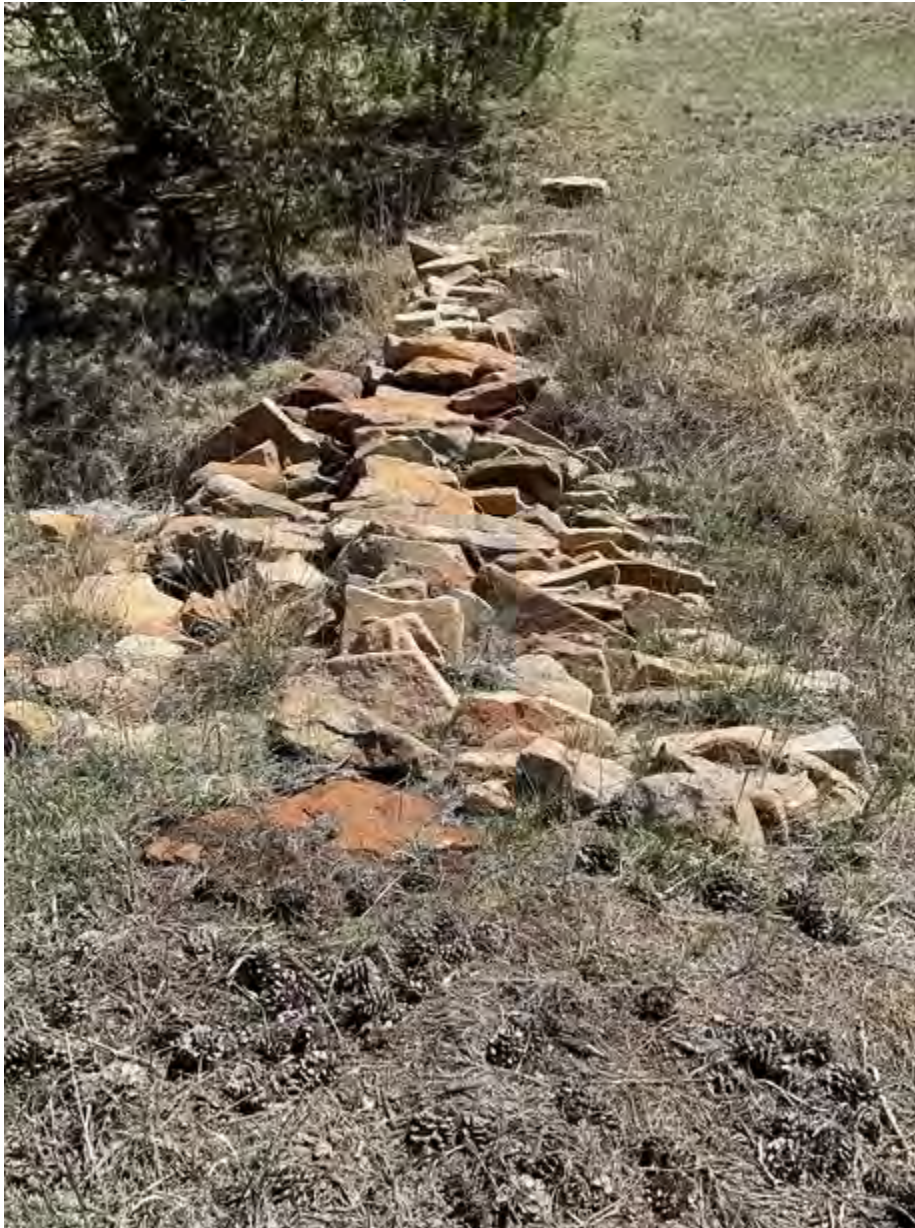
Photo 4 looking cross slope (valley left)

Some rocks dislodged or broken

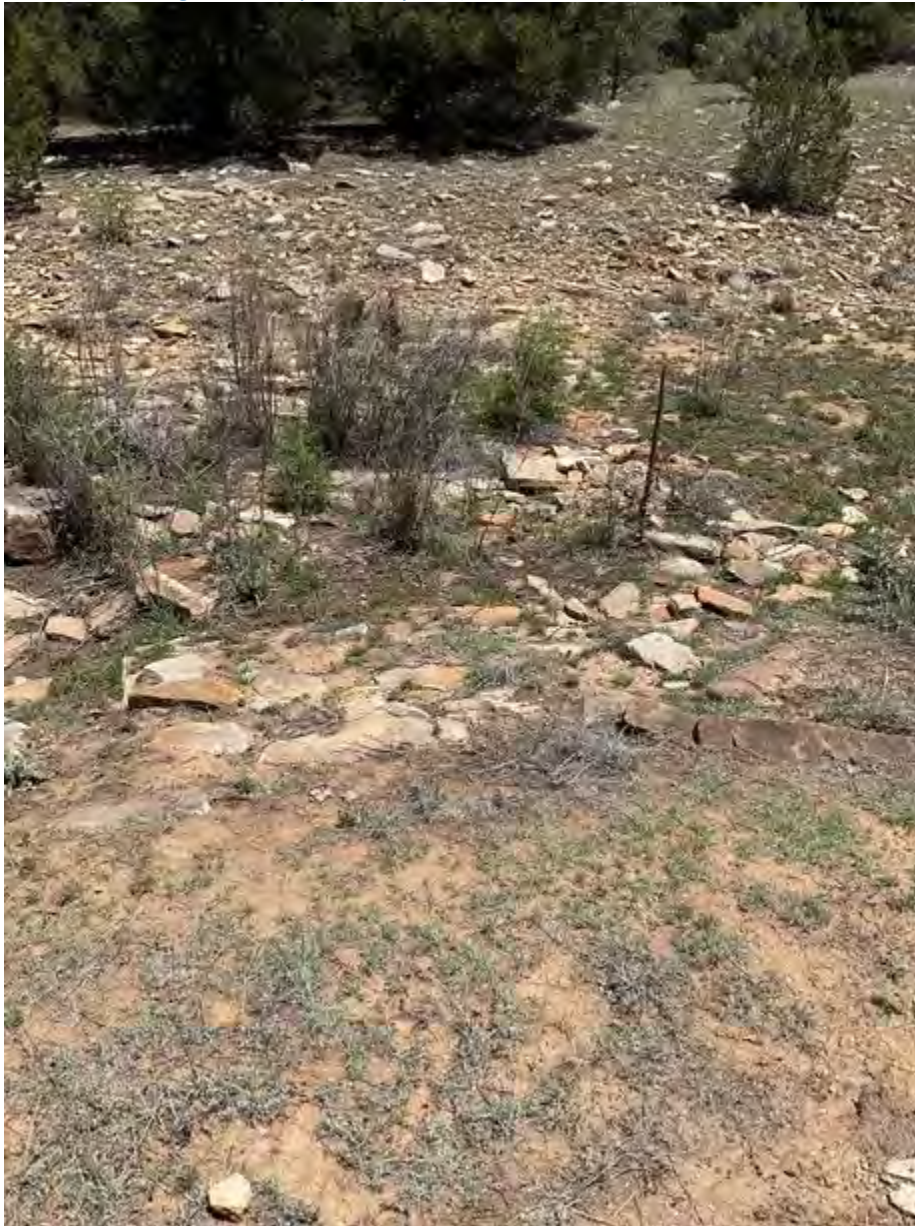
Photo 4 looking cross slope (valley left)

Some rocks dislodged or broken

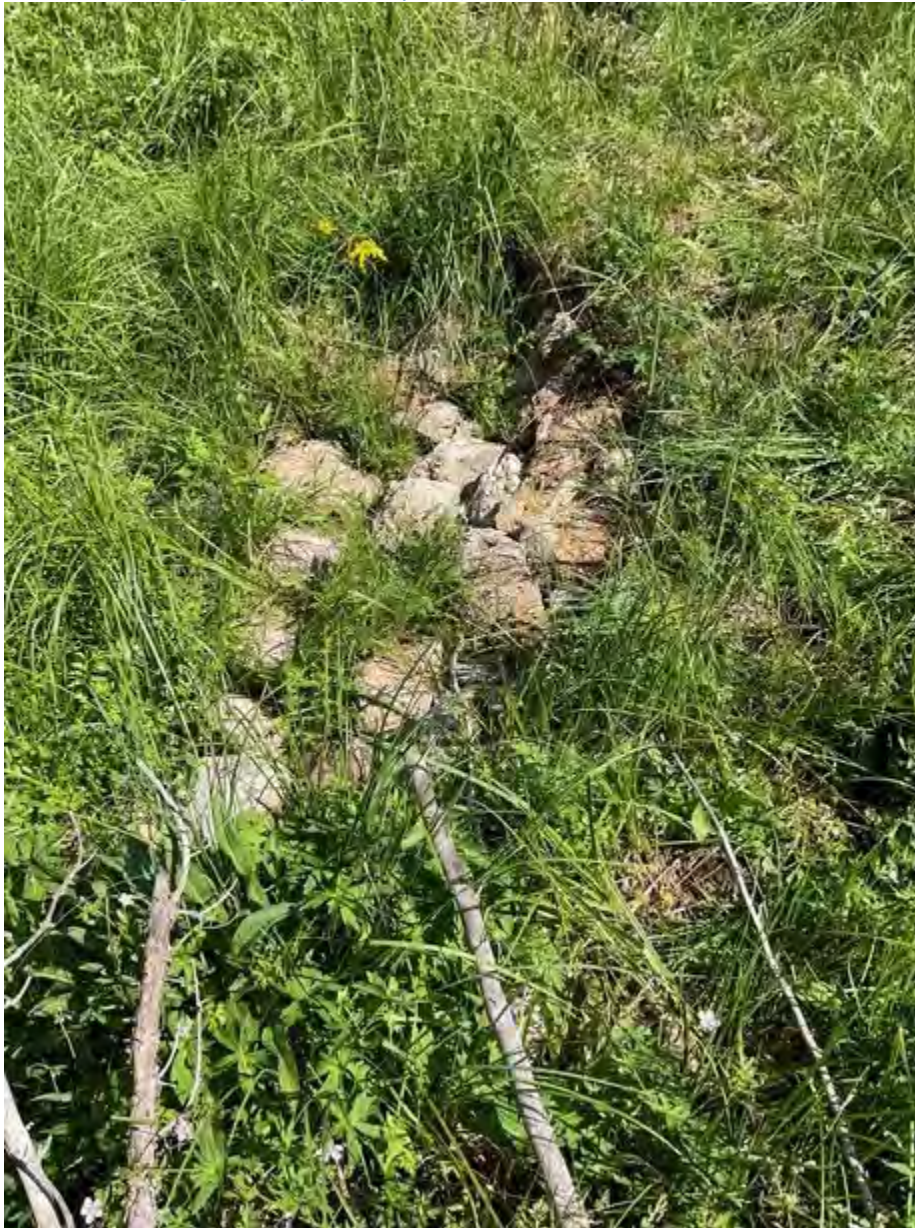
Photo 4 looking cross slope (valley left)

Some rocks dislodged or broken

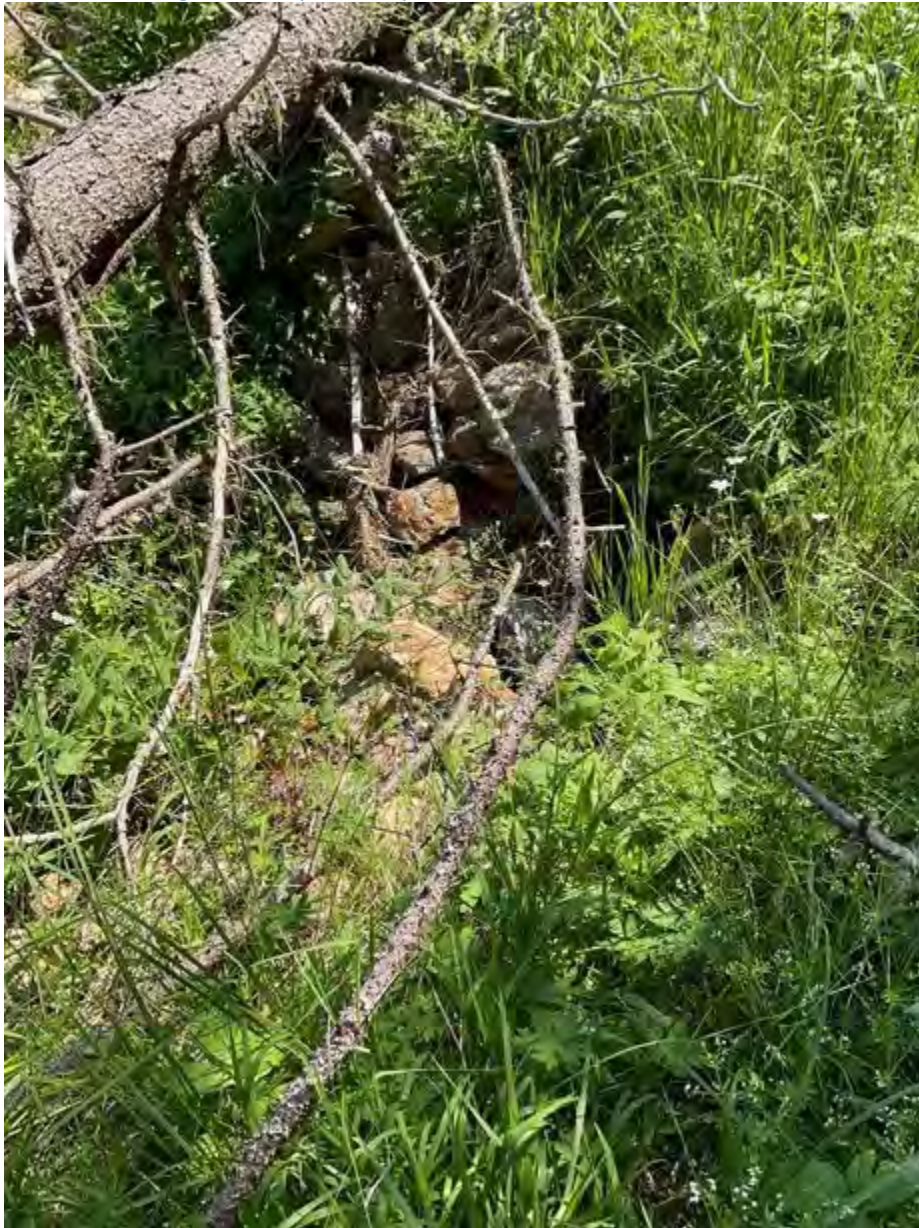
Photo 4 looking cross slope (valley left)

Some rocks dislodged or broken

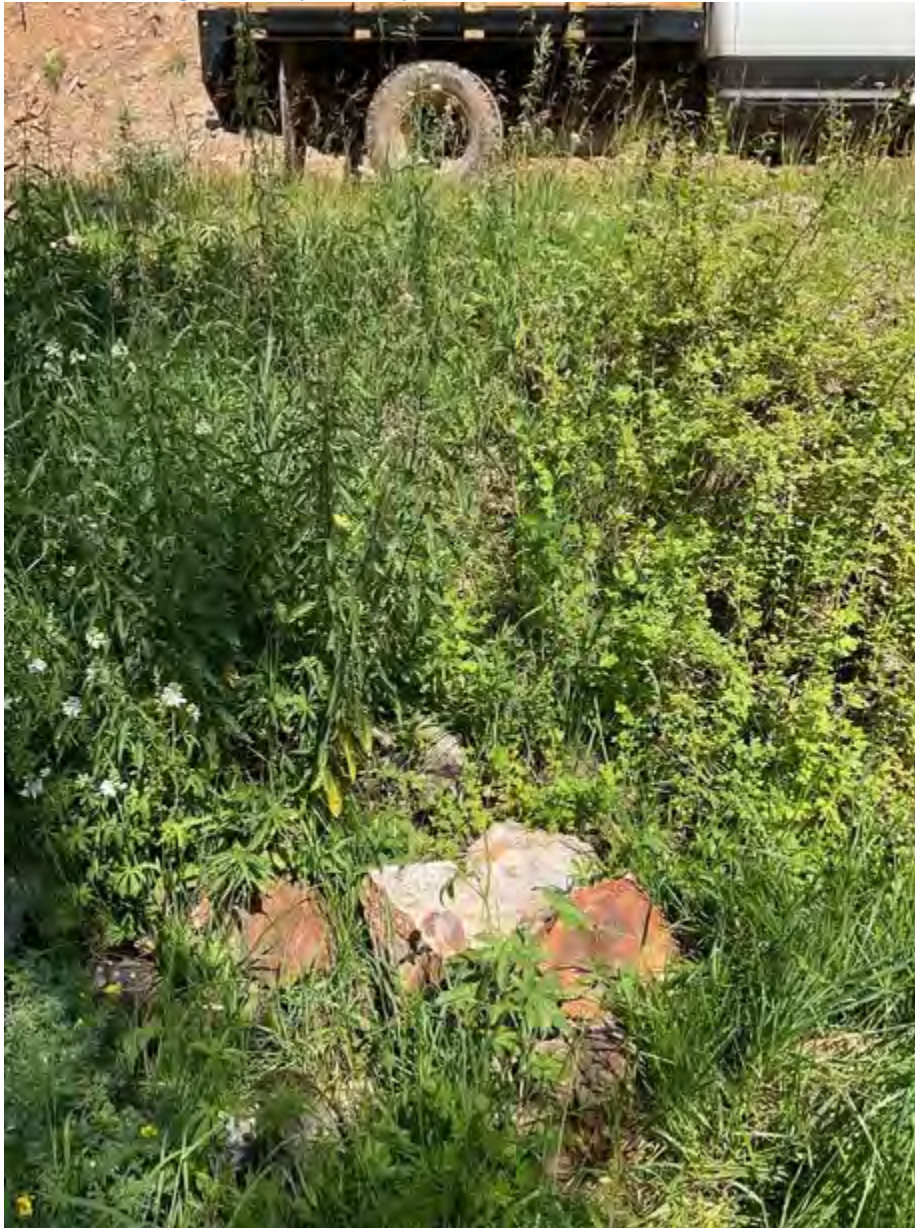
Photo 4 looking cross slope (valley left)

Some rocks dislodged or broken

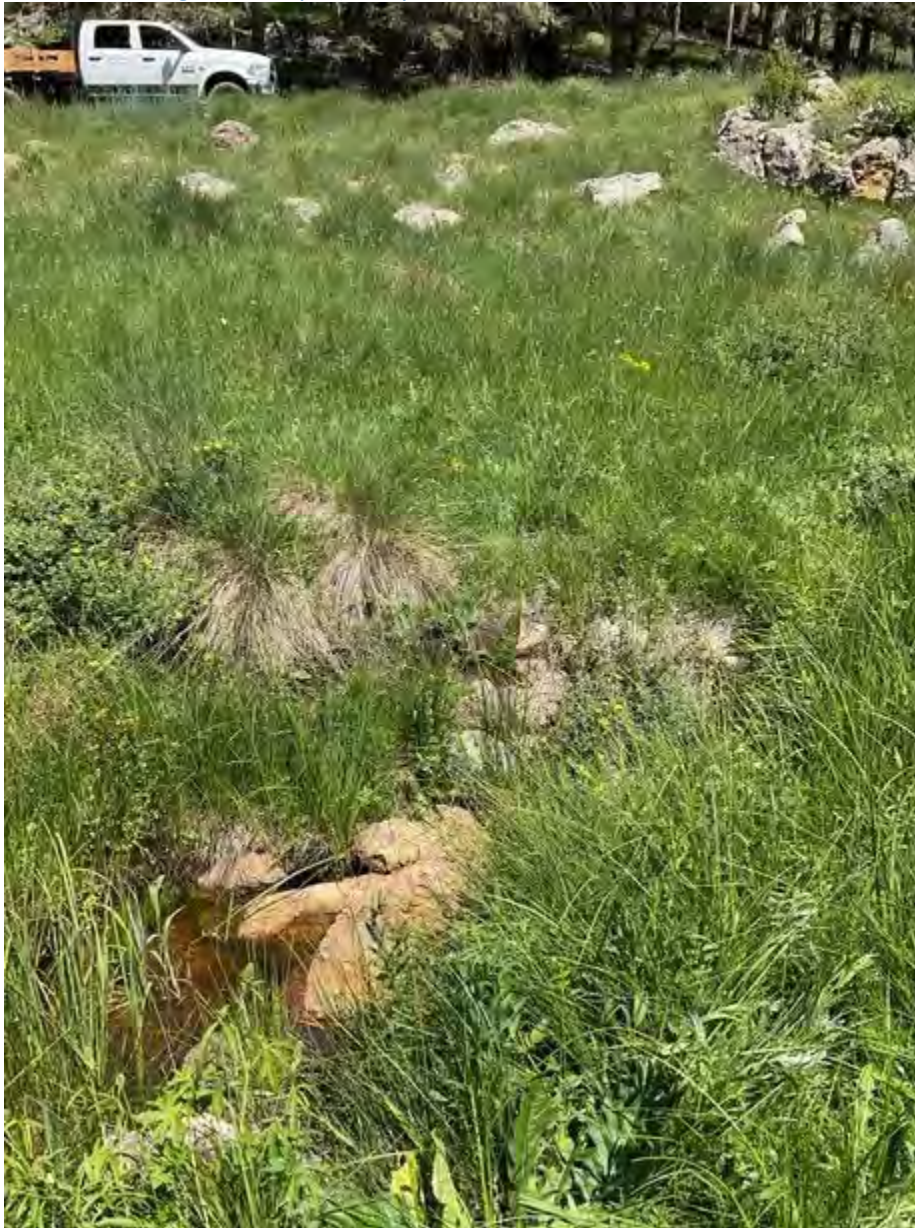
Photo 4 looking cross slope (valley left)

Some rocks dislodged or broken

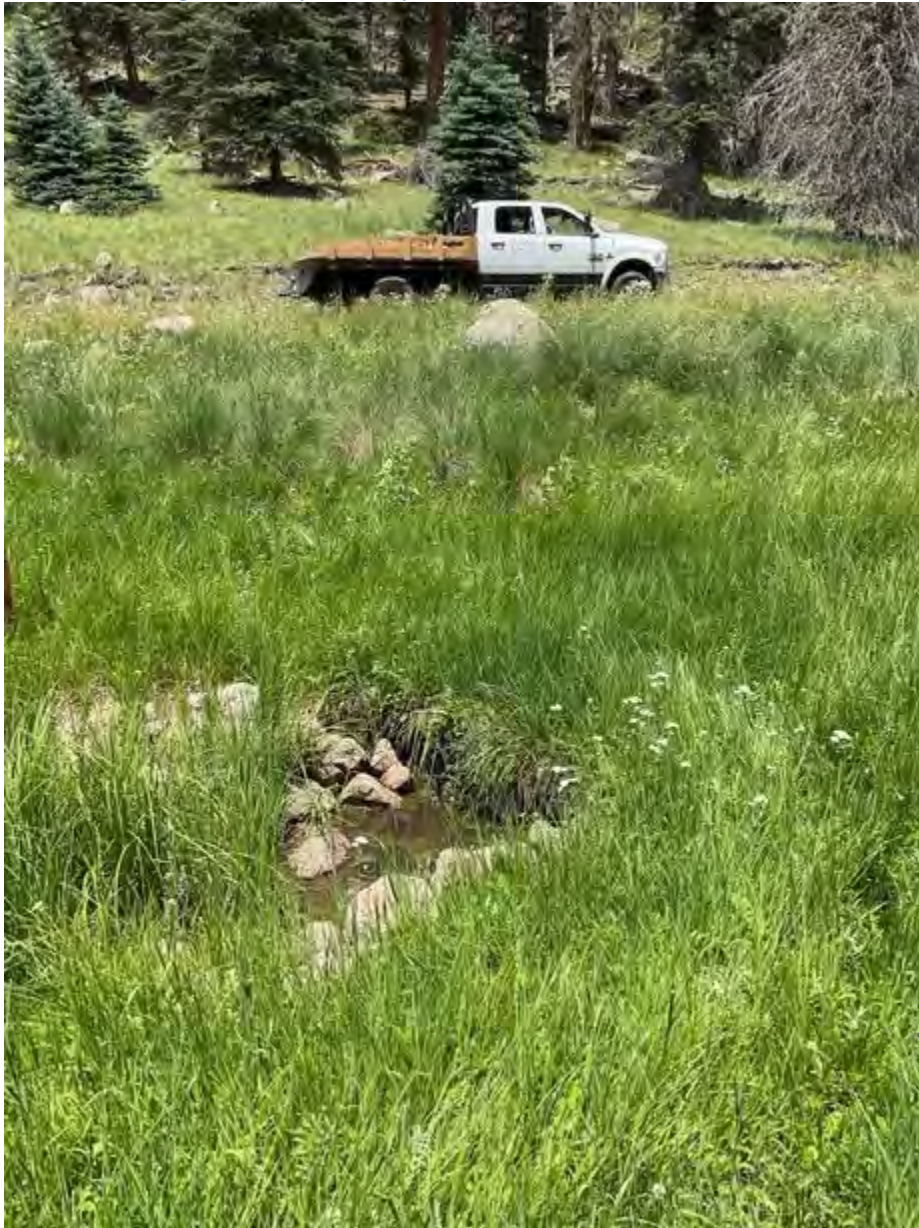
Photo 4 looking cross slope (valley left)

Some rocks dislodged or broken

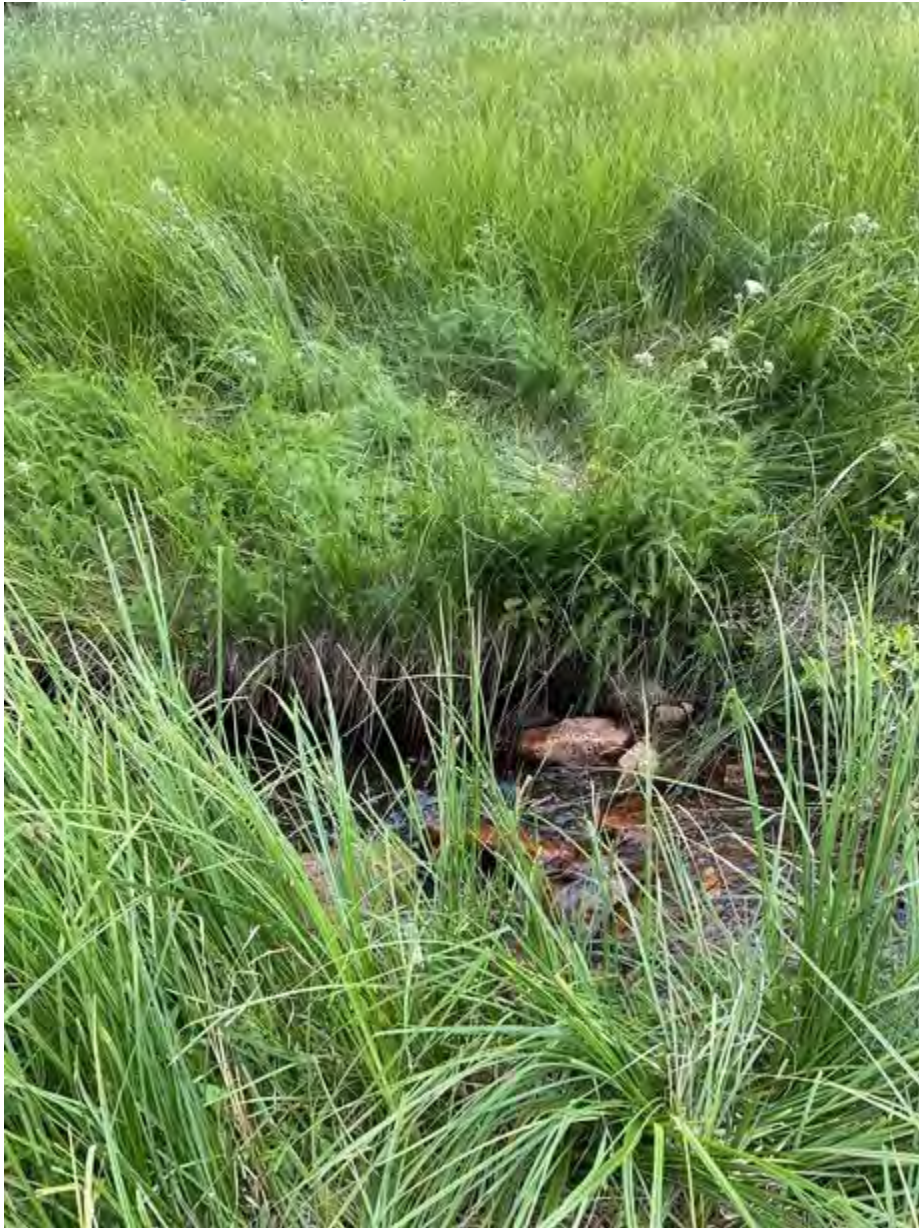
Photo 4 looking cross slope (valley left)

Some rocks dislodged or broken

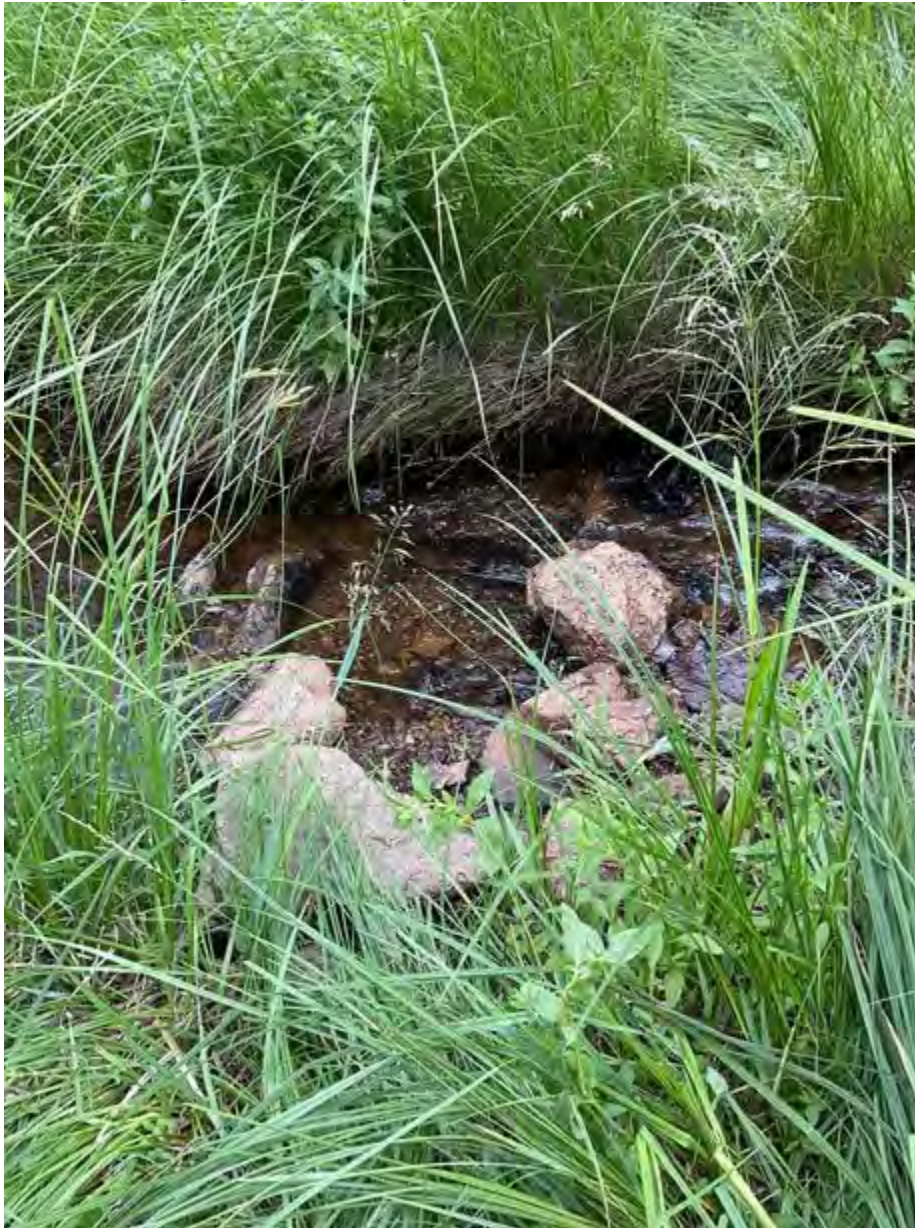
Photo 4 looking cross slope (valley left)

Some rocks dislodged or broken

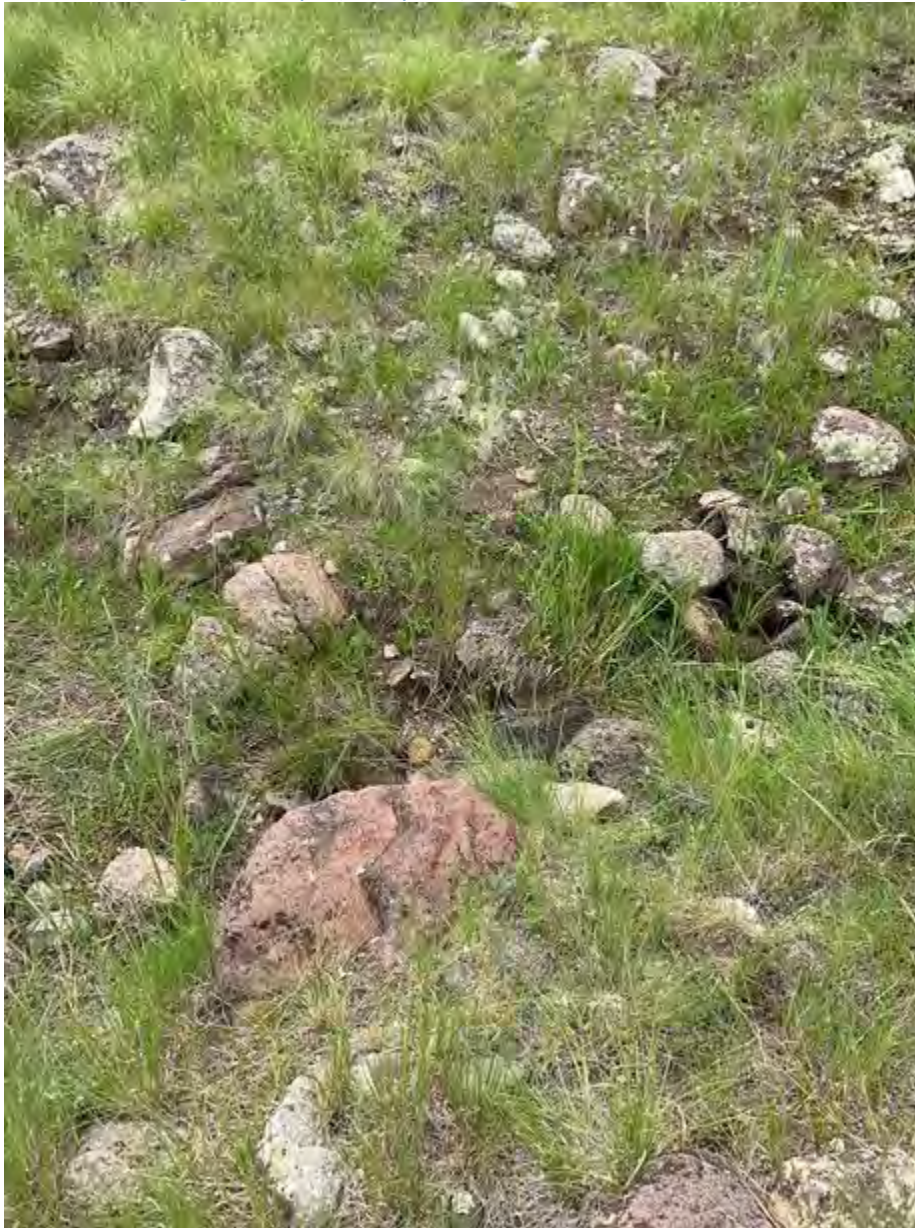
Photo 4 looking cross slope (valley left)

Some rocks dislodged or broken

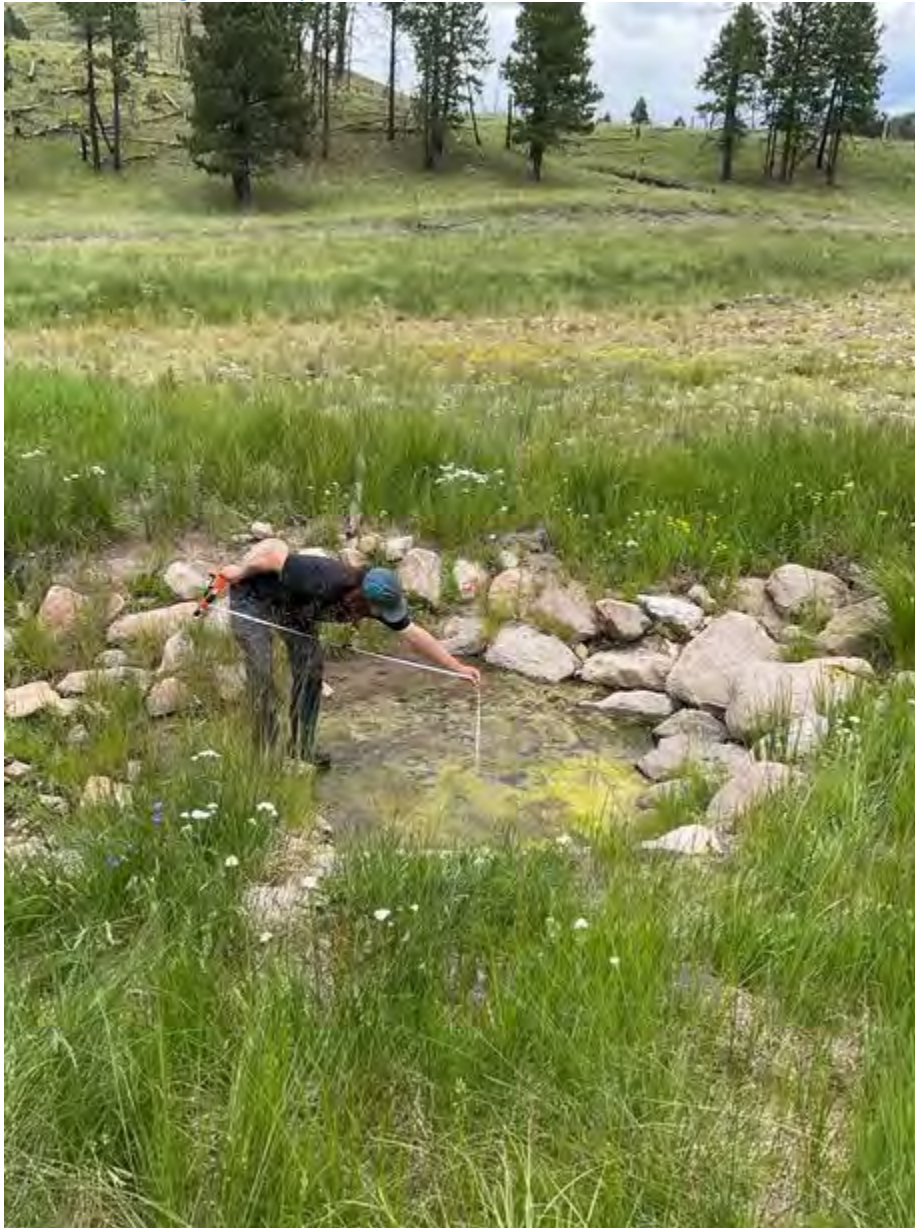
Photo 4 looking cross slope (valley left)

Some rocks dislodged or broken

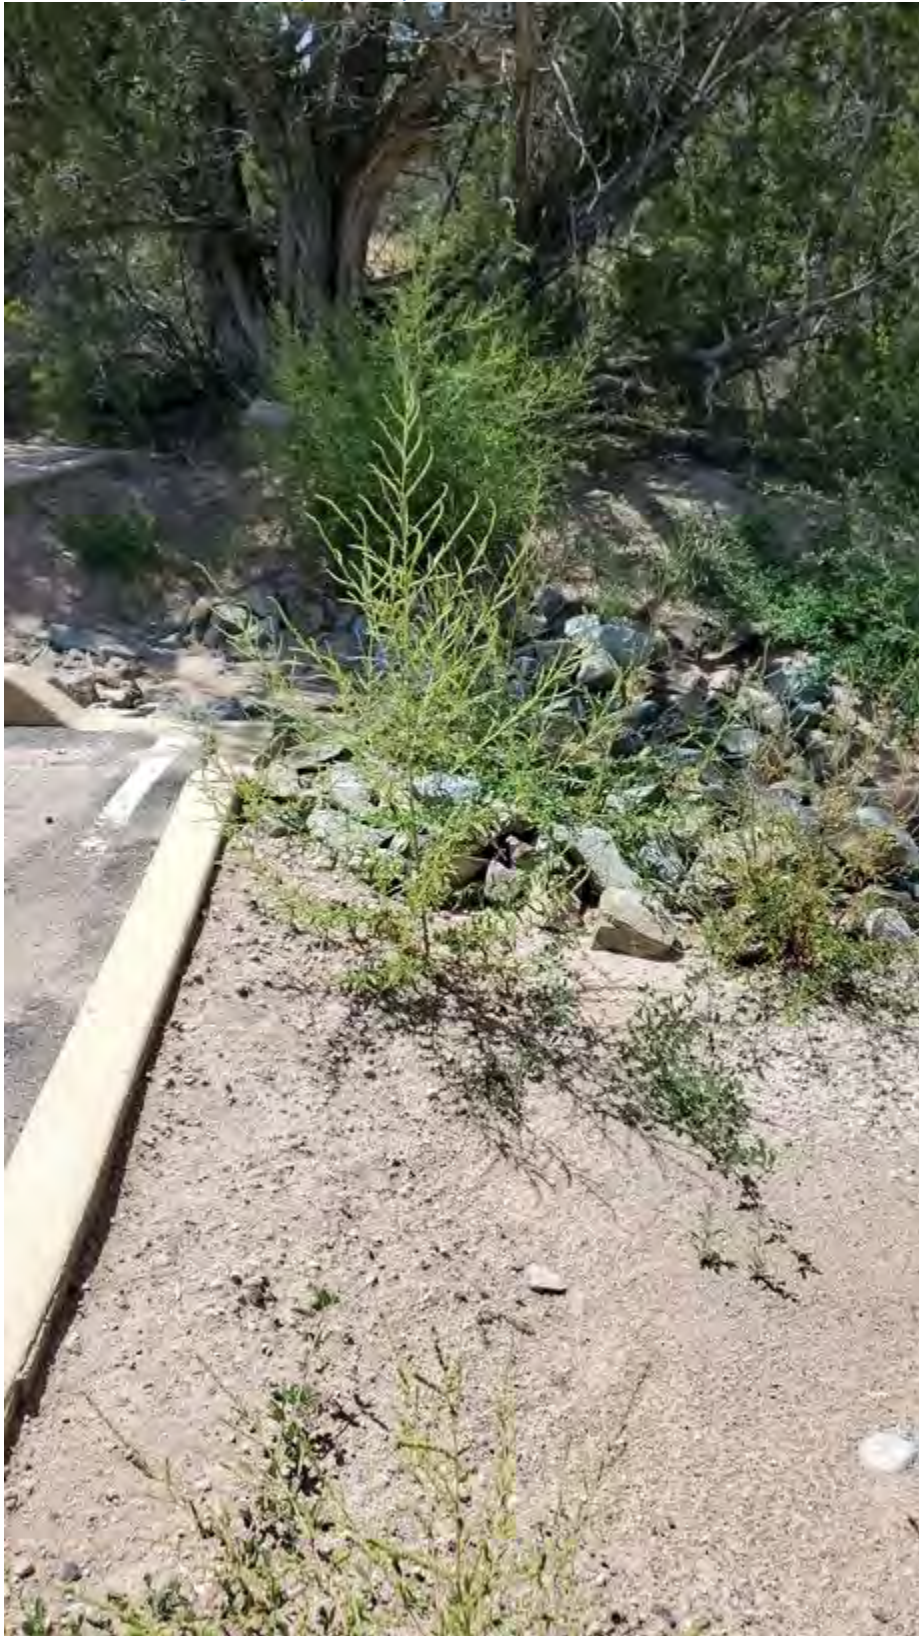
Photo 4 looking cross slope (valley left)

Some rocks dislodged or broken
