**Zuni Bowl and One Rock Check Dam Research –
Phase 1**

Final Report

December 2024

Rio Grande Return for the New Mexico Department of Transportation Research Bureau

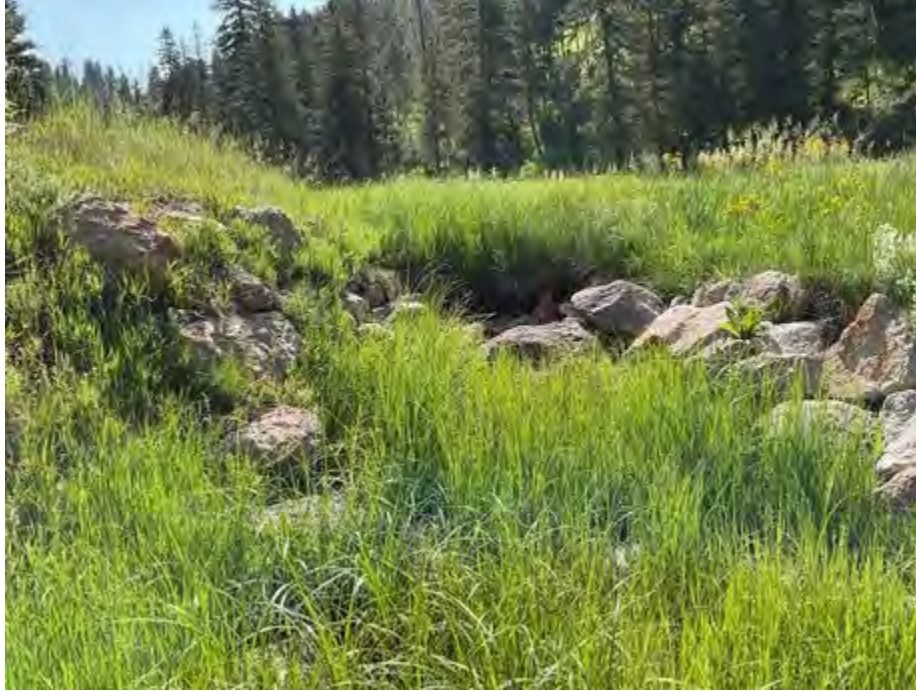
The majority of structures surveyed (68%) were entirely intact, whereas the remainder (32%) had at least one rock dislodged or broken. This is shown in Figure 3-3. This means that most of the structures have become integrated with the landscape and are likely functioning to arrest erosion. Dislodged rocks were deemed to be caused by water in all cases except one that was identified as human interference. RGR did not identify or survey any significantly deteriorated structures. Figure 3-4 shows a structure where some rocks were dislodged by water.

Figure 3-4. Example of some rocks dislodged or broken. Rocks were displaced from the Zuni Bowl Pour-Over shown in the center of the photo. Sulphur Creek #2. Object ID 51 in survey. Location: -106.6014258, 35.9241155. Photo looking upslope.

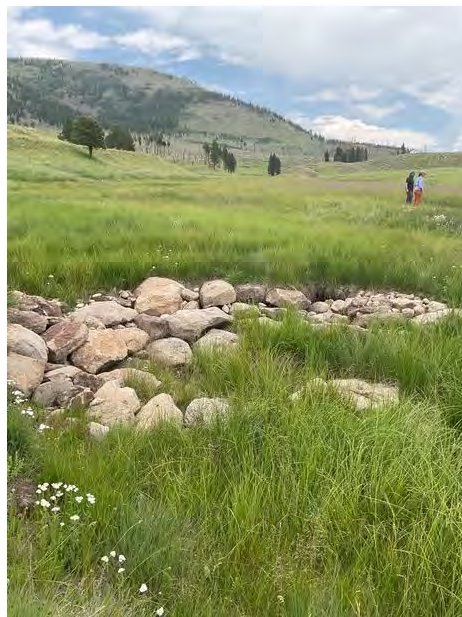
The majority of the structures (75%) exhibited no new erosion. This is shown in Figure 3-5. Some structures experienced undercutting (or piping) around the rocks (14%). Fewer show signs of erosion around the sides of the structure (8%). At the remaining (3%) of survey points, erosion was observed between the Zuni Bowl and One Rock Dam due to steep slopes. Figure 3-6 shows an example of a structure where undercutting or piping has occurred.

Figure 3-6. Undercutting or piping through the rocks is seen on the far side of the Zuni Bowl wall on the right. Santa Rosa #6, Object ID 55 in survey. Location: -106.5974051, 35.92597653. Looking toward valley left.

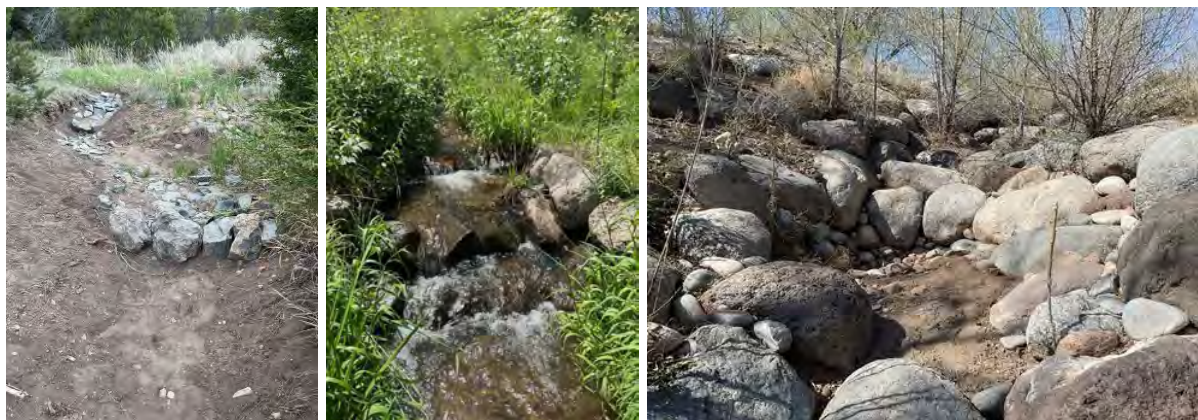
means some edges and flat surfaces. Round means all rounded. Using rocks that are partially angular to angular is desirable because these rocks will interlock and reduce pore space in the structure. Figure 3-9 shows examples of structures with different rock angularity.

Figure 3-9. Examples of angular (left), partially angular (middle) and round (right) rocks. Locations: -106.3531756, 35.0482939; -106.5187878, 35.86520847; and -105.97 27933, 35.68119967, respectively.

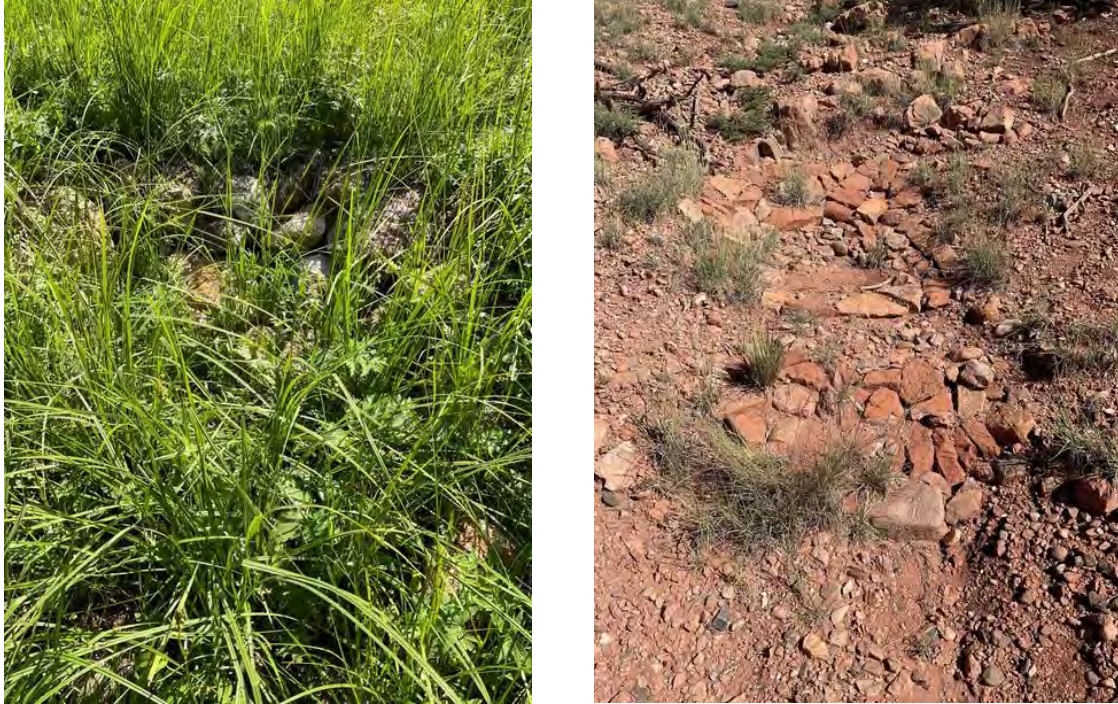
*Figure 3-15. Examples of 76-100% vegetated (left) and 1-24% vegetated (right).
Locations: -106.6013747, 35.9240822; and -105.942457, 35.44432338, respectively.*

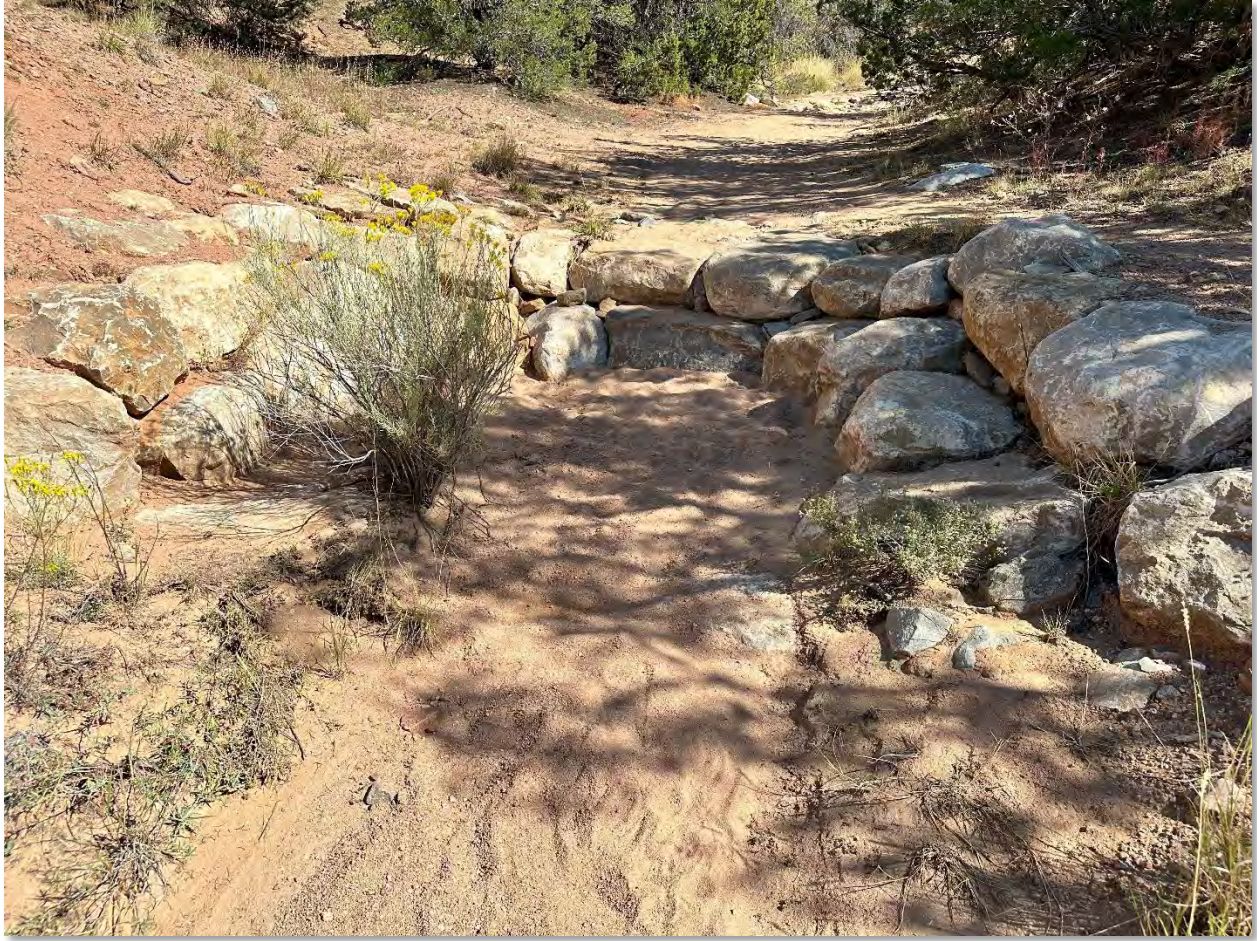
The field trip site has numerous examples of rock structures built by Watershed Artisans, Inc., The RainCatcher Inc, and Southwest Urban Hydrology, LLC in approximately 2014. The structures are intact and embedded with little evidence of new erosion or displacement. Workshop participants were able to see two Zuni Bowl/One Rock Dam structures, several rock rundowns, plunge pools (similar to successive Zuni Bowls on a steep slope, and 1930s-era gabion baskets in the arroyo, before the snow began to obscure the structures. This is shown in Figure 4-4. Because of the deteriorating weather, the field trip itinerary was truncated. Participants were advised that they could come back to the arroyo to see structures at another time as it is public property. A Zuni Bowl in the arroyo is shown in Figure 4-5. There are several other rock structures visible in the arroyo downstream to just beyond the culvert under Camino Corrales.

Figure 4-5. Zuni Bowl in the arroyo at Santa Fe Botanical Gardens. Photo taken on a clear day prior to the field trip. Location: -105.928595, 35.665349.

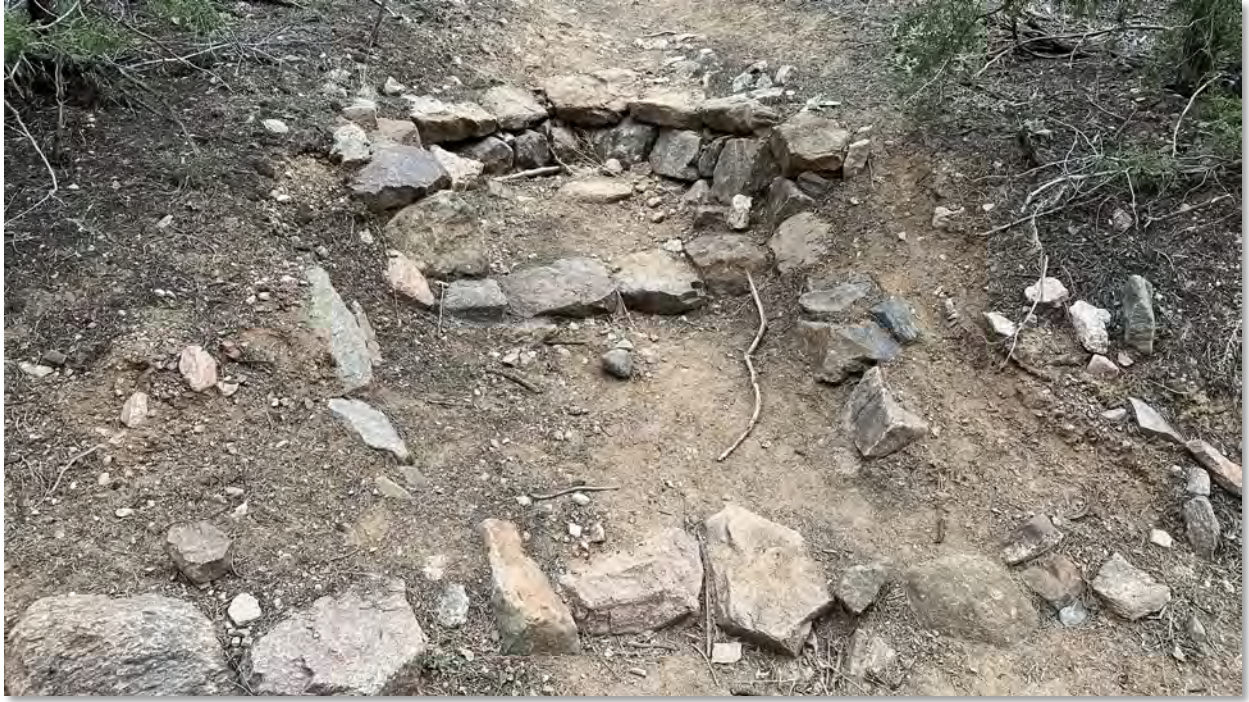
Figure 5-1. Santa Fe Botanical Gardens 10. Object ID 1 in the survey. Location: -105.93051, 35.664118. Photo looking upslope.

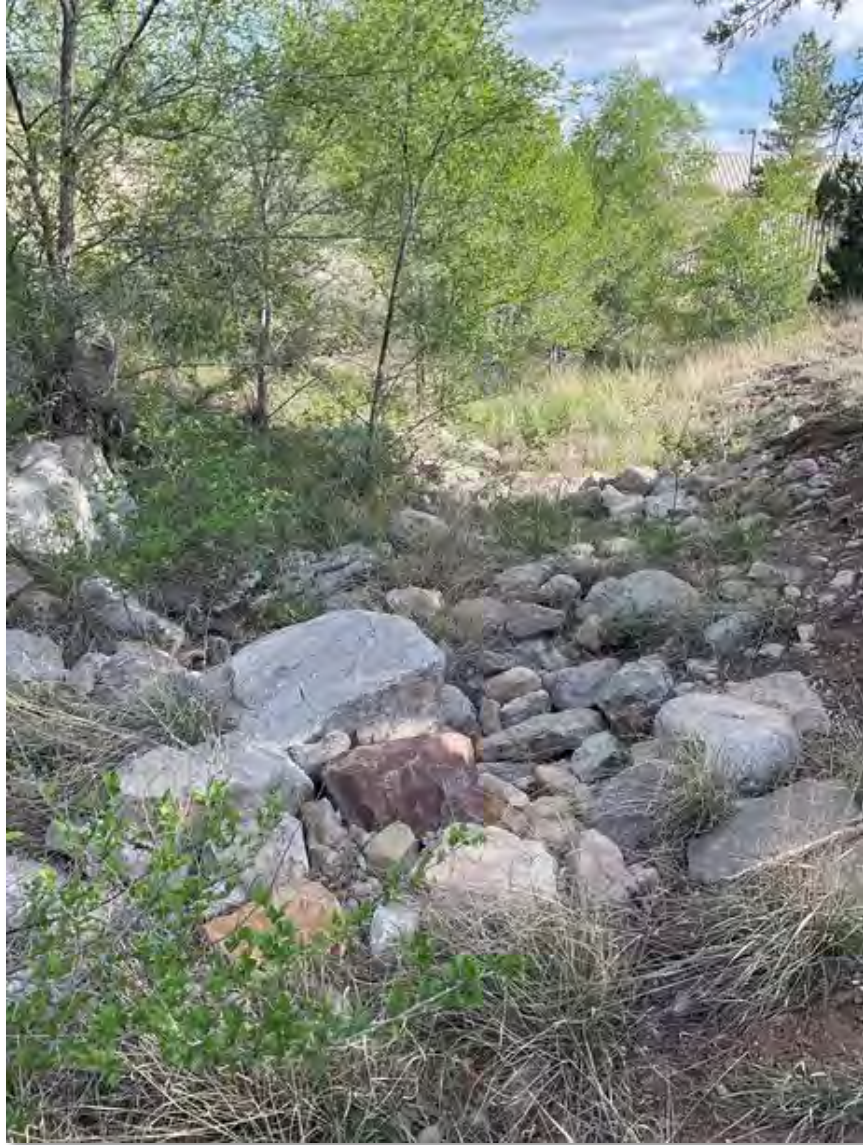
Figure 5-2. Cedro Creek #1. Object ID 3 in the survey. Location: -106.38461, 35.074242. Photo looking downslope.

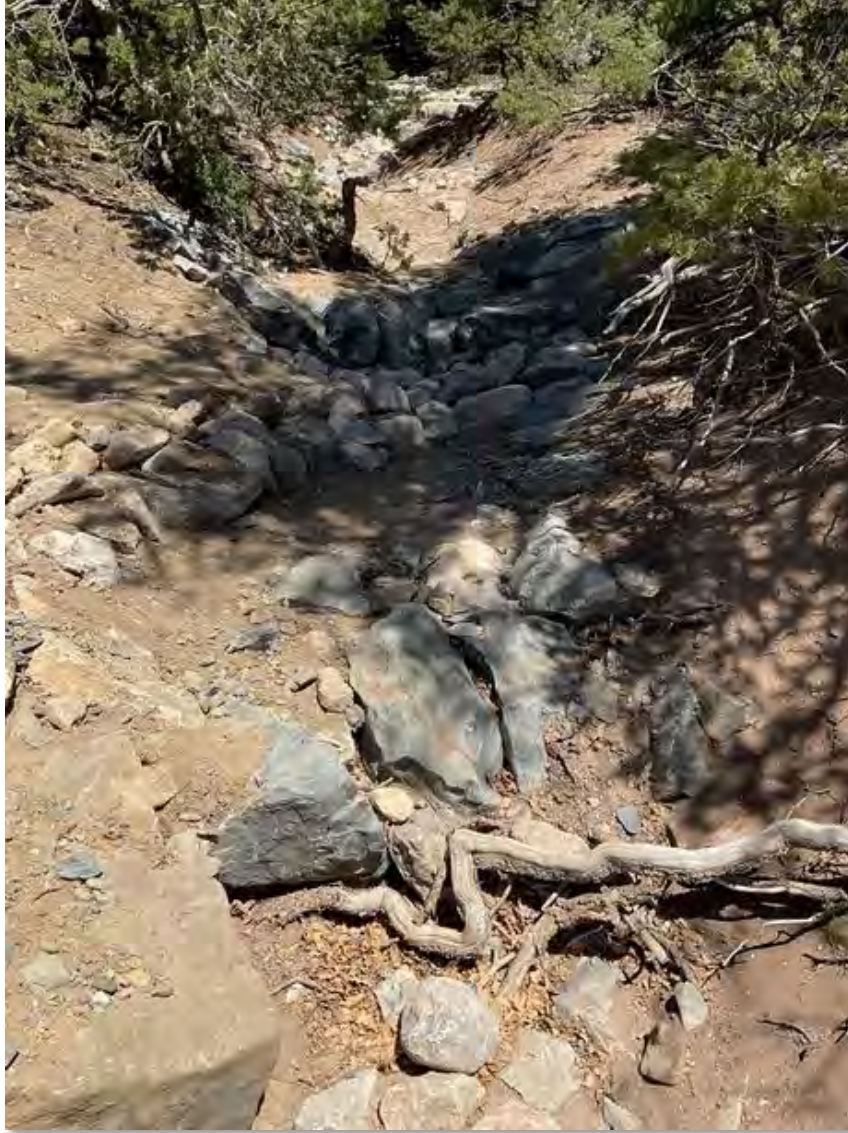
Figure 5-3. Juan Tomas #13, Rio Mora NWR. Object ID 14 in the survey. Location: -106.35365, 35.04917. Photo looking upslope.

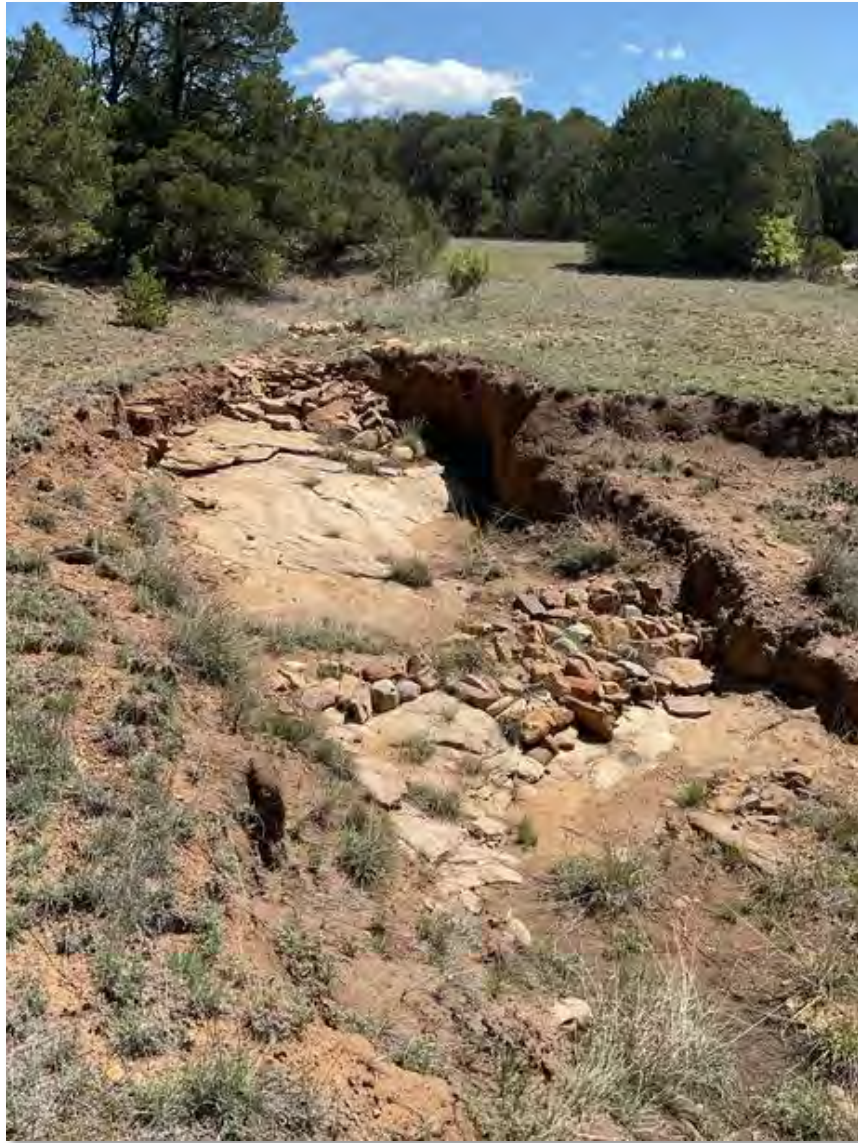
Figure 5-4. Rio Mora NWR #2. Object ID 35 in the survey. Location: -105.0570489, 35.83039503. Photo looking upslope.

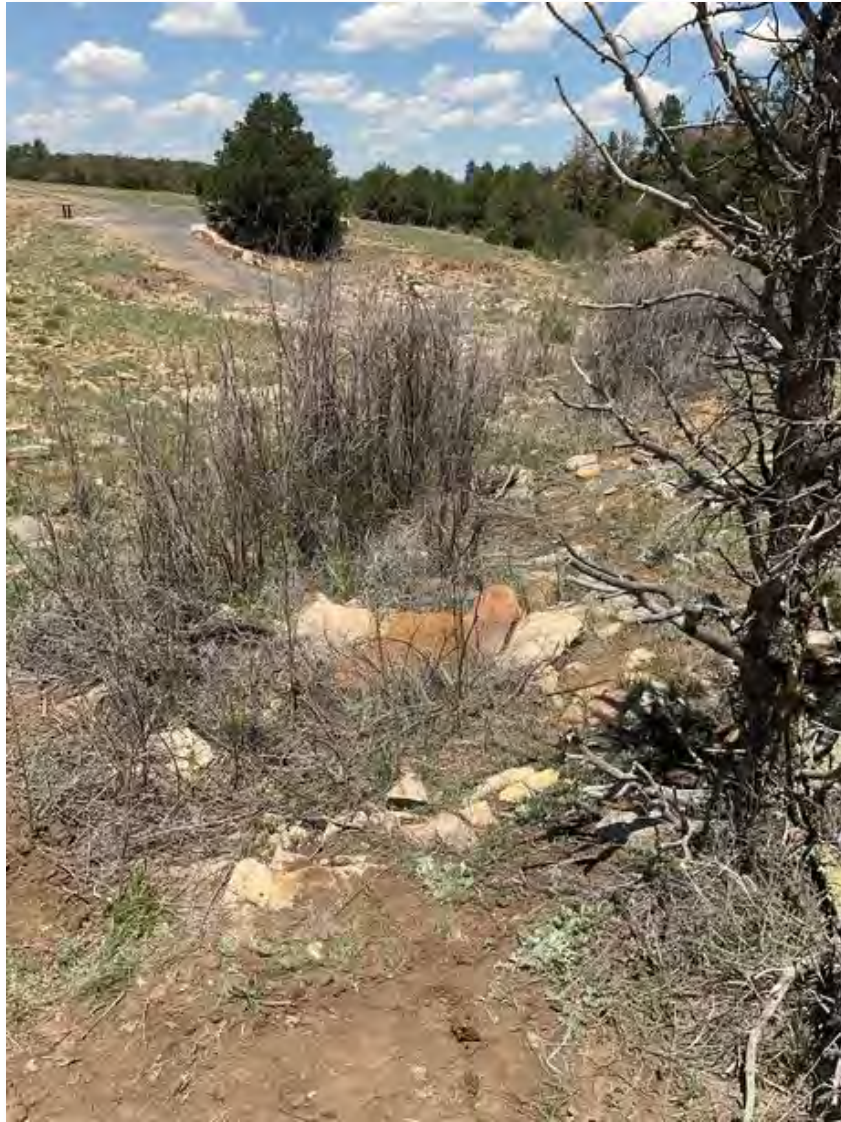
Figure 5-5. Rio Mora NWR #12. Object ID 38 in the survey. Location: -105.073796, 35.83369238. Photo looking downslope.

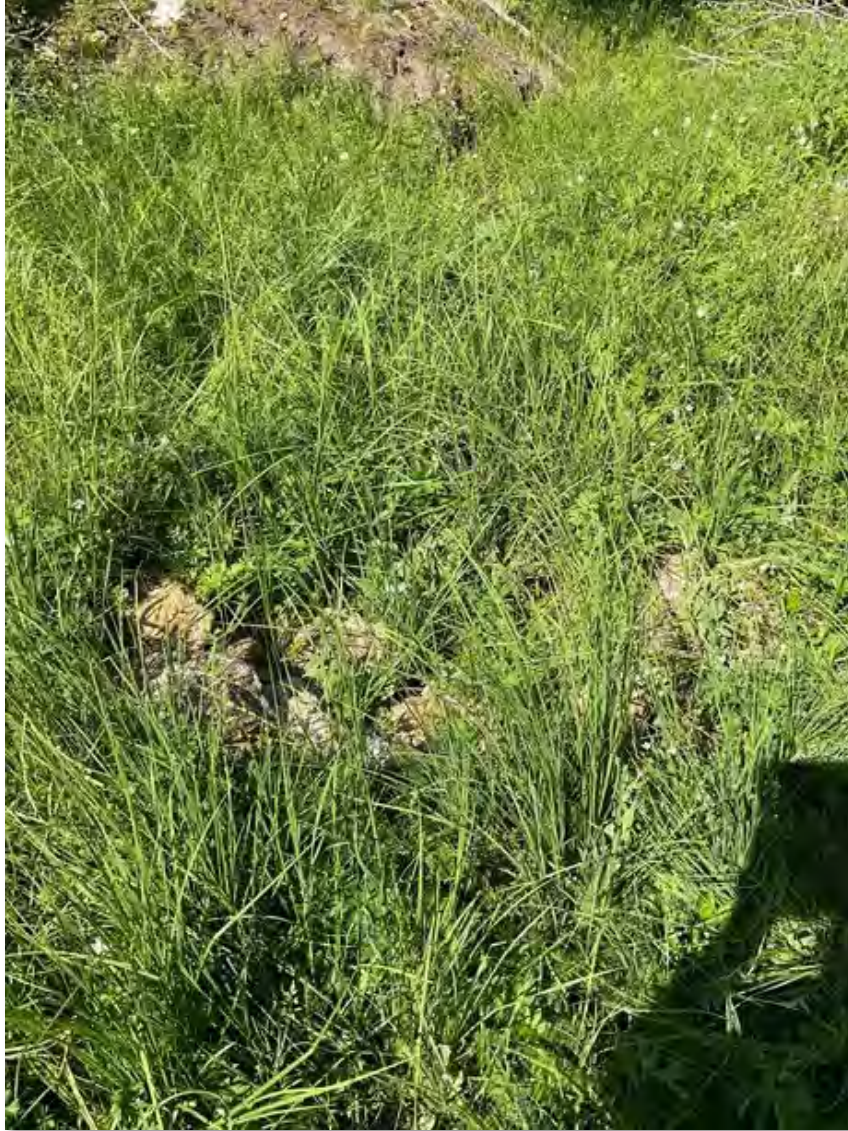
Figure 5-6. Sulphur Creek #3. Object ID 52 in the survey. Location: -106.6013747, 35.9240822. Photo looking downslope. Structure is obscured by vegetation.

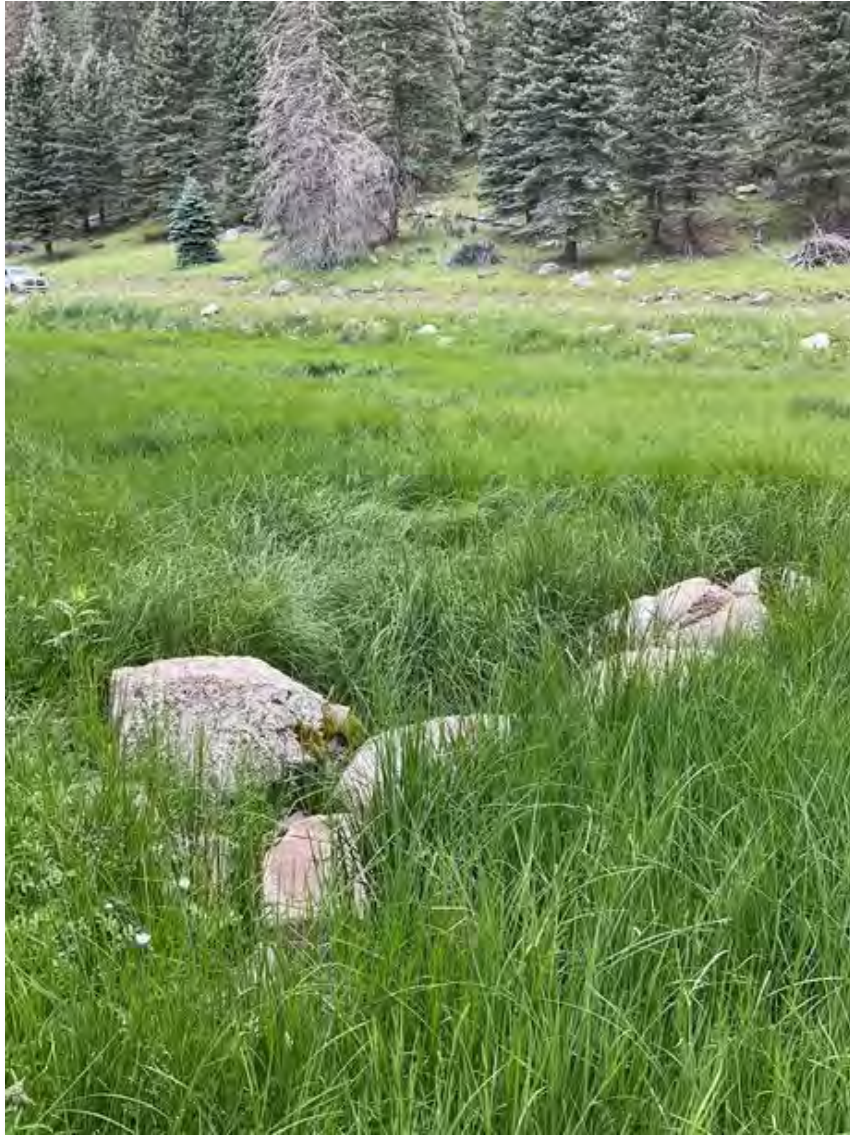
Figure 5-7. Sulphur Creek #14. Object ID 63 in the survey. Location: -106.5914269, 35.93480662 Photo looking downslope. Much of the structure is obscured by vegetation.

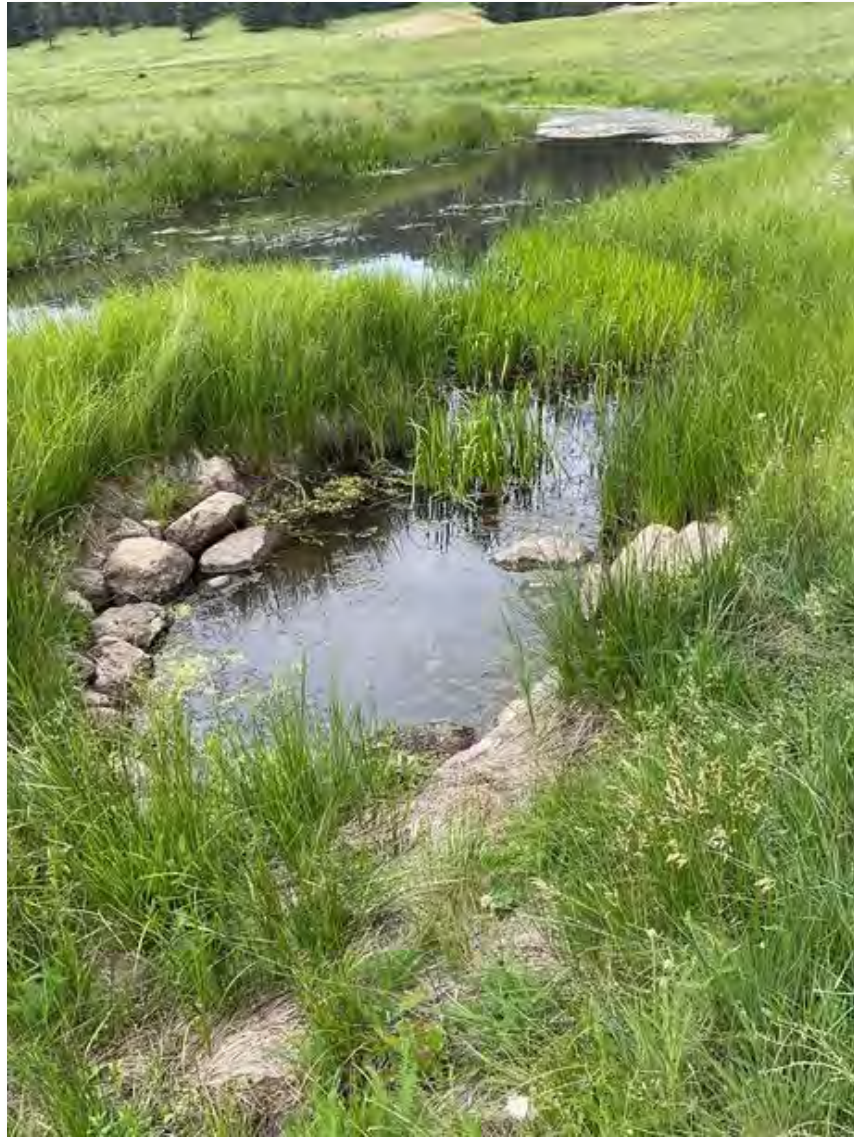
Figure 5-8. Sulphur Creek #15. Object ID 64 in the survey. Location: -106.588288, 35.93802508. Photo looking downslope.

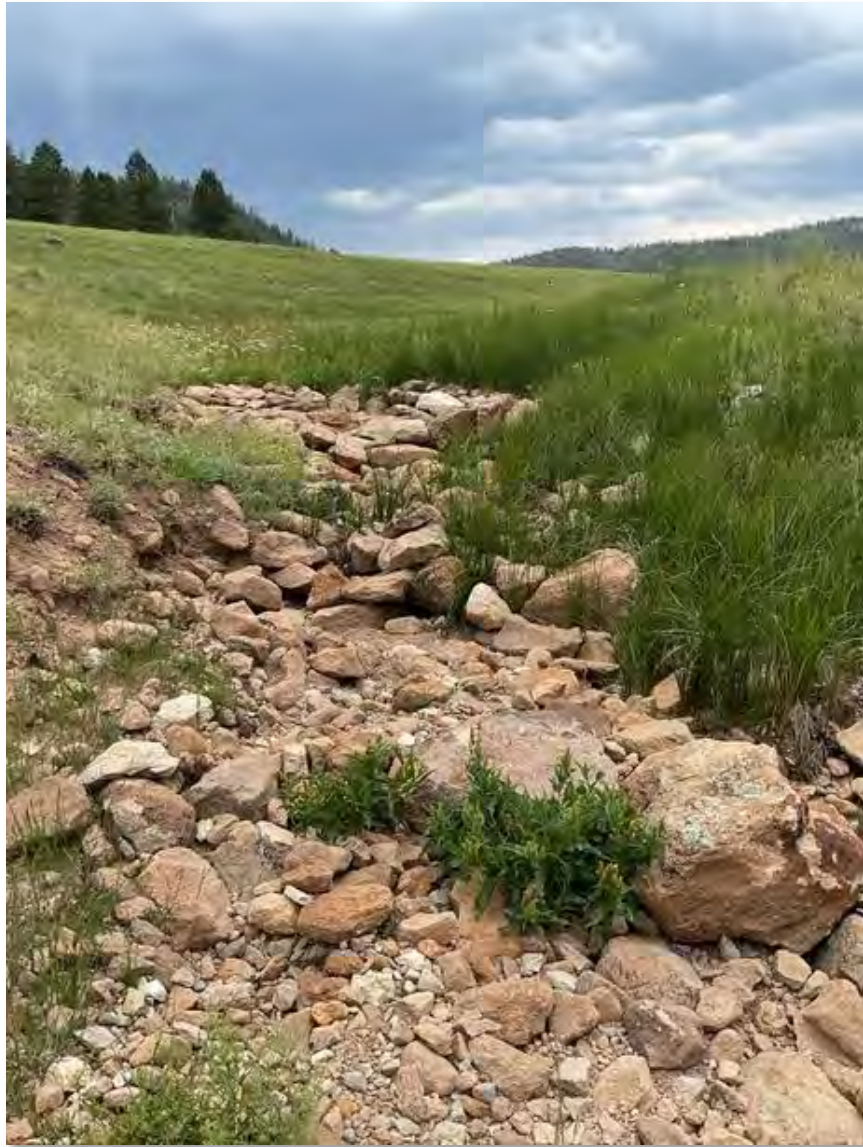
Figure 5-9. Sulphur Creek #17. Object ID 66 in the survey. Location: -106.5808215, 35.9372305. Photo looking upslope.

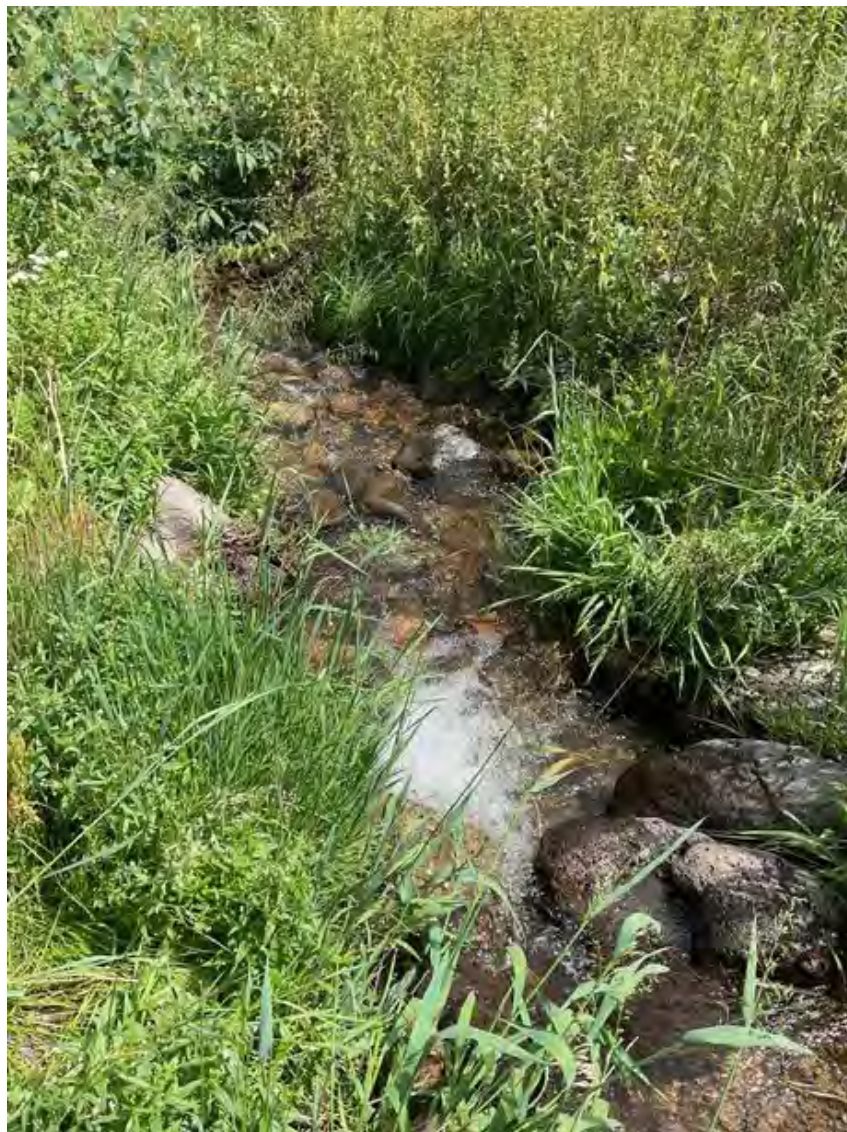
Figure 5-10. La Jara Creek #1. Object ID 79 in the survey. Location: -106.518787235.8651939. Photo looking downslope.

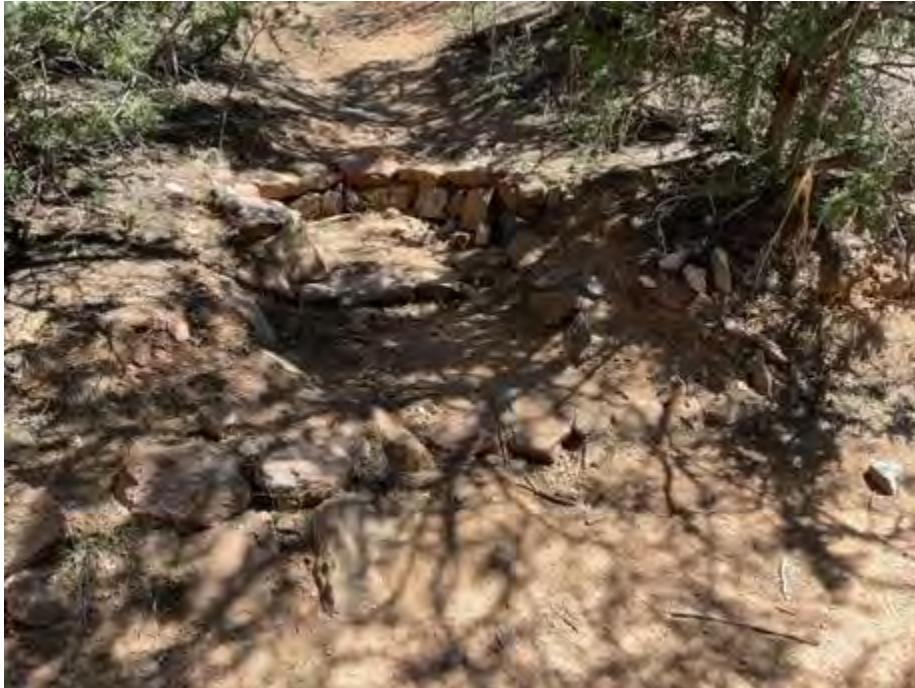
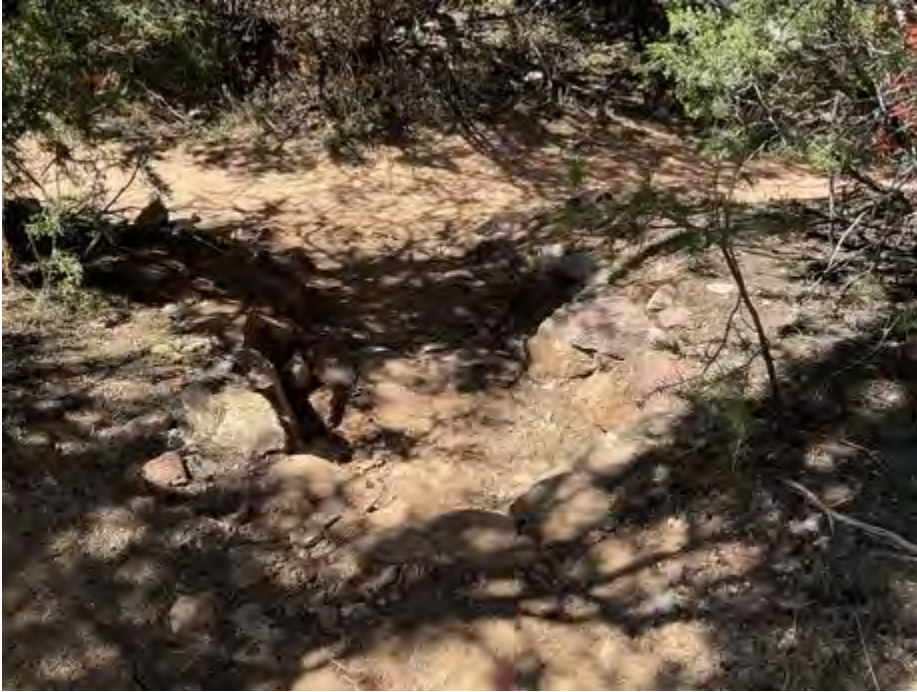
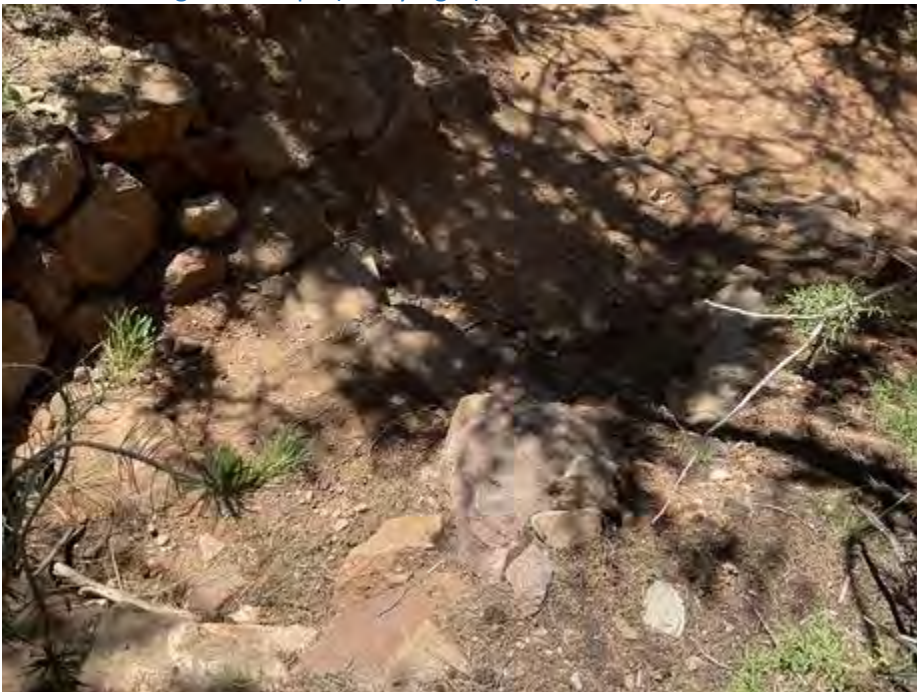
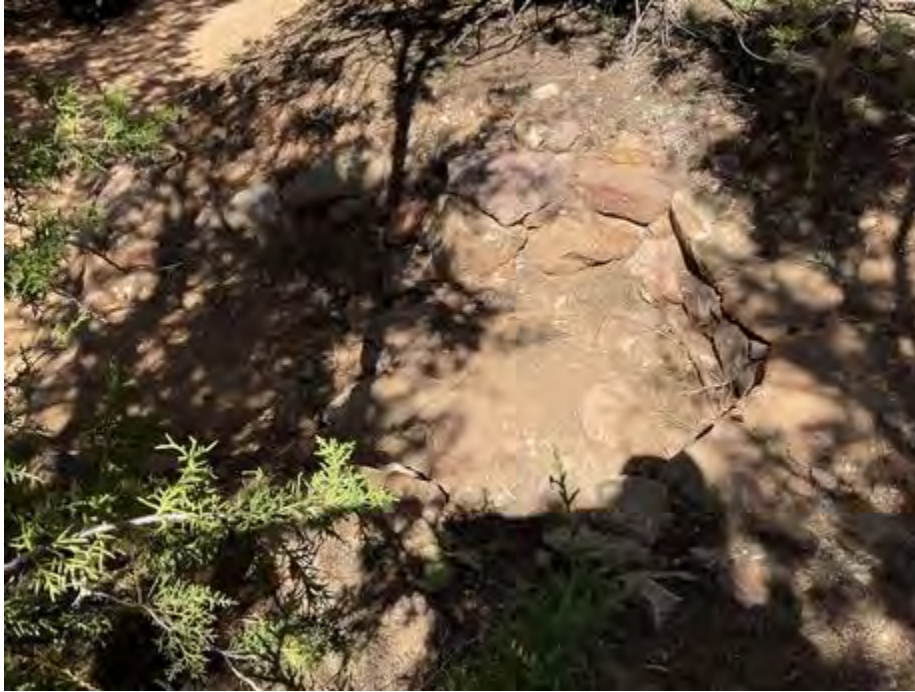
All rocks intact

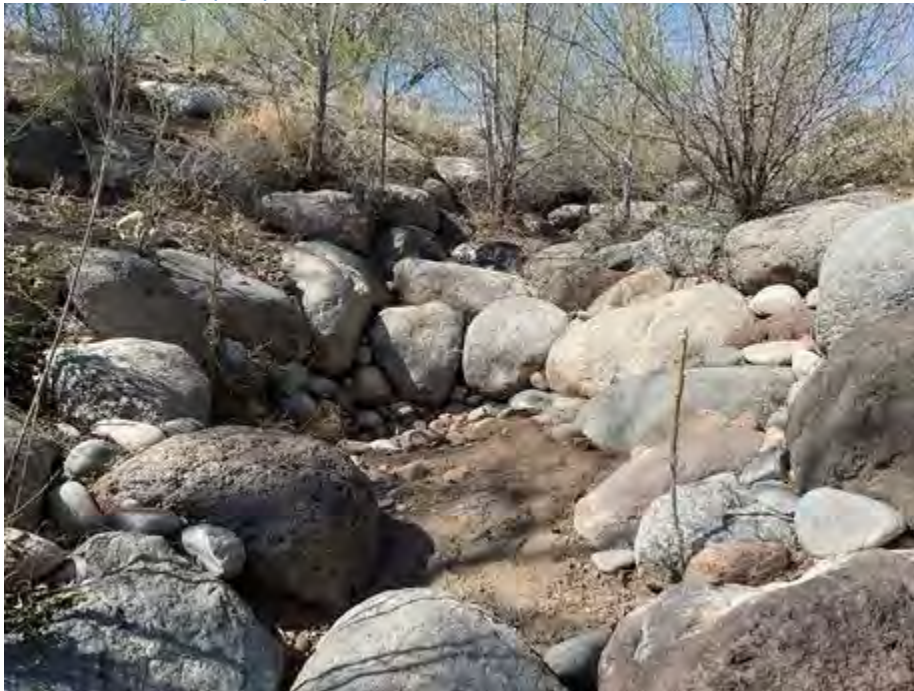
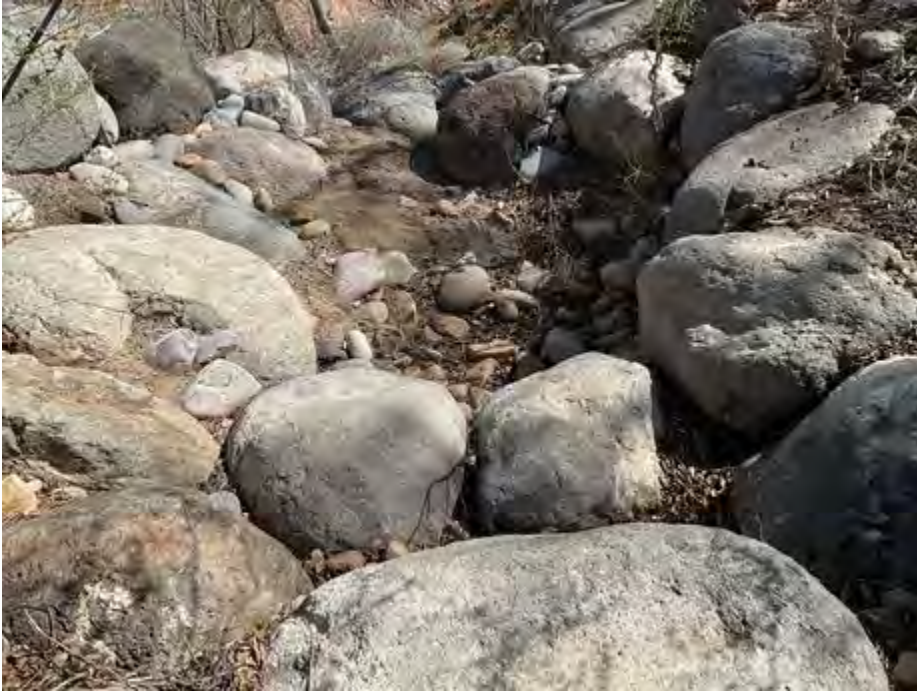
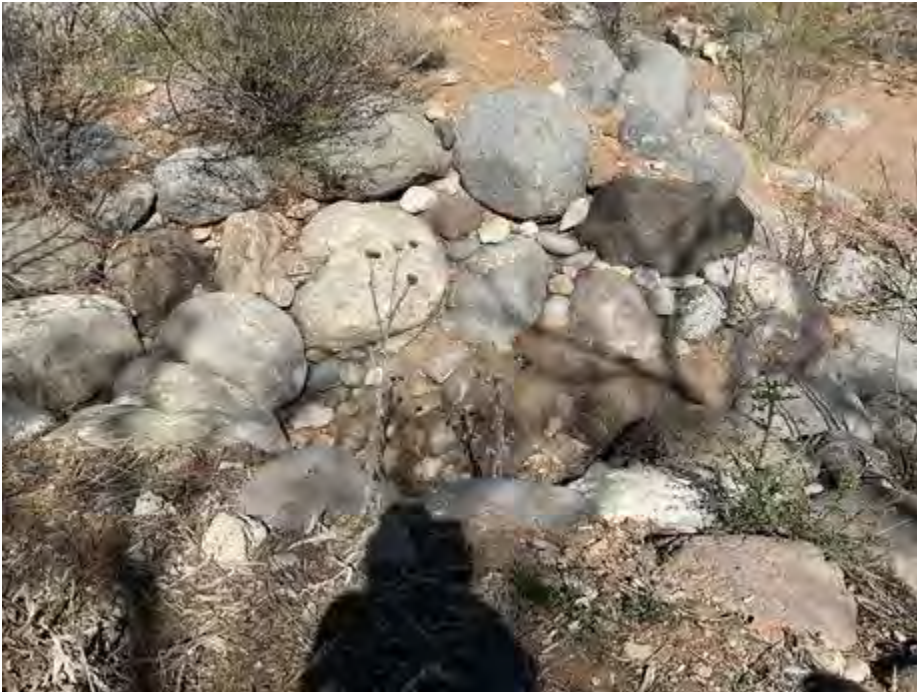
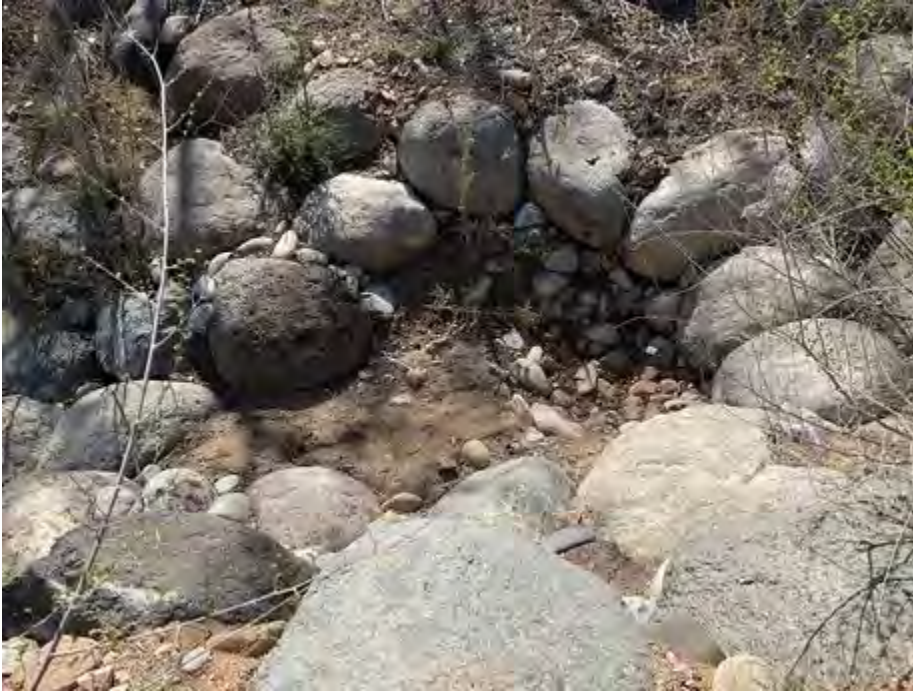
All rocks intact
