**Zuni Bowl and One Rock Check Dam Research –
Phase 1**

Final Report

December 2024

Rio Grande Return for the New Mexico Department of Transportation Research Bureau

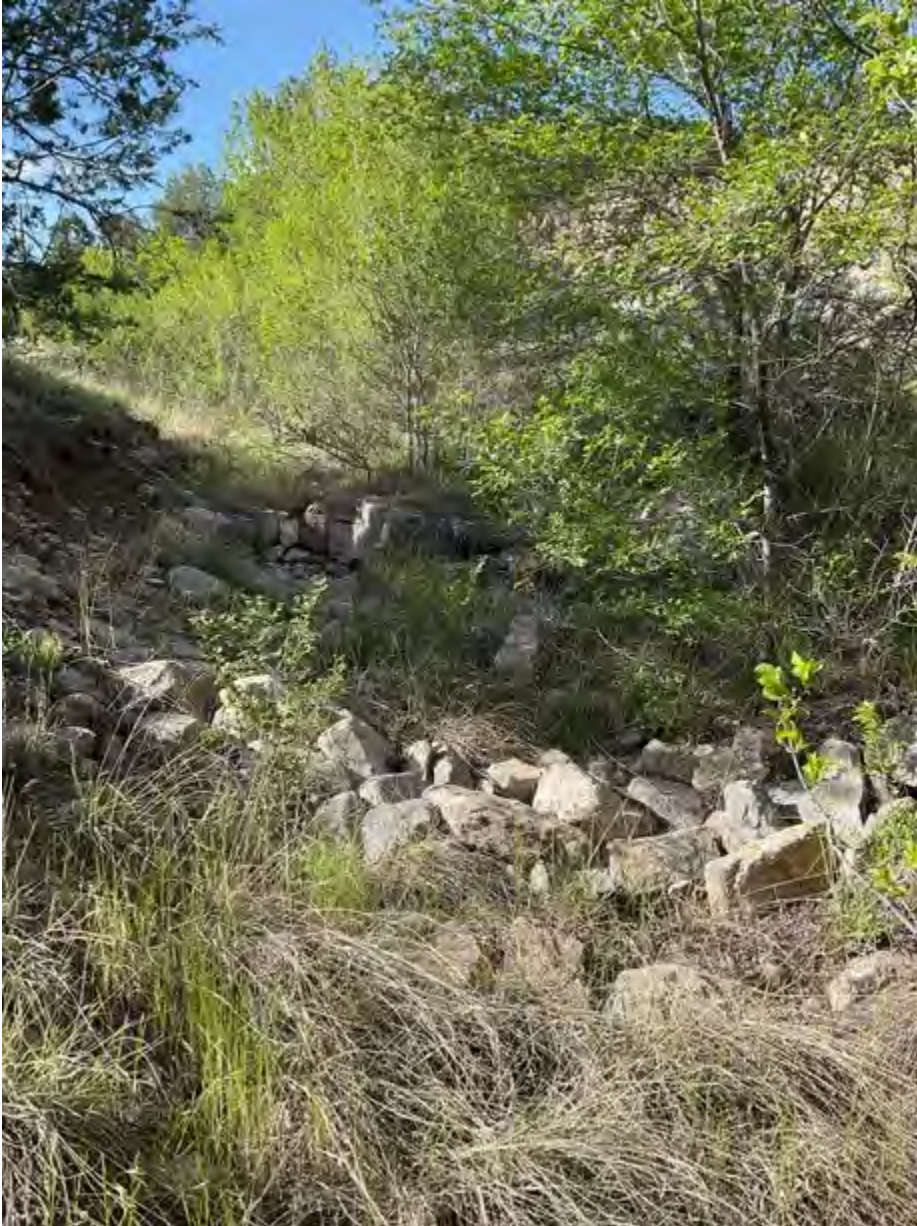
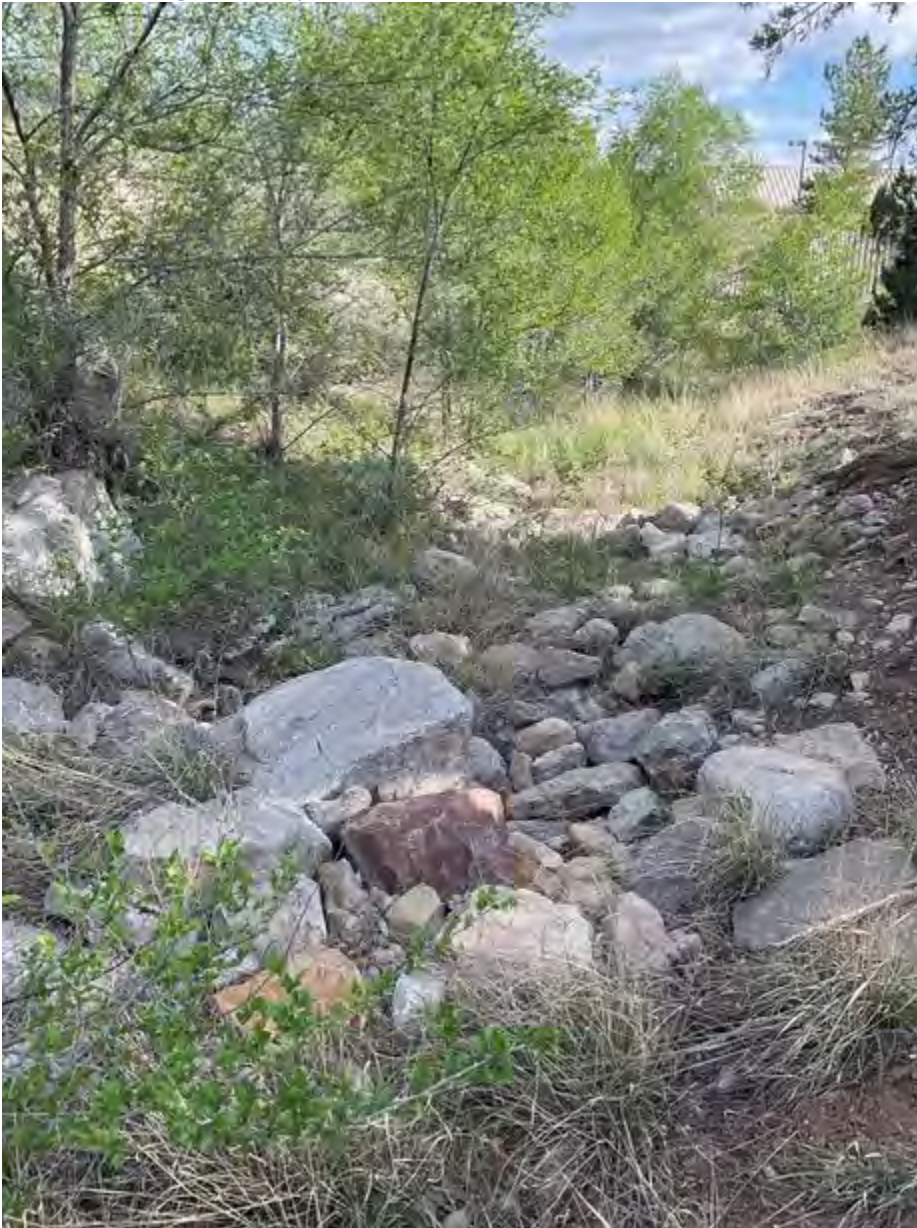
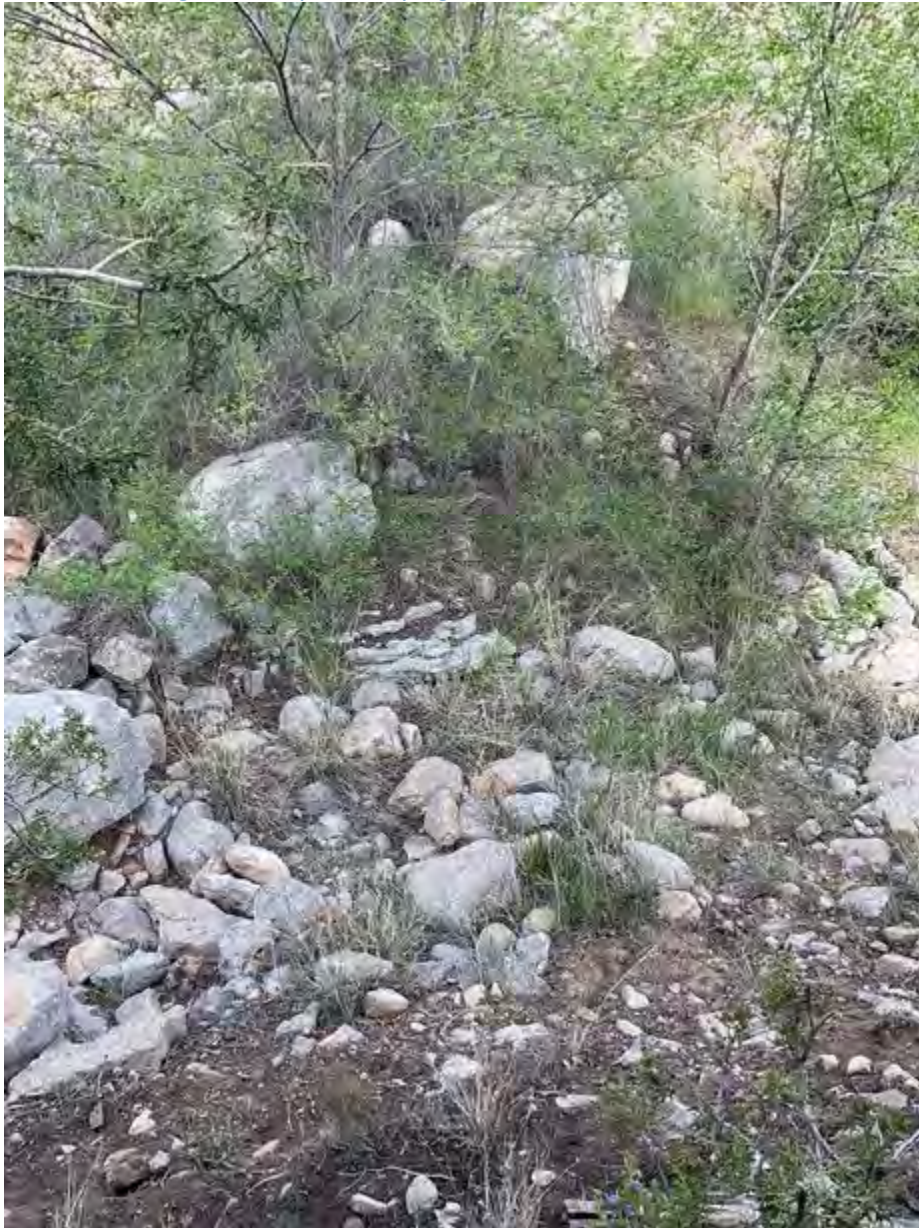
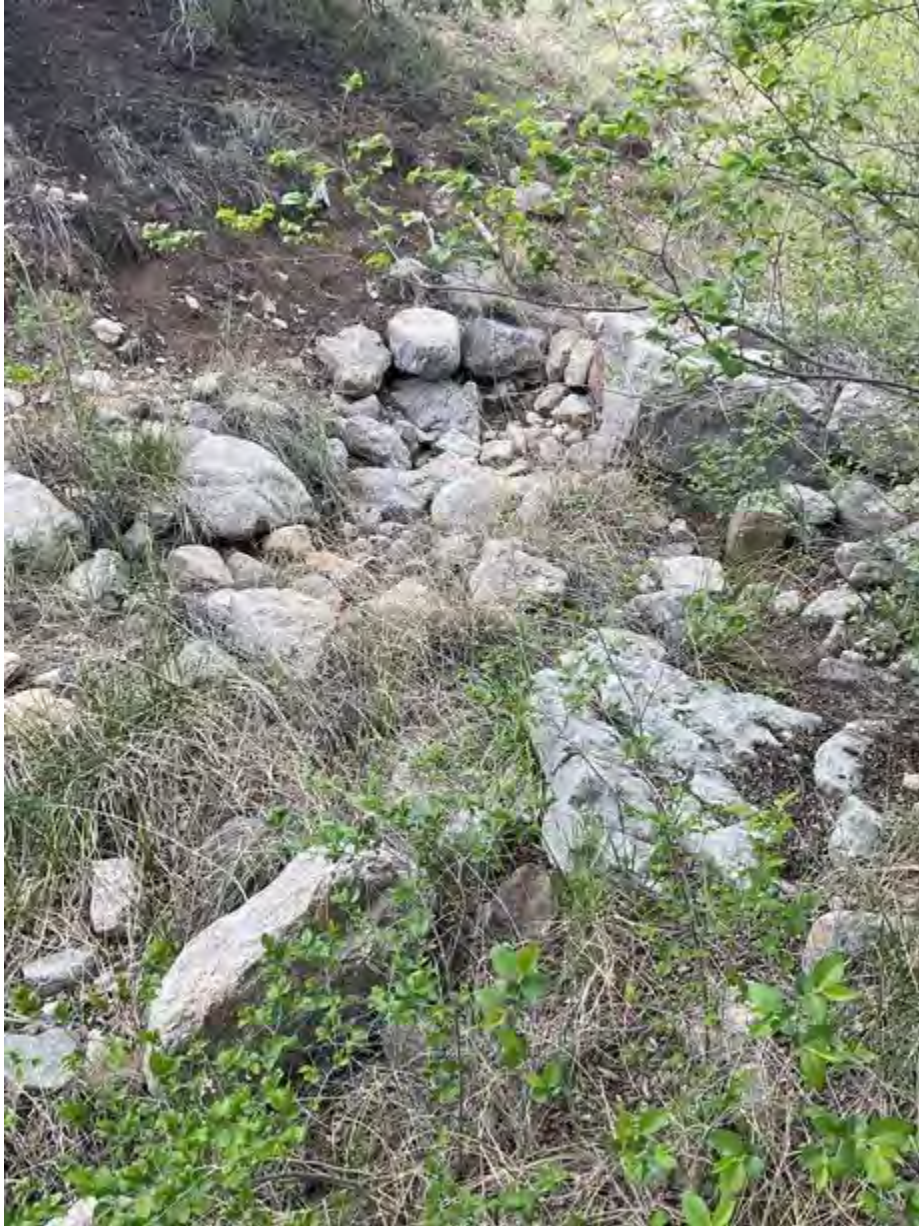
All rocks intact

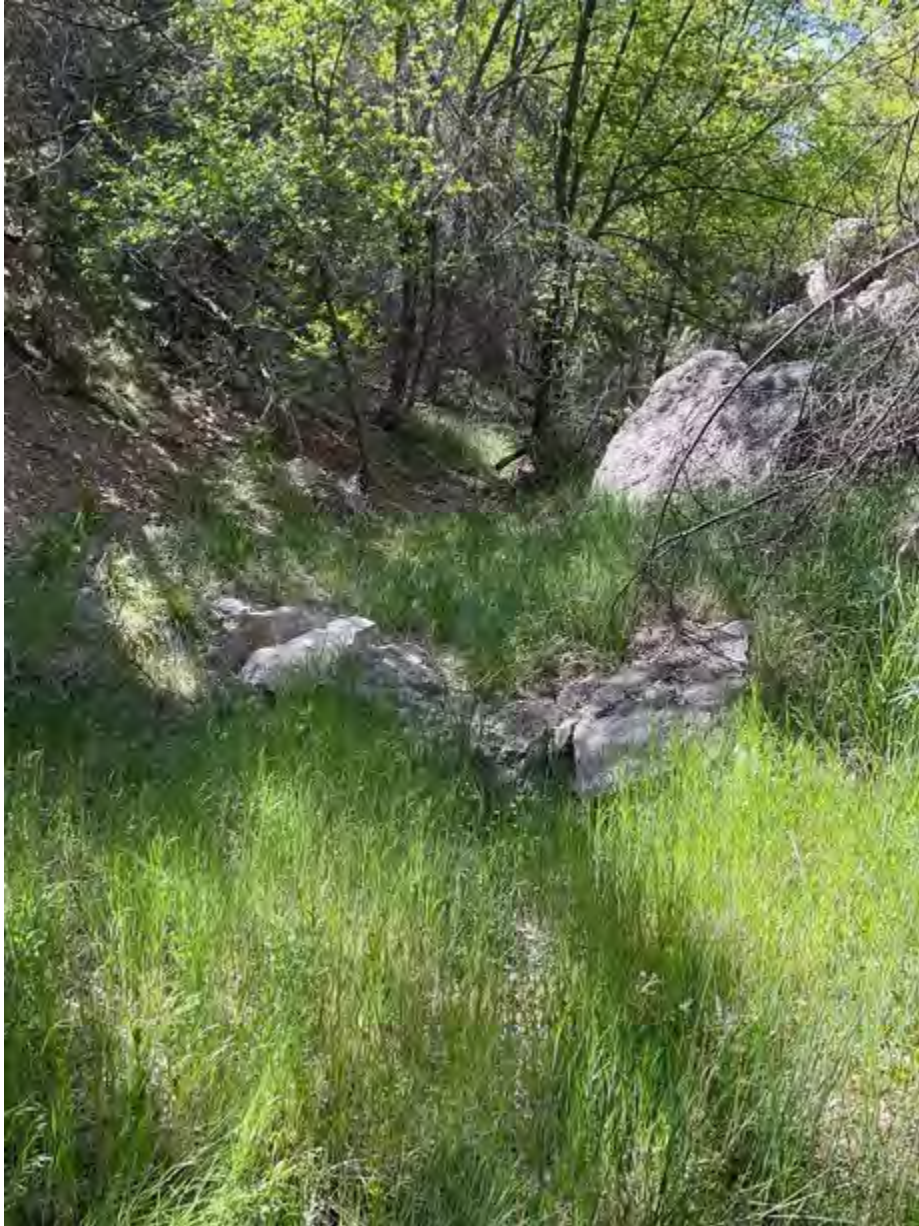
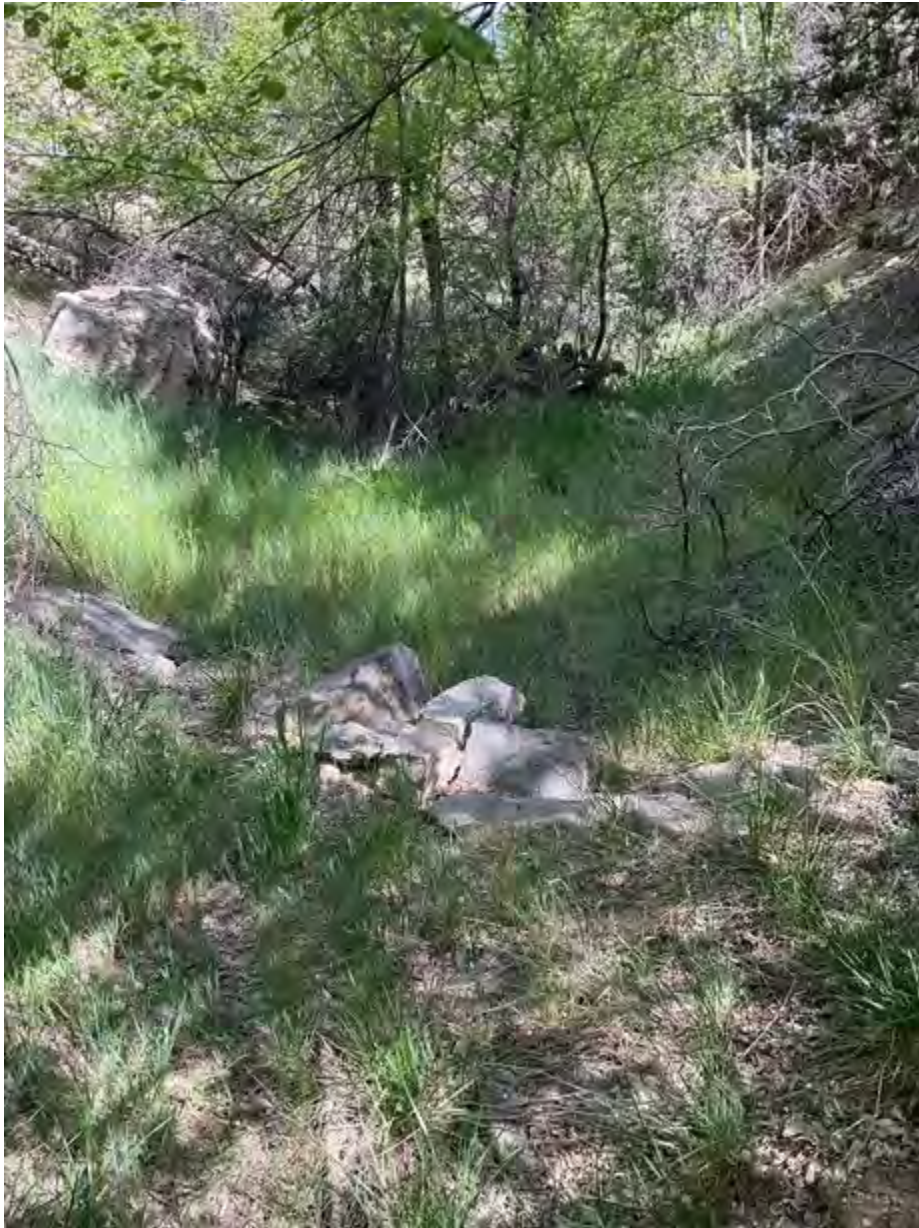
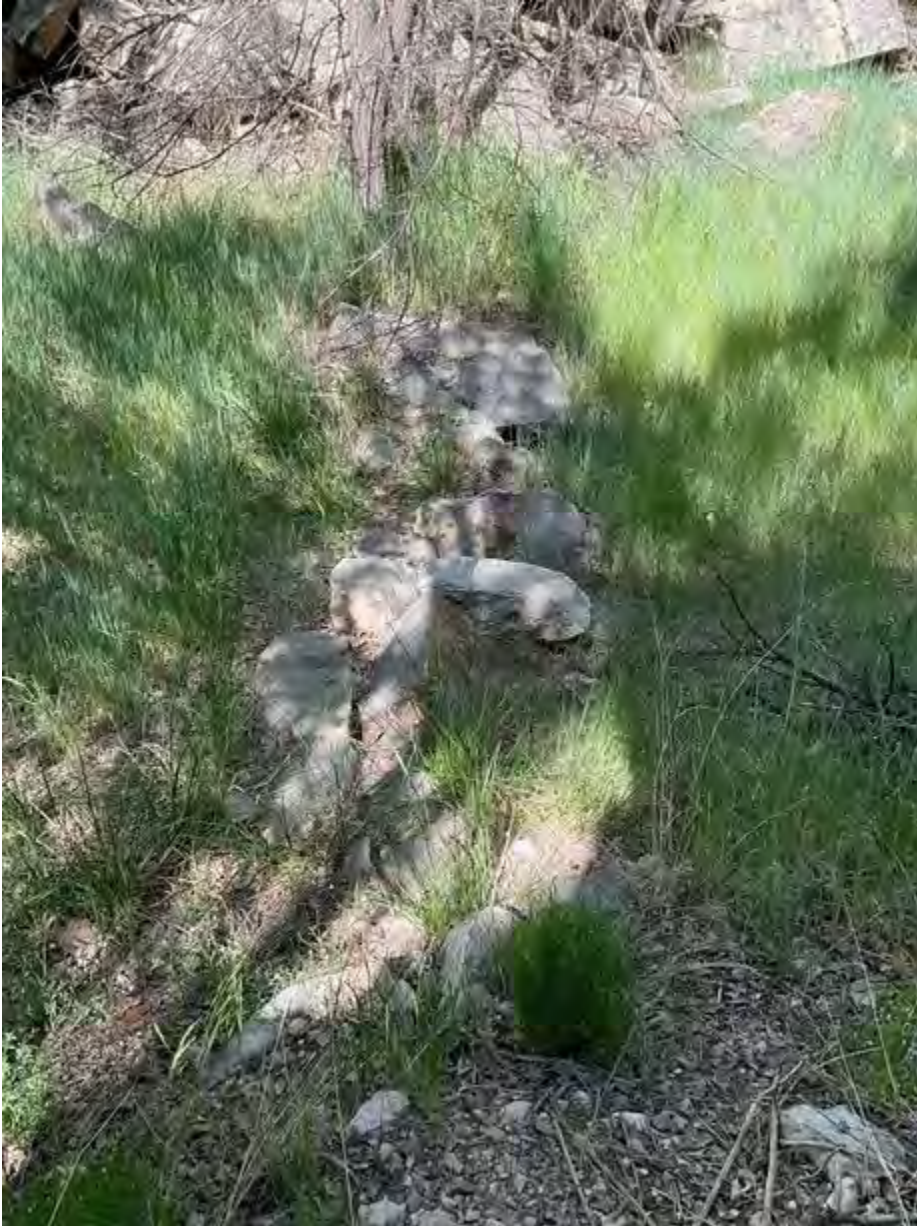
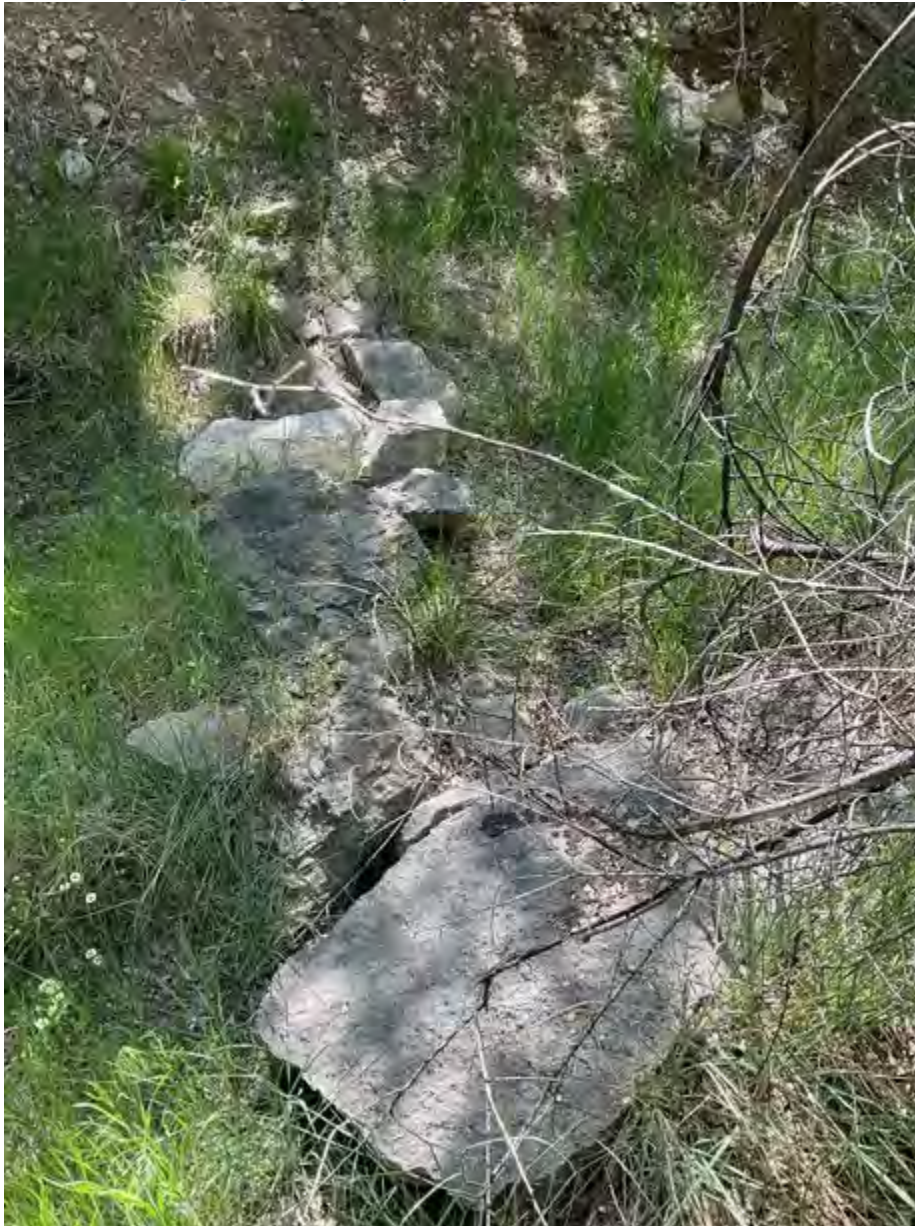
All rocks intact

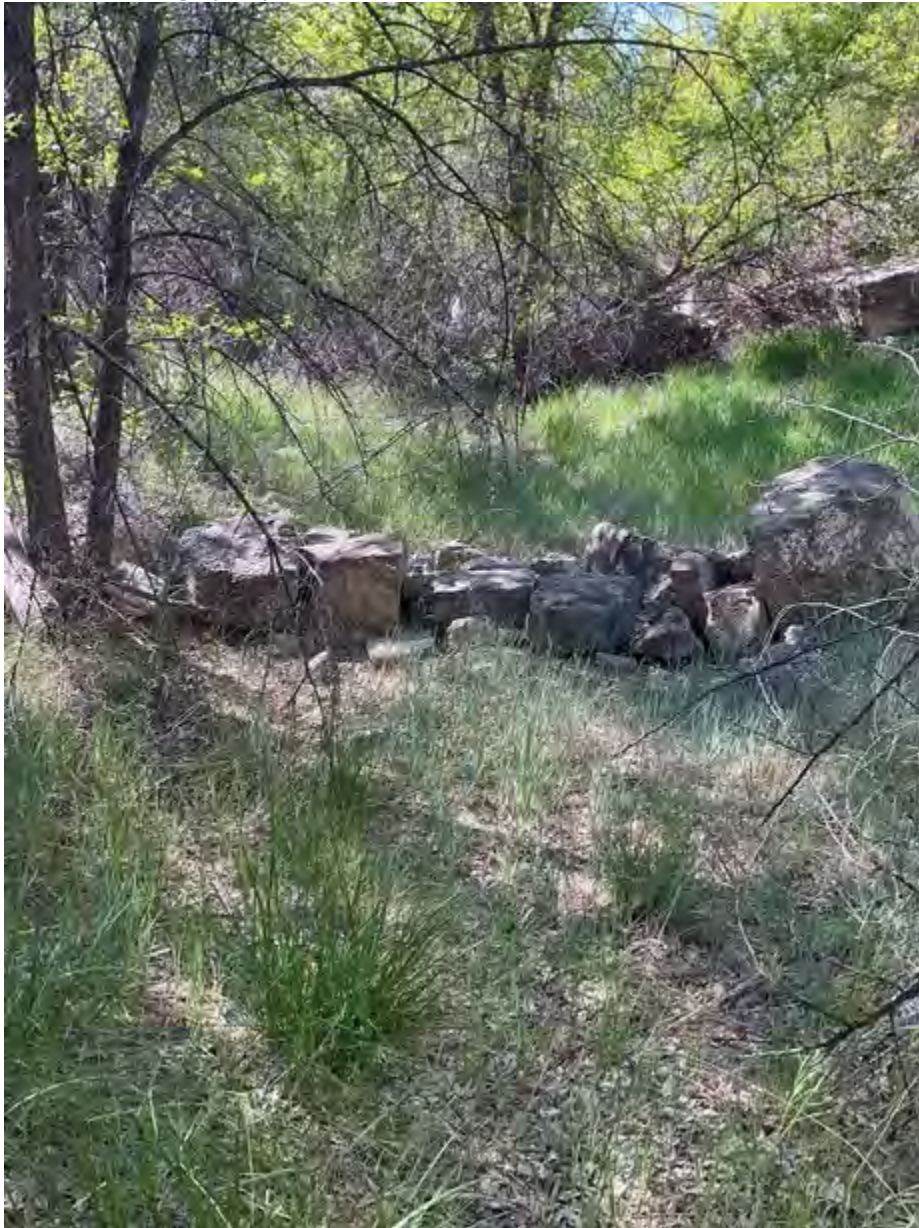
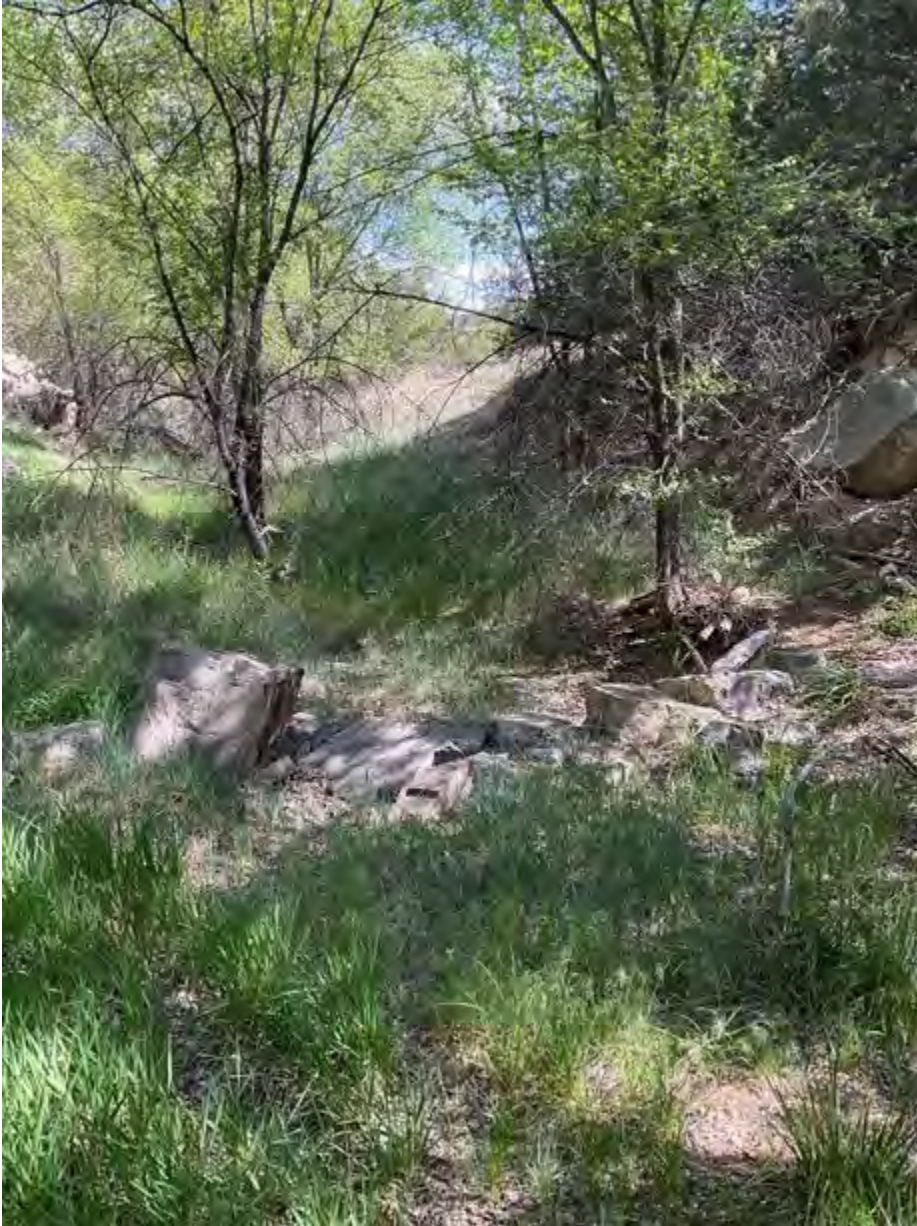
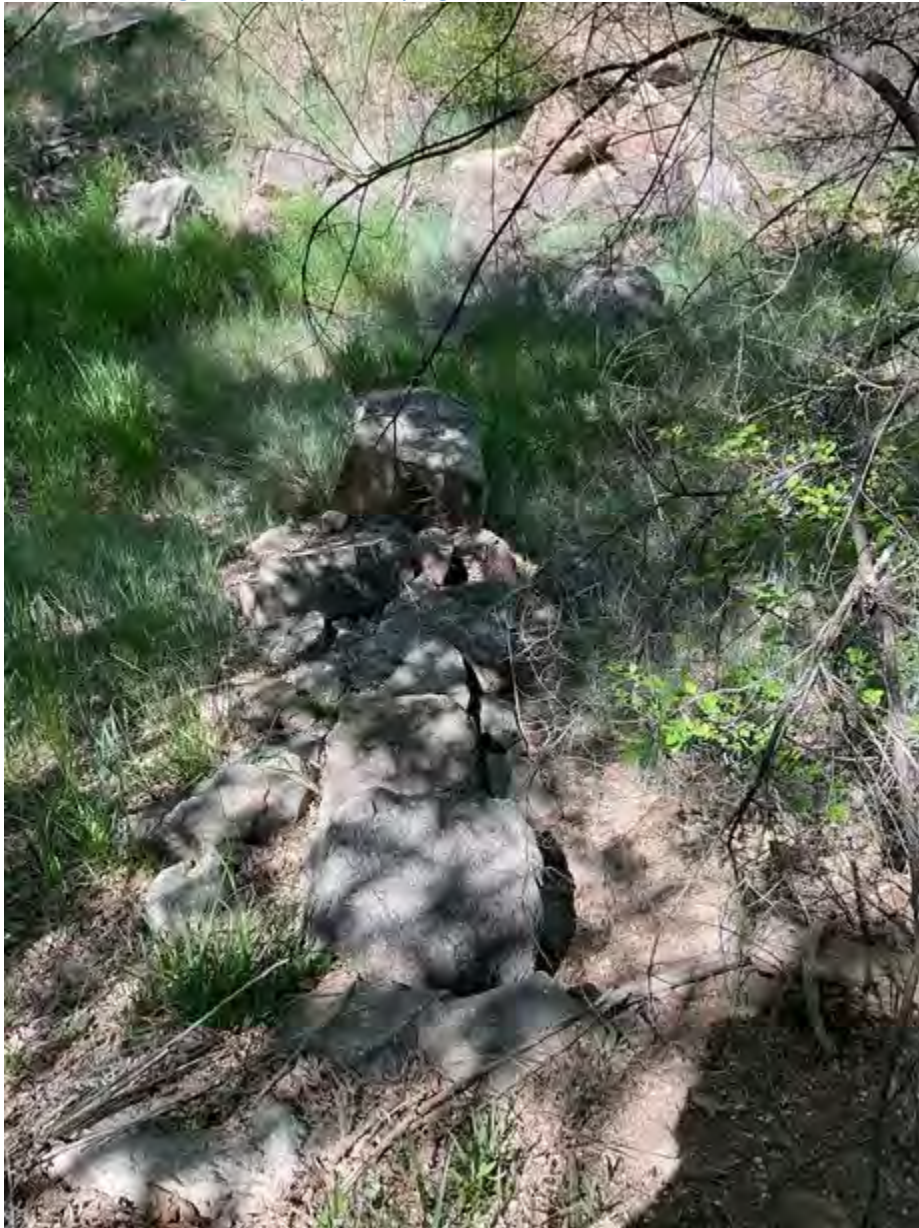
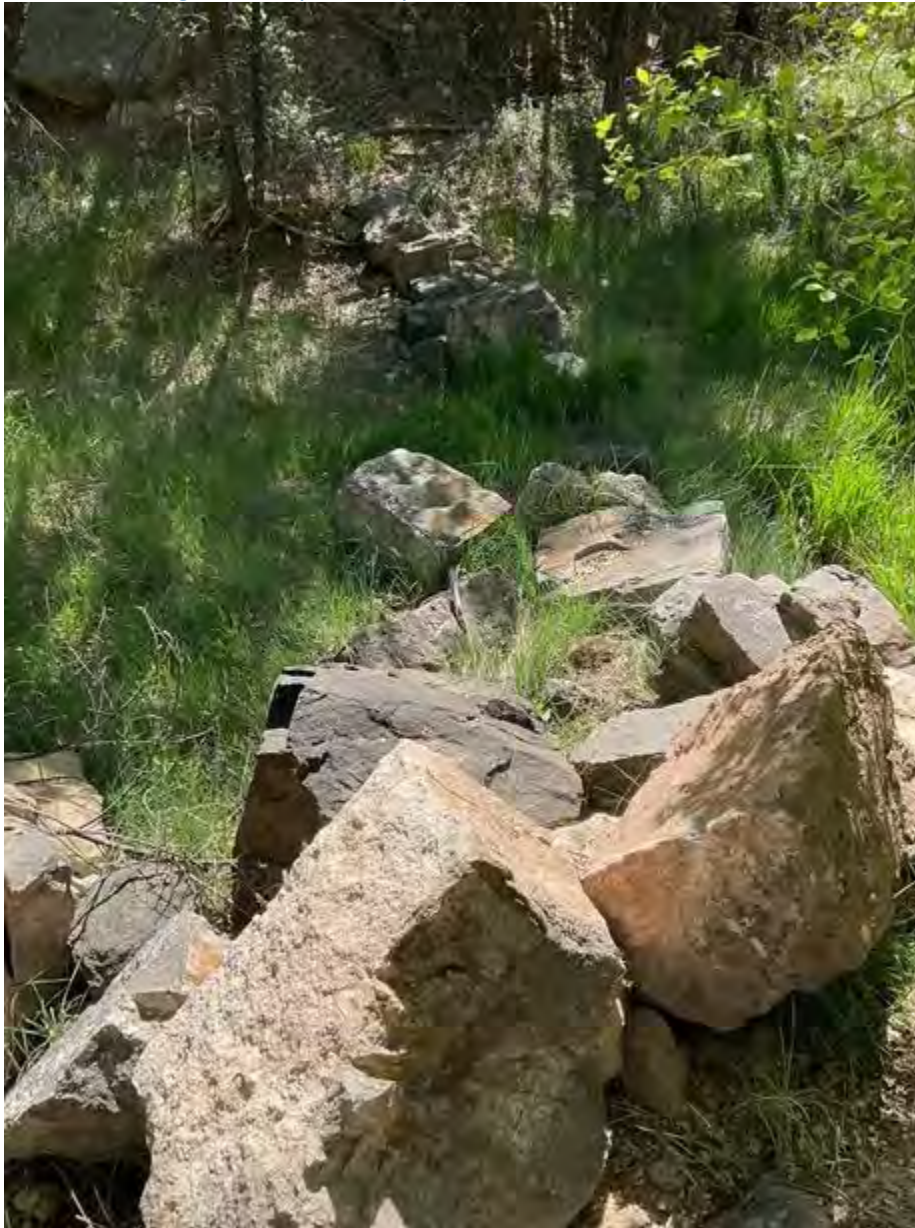
All rocks intact

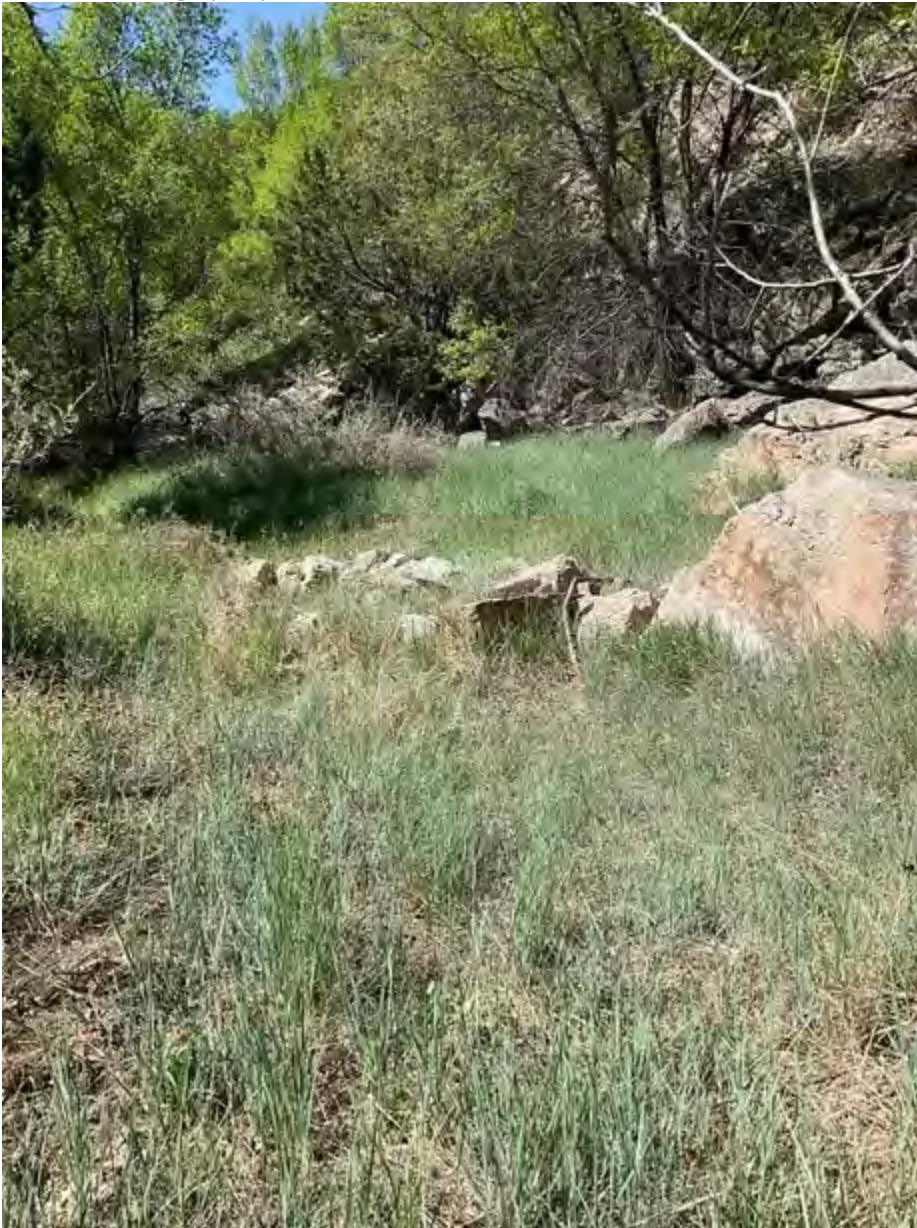
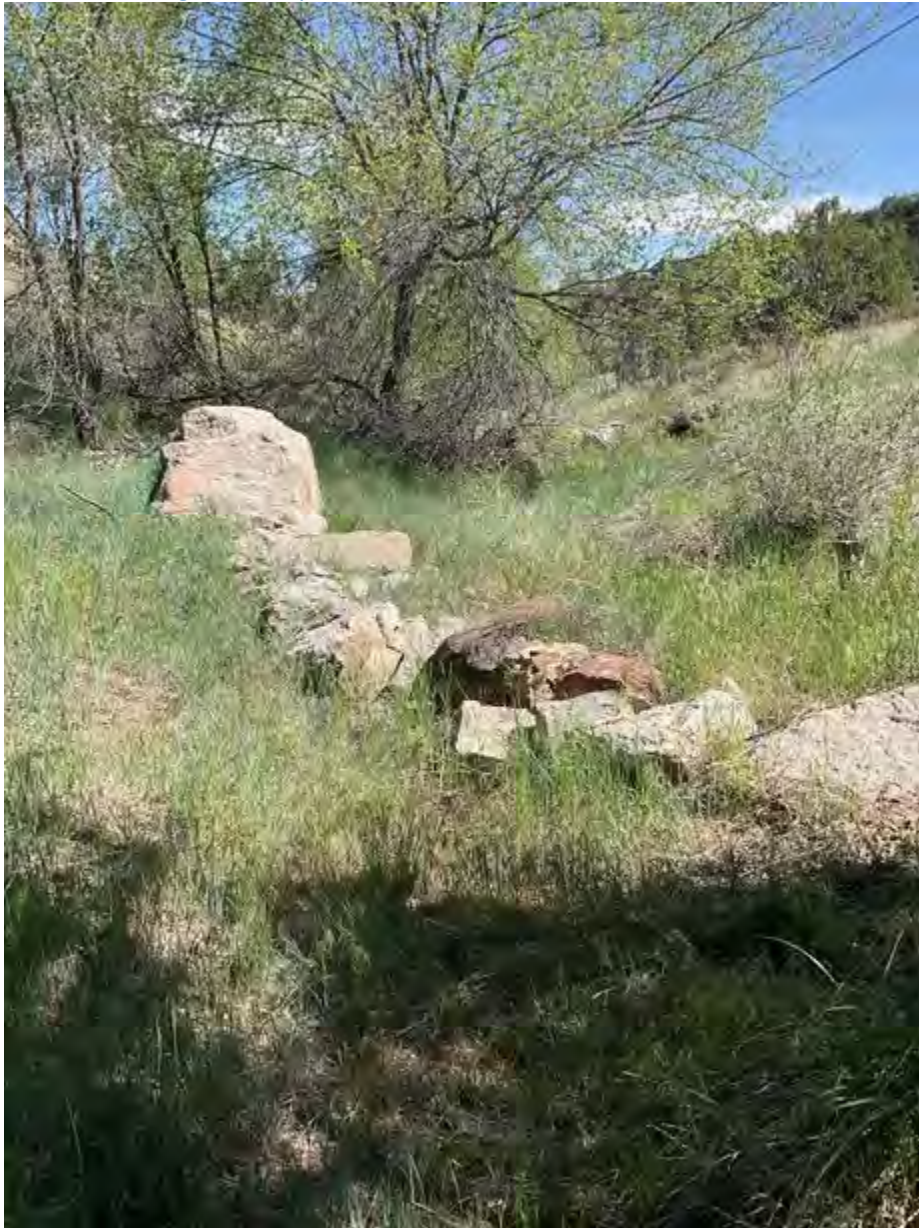
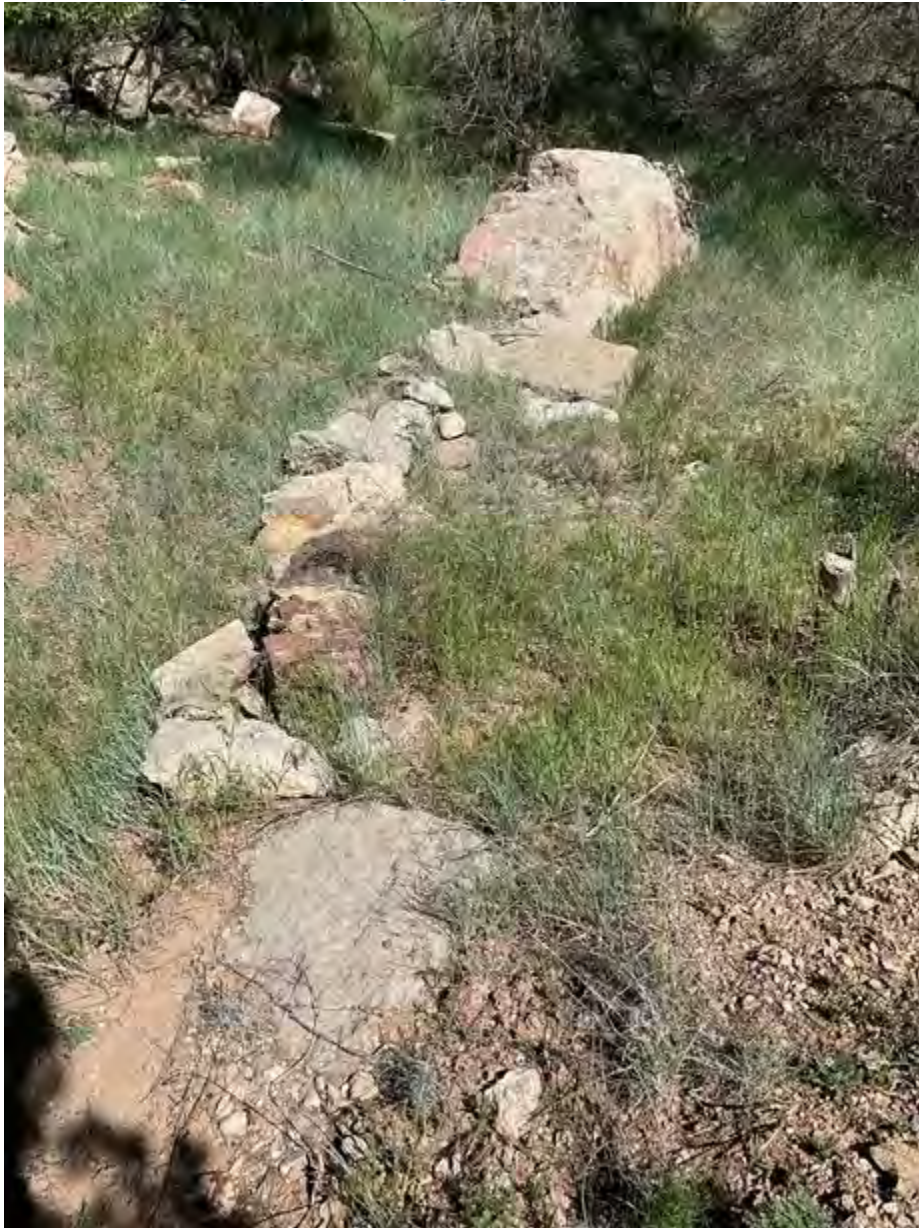
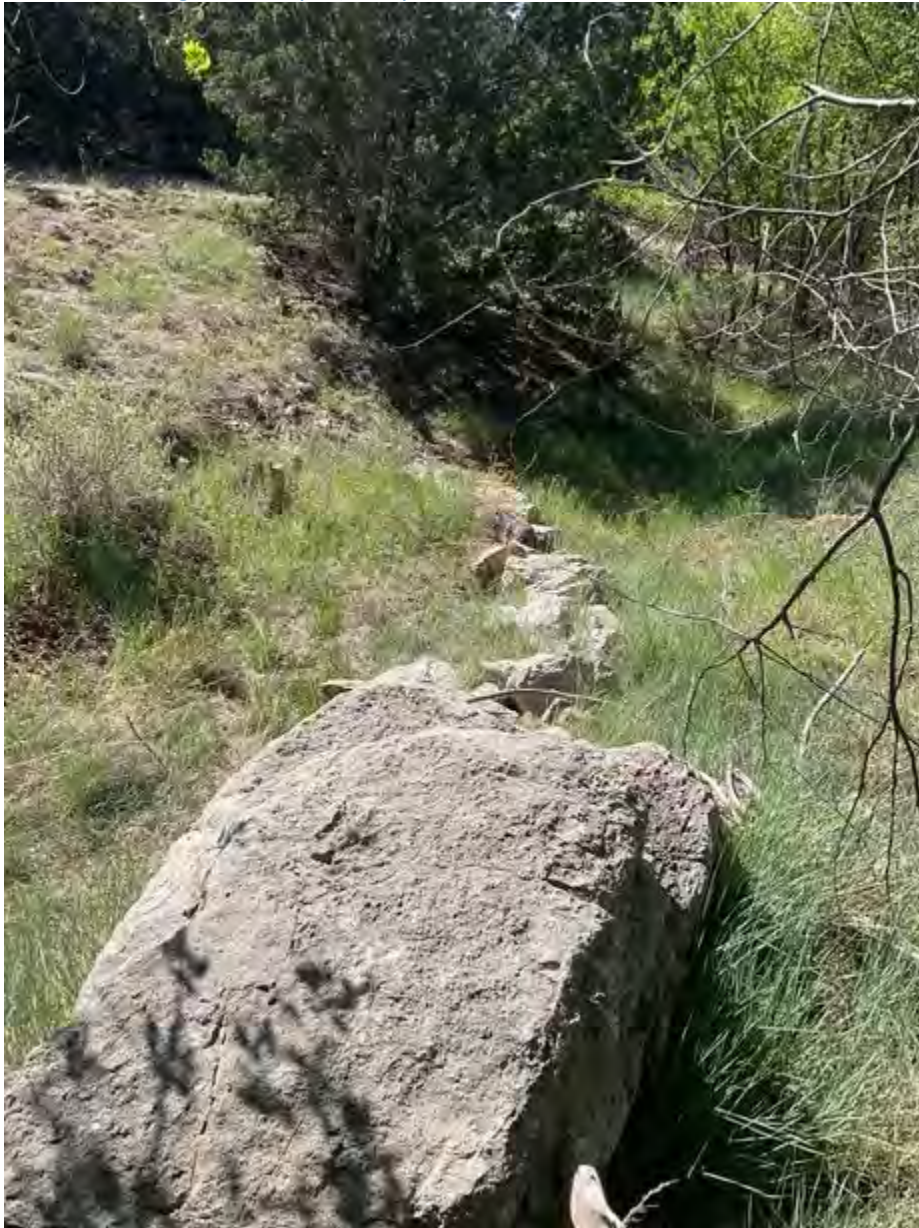
All rocks intact

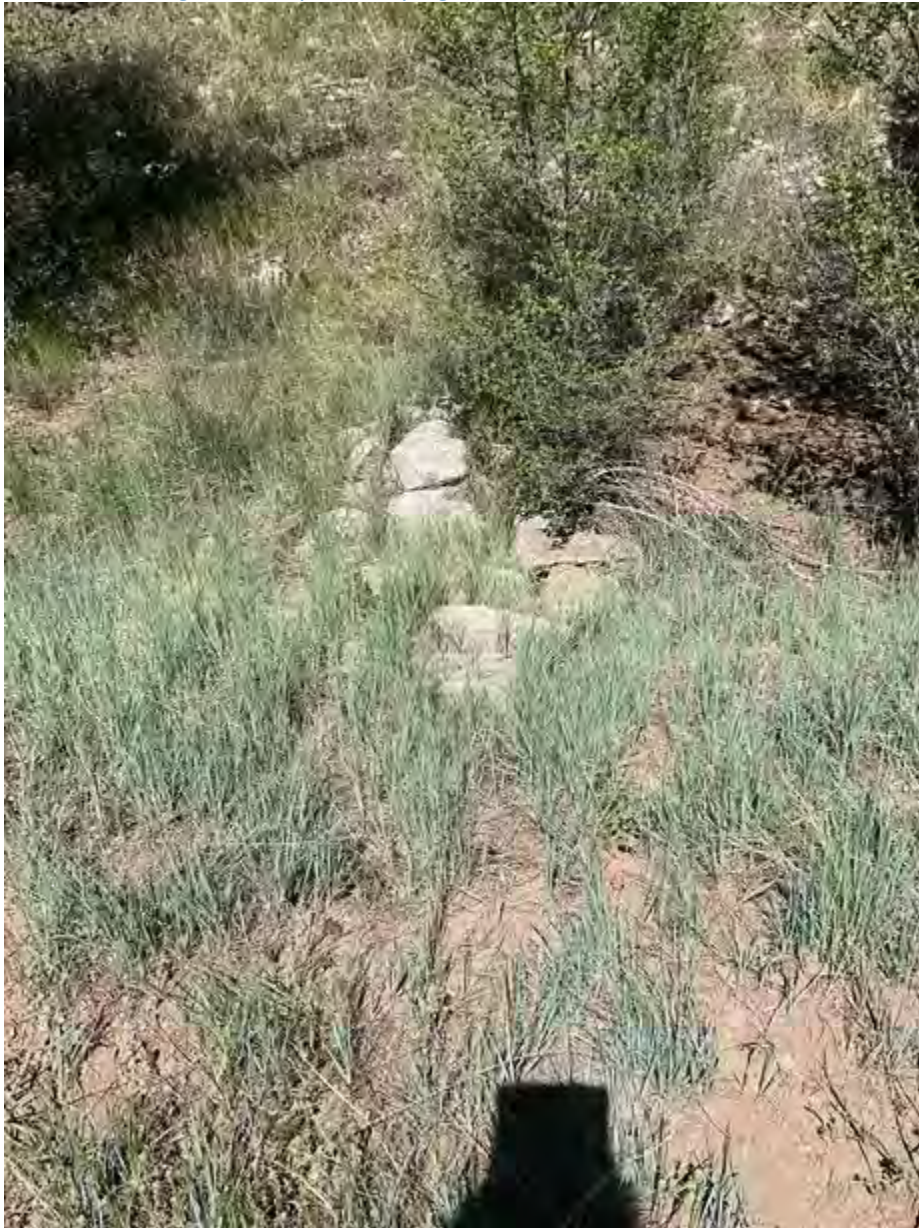
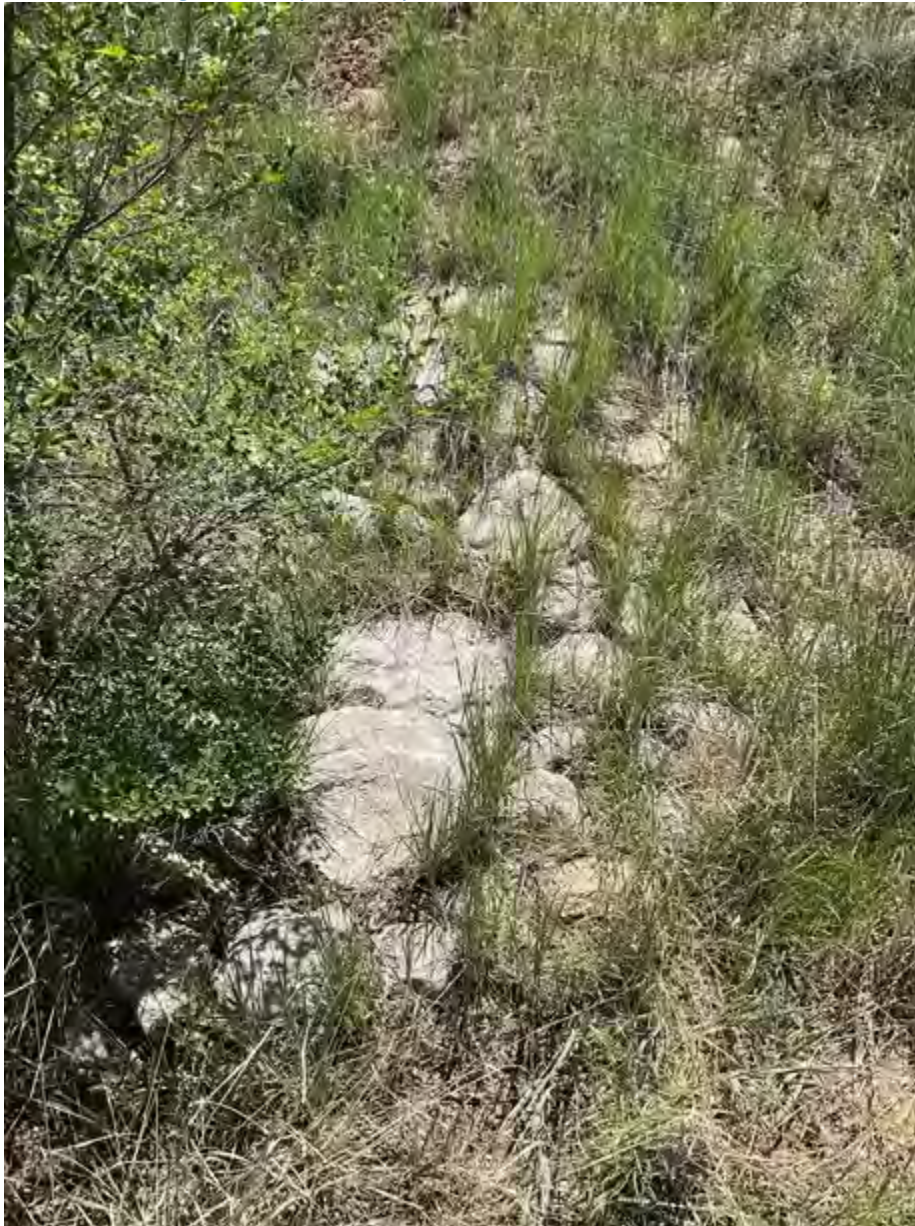
All rocks intact
