**Zuni Bowl and One Rock Check Dam Research –
Phase 1**

Final Report

December 2024

Rio Grande Return for the New Mexico Department of Transportation Research Bureau

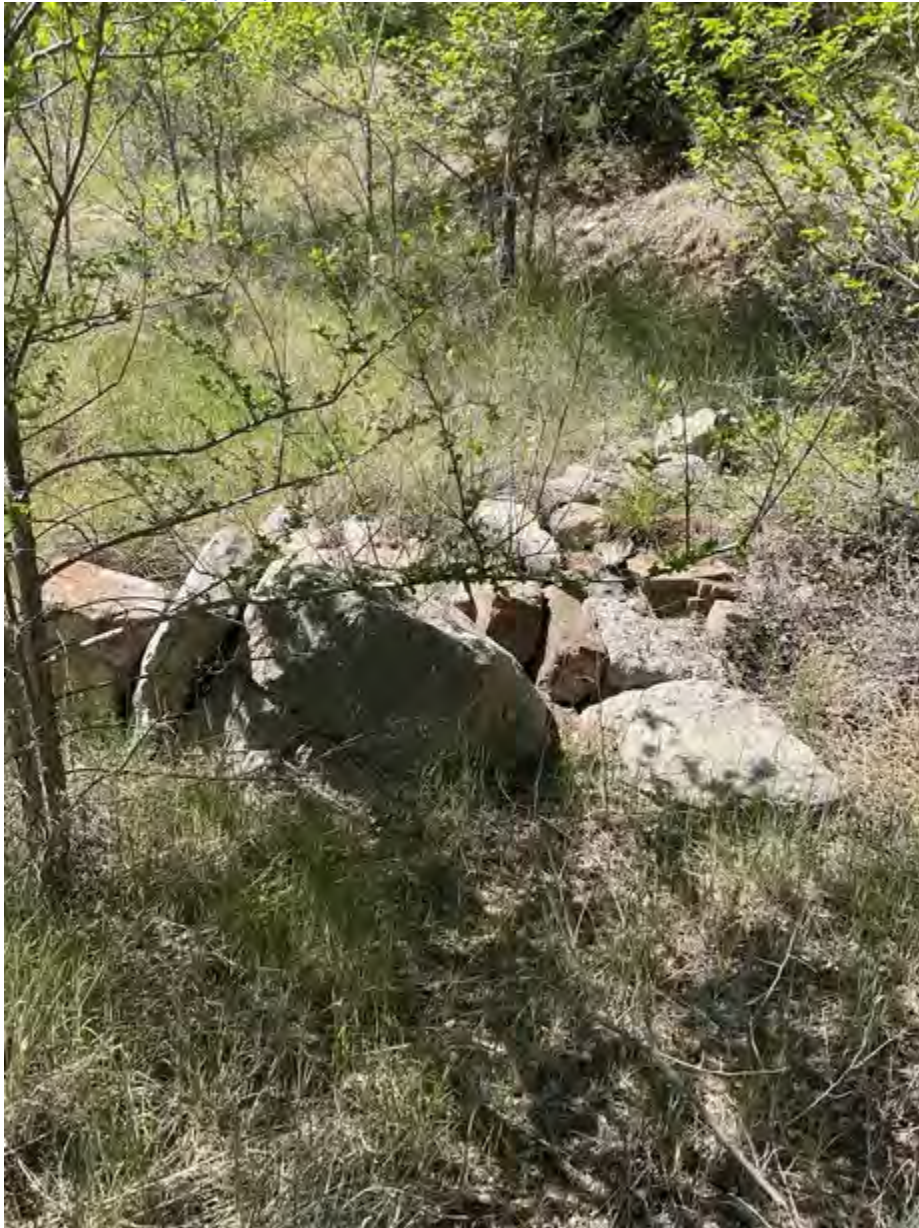
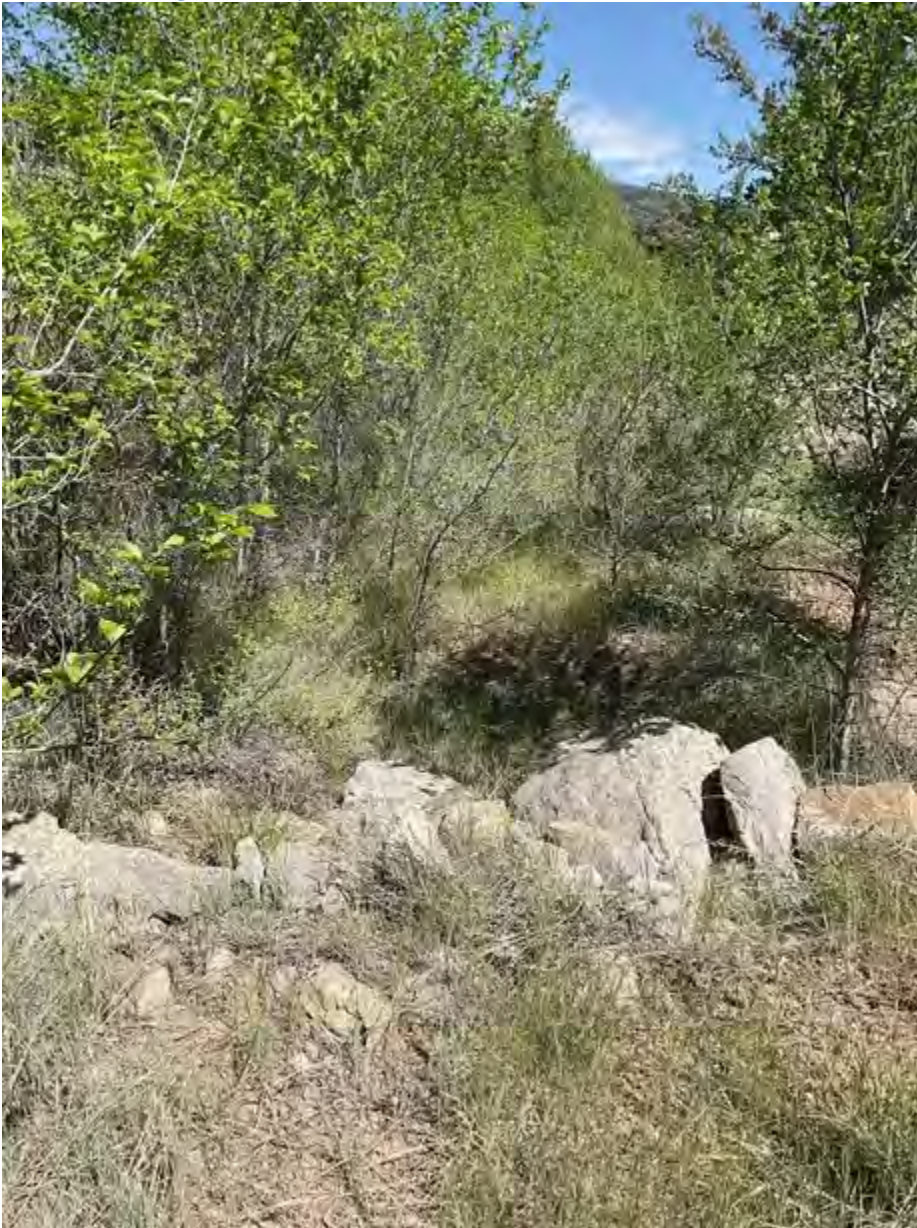
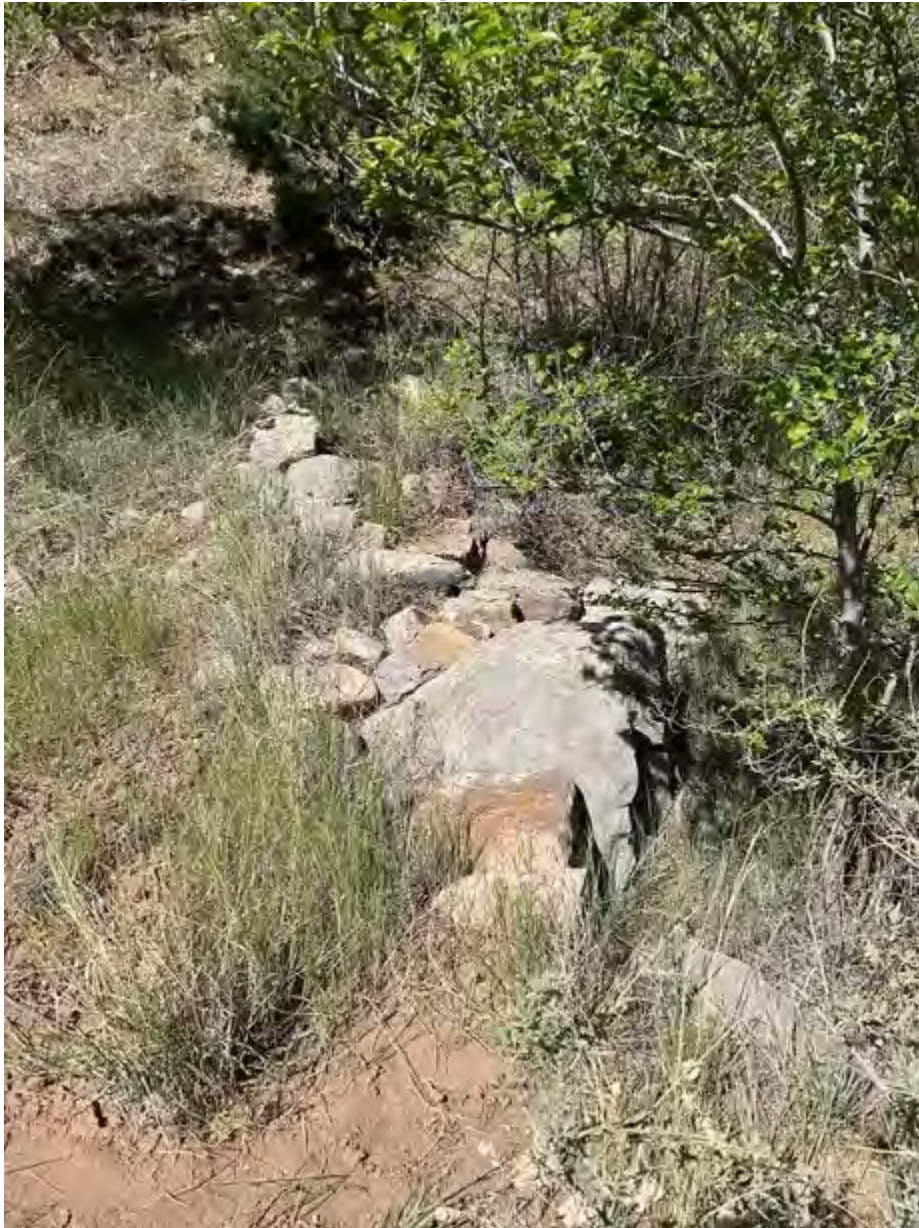
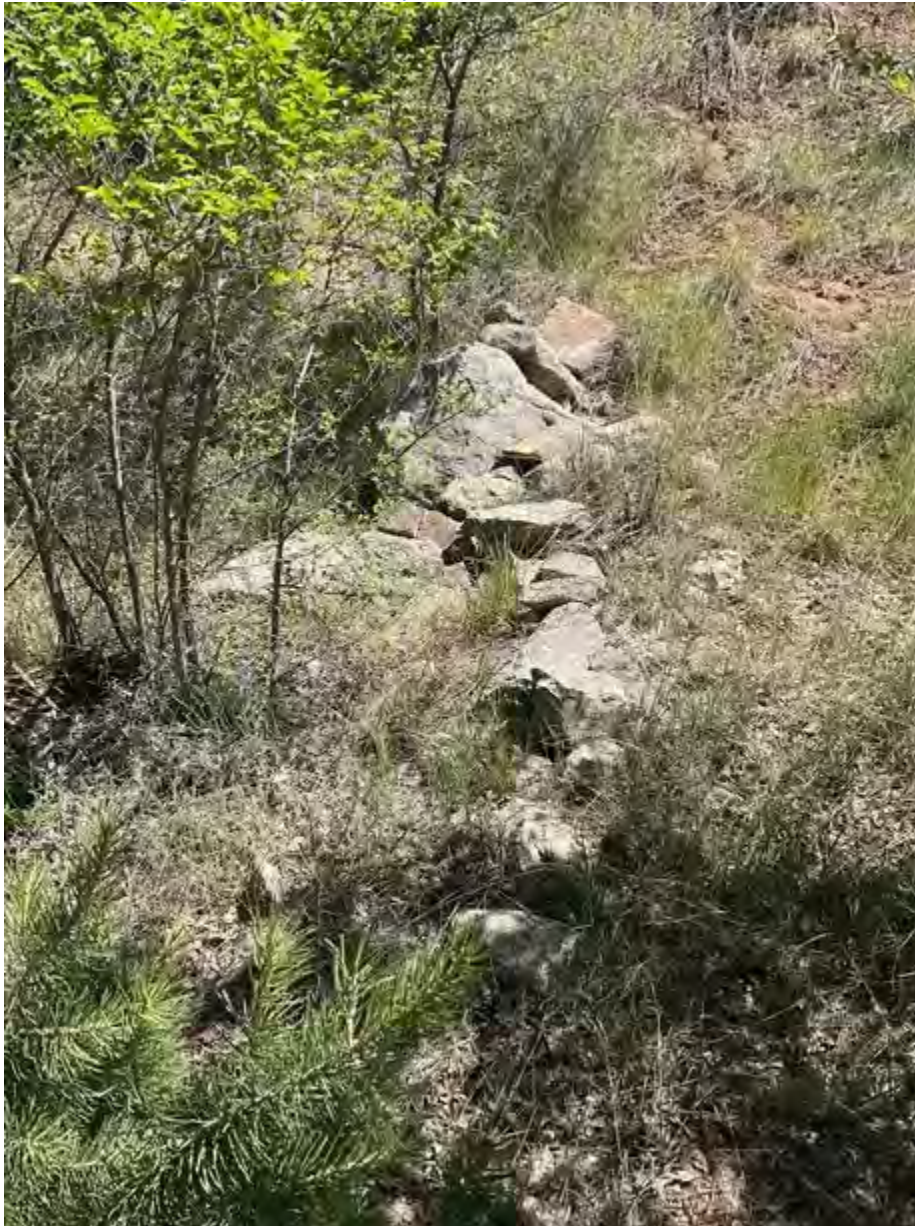
All rocks intact

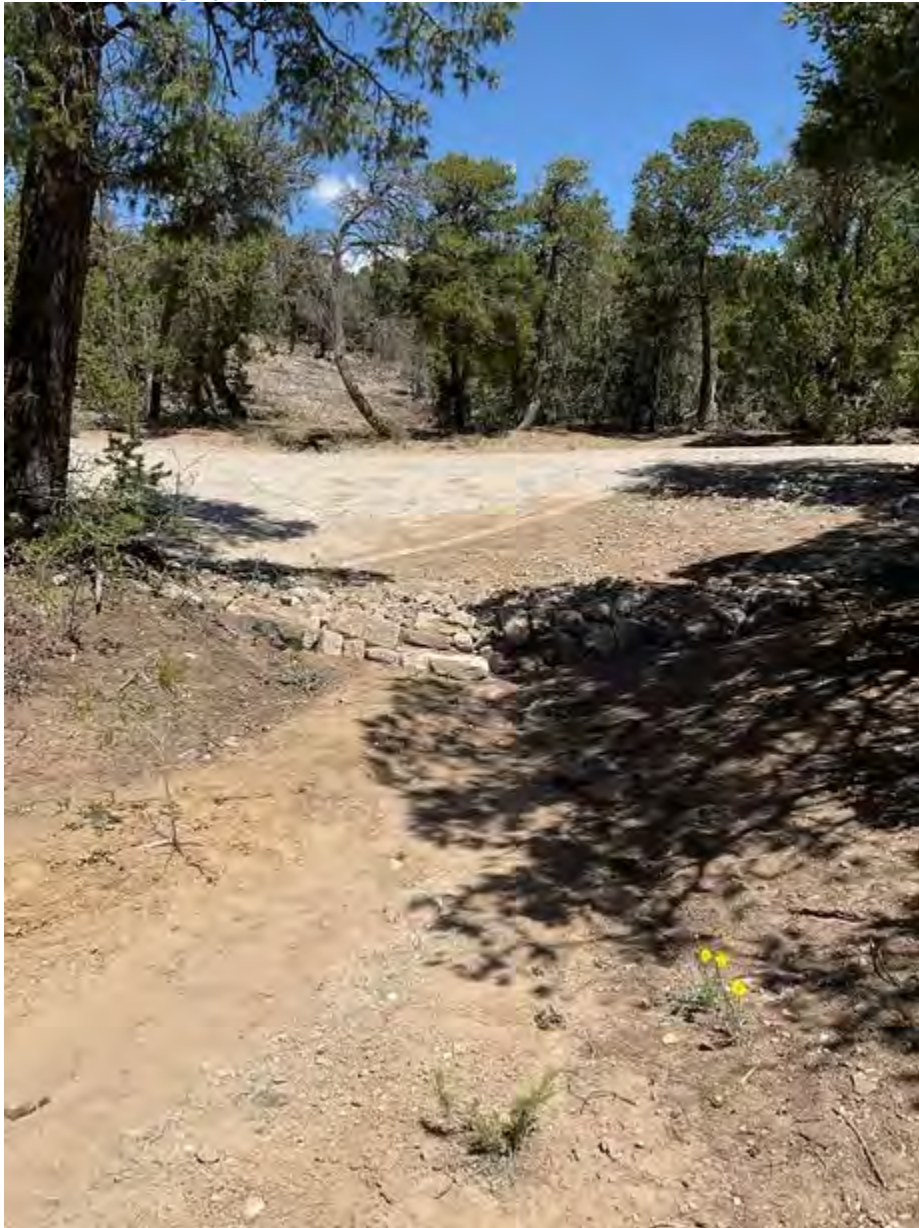
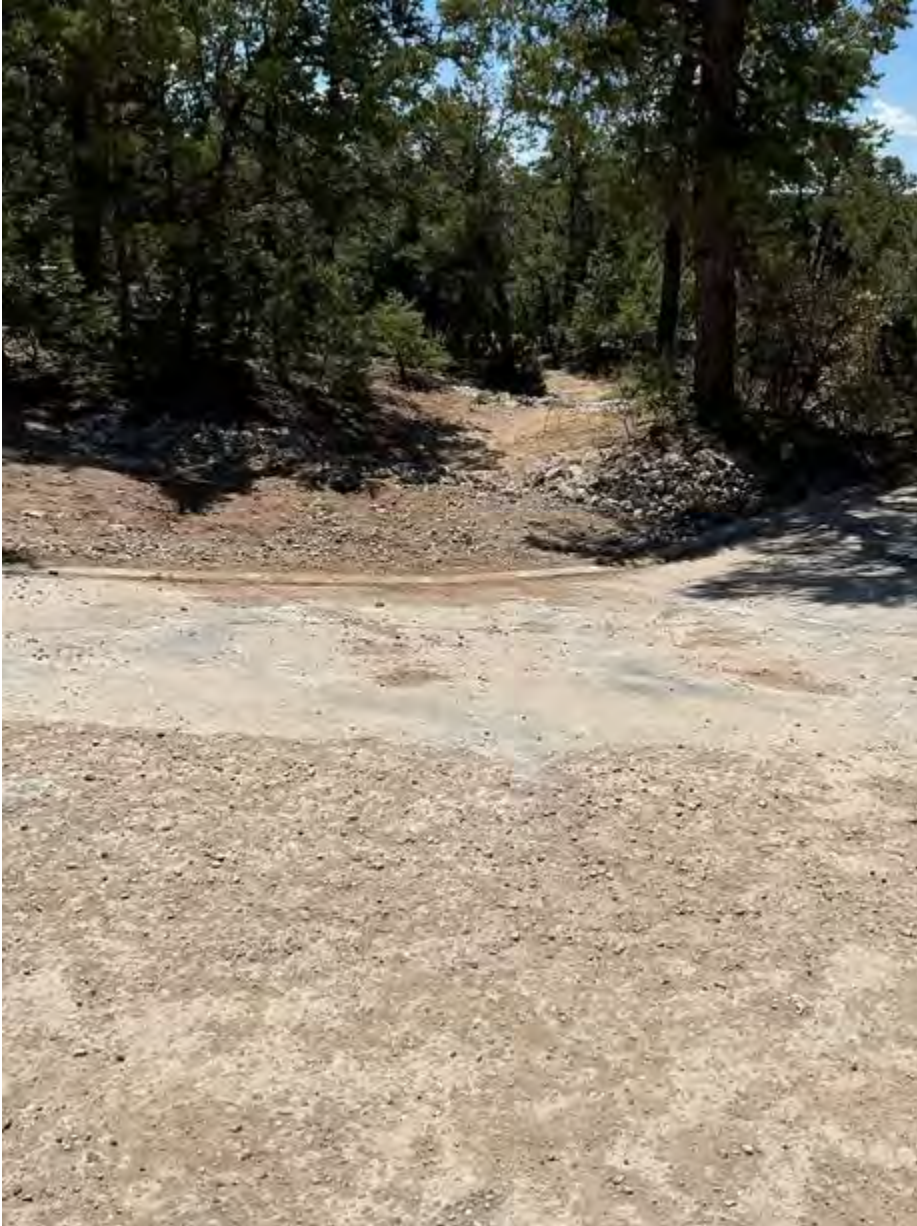
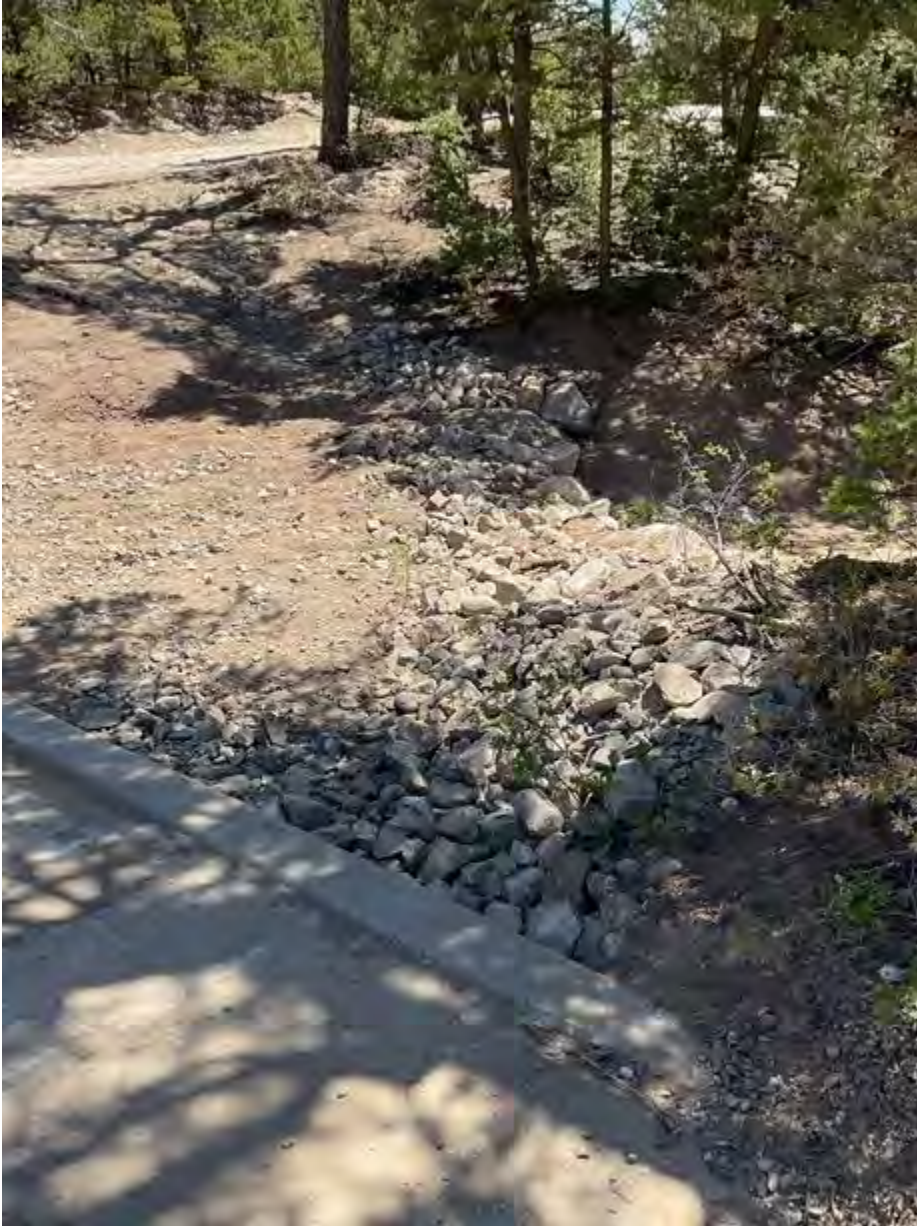
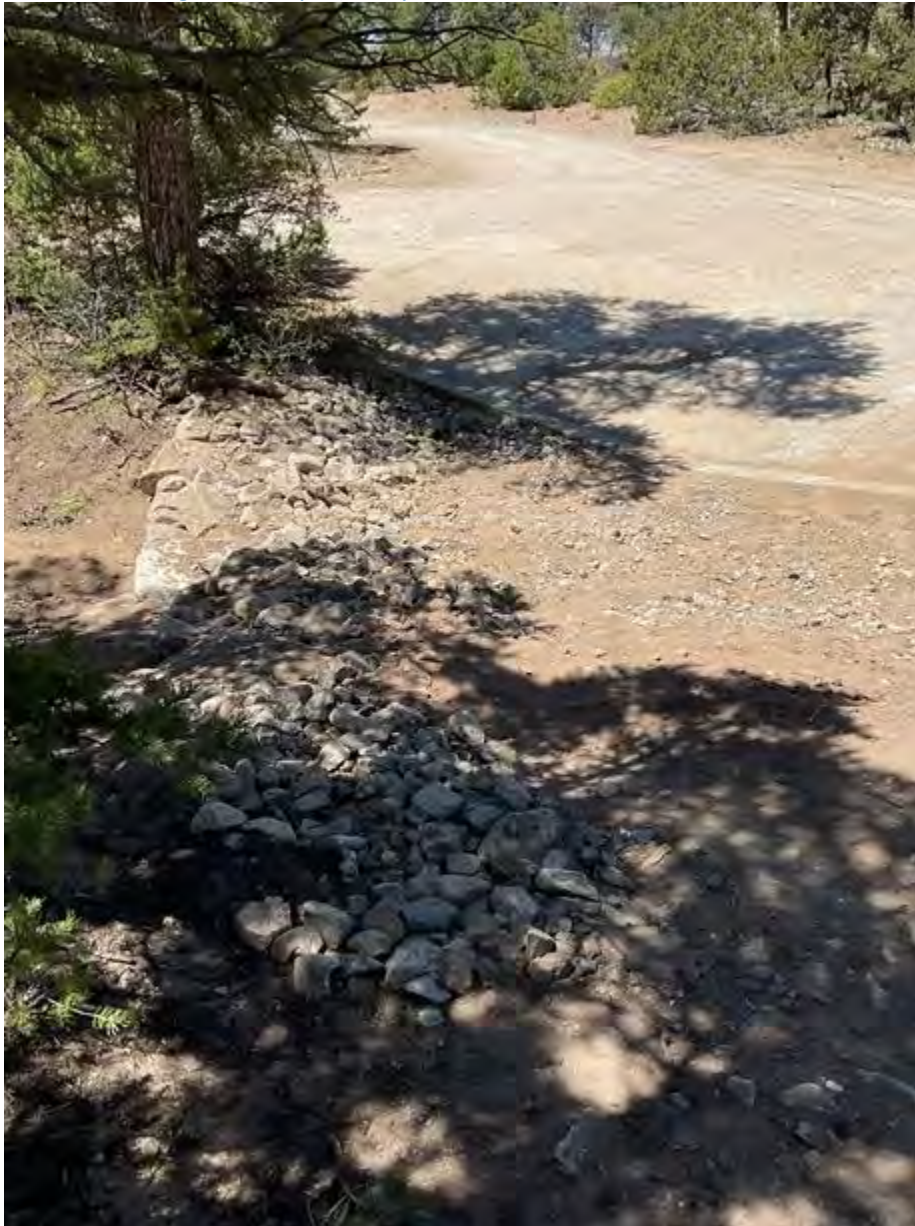
All rocks intact

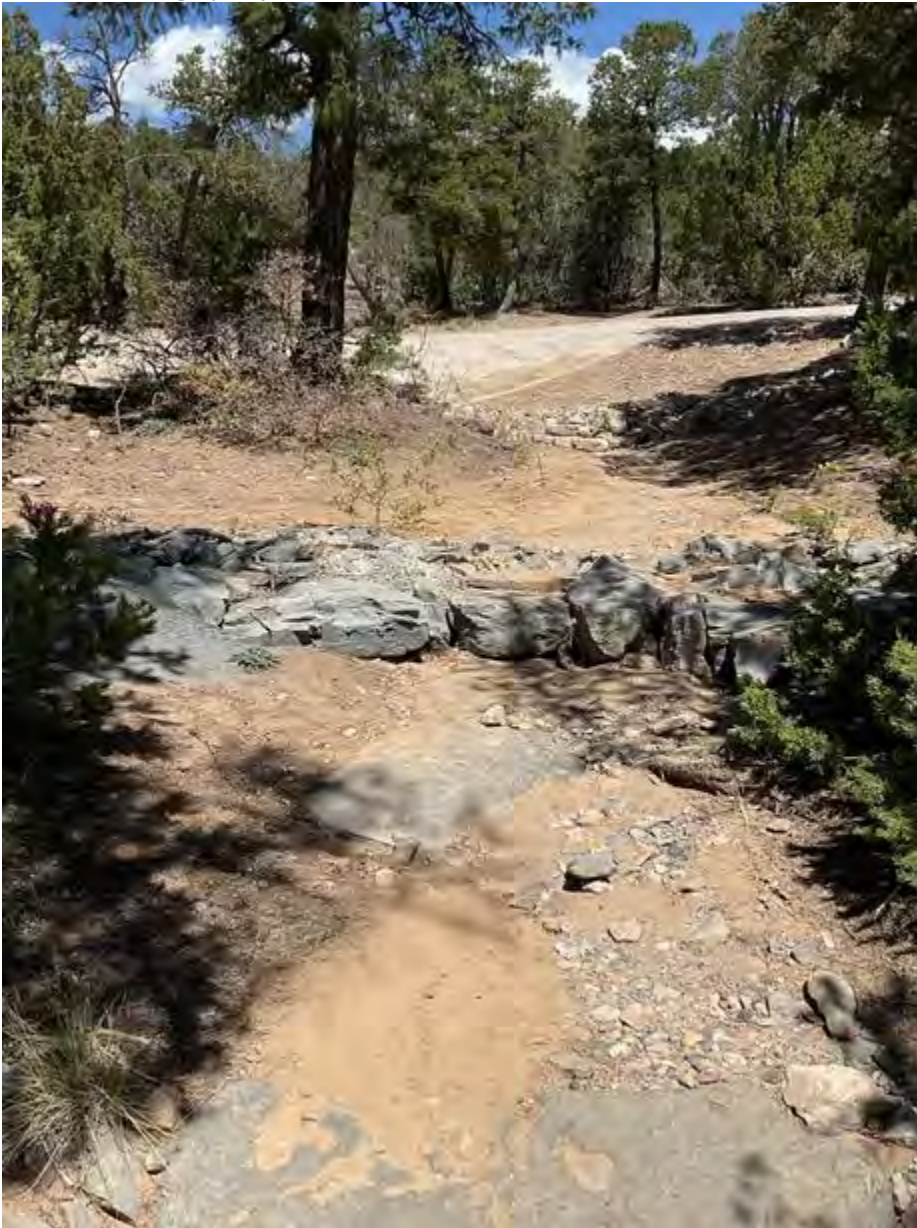
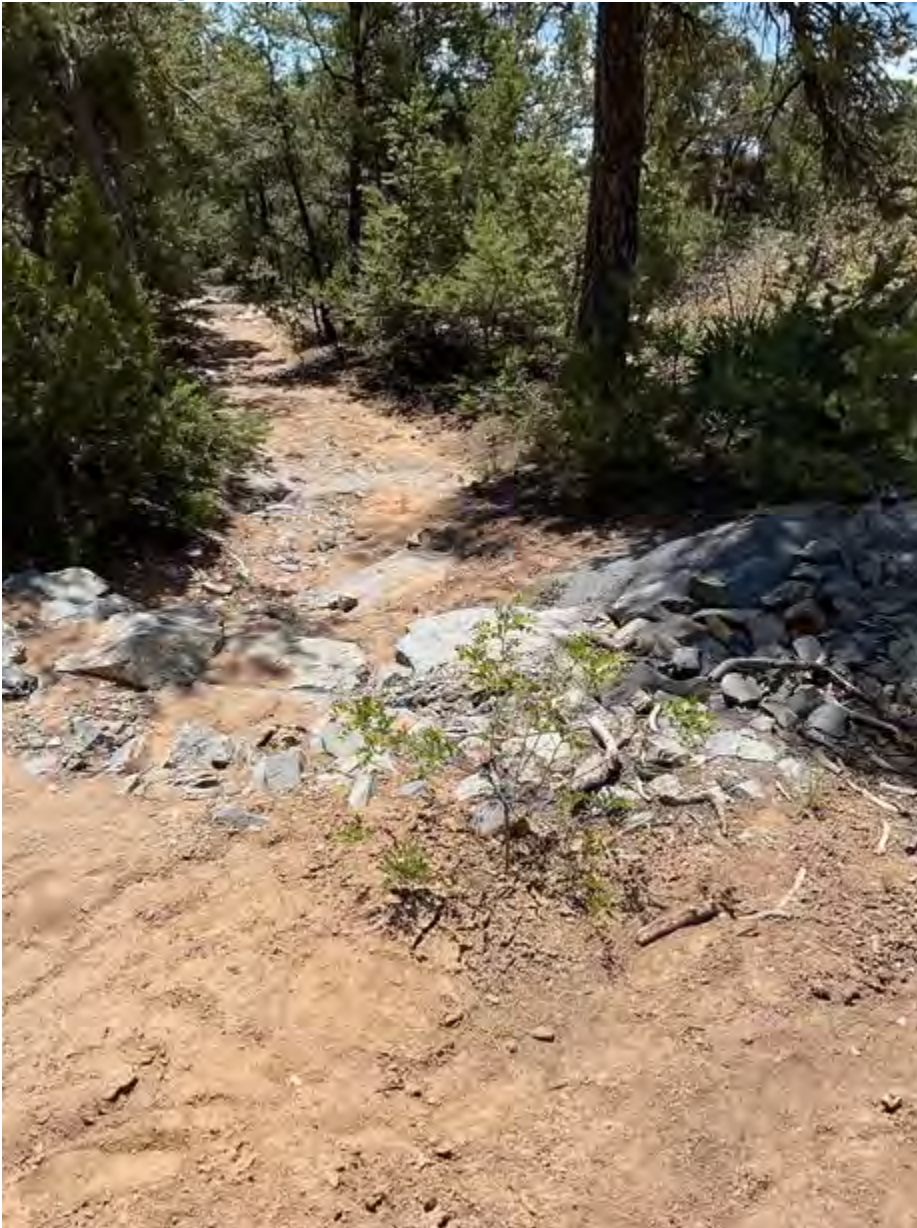
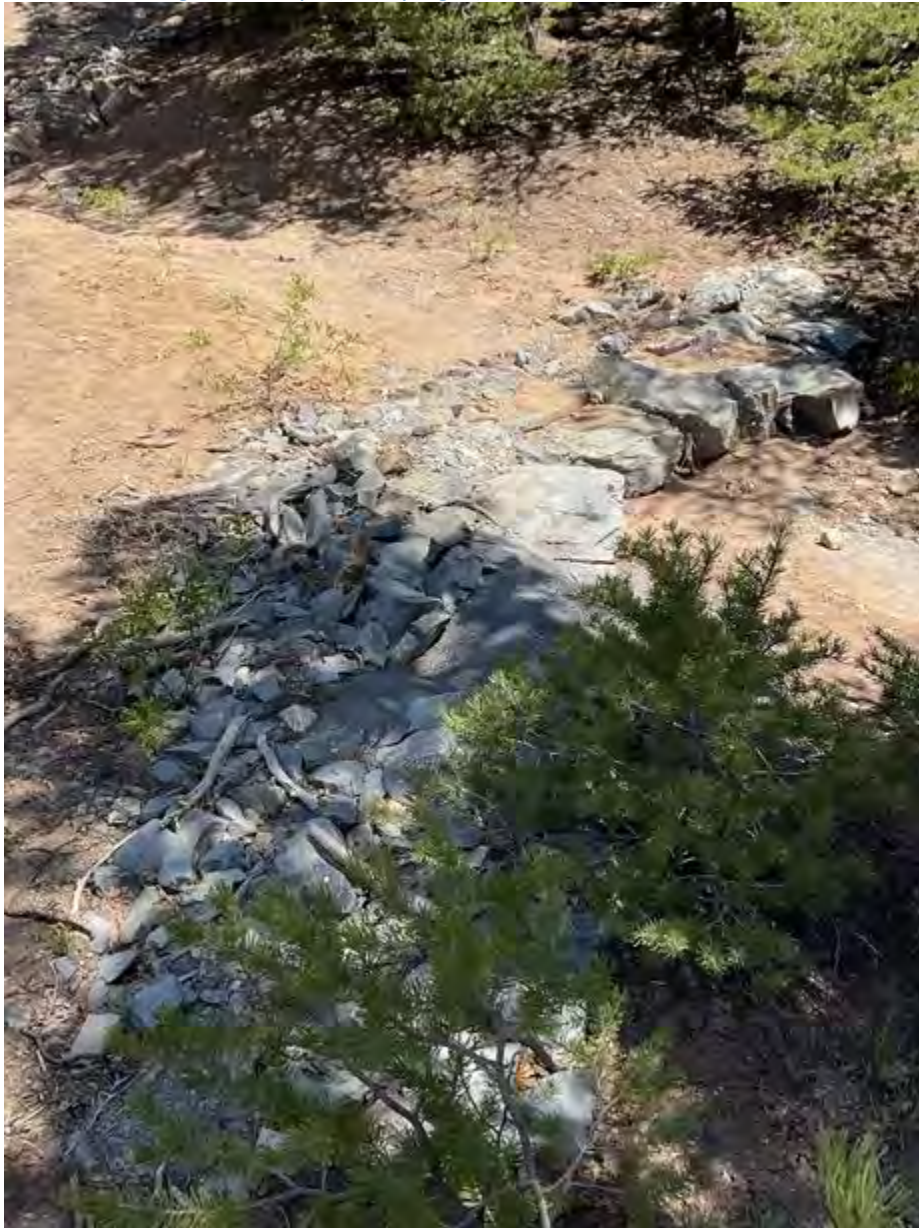
Some rocks dislodged or broken

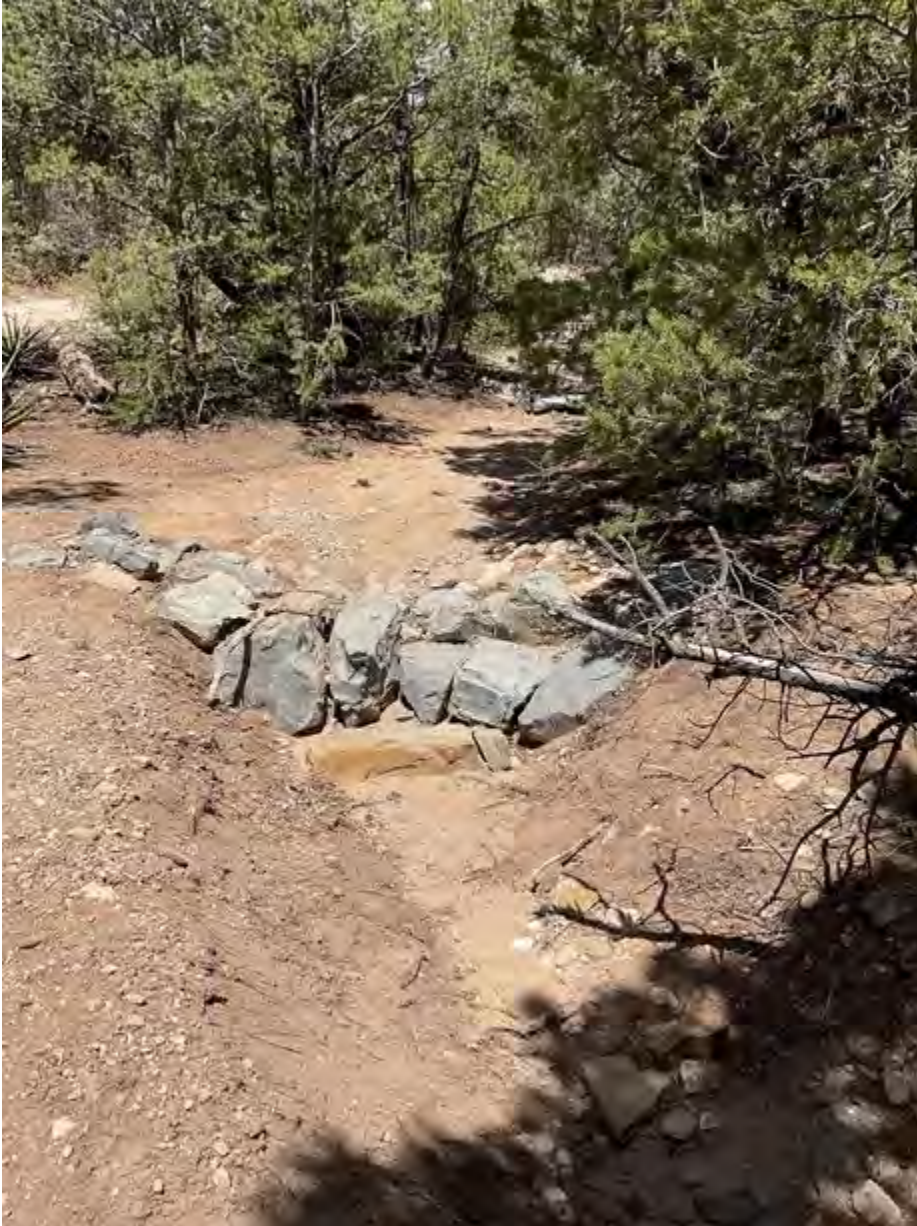
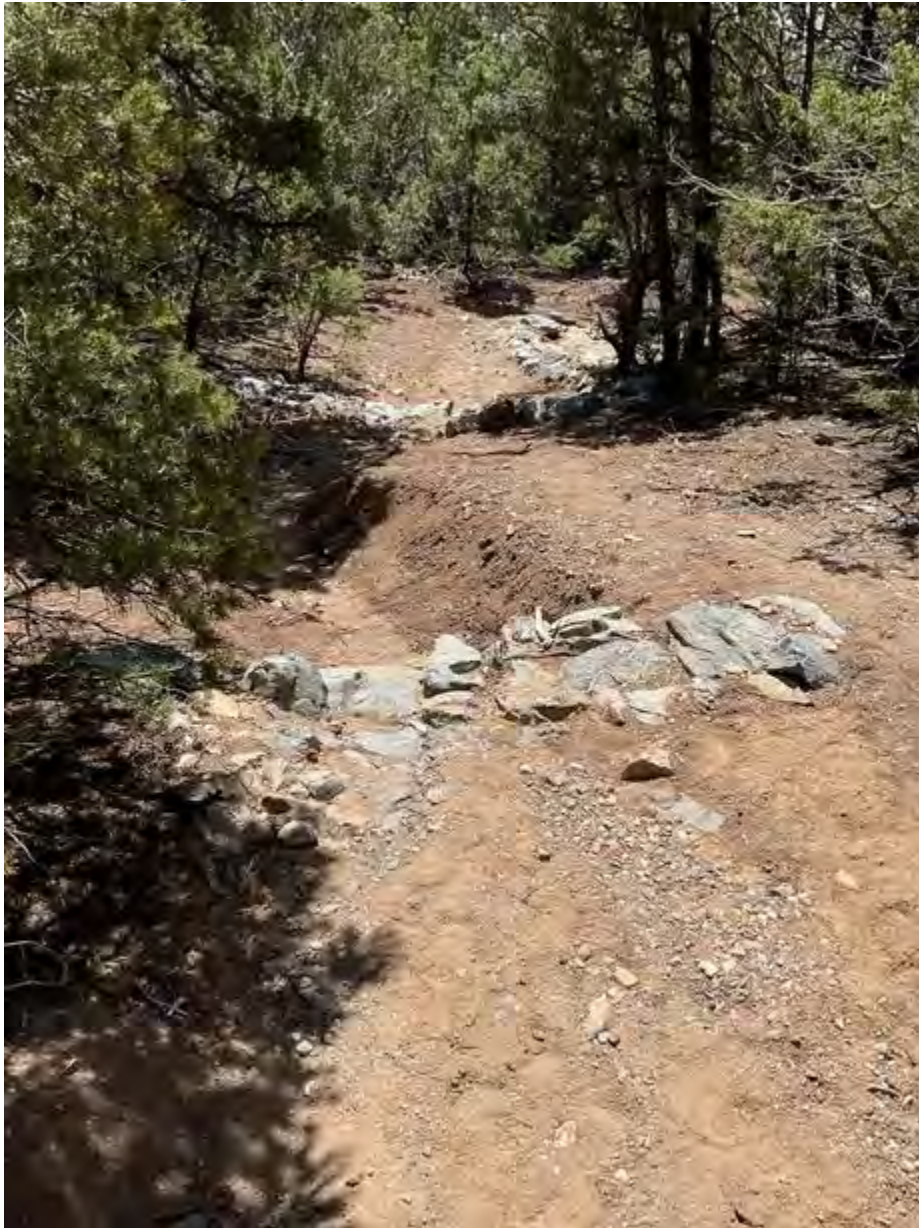
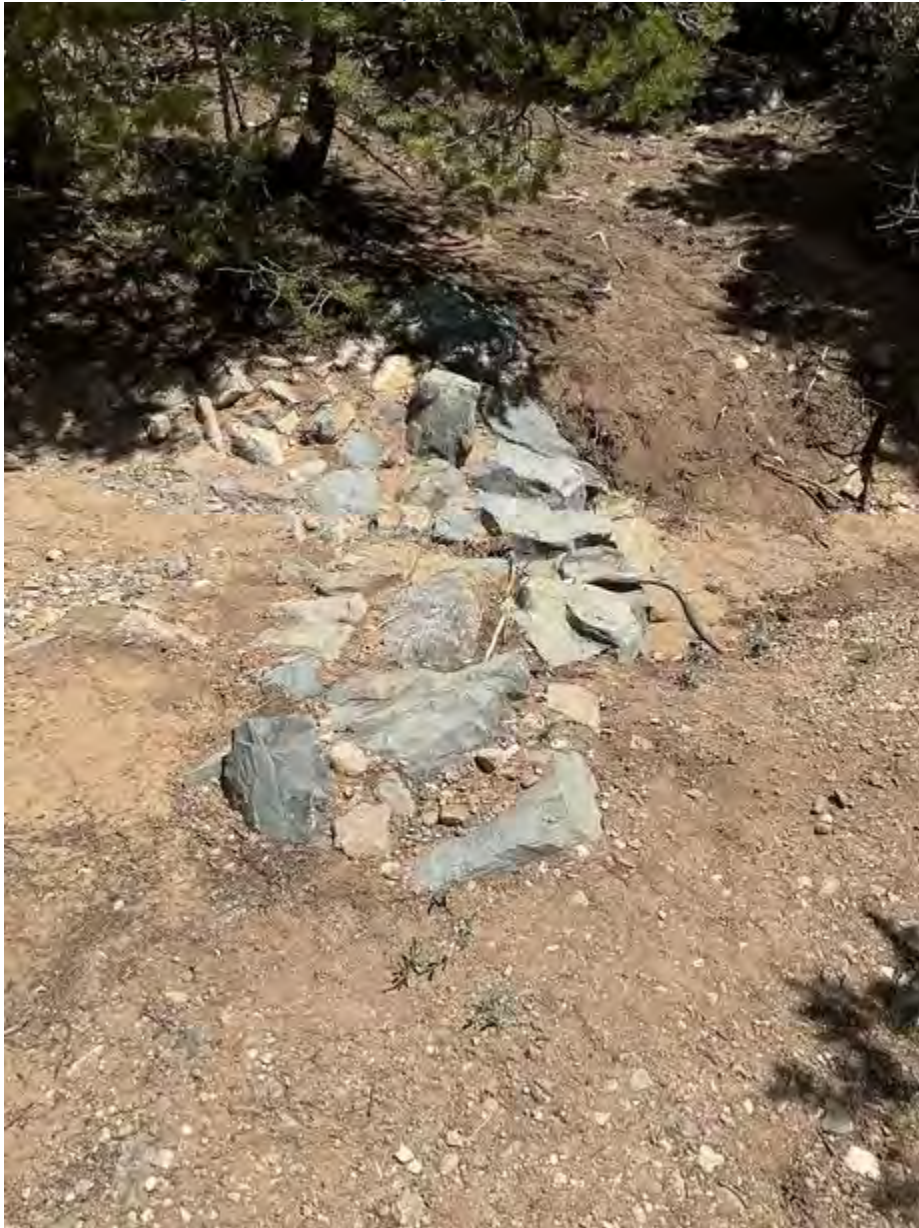
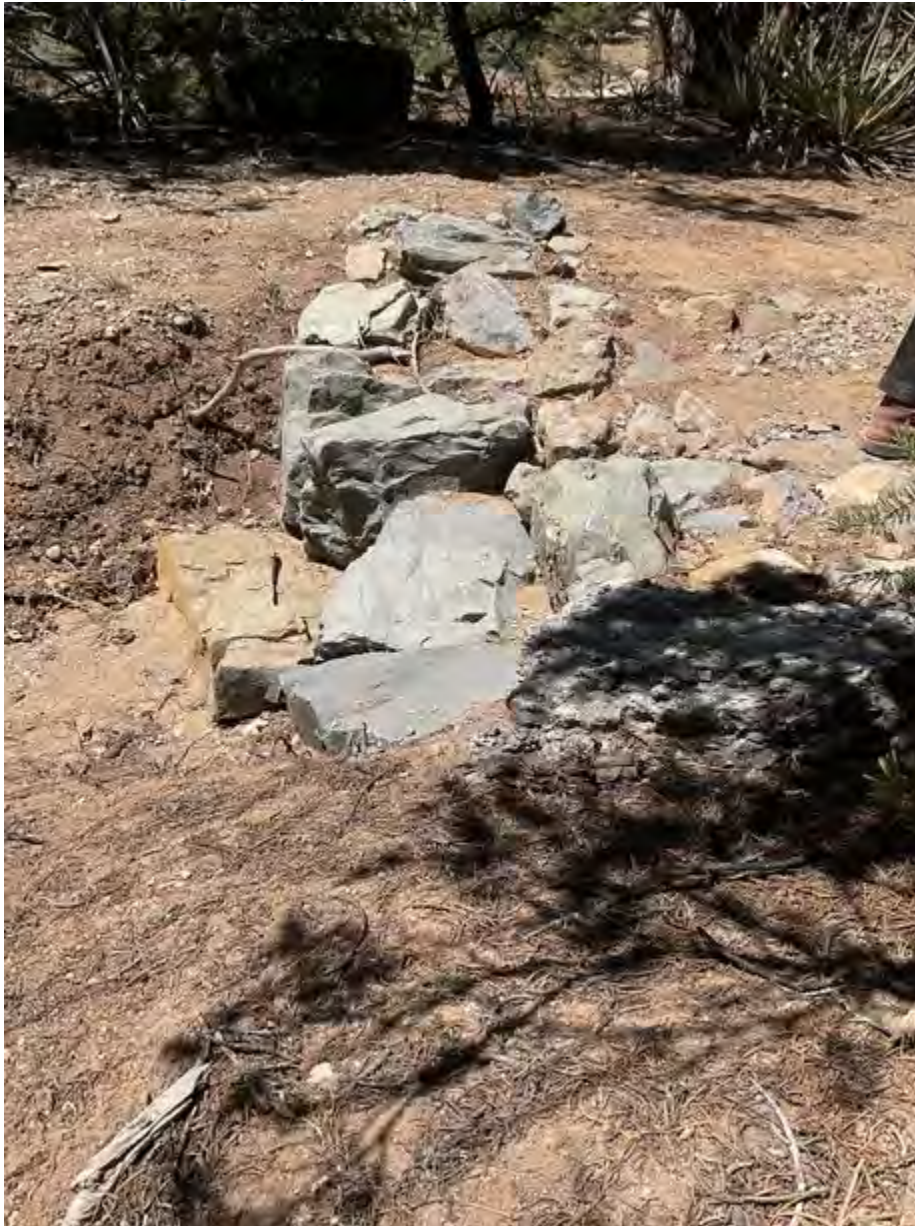
All rocks intact

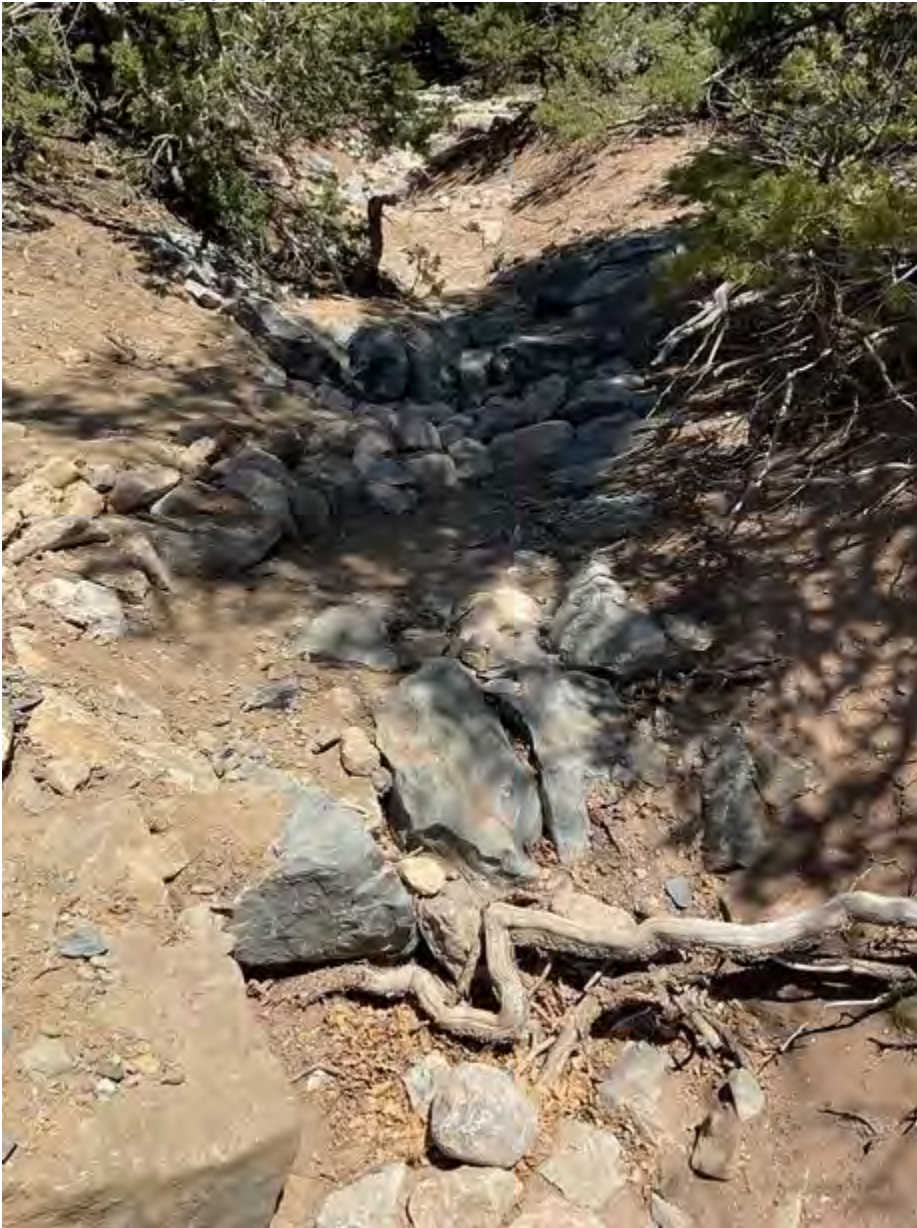
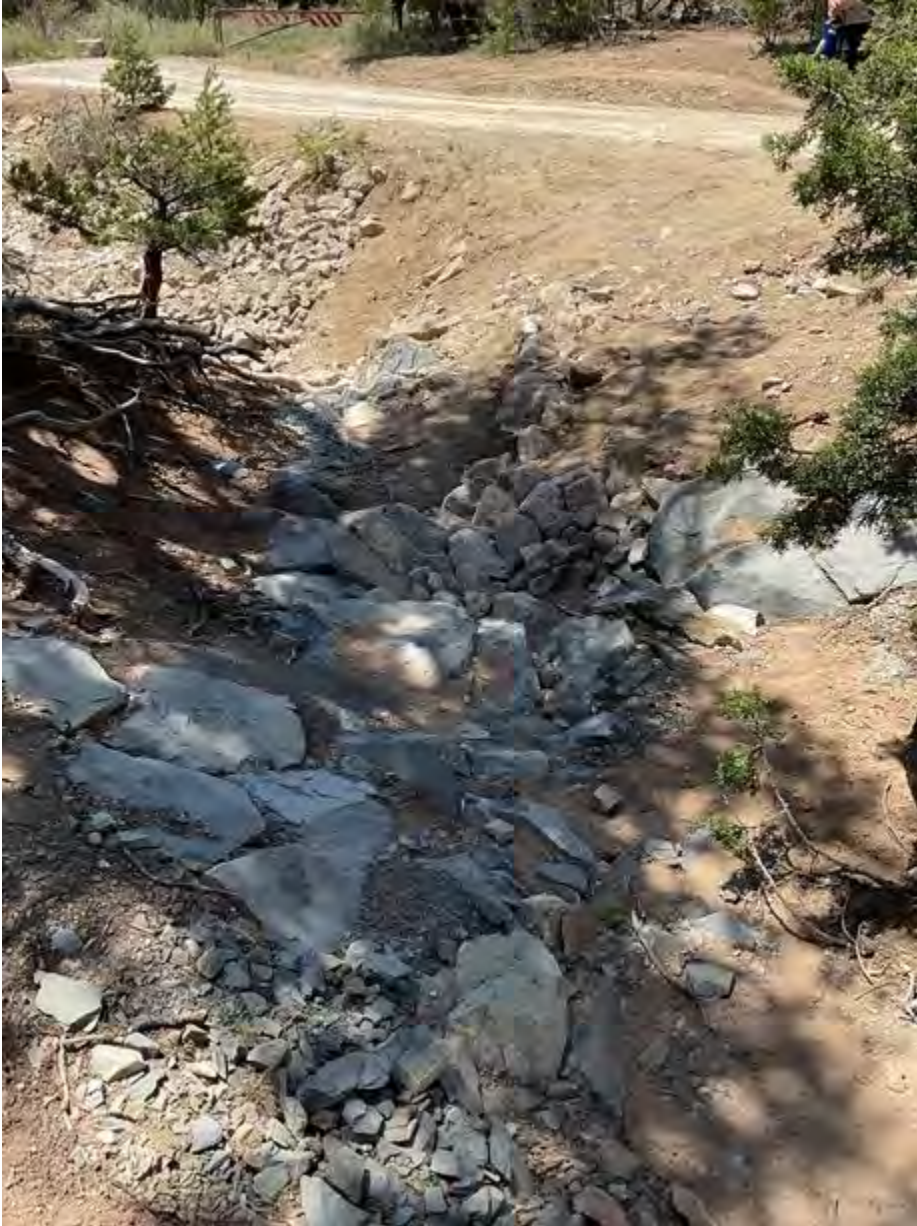
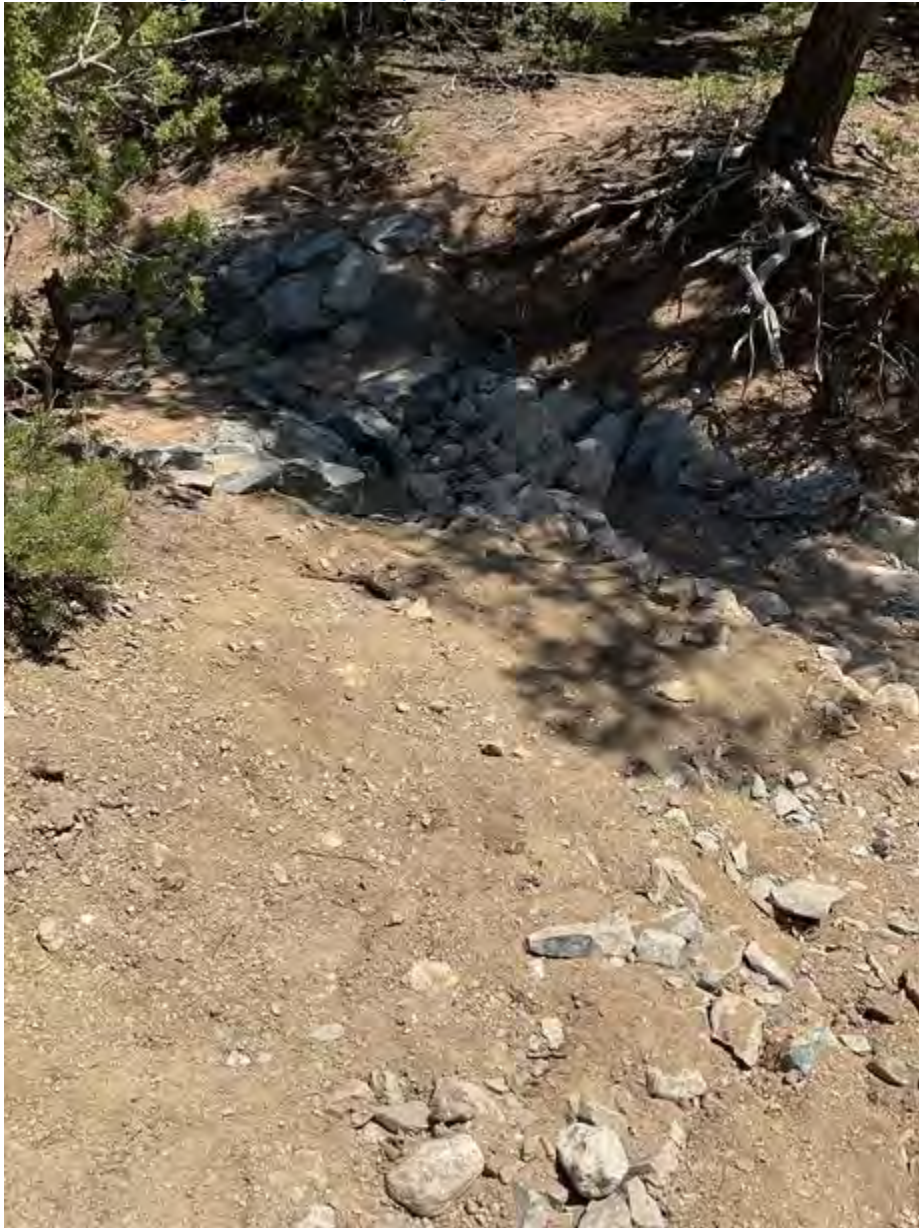
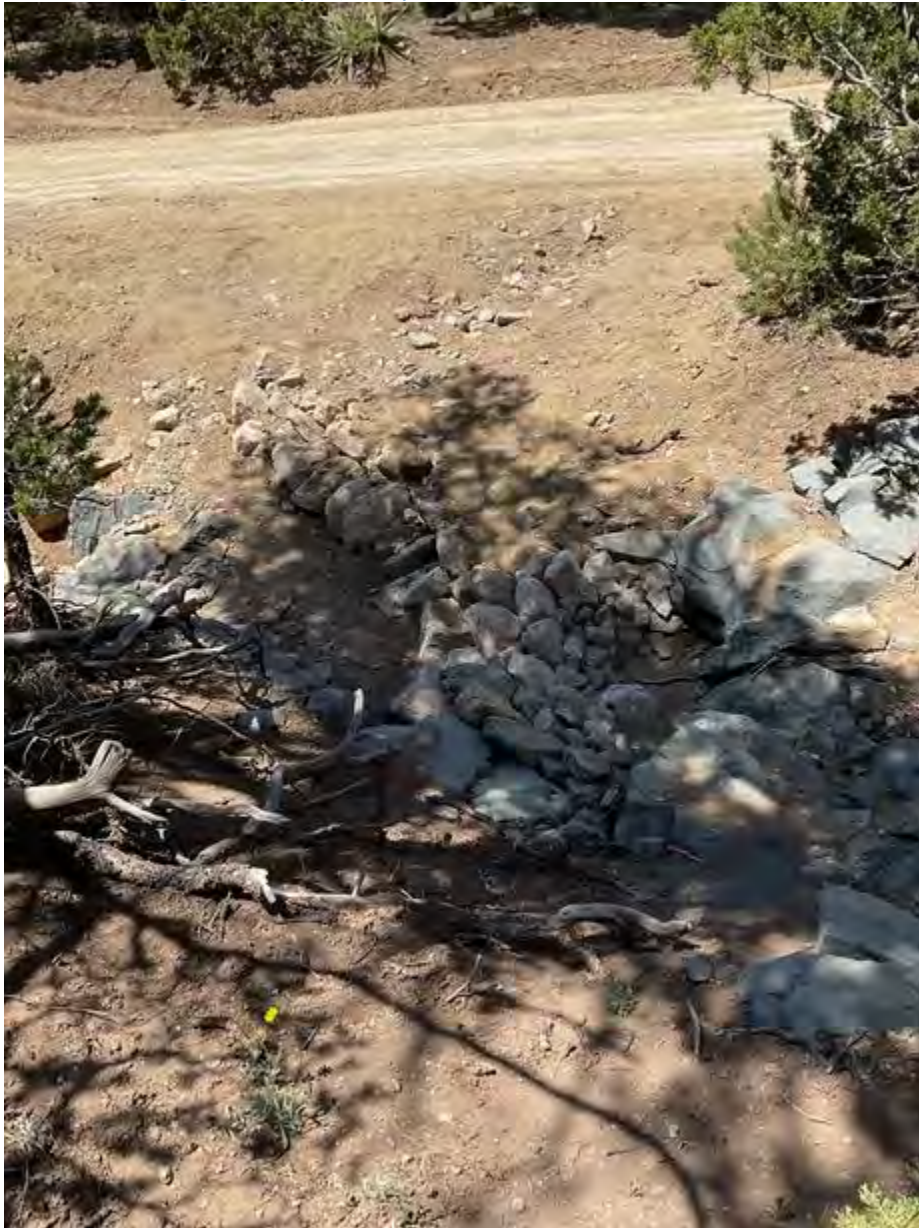
All rocks intact

Difference between ZB and ORD Condition
ORD downstream edge erosion

Additional Notes
Very recent repair
