**Zuni Bowl and One Rock Check Dam Research –
Phase 1**

Final Report

December 2024

Rio Grande Return for the New Mexico Department of Transportation Research Bureau

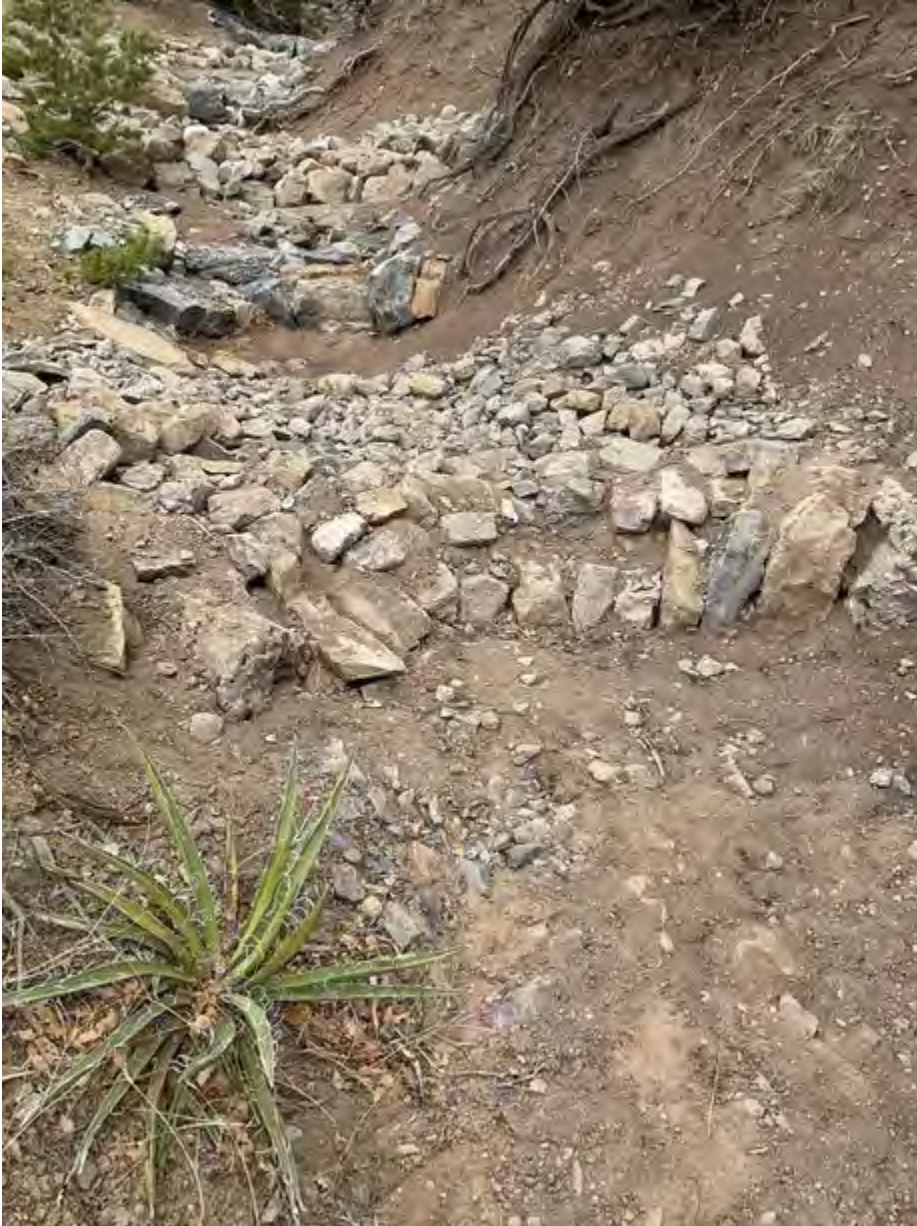
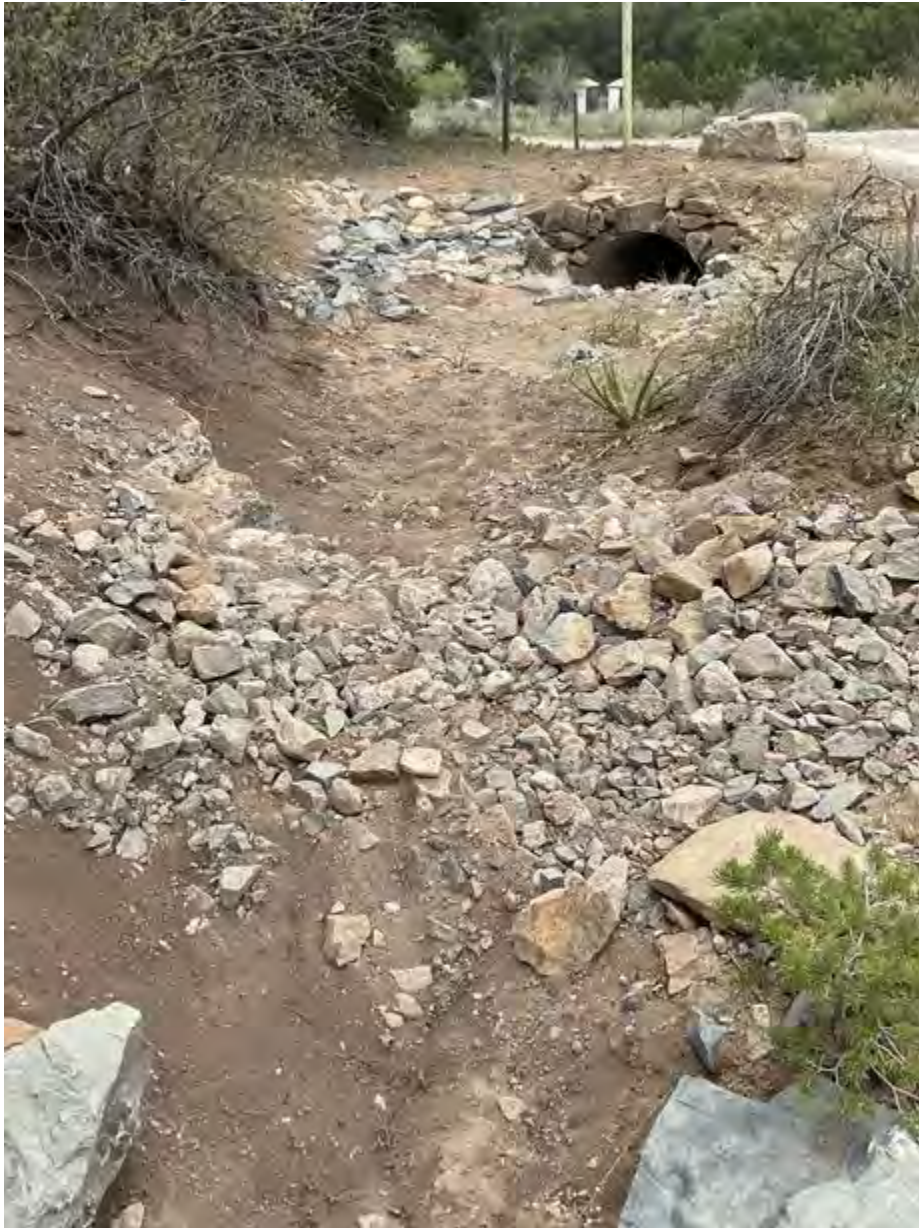
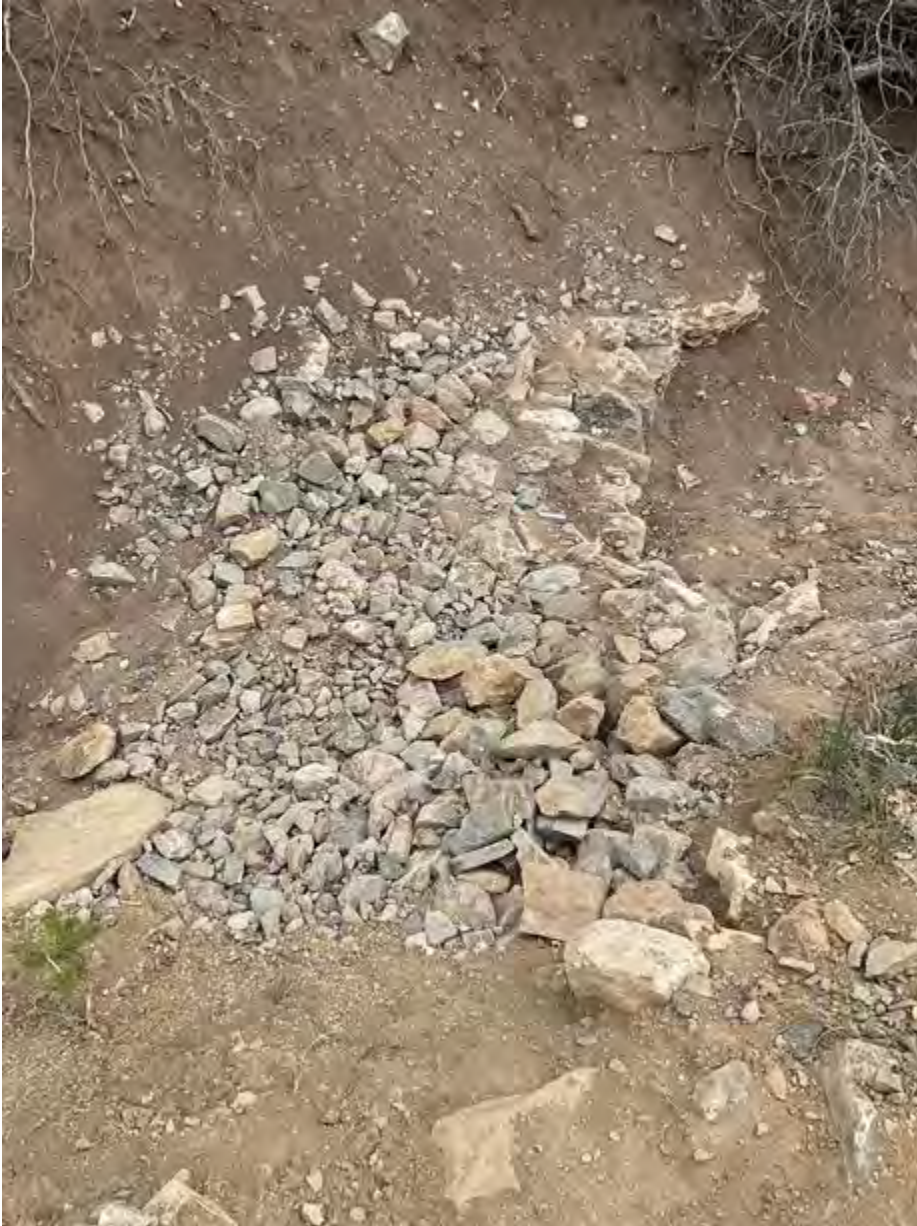
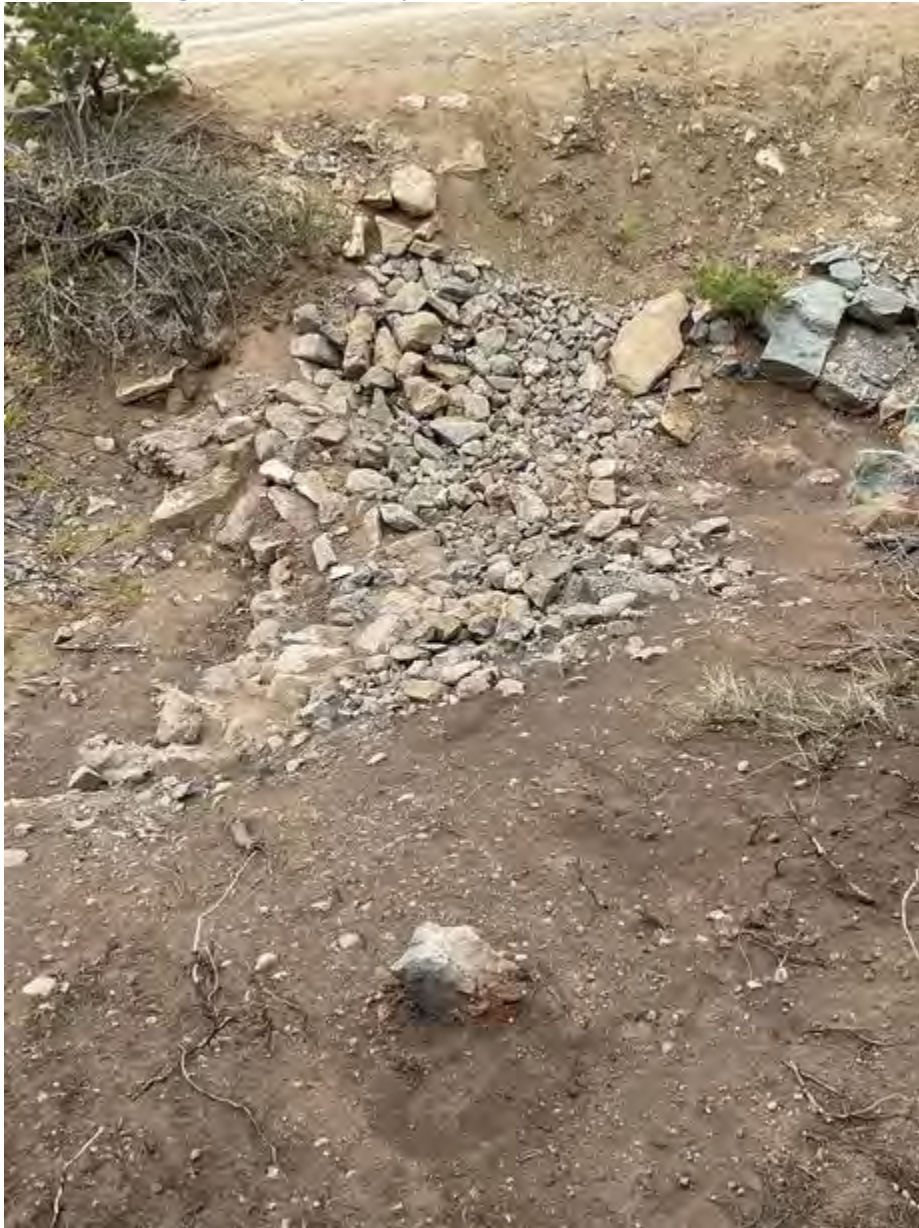
All rocks intact

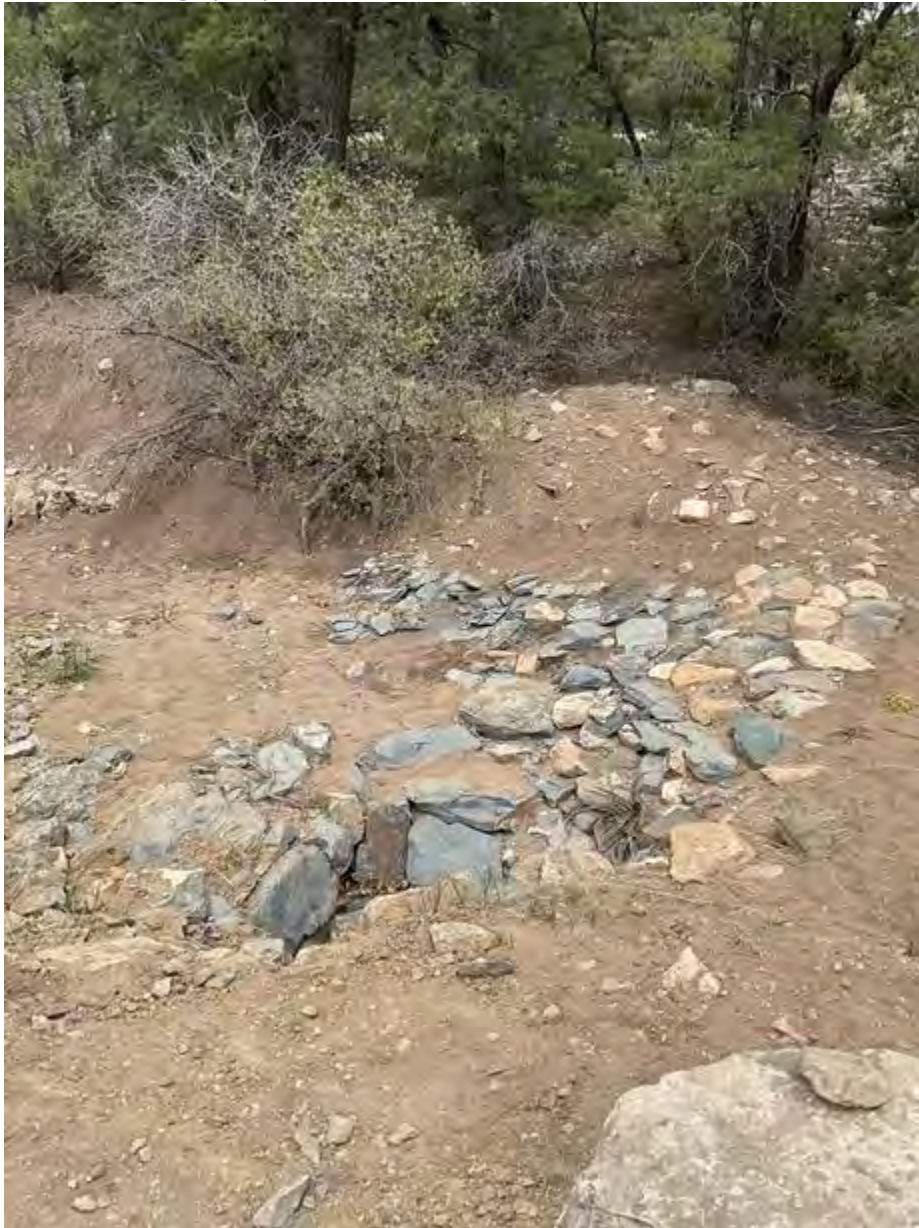
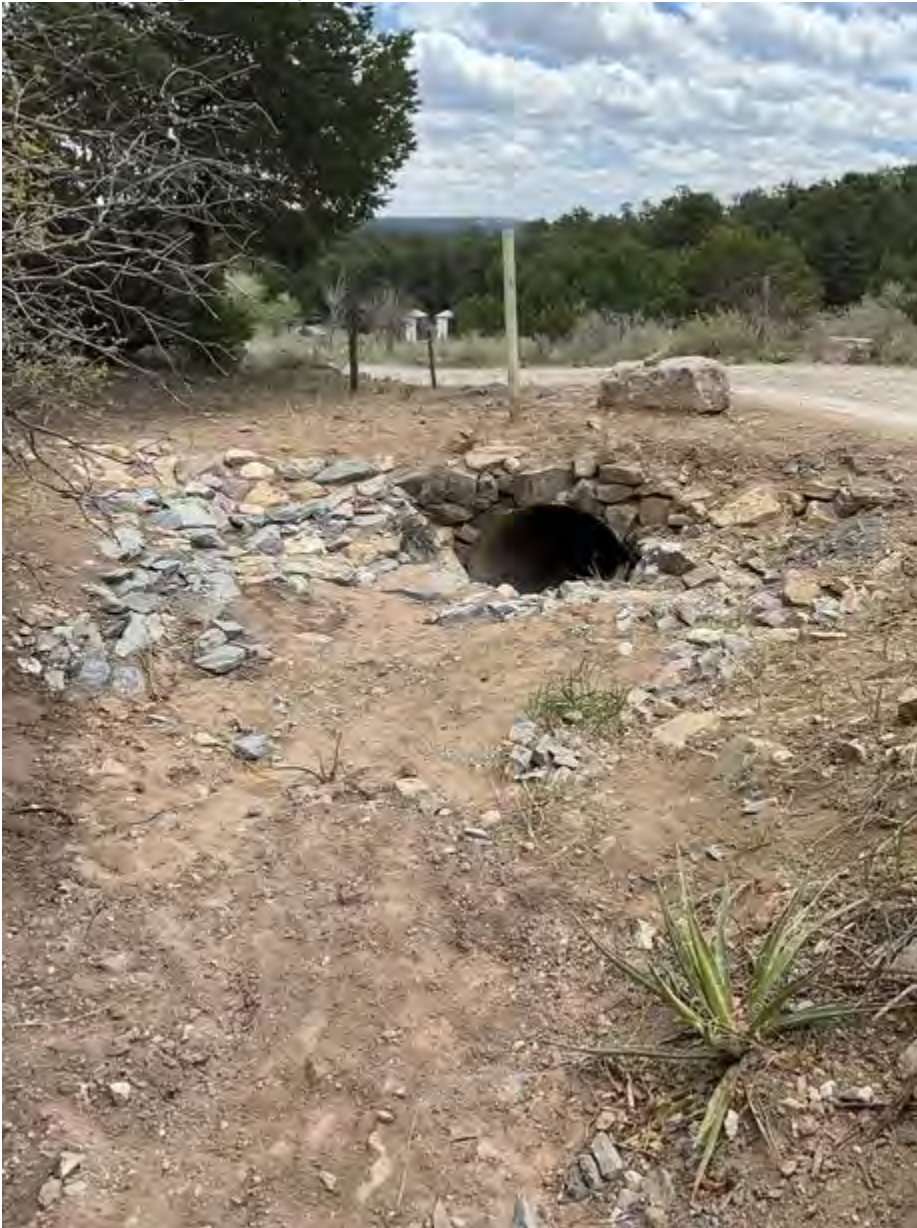
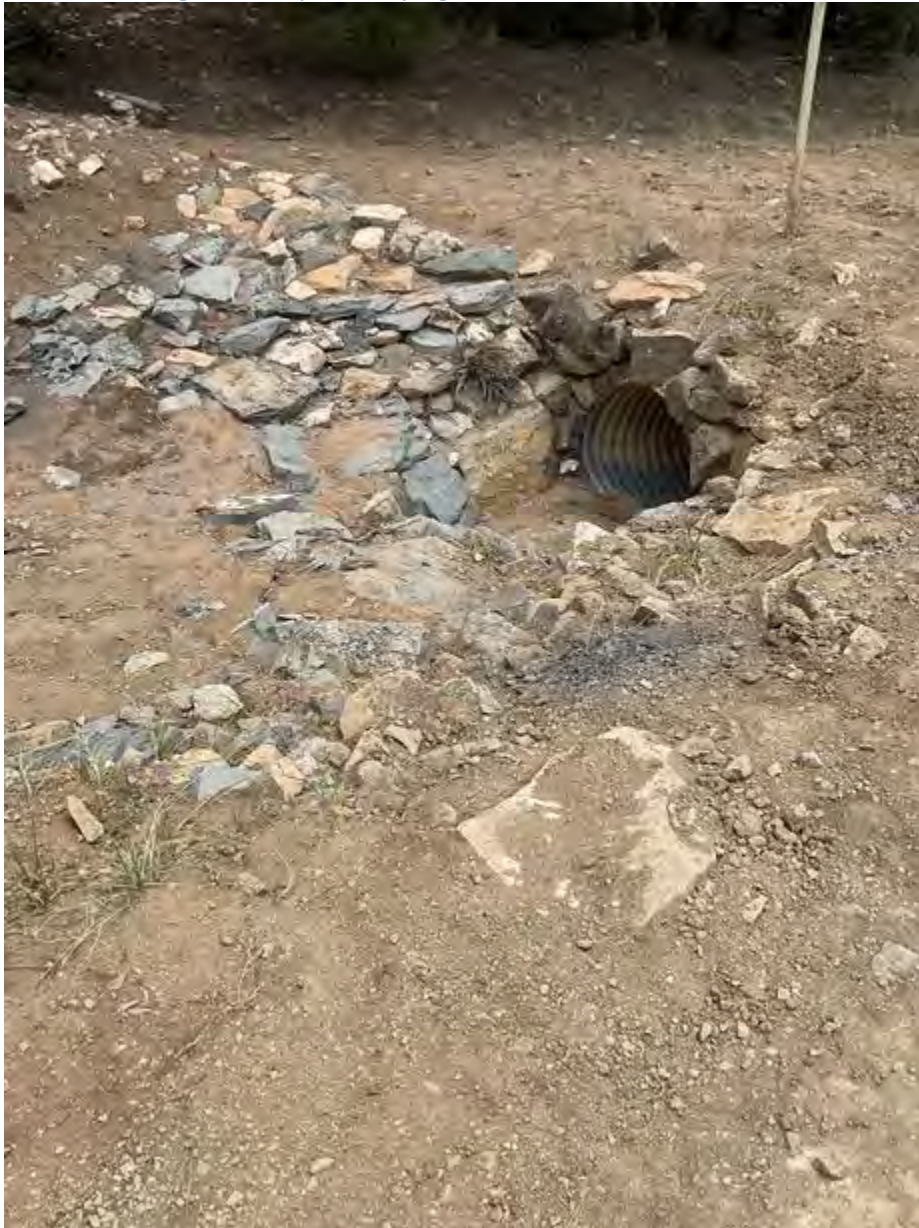
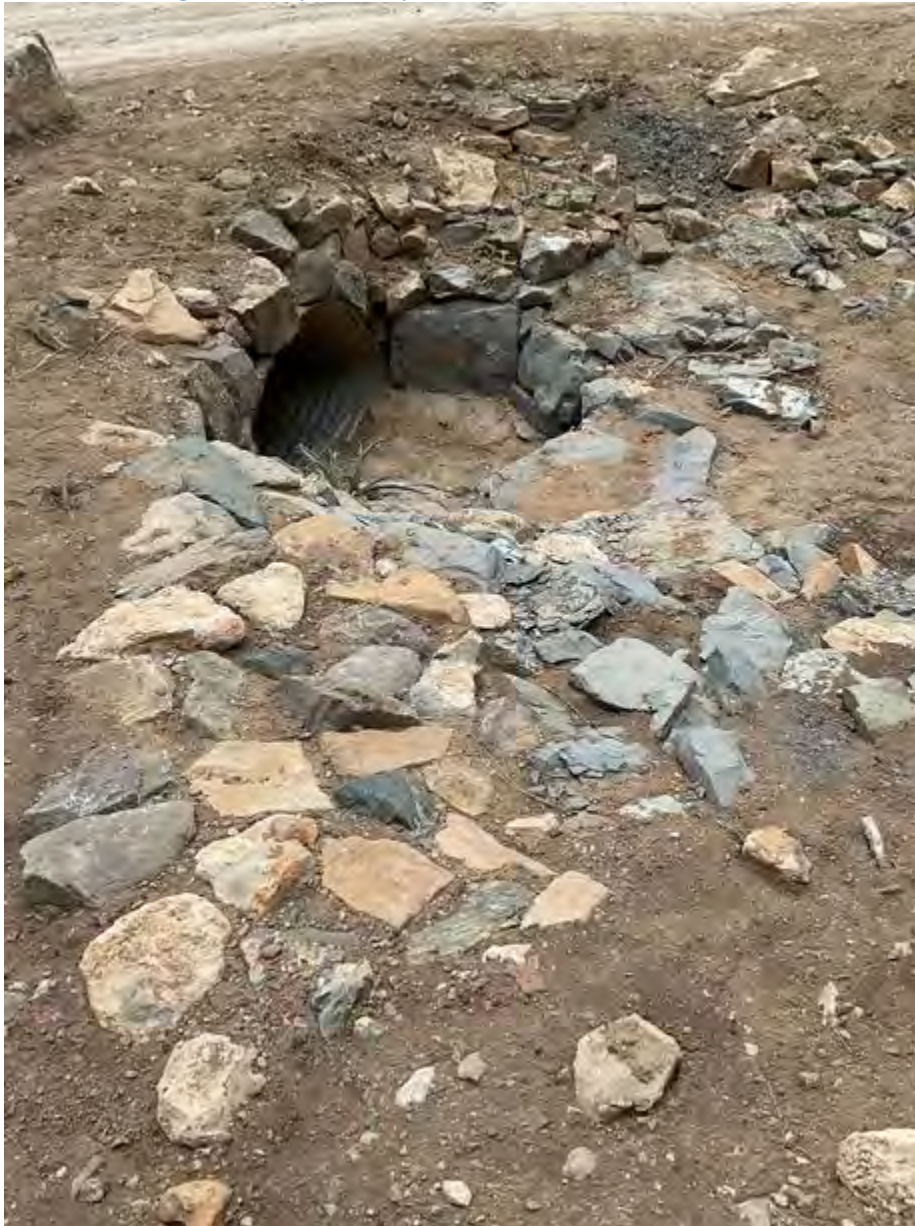
All rocks intact

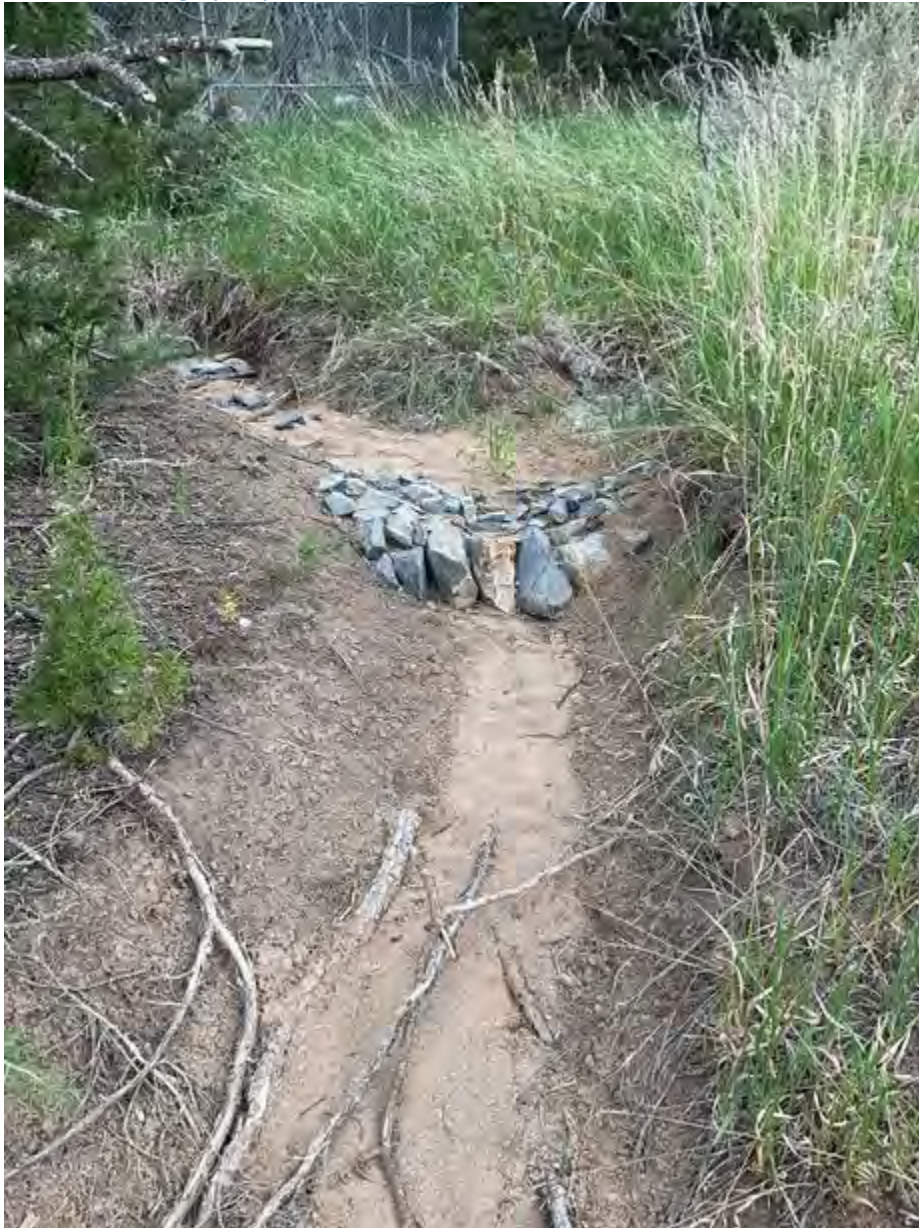
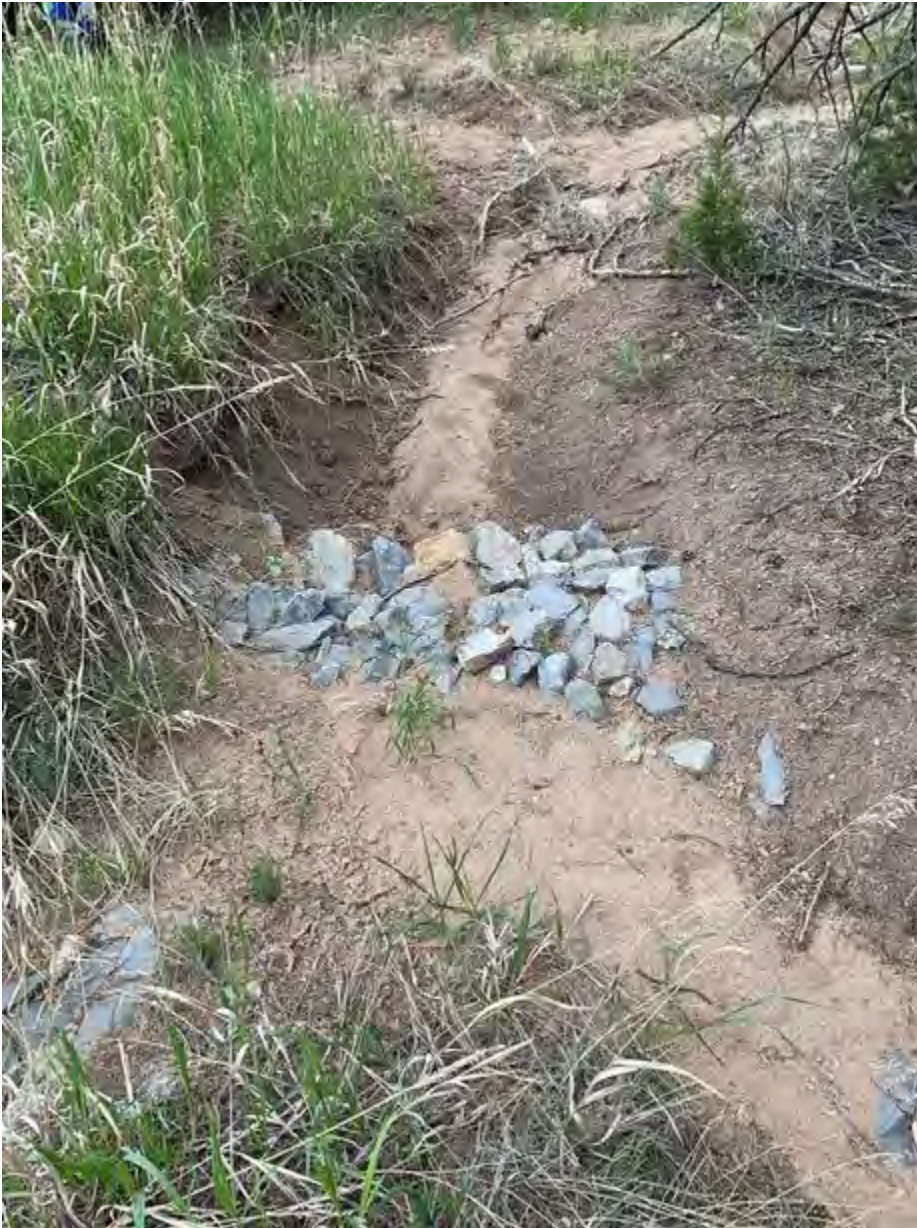
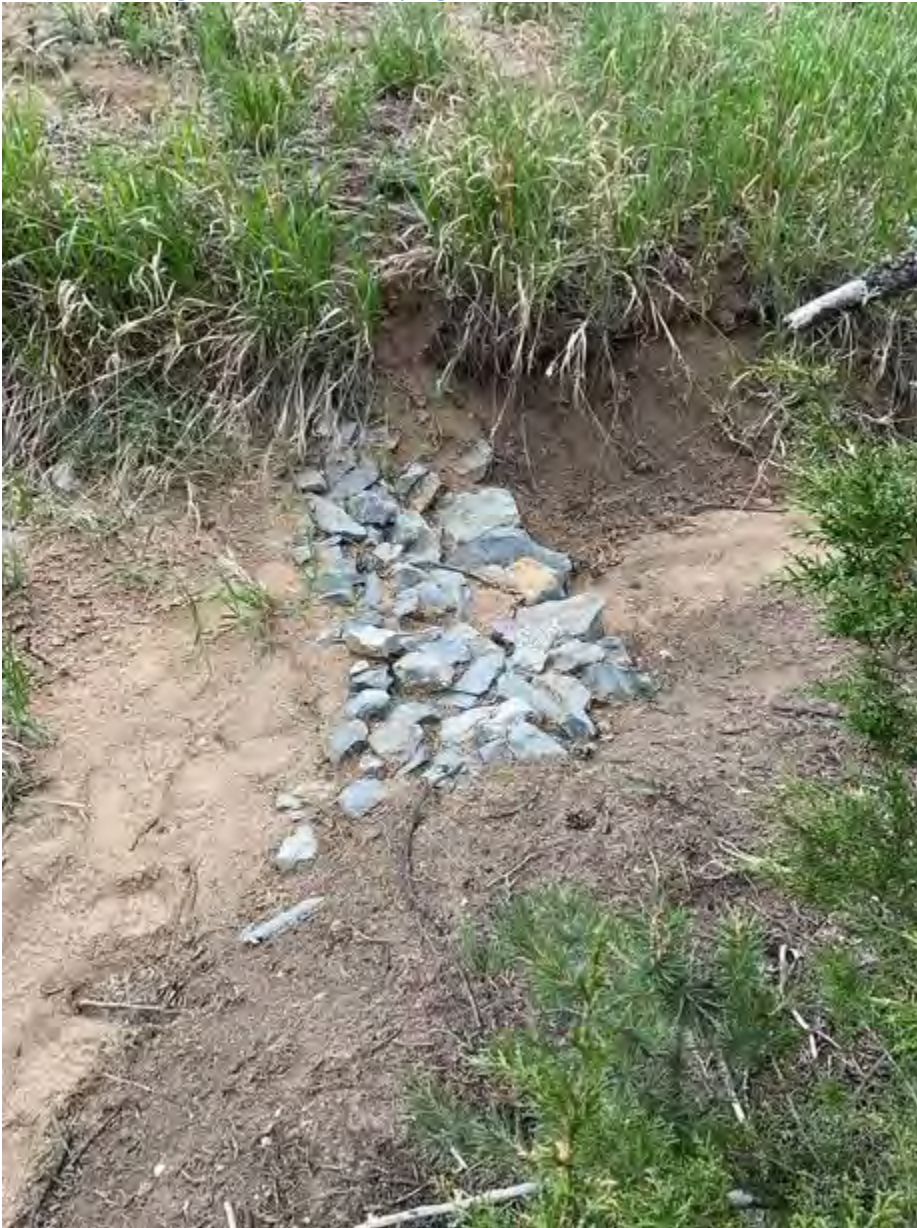
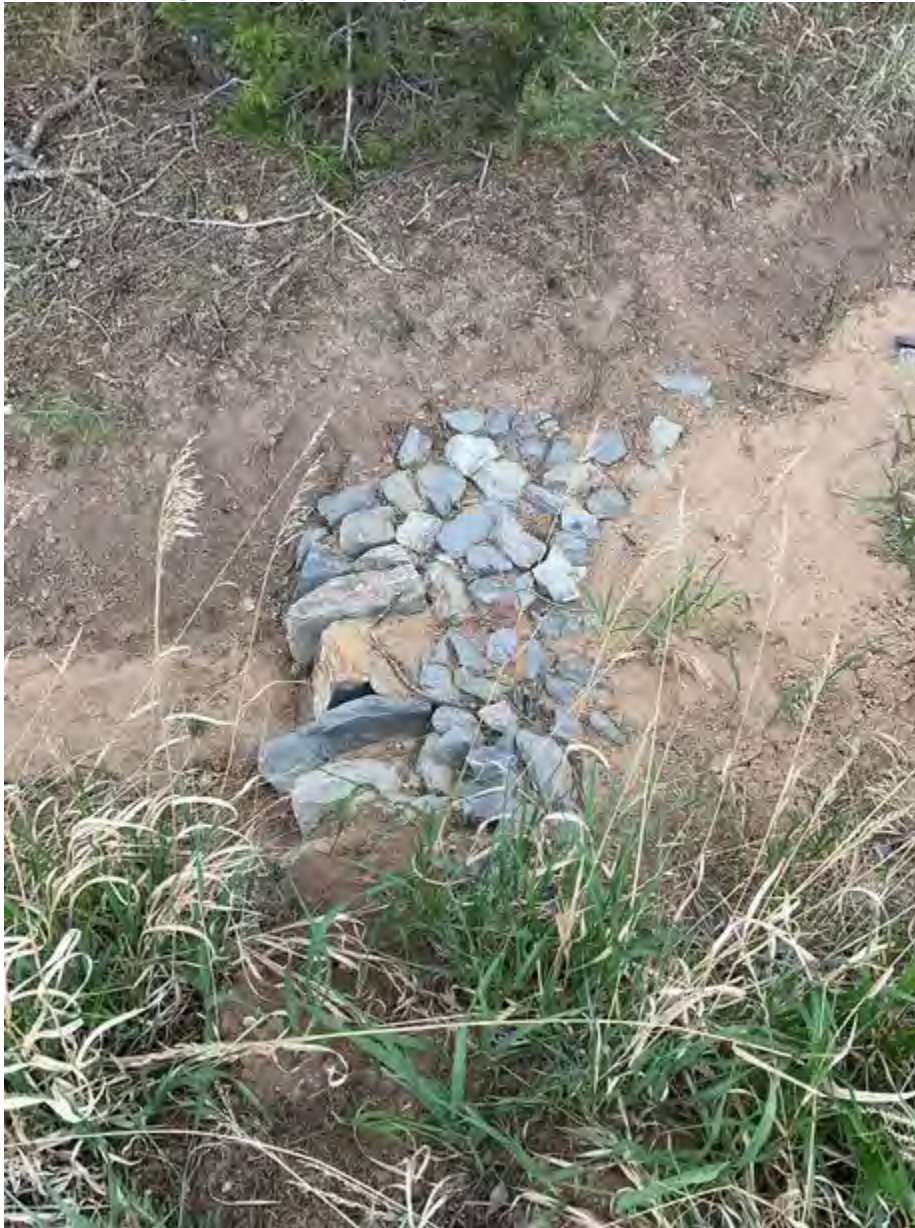
All rocks intact

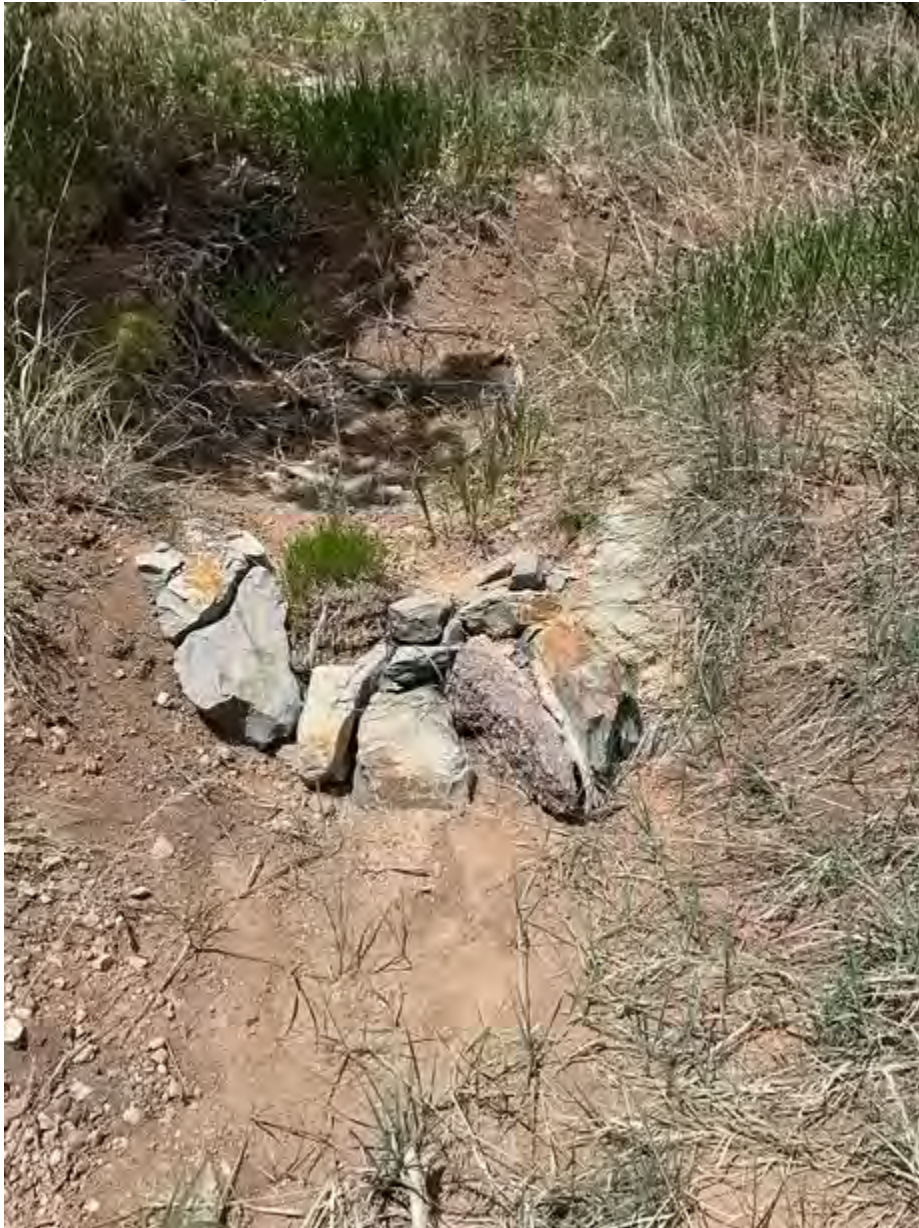
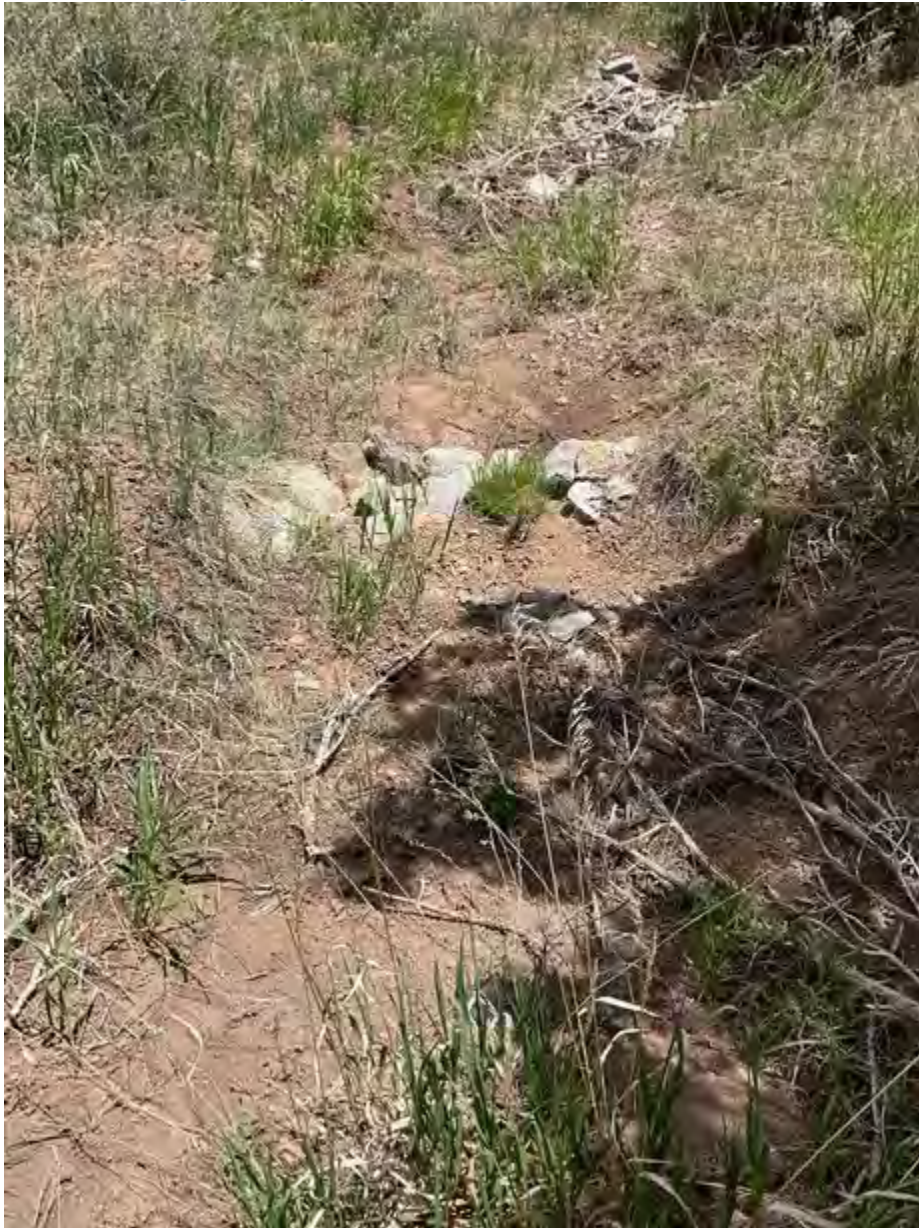
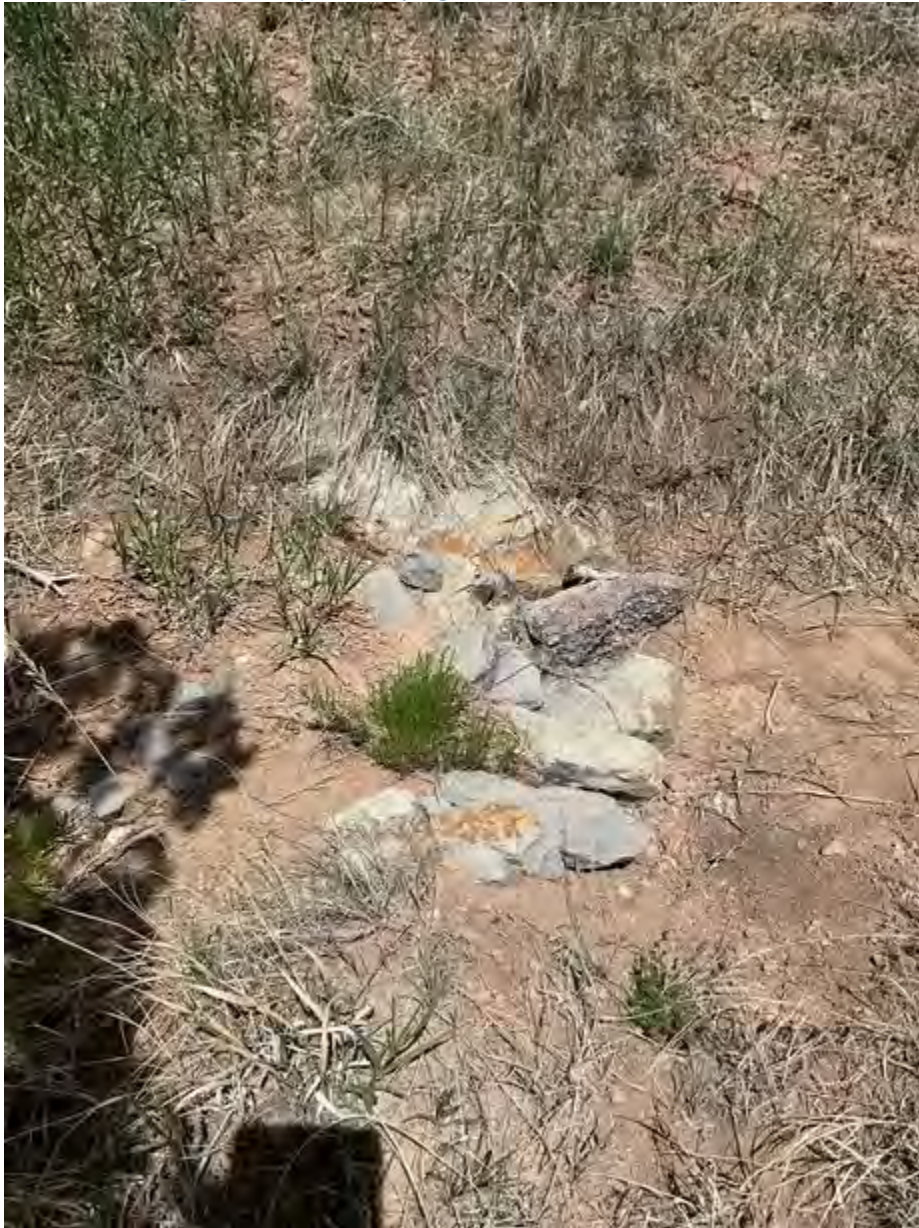
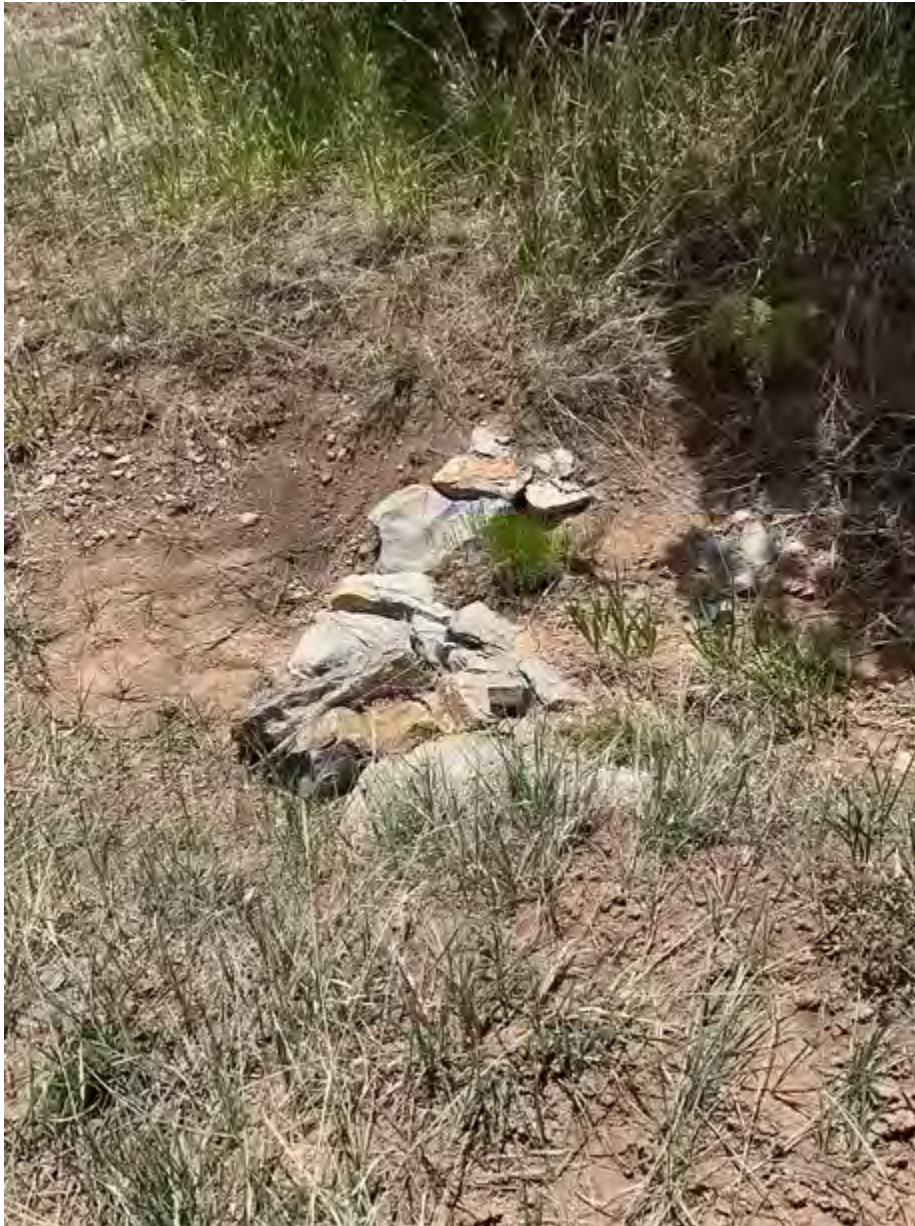
All rocks intact

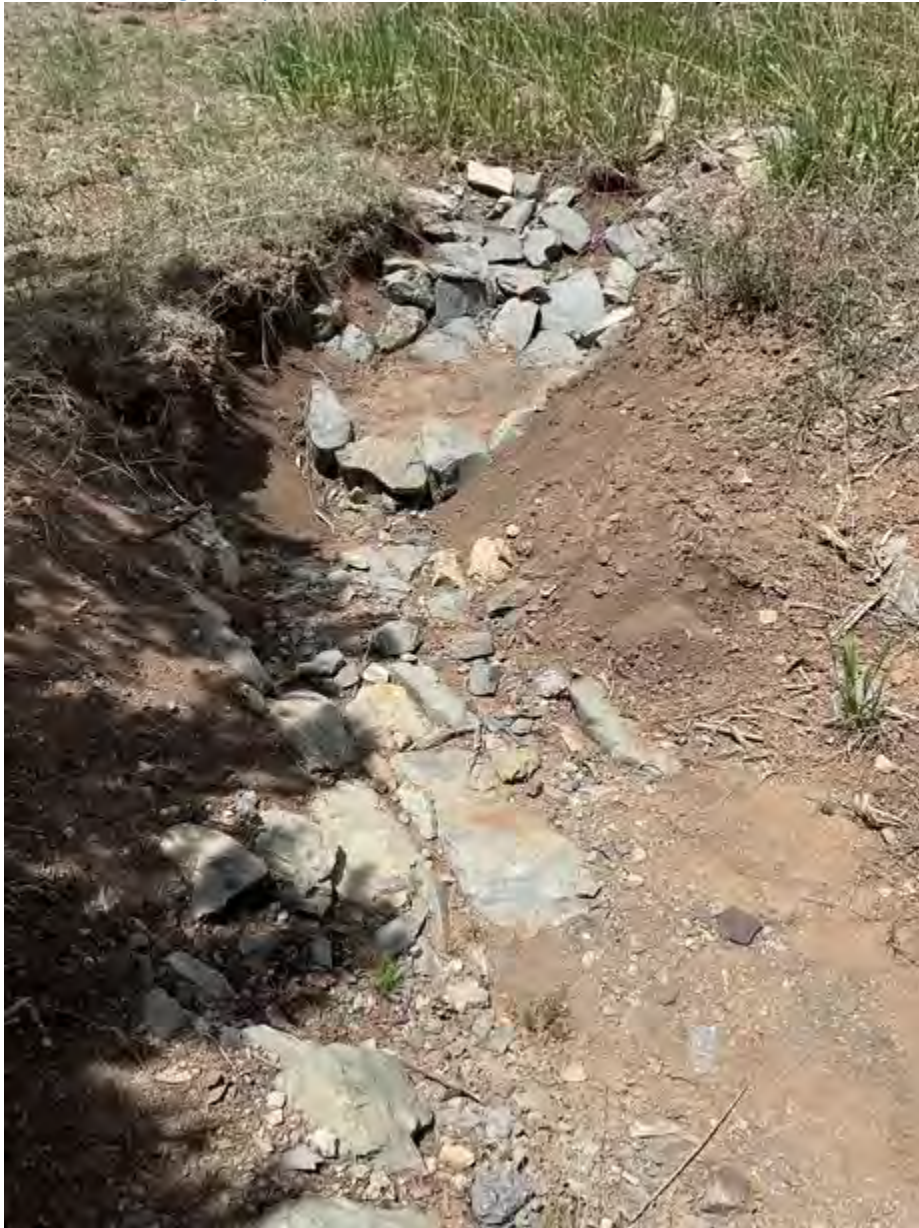
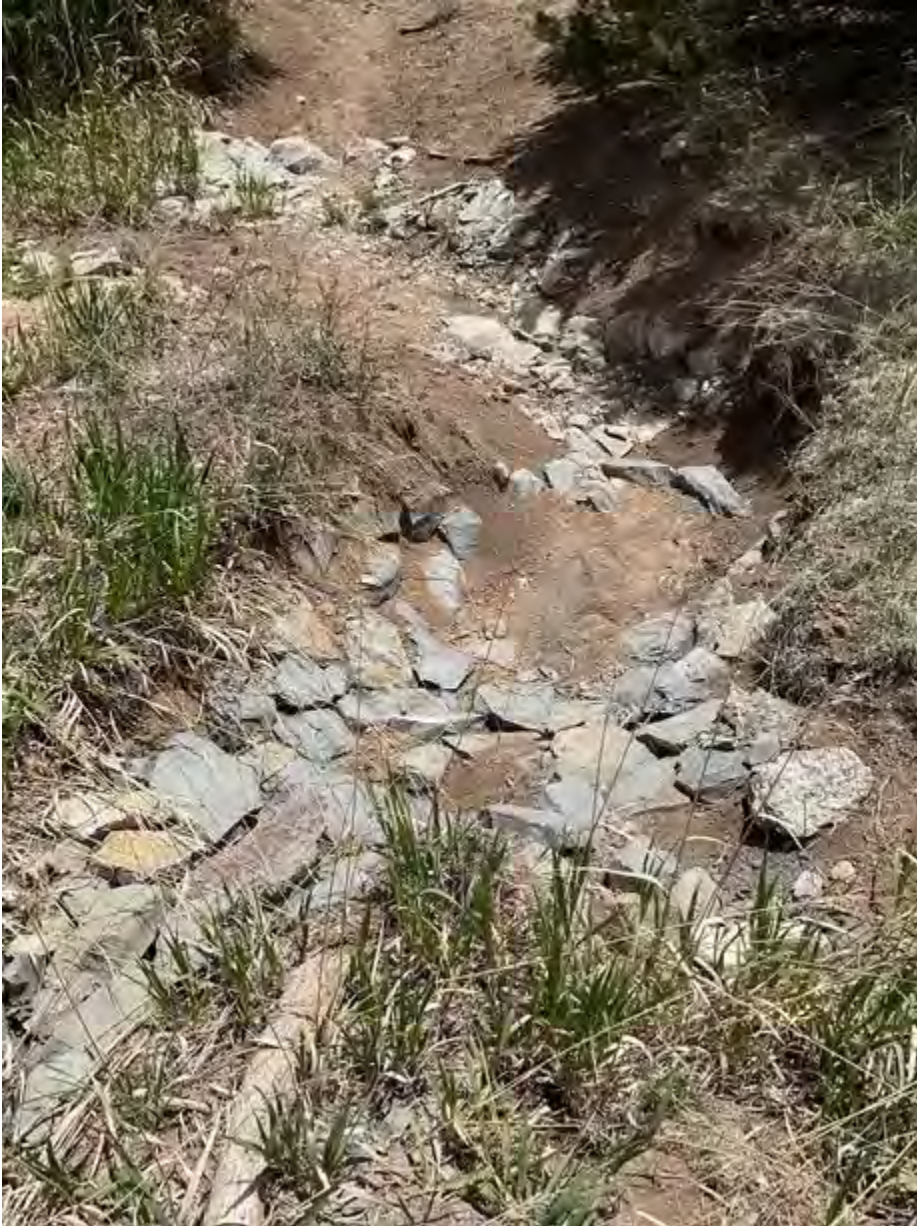
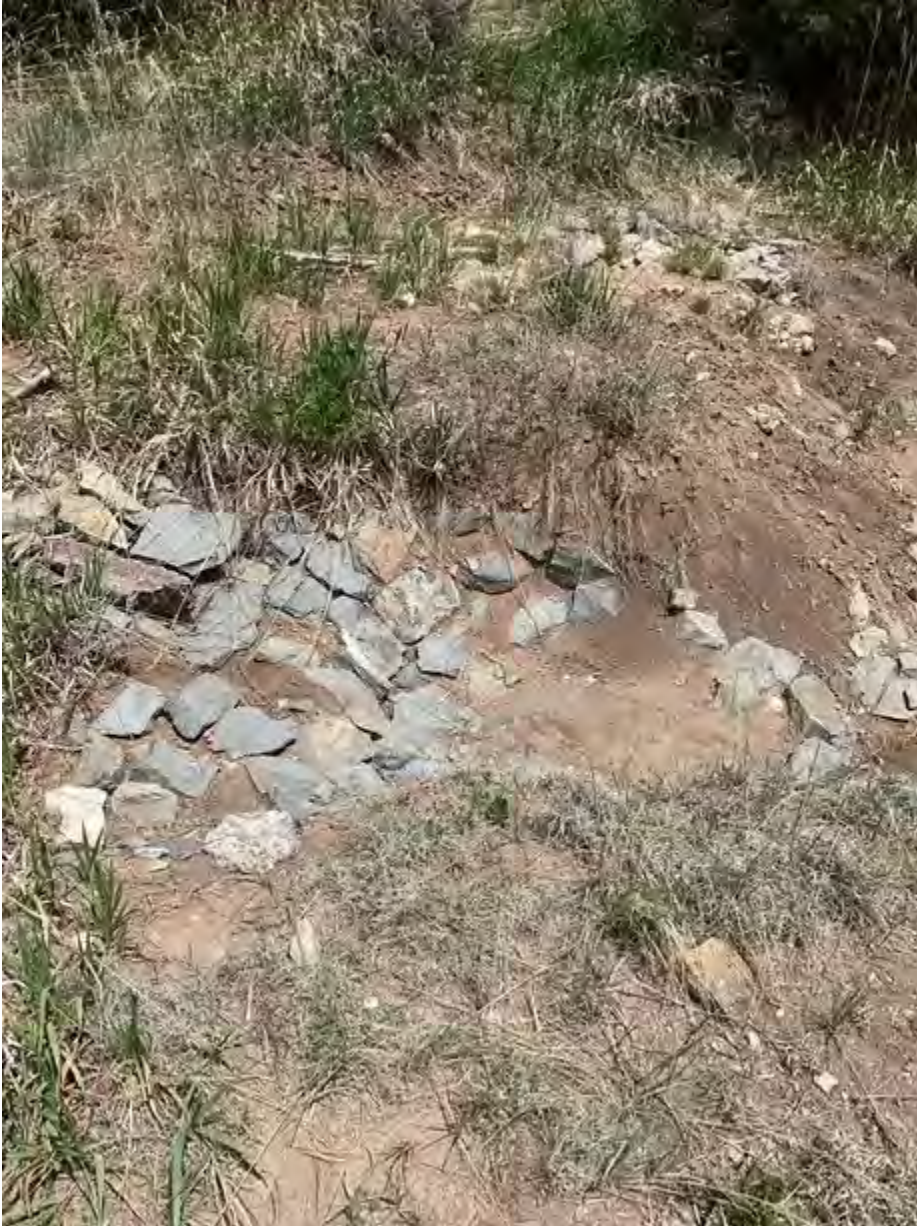
Some rocks dislodged or broken
