**Zuni Bowl and One Rock Check Dam Research –
Phase 1**

Final Report

December 2024

Rio Grande Return for the New Mexico Department of Transportation Research Bureau

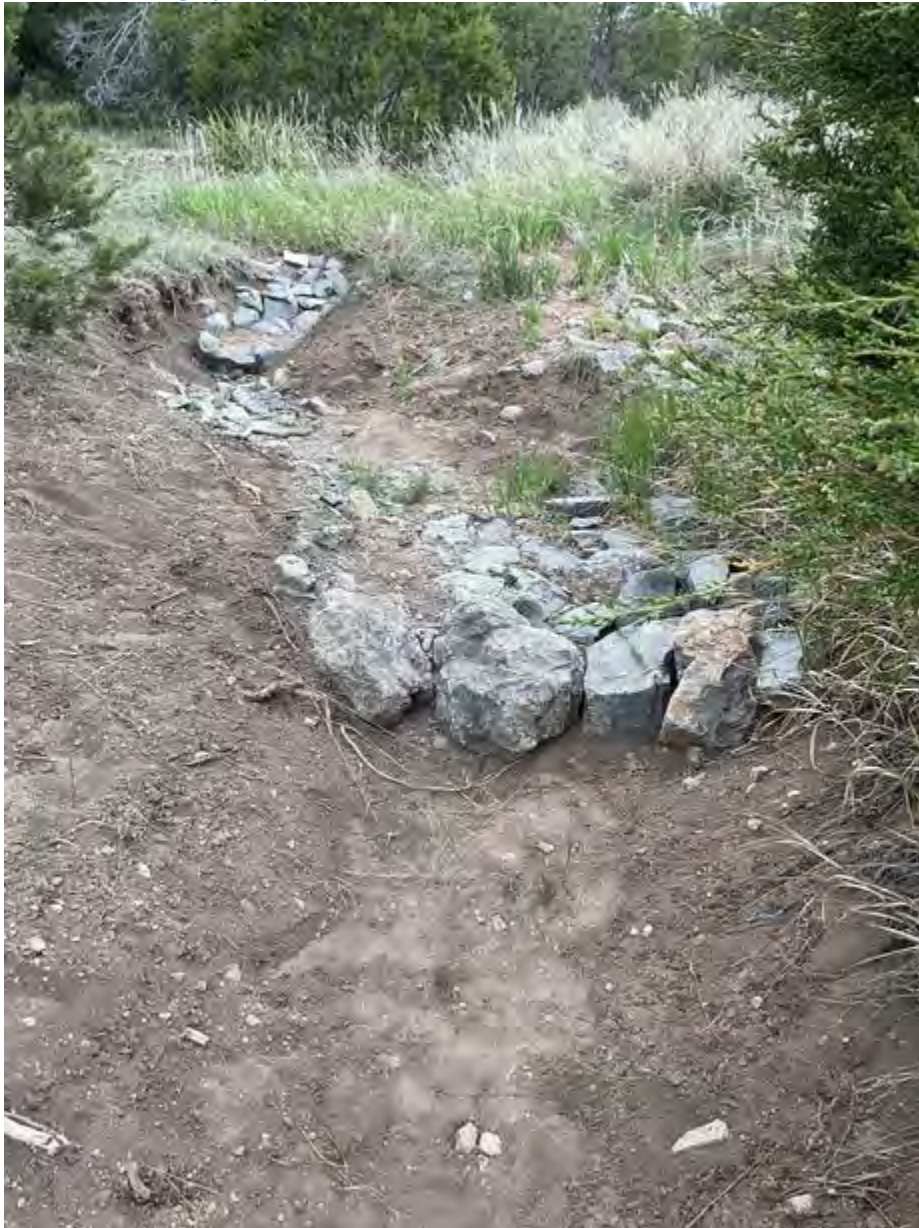
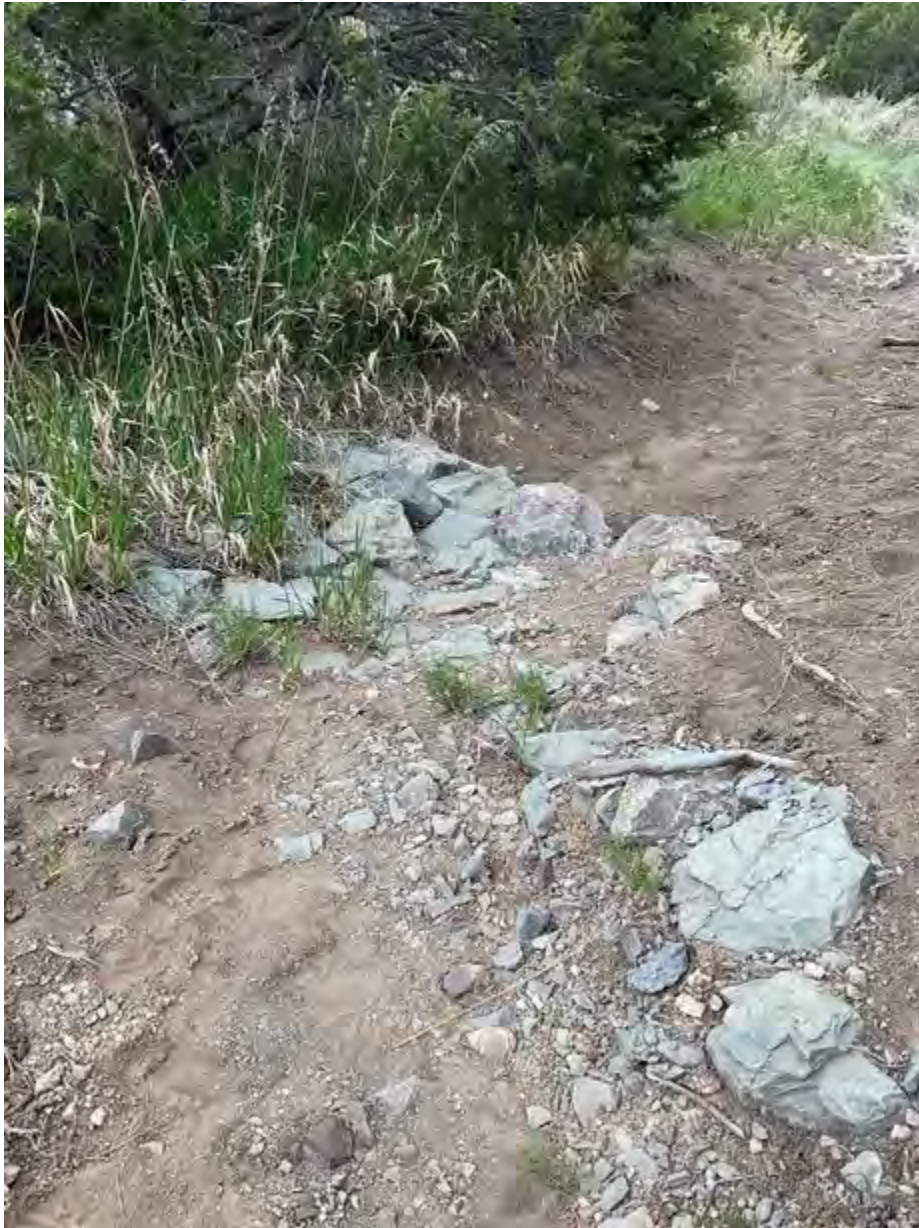
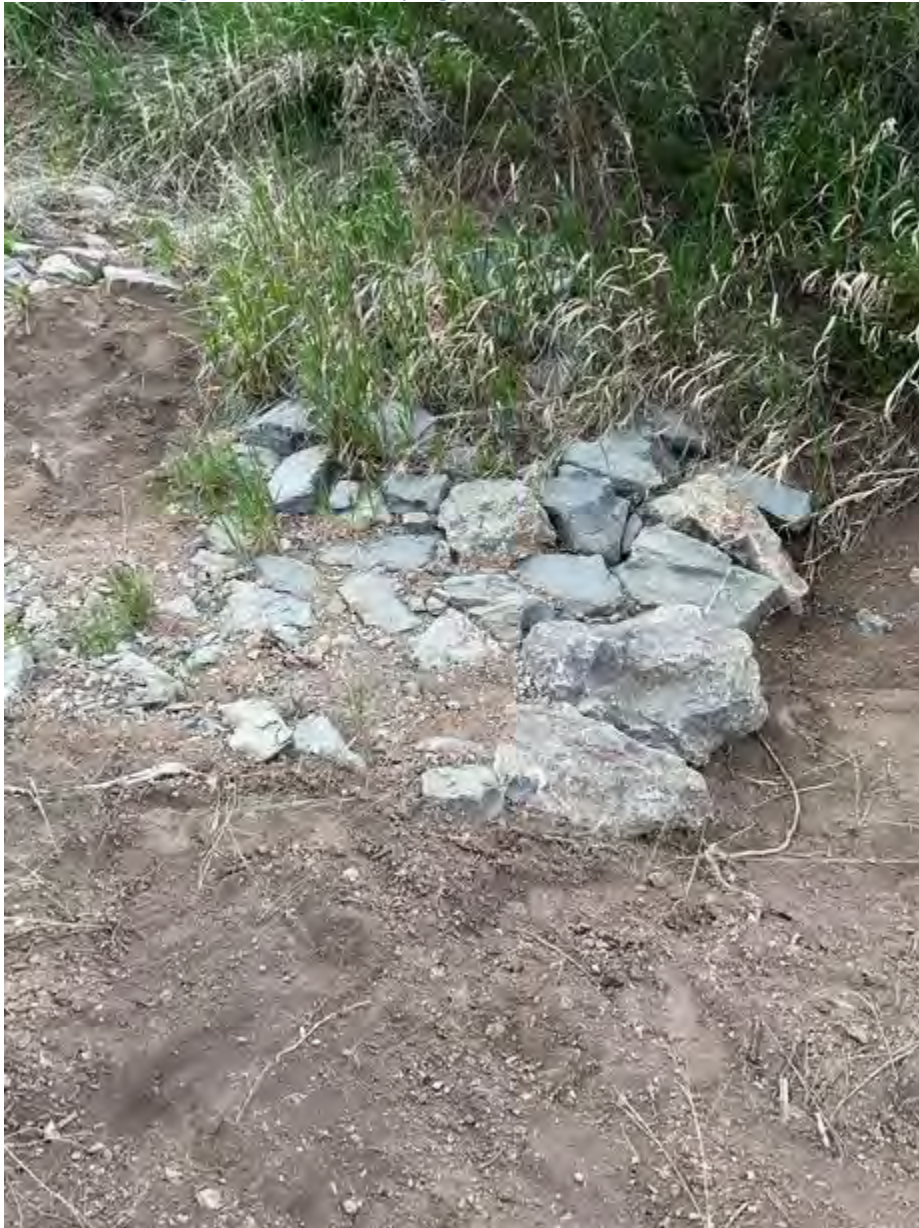
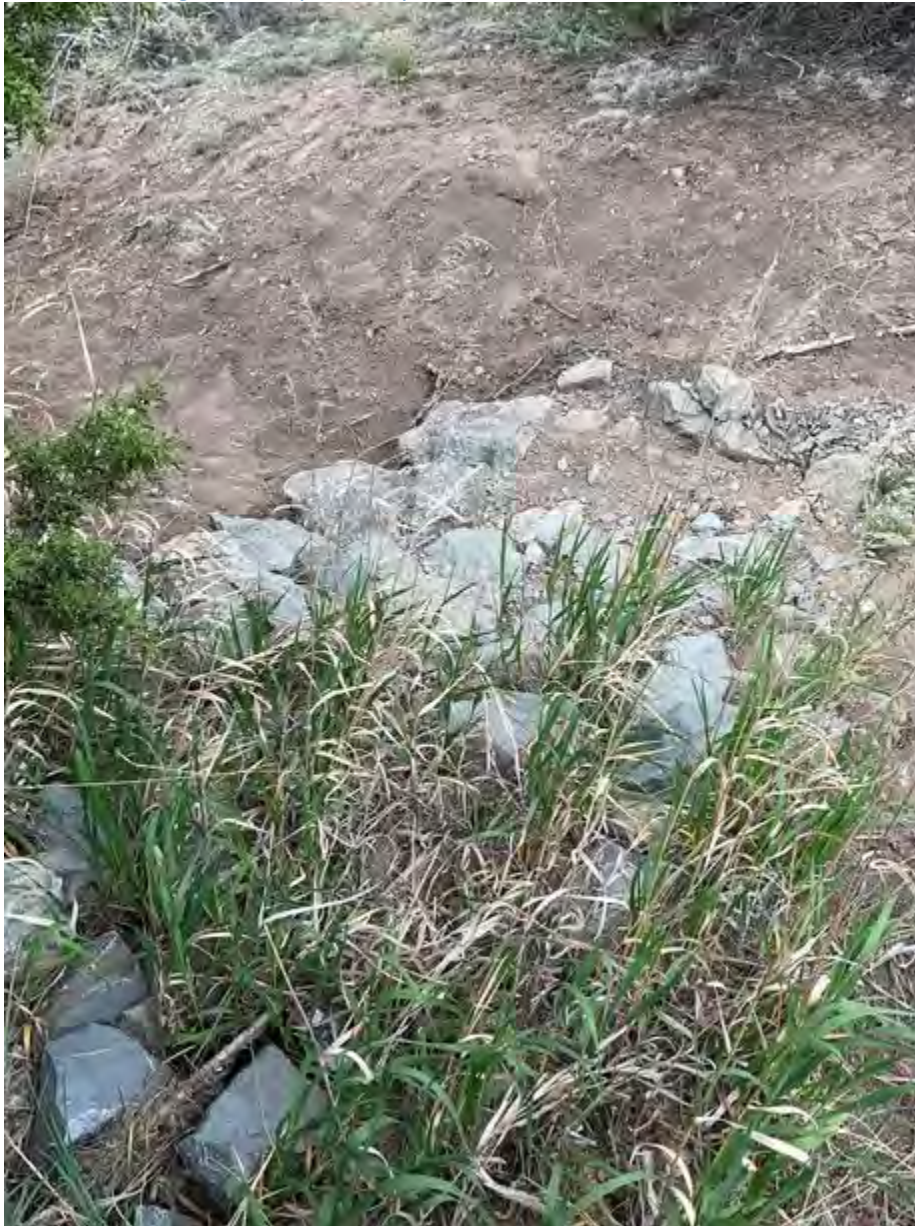
-106.3531756 35.0482939

All rocks intact

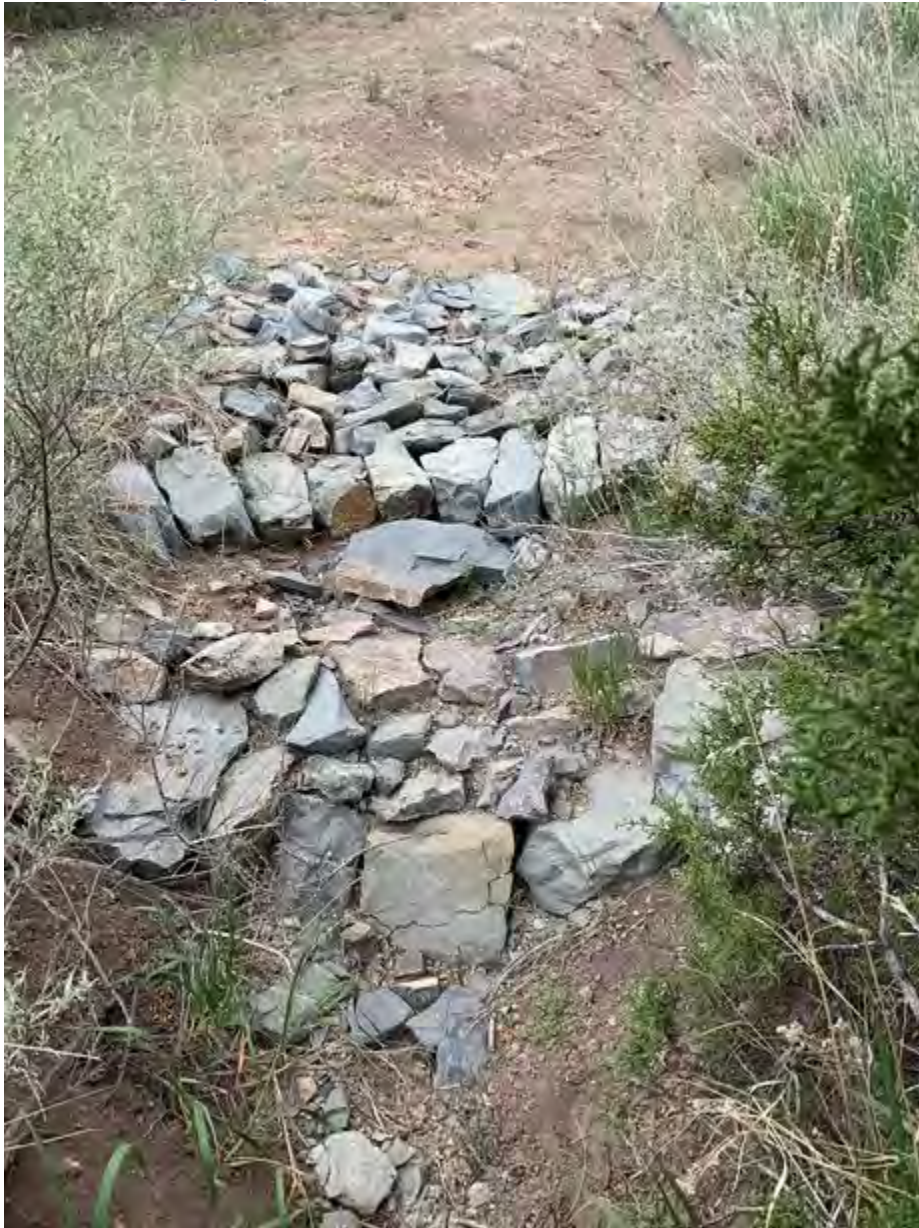
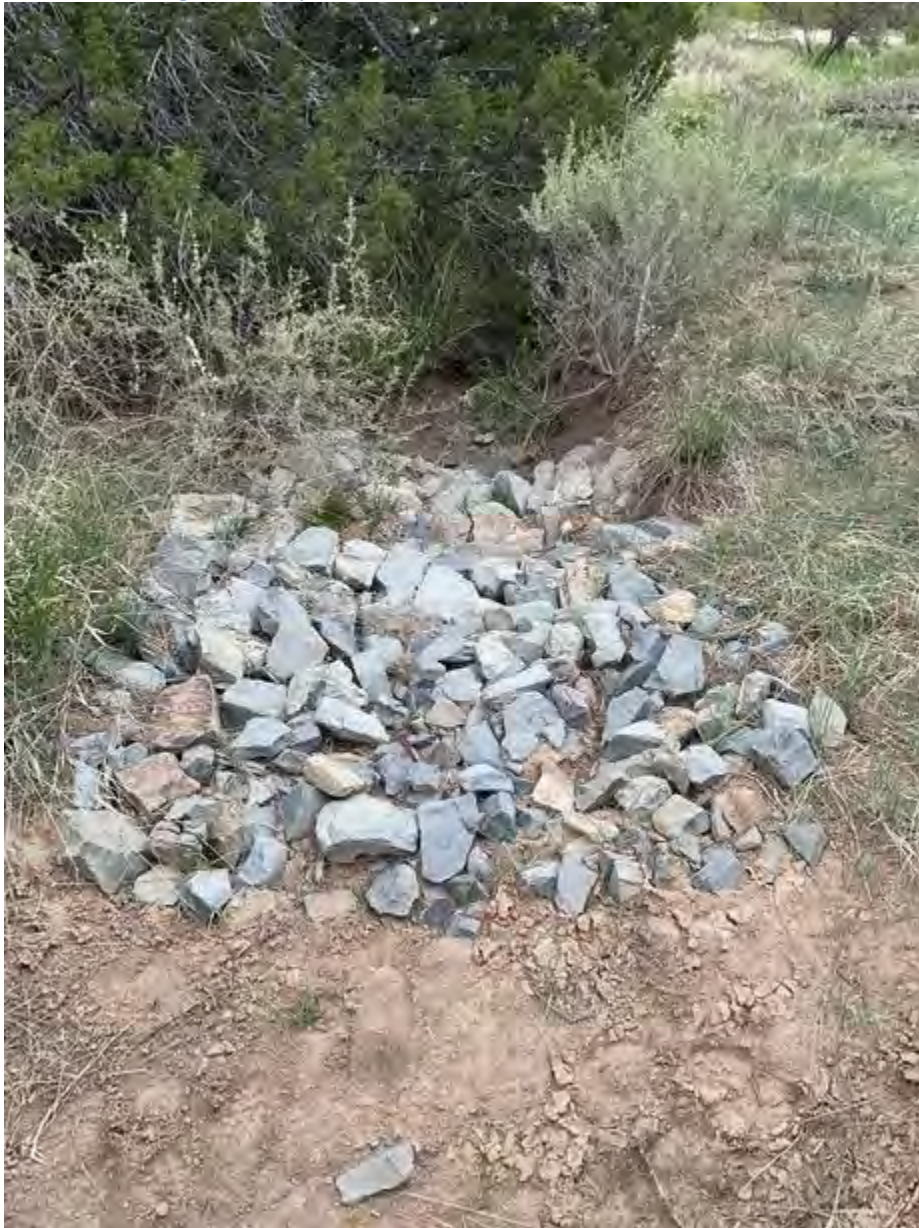
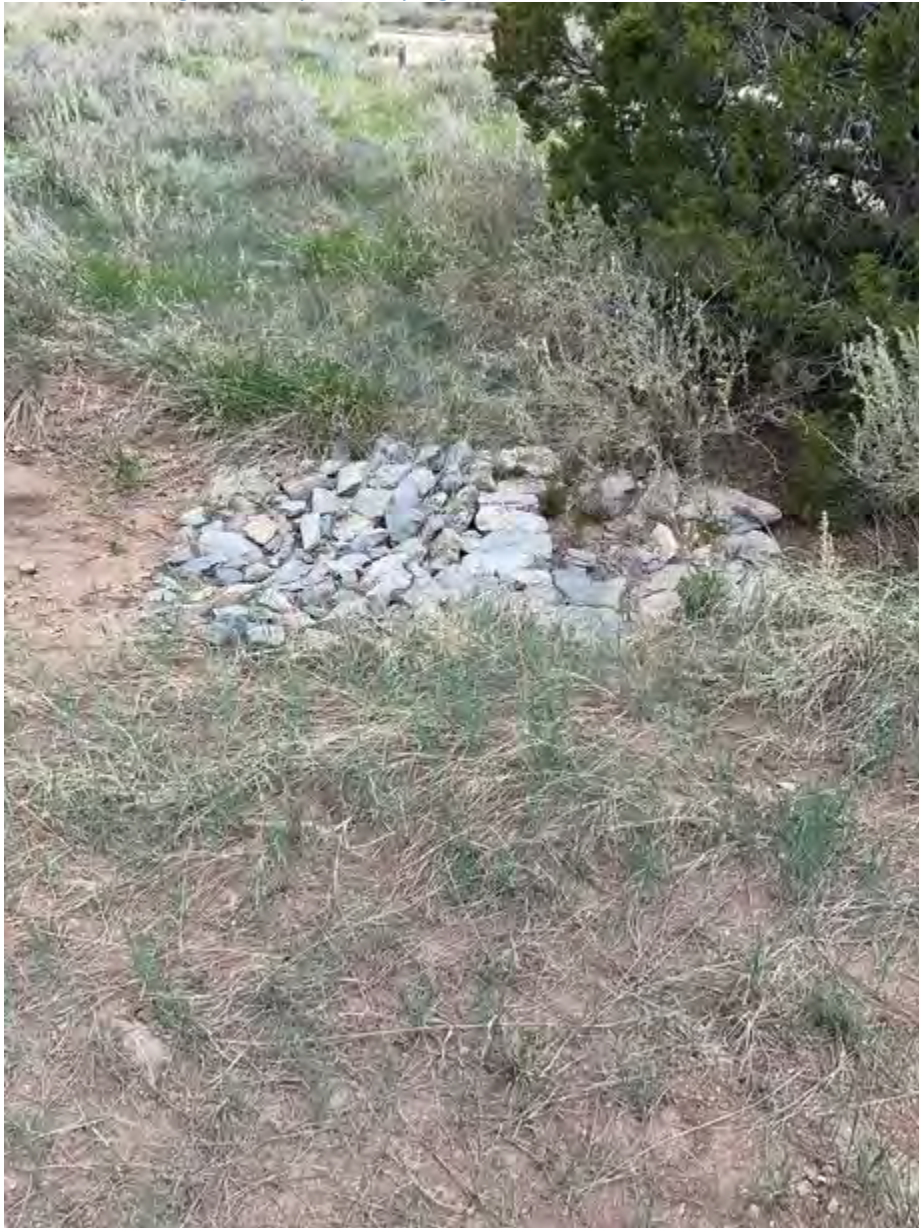
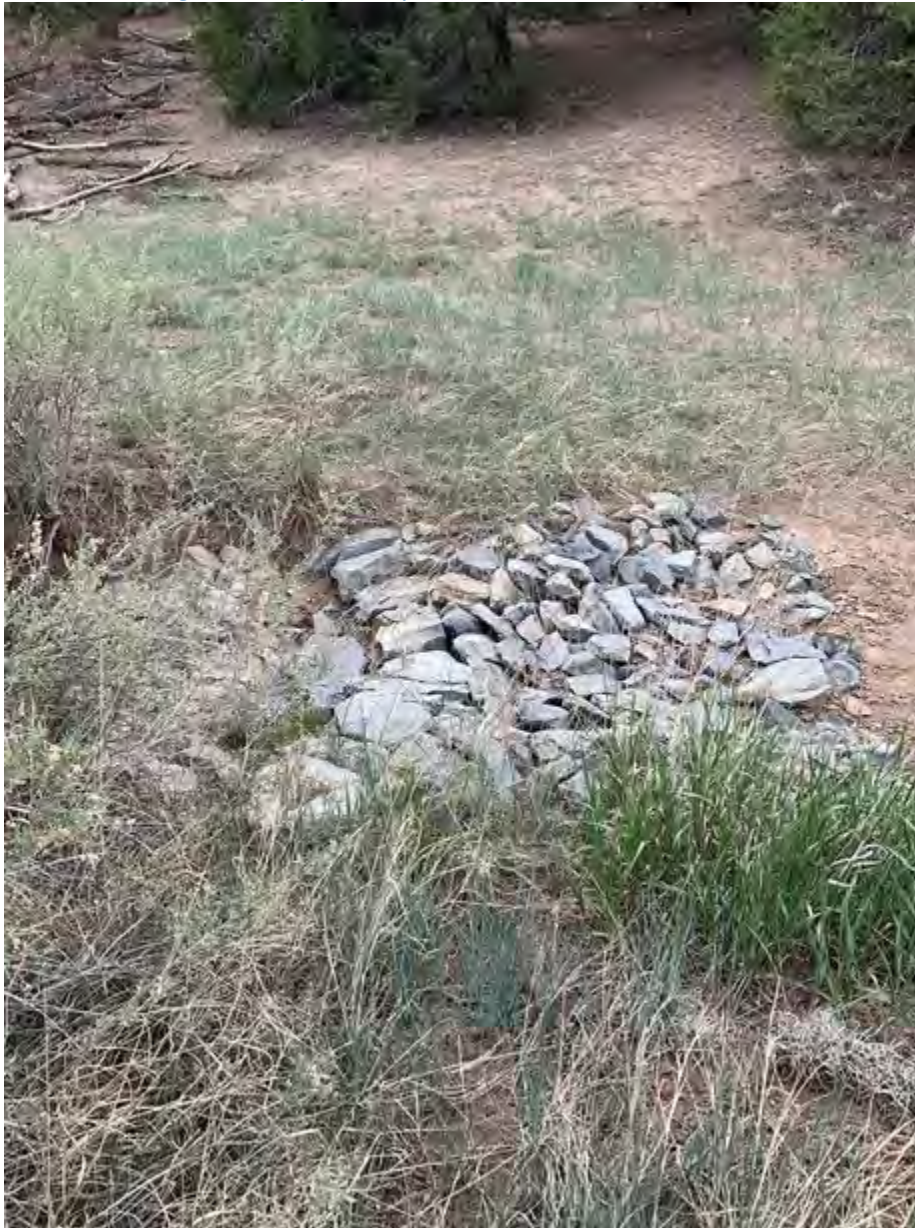
-106.3529516 35.0481111

All rocks intact

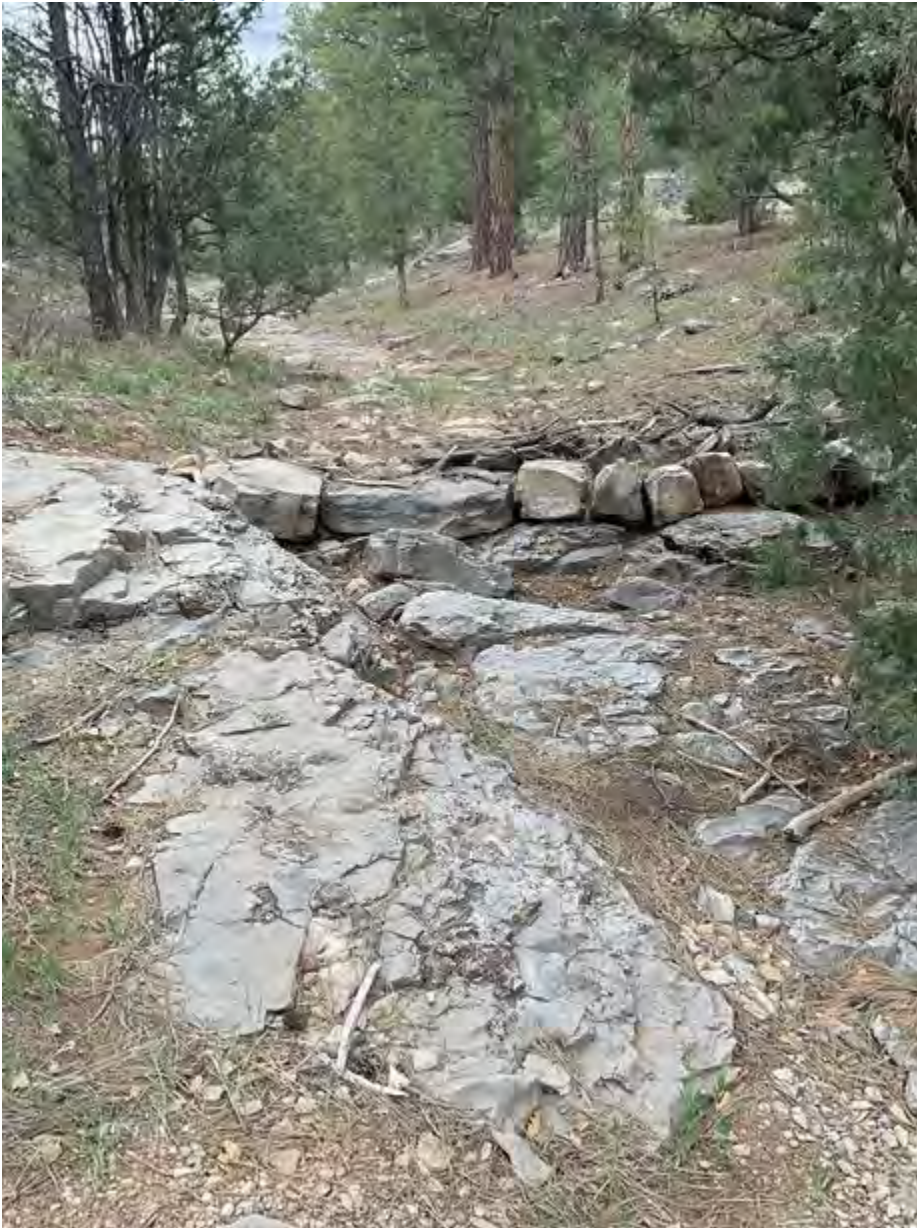
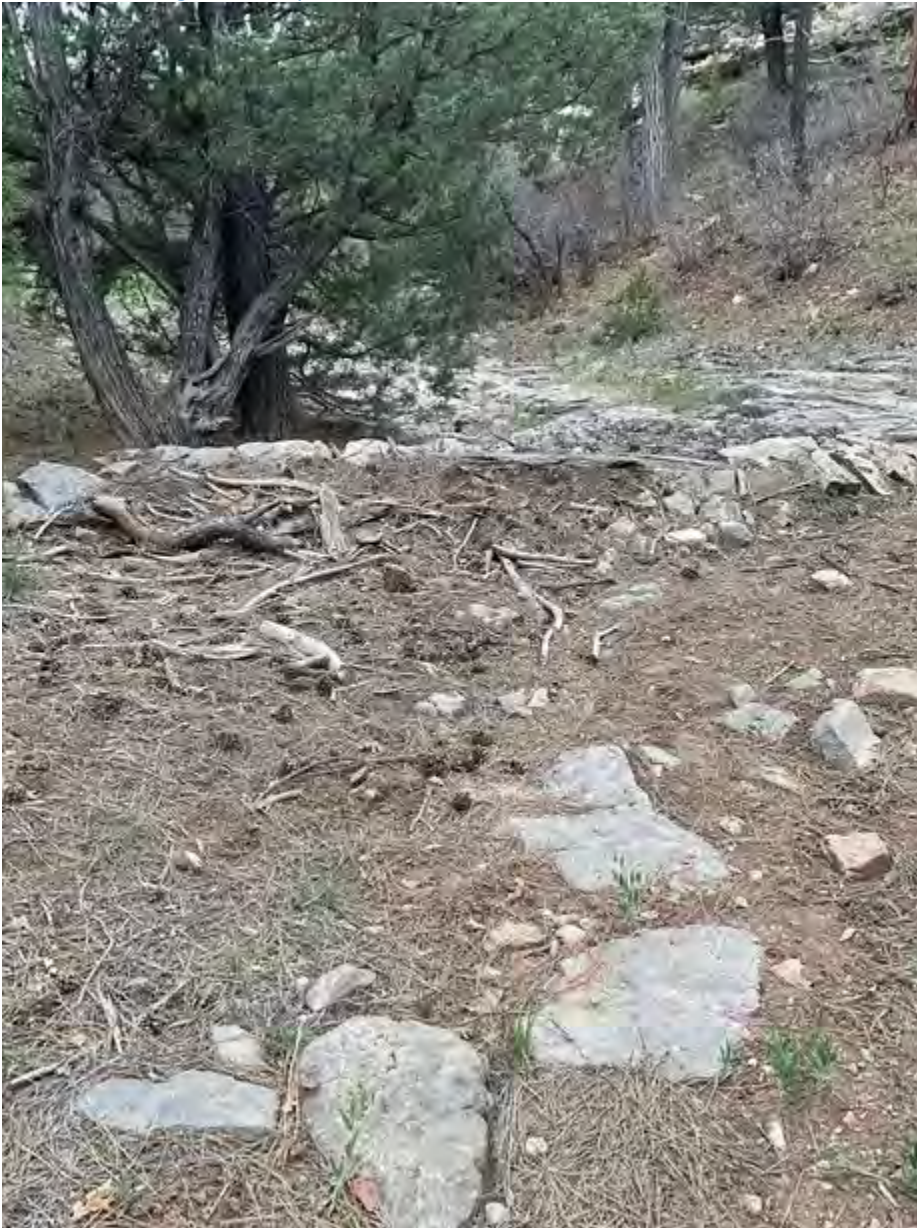
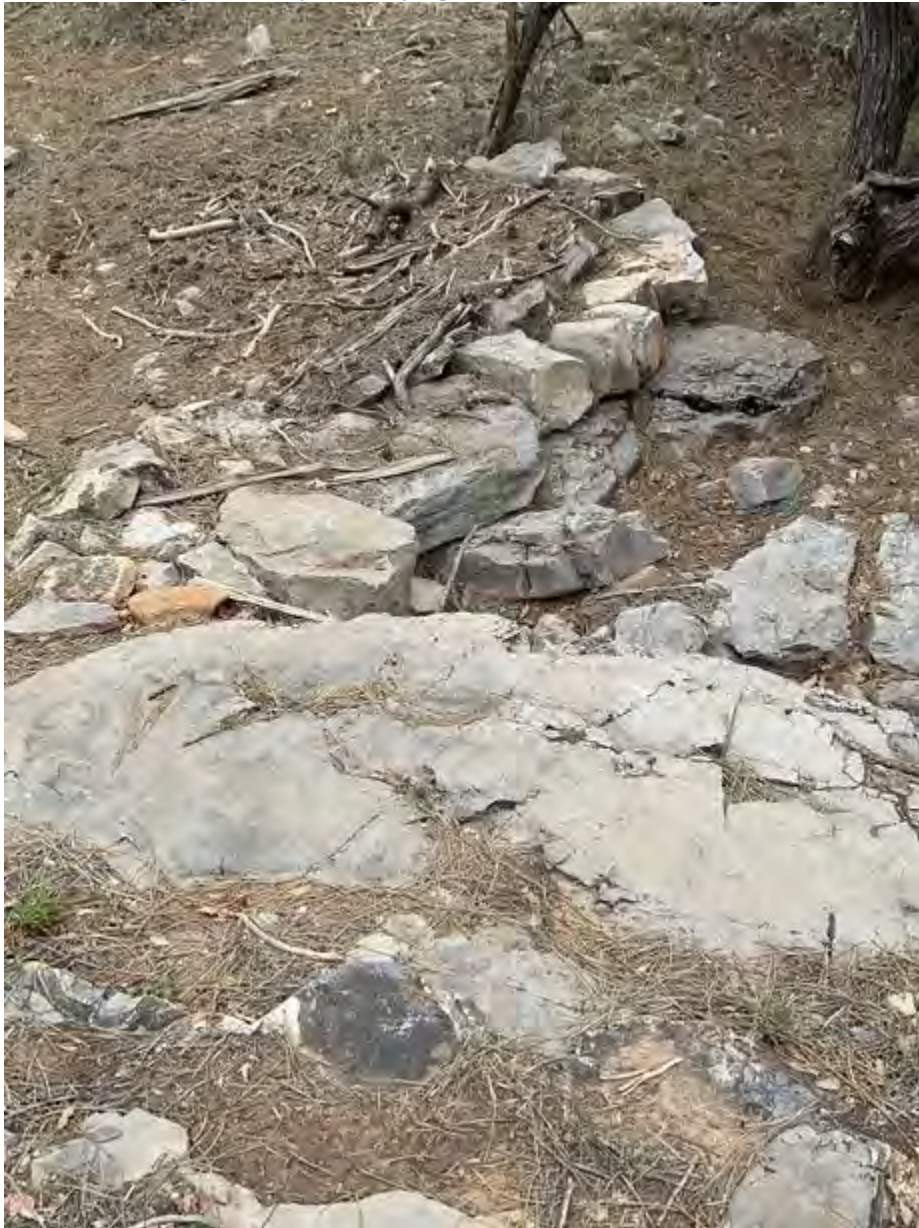
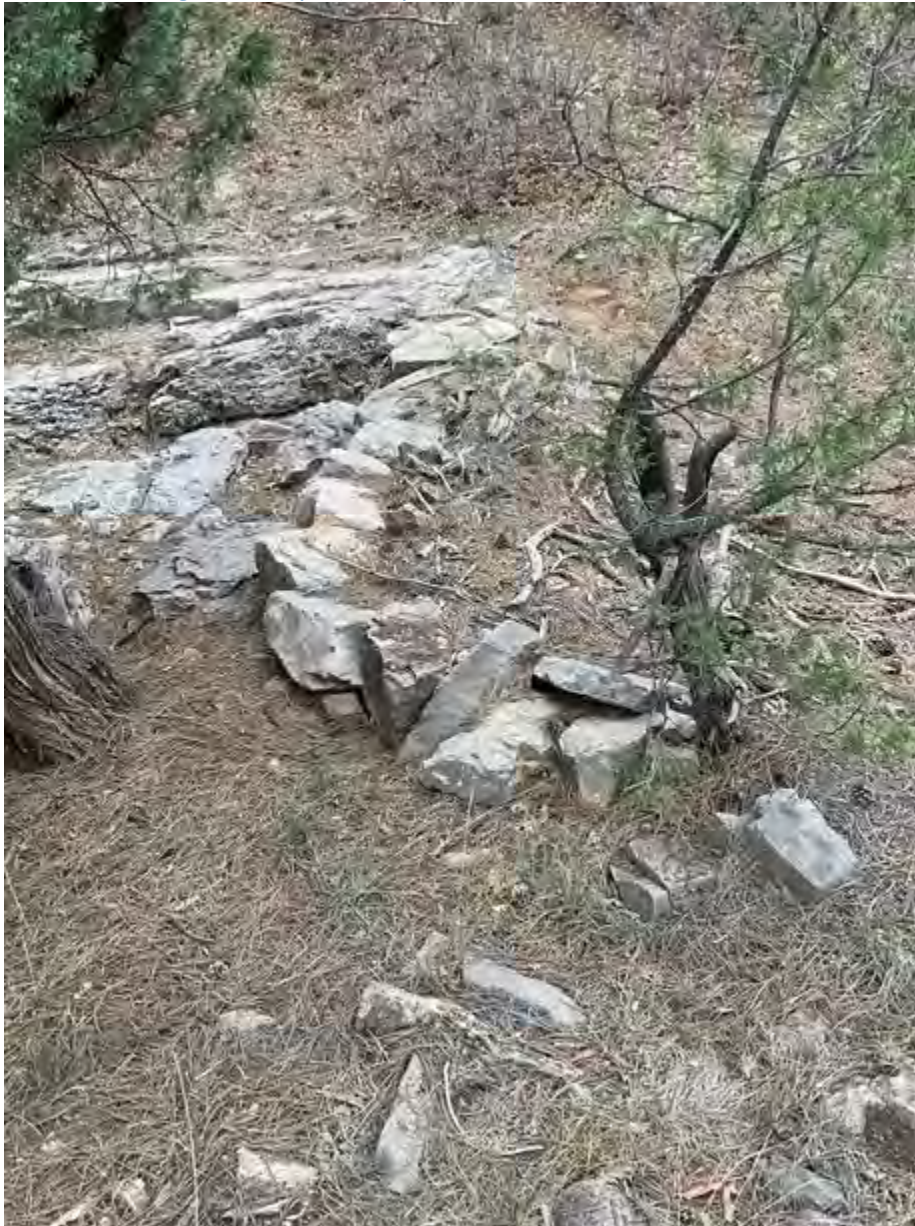
-106.3410934 35.01663208

All rocks intact

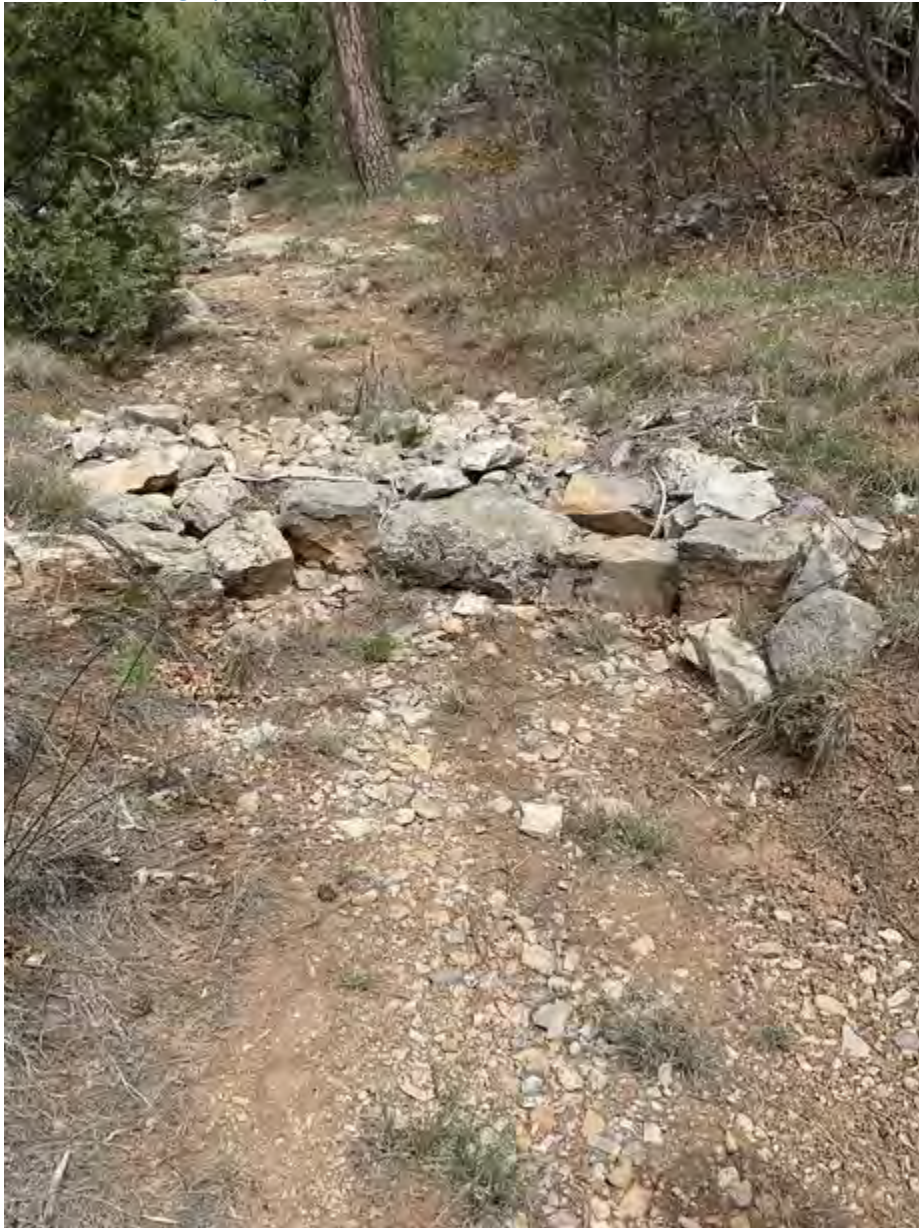
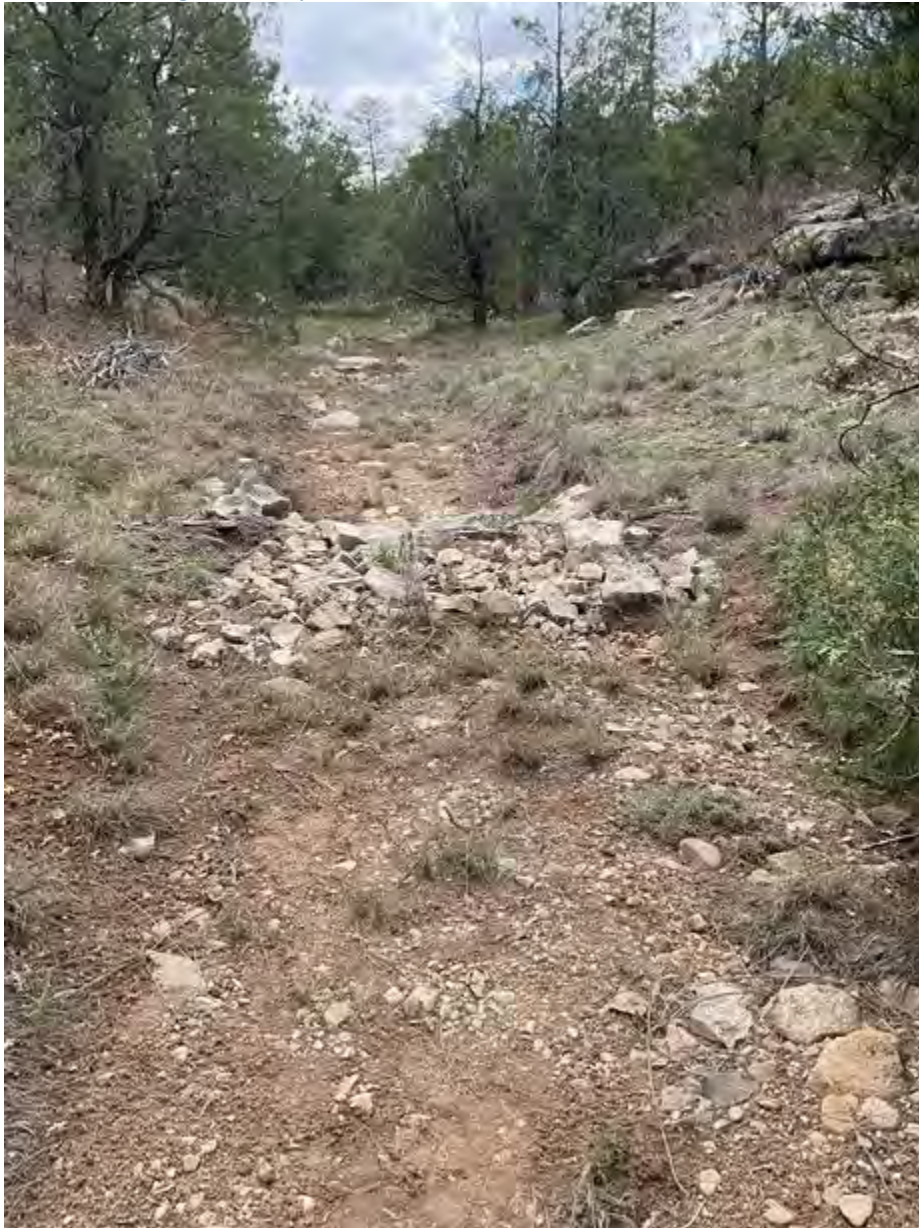
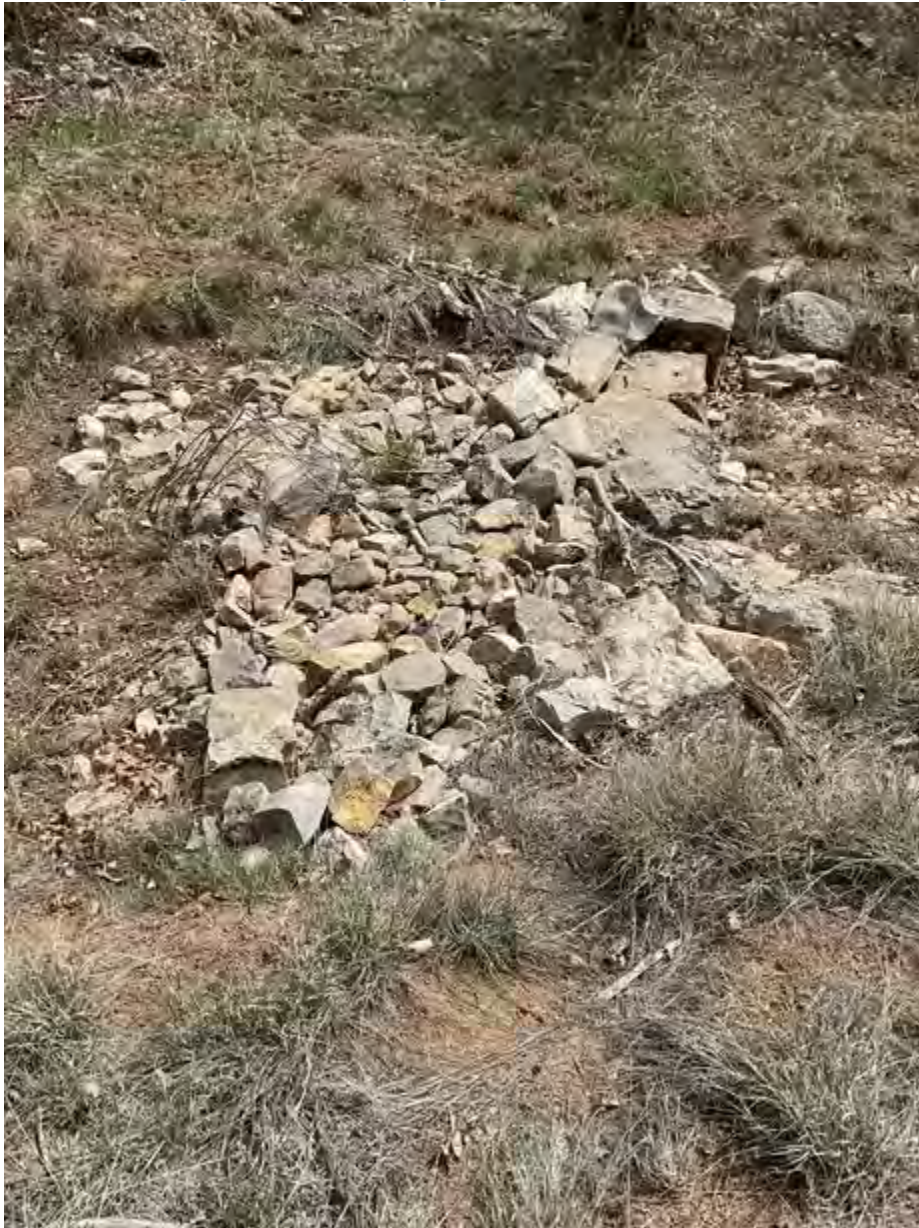
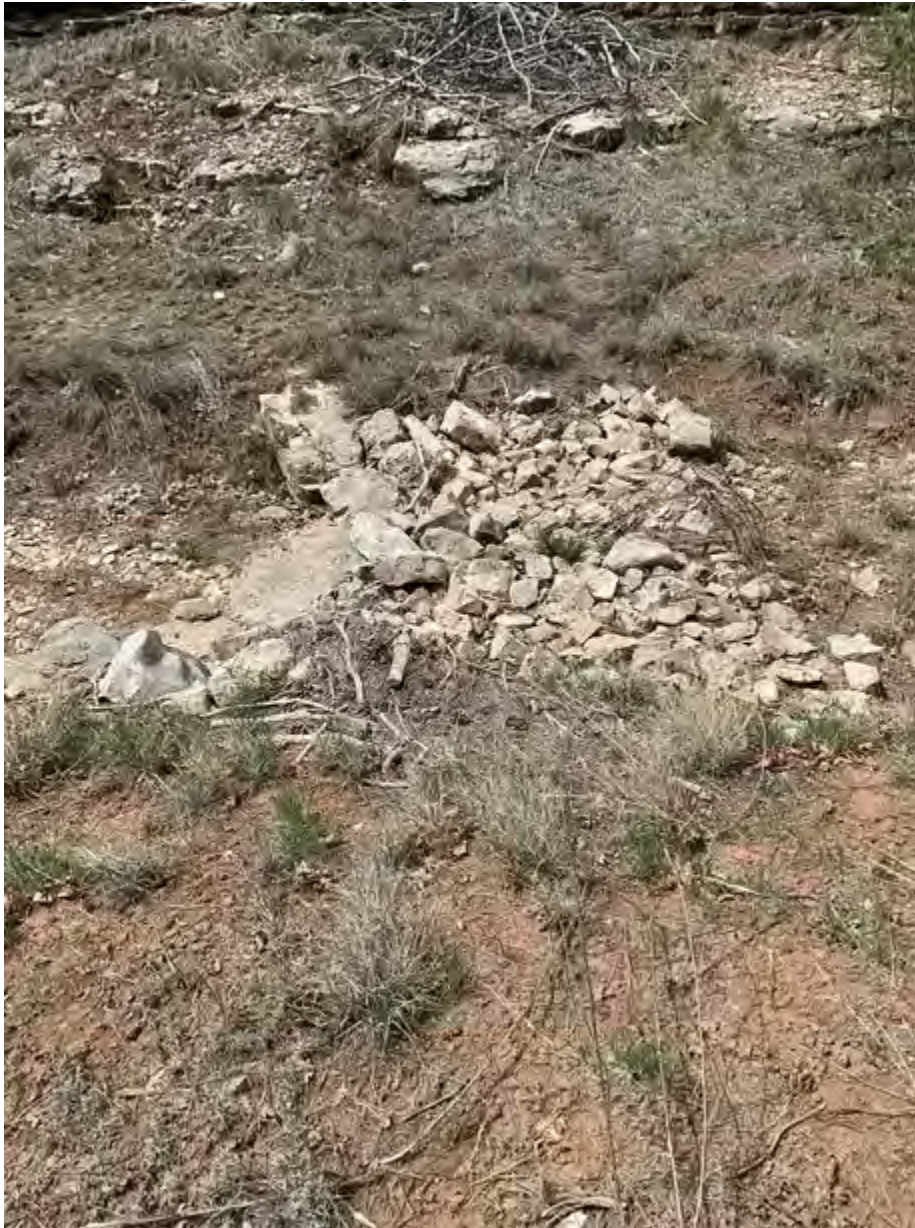
-106.3386906 35.0170153

All rocks intact

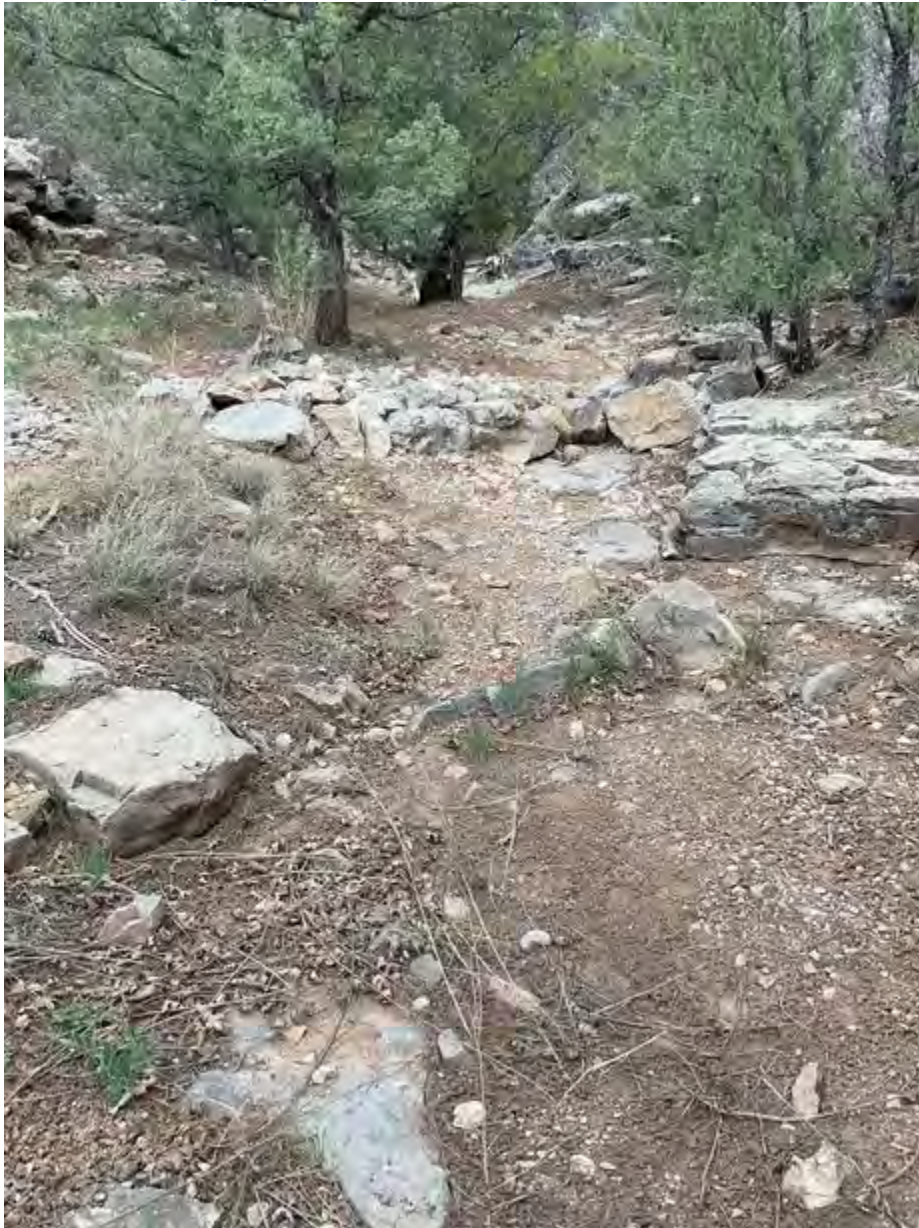
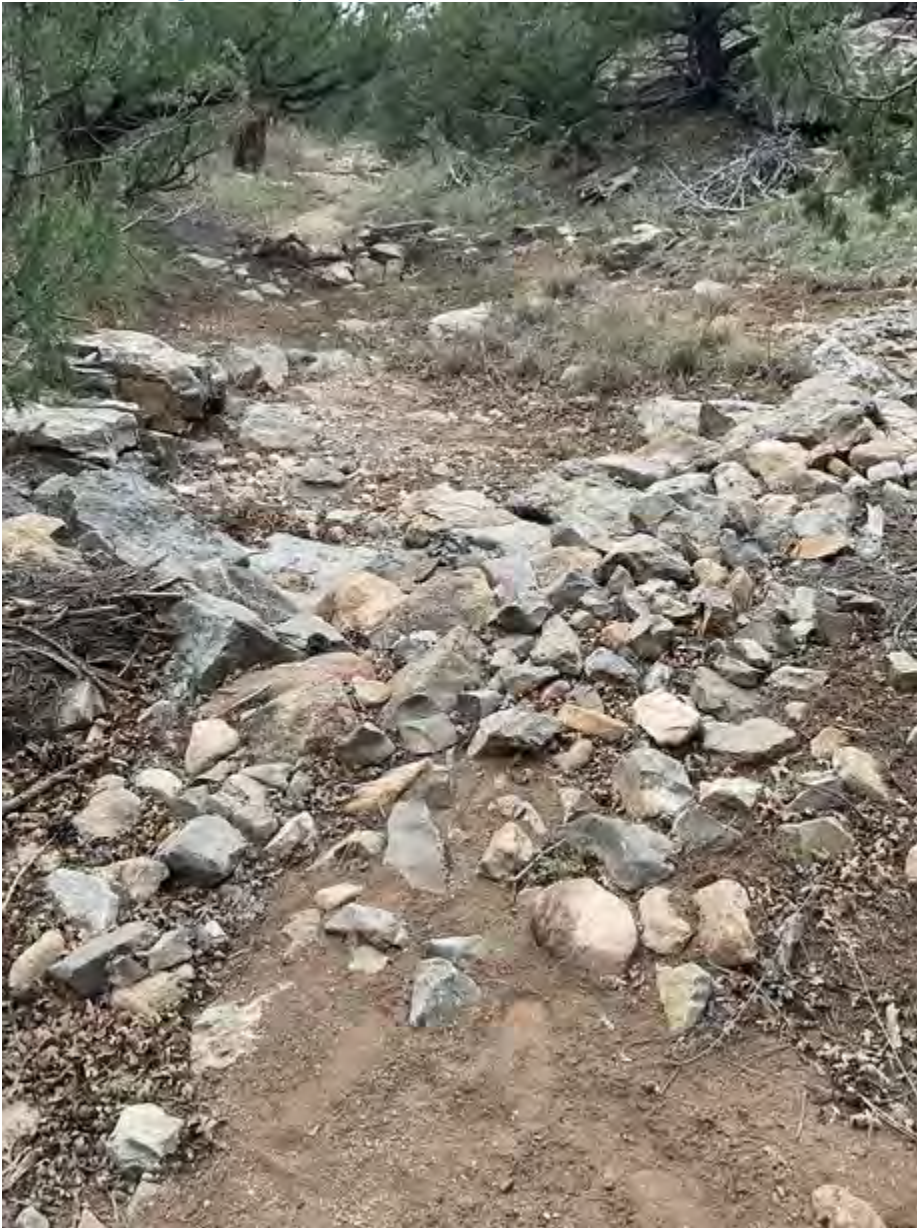
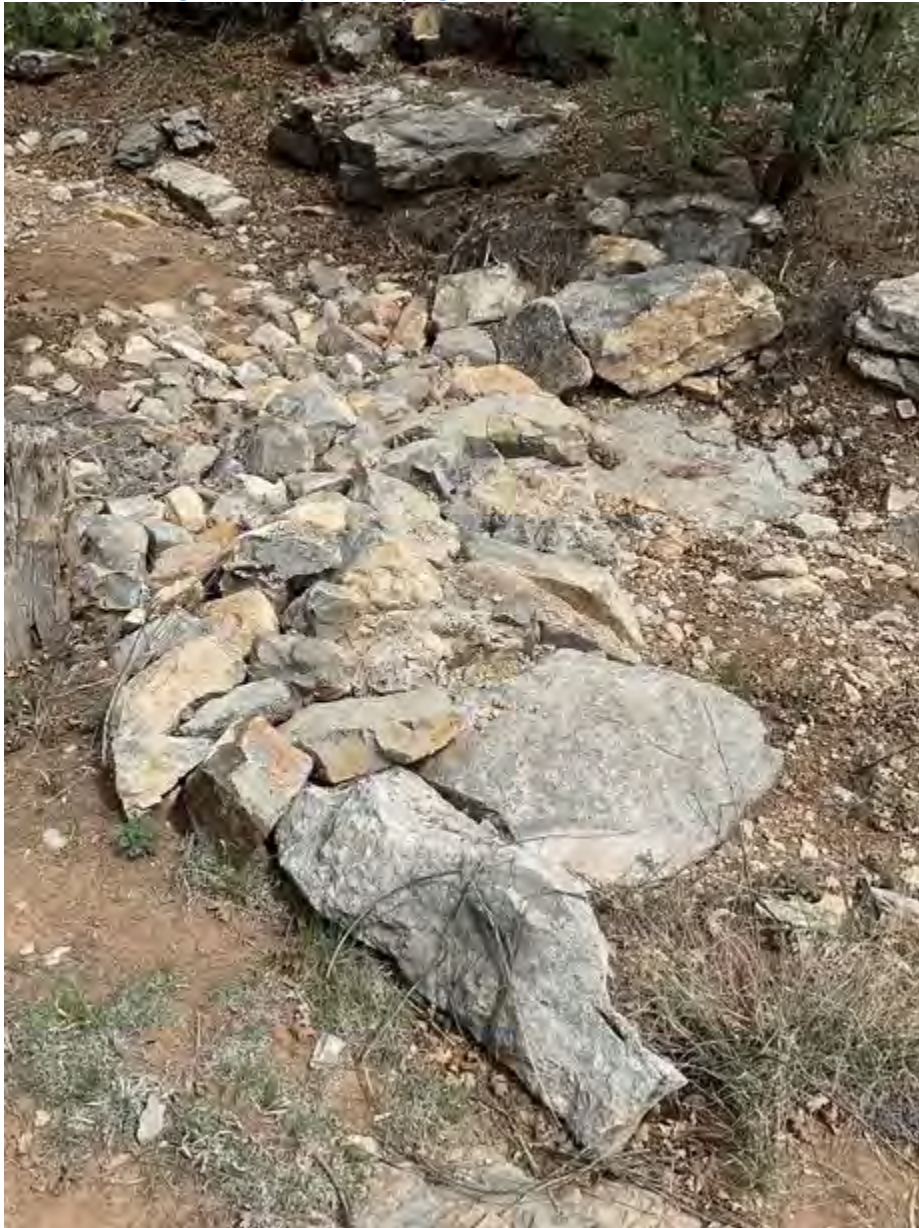
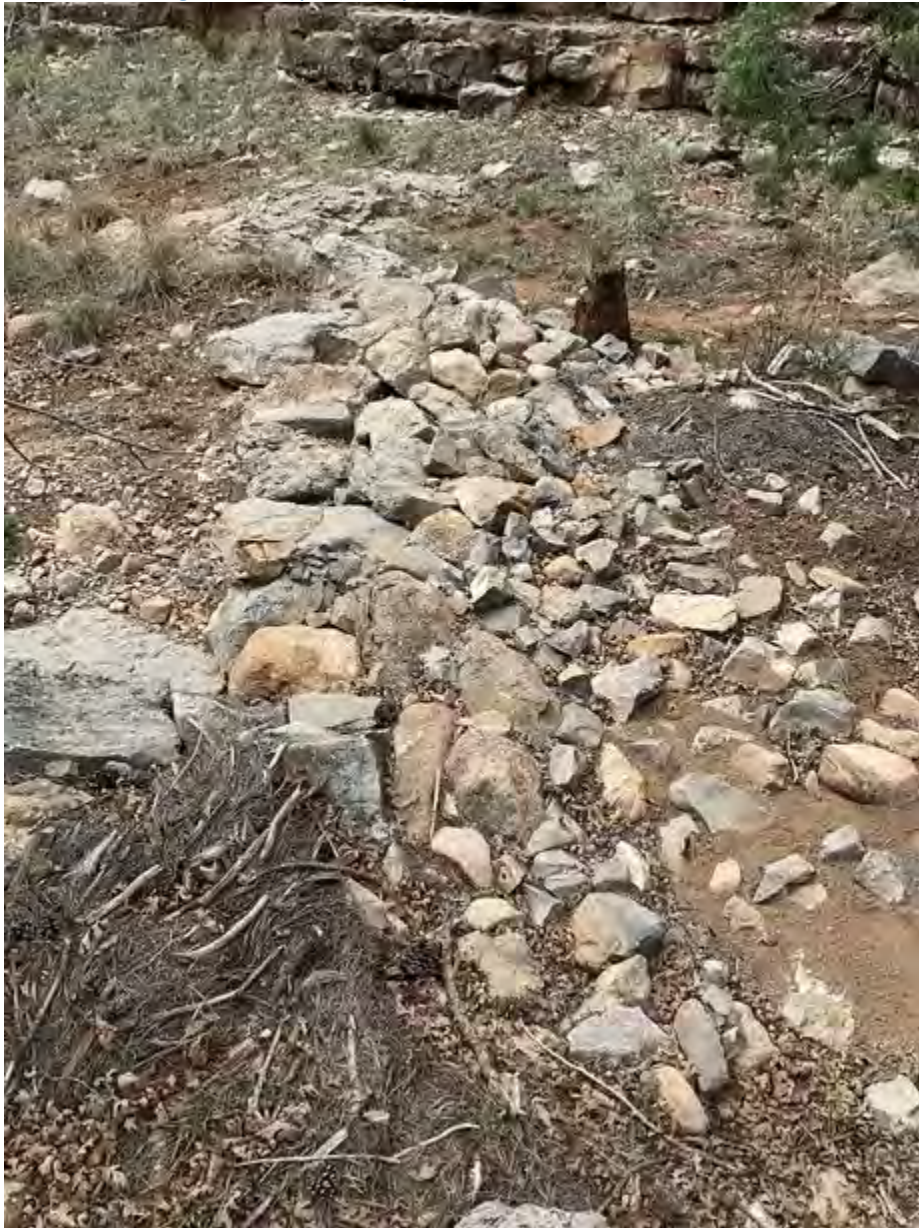
-106.338352 35.0171092

All rocks intact
