**Zuni Bowl and One Rock Check Dam Research –
Phase 1**

Final Report

December 2024

Rio Grande Return for the New Mexico Department of Transportation Research Bureau

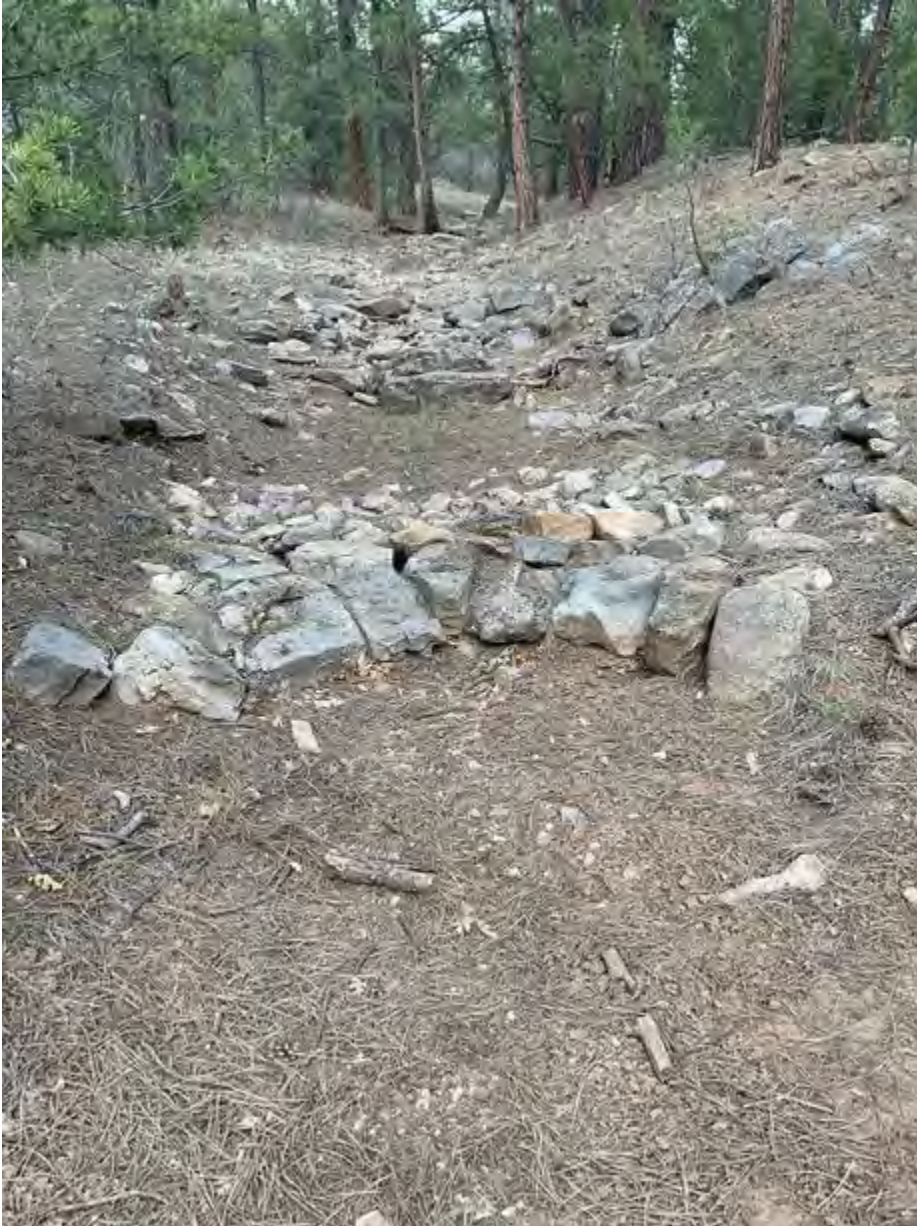
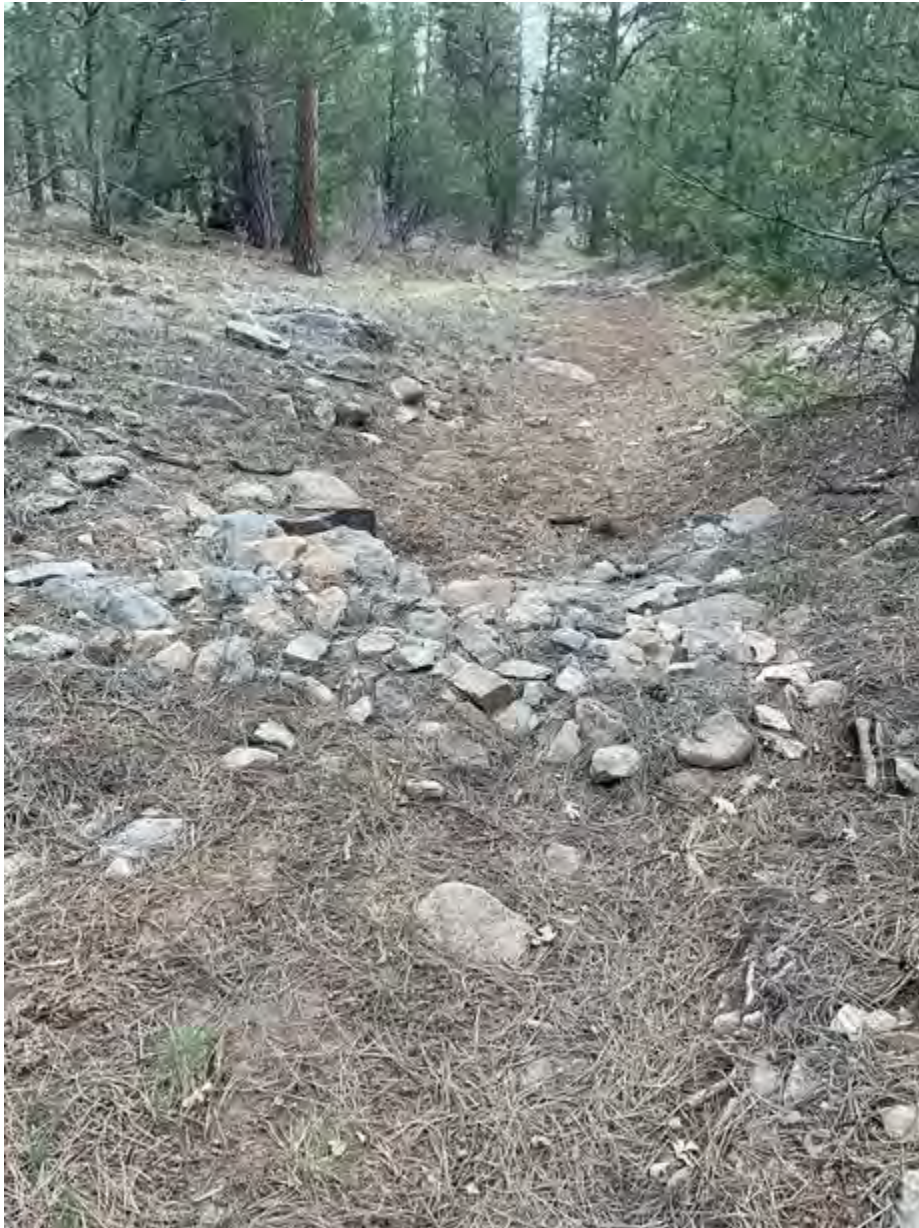
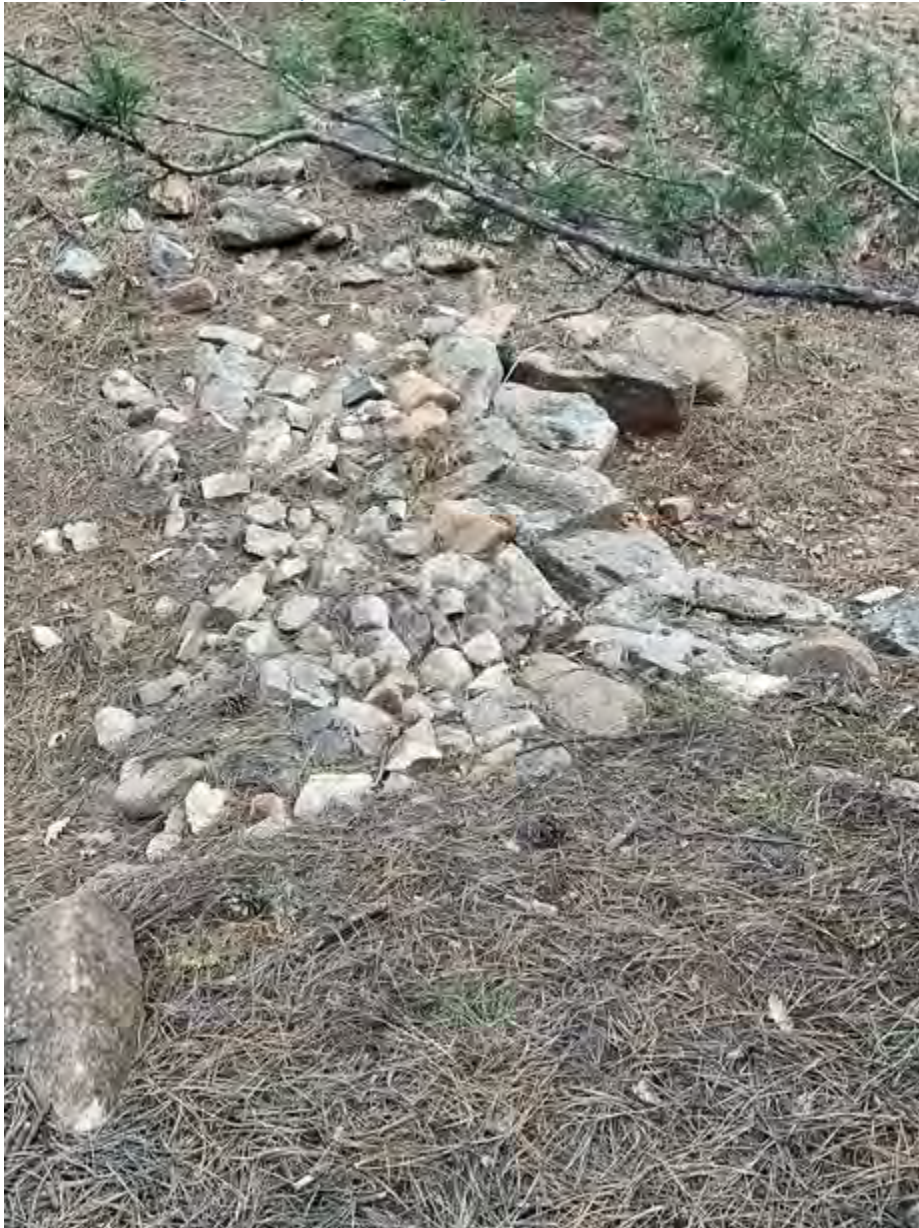
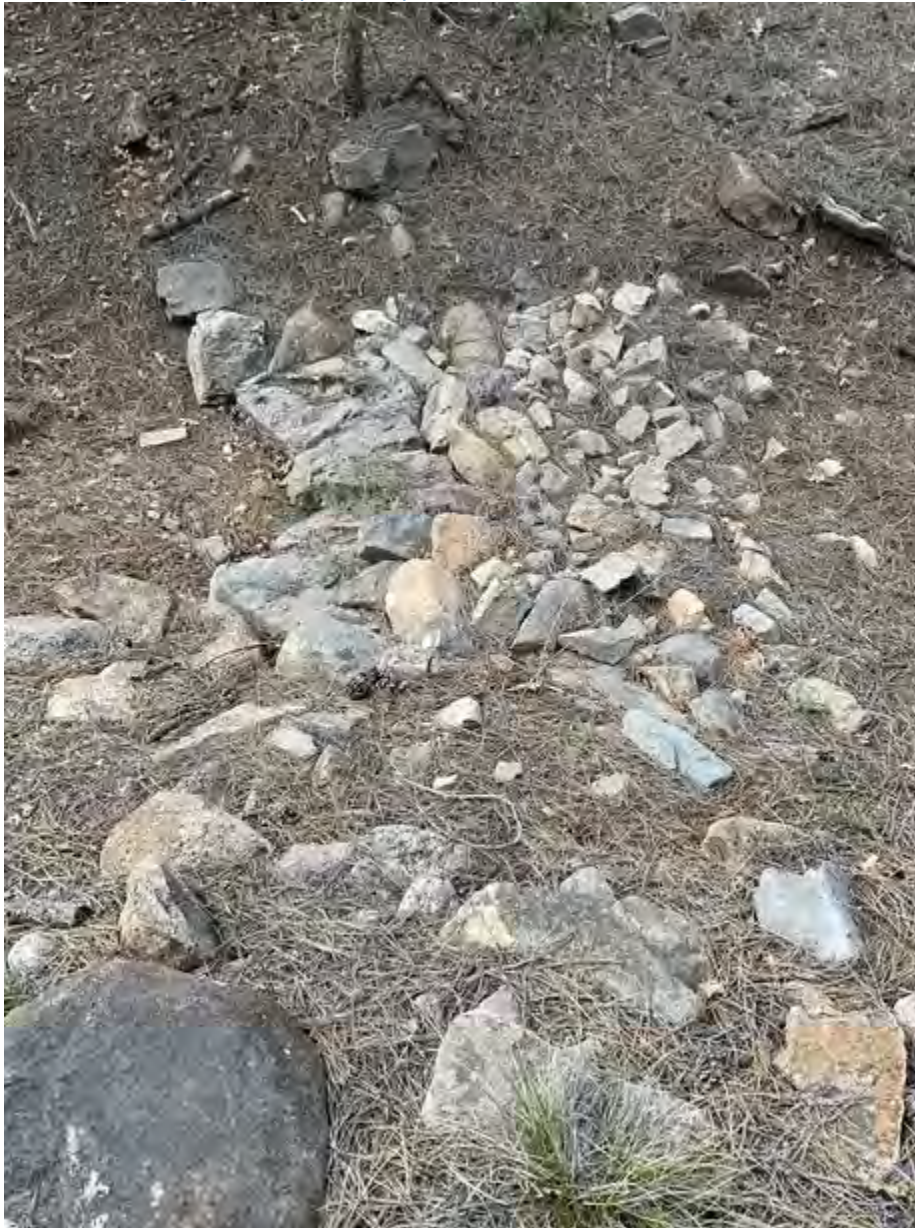
-106.338352 35.0171092

All rocks intact

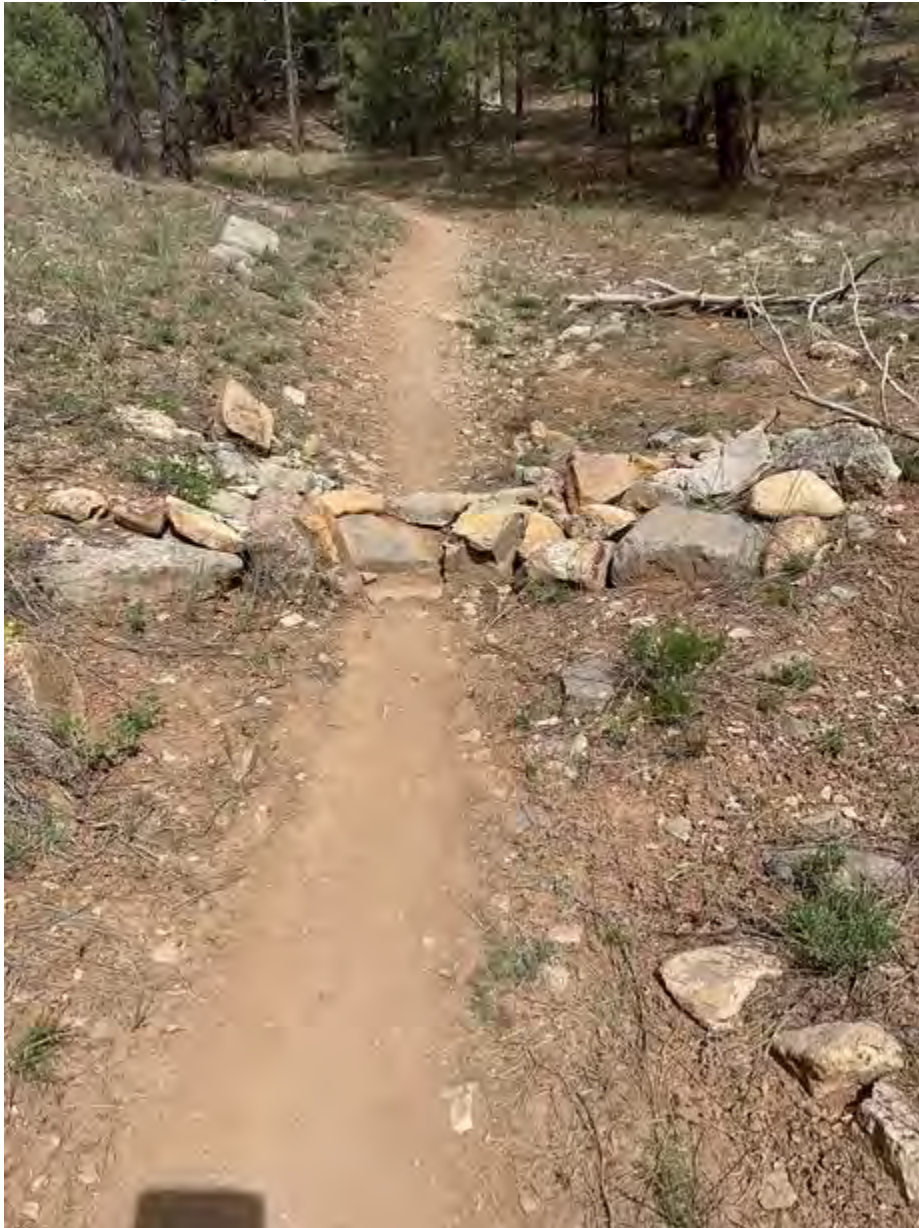
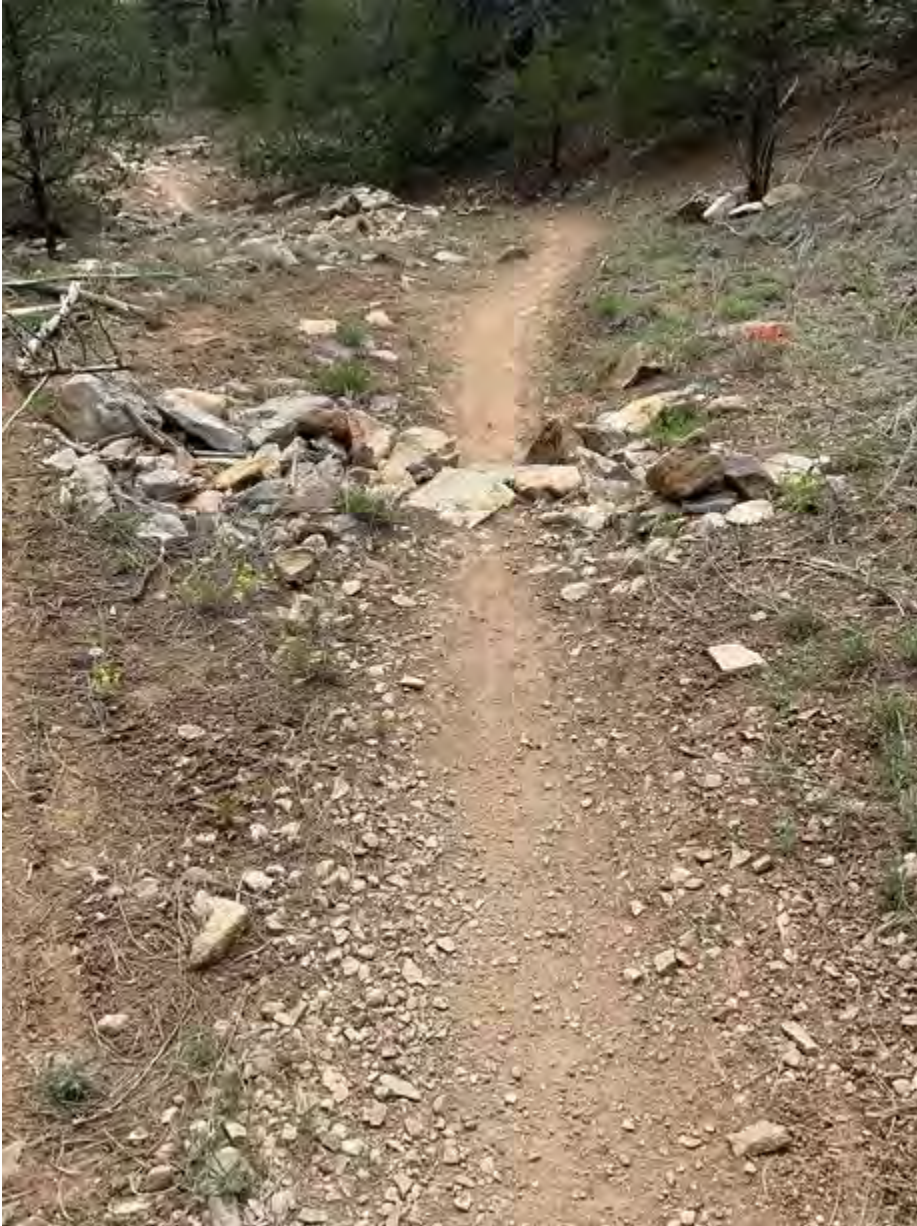
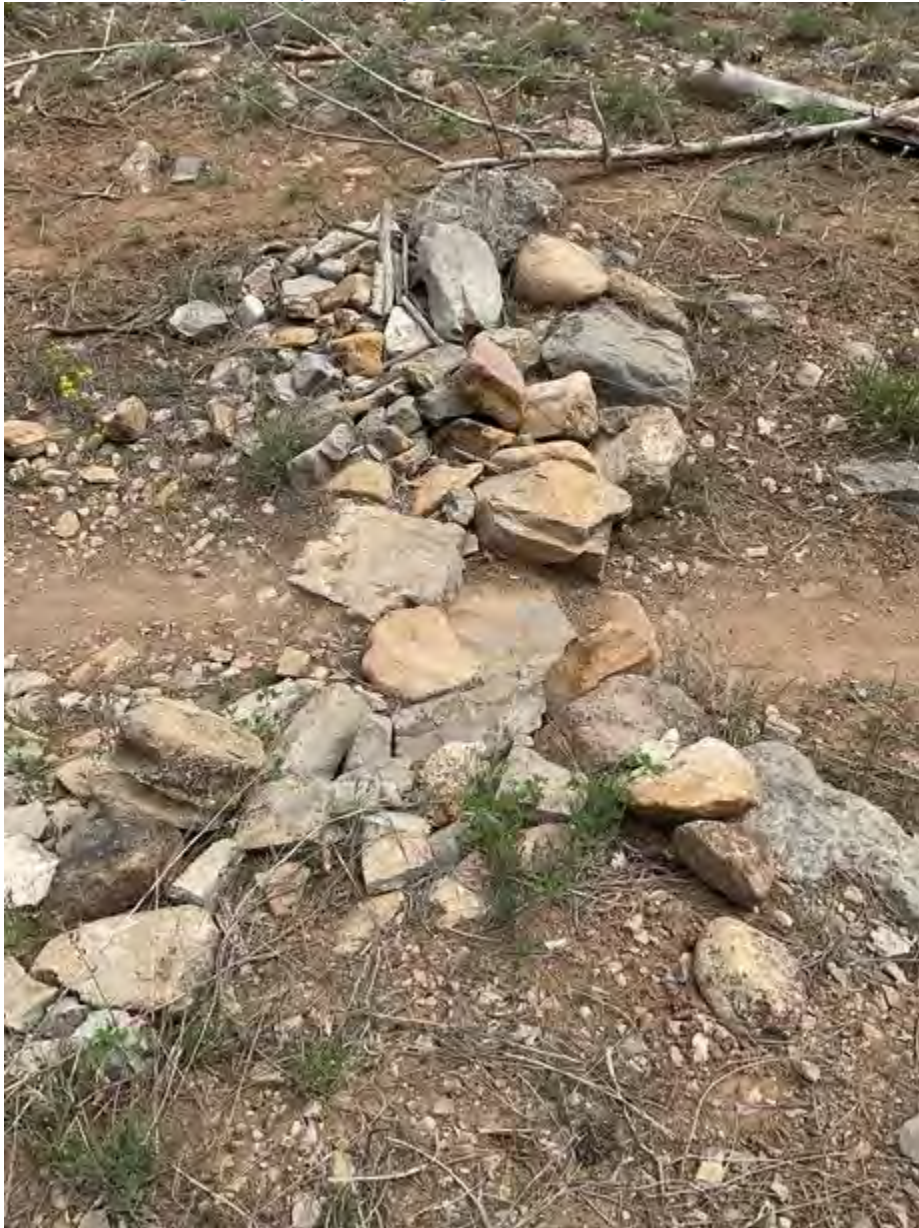
-106.3330915 35.0182646

Some rocks dislodged or broken

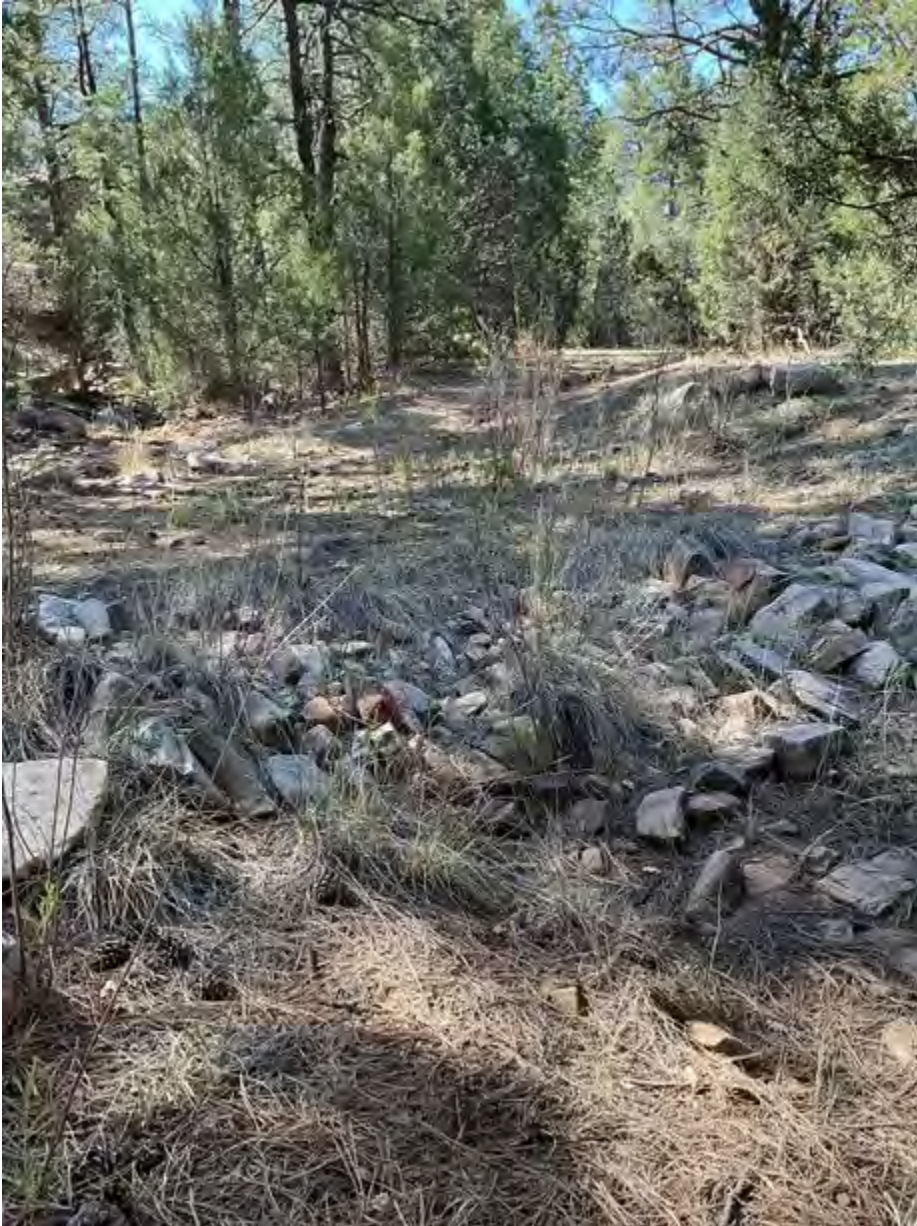
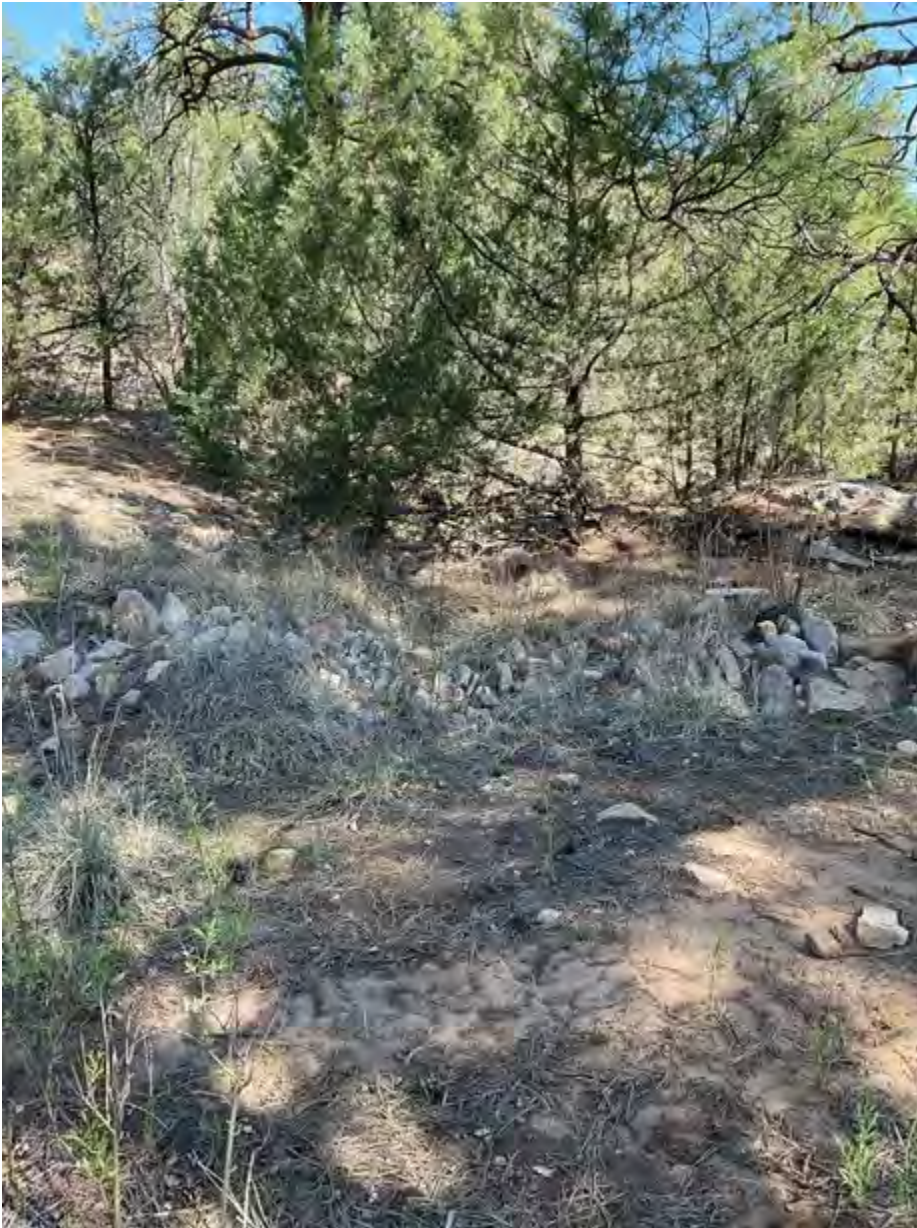
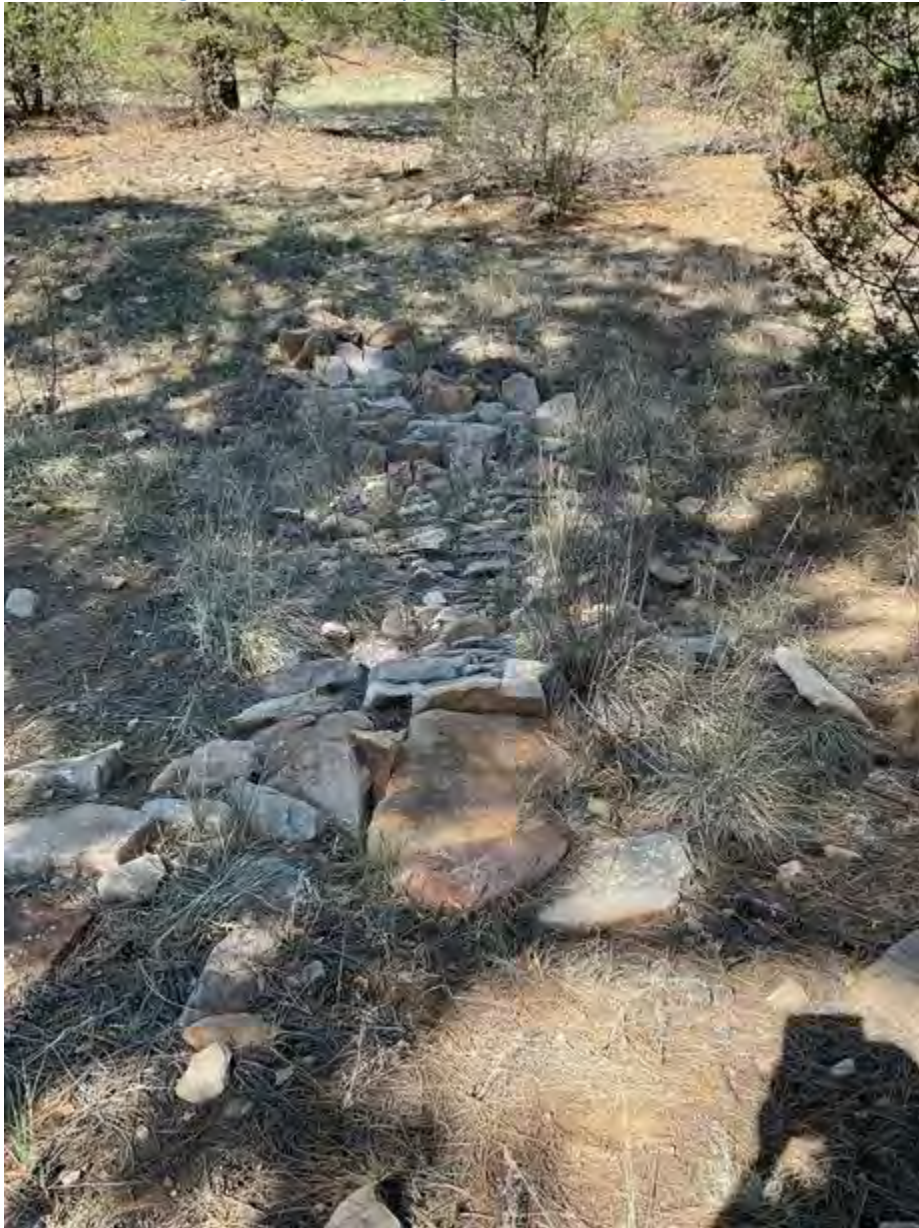
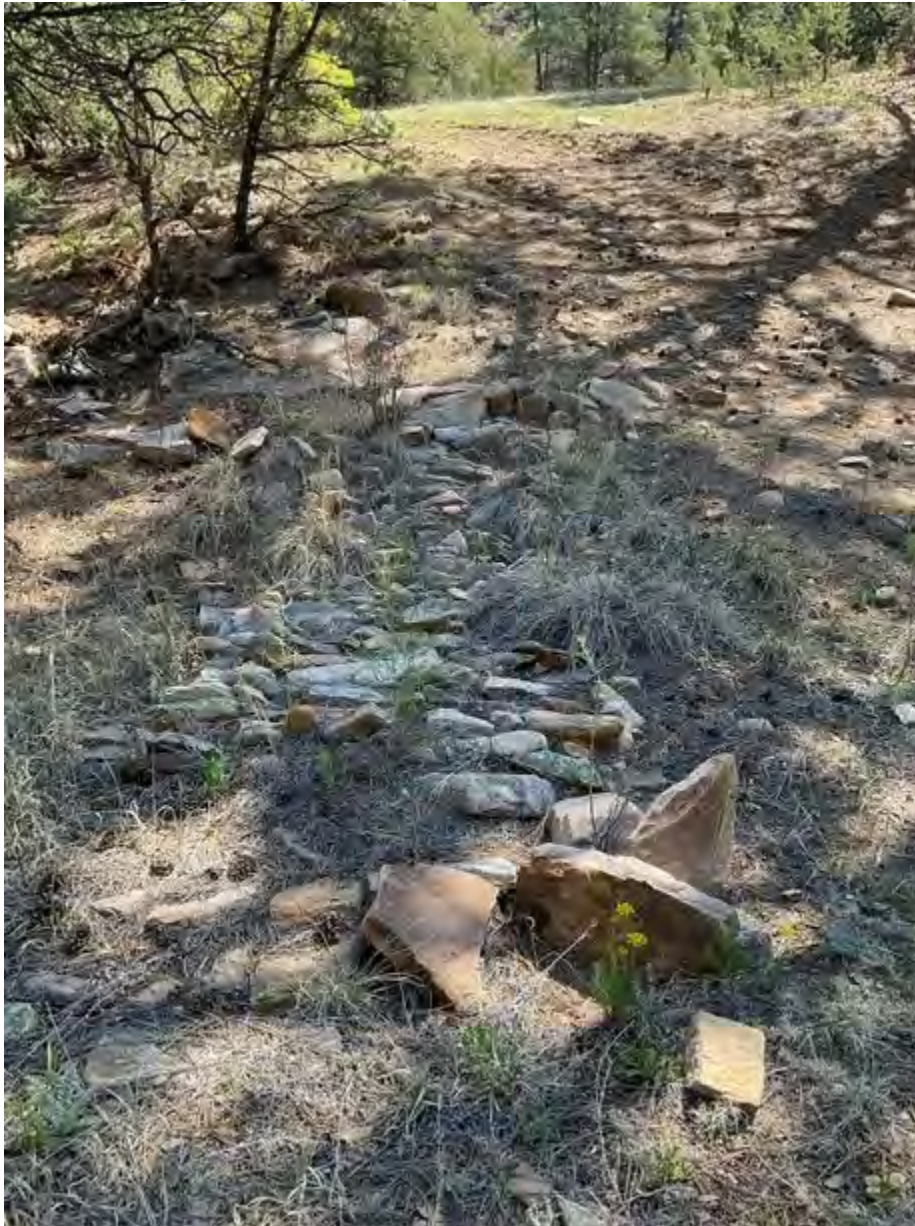
-105.0615005 35.83273165

All rocks intact

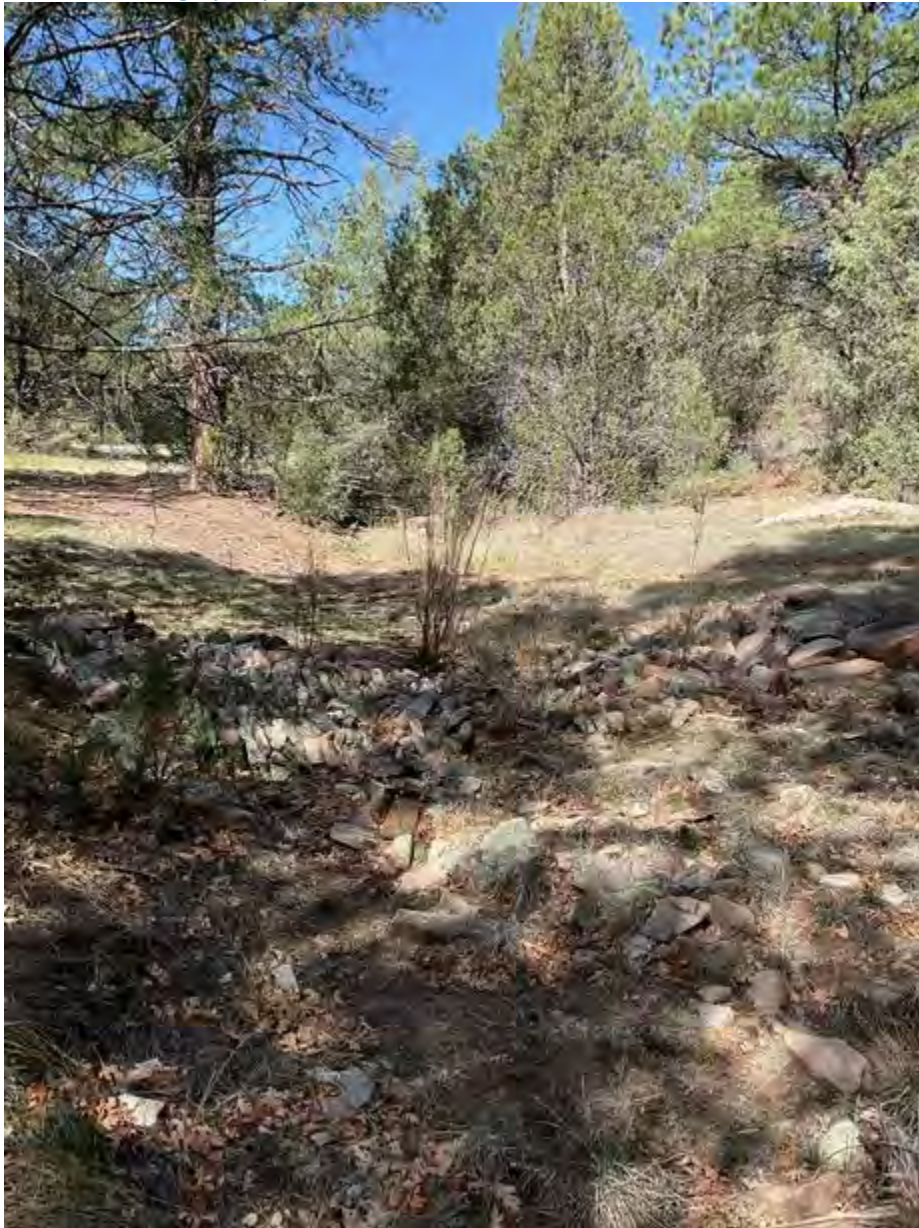
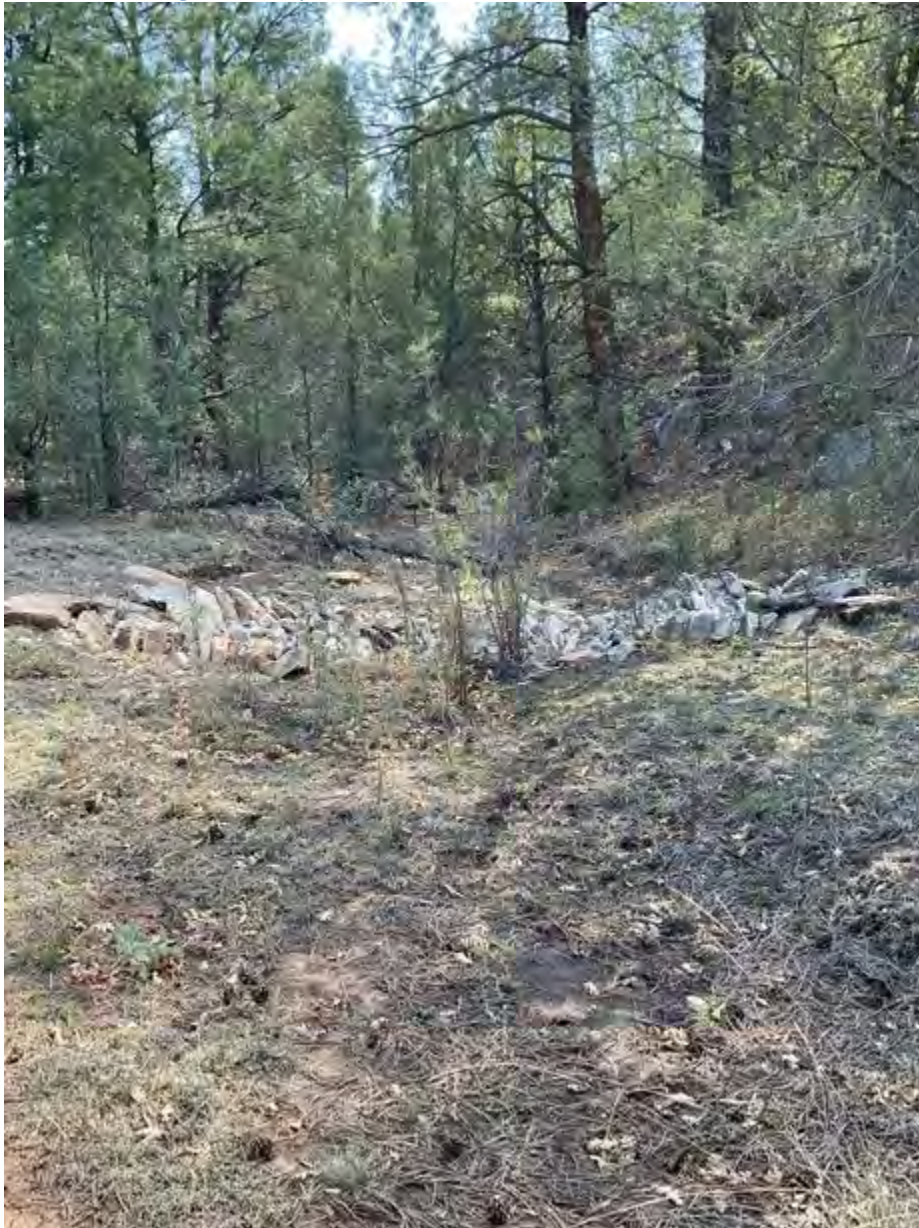
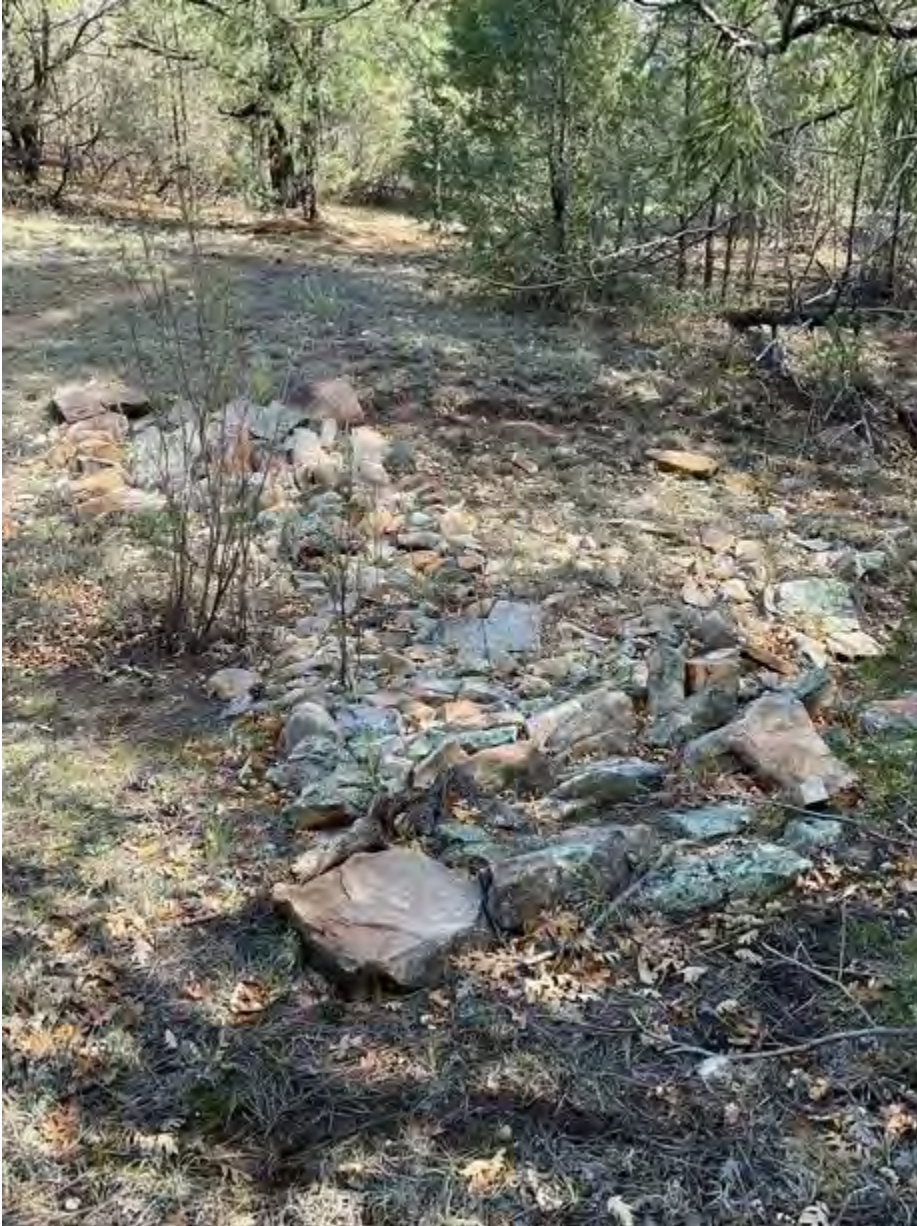
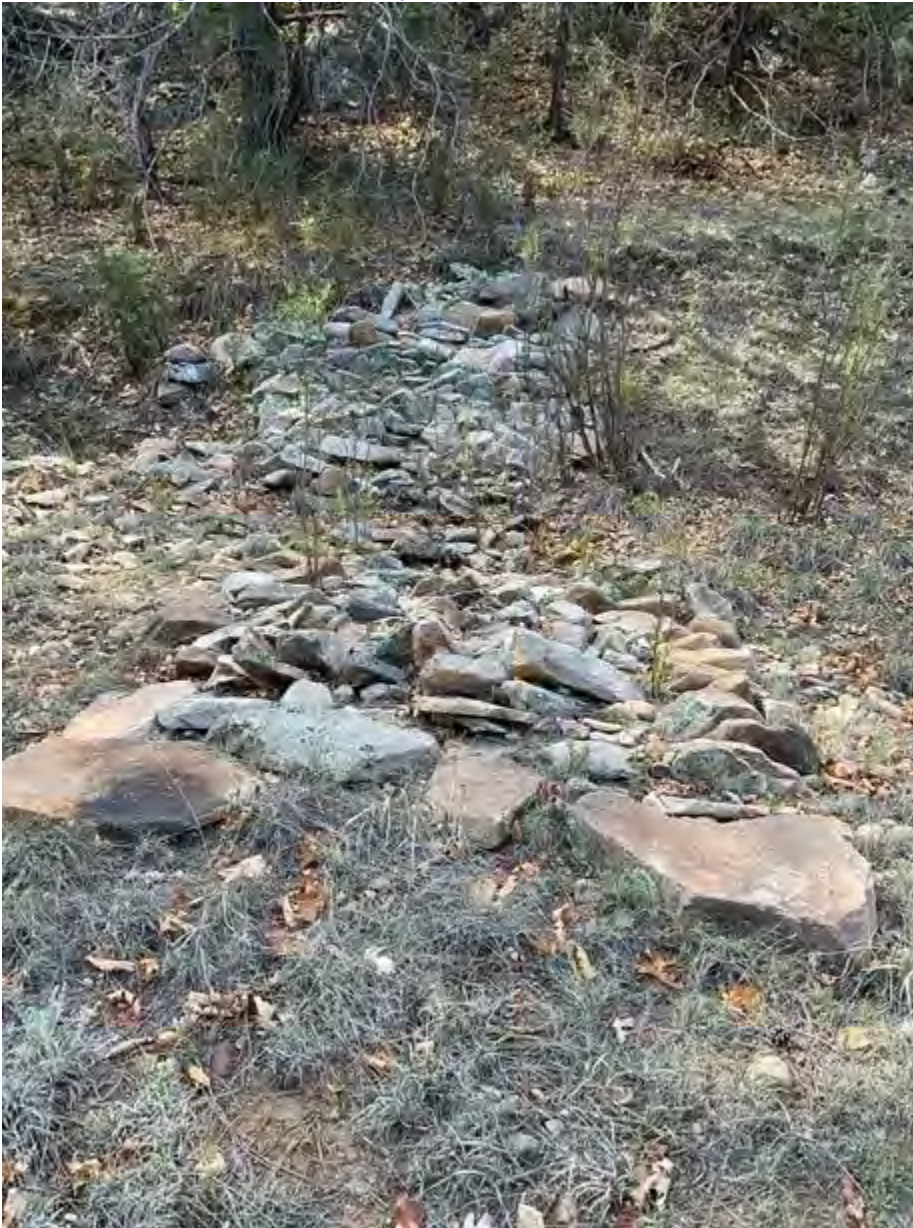
-105.0616055 35.83217267

Some rocks dislodged or broken

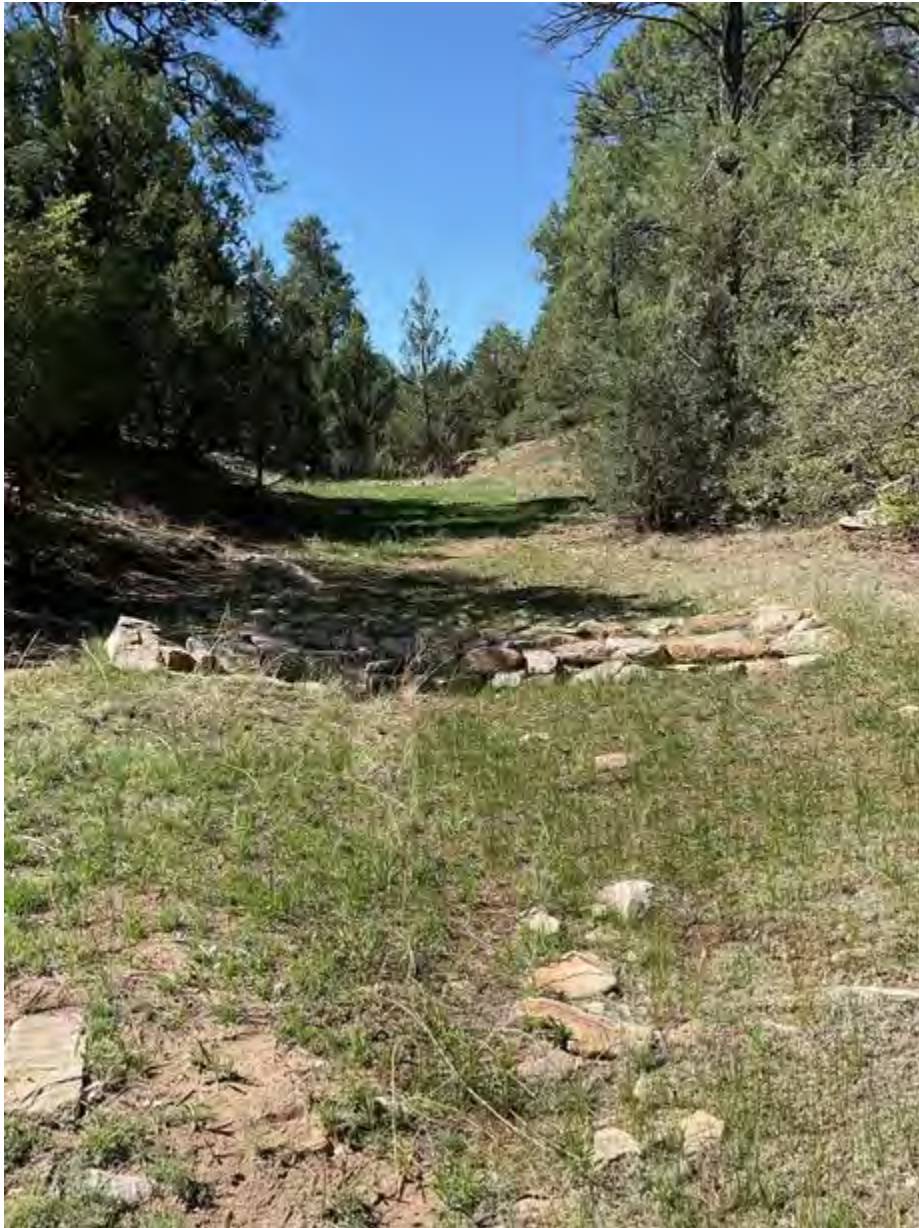
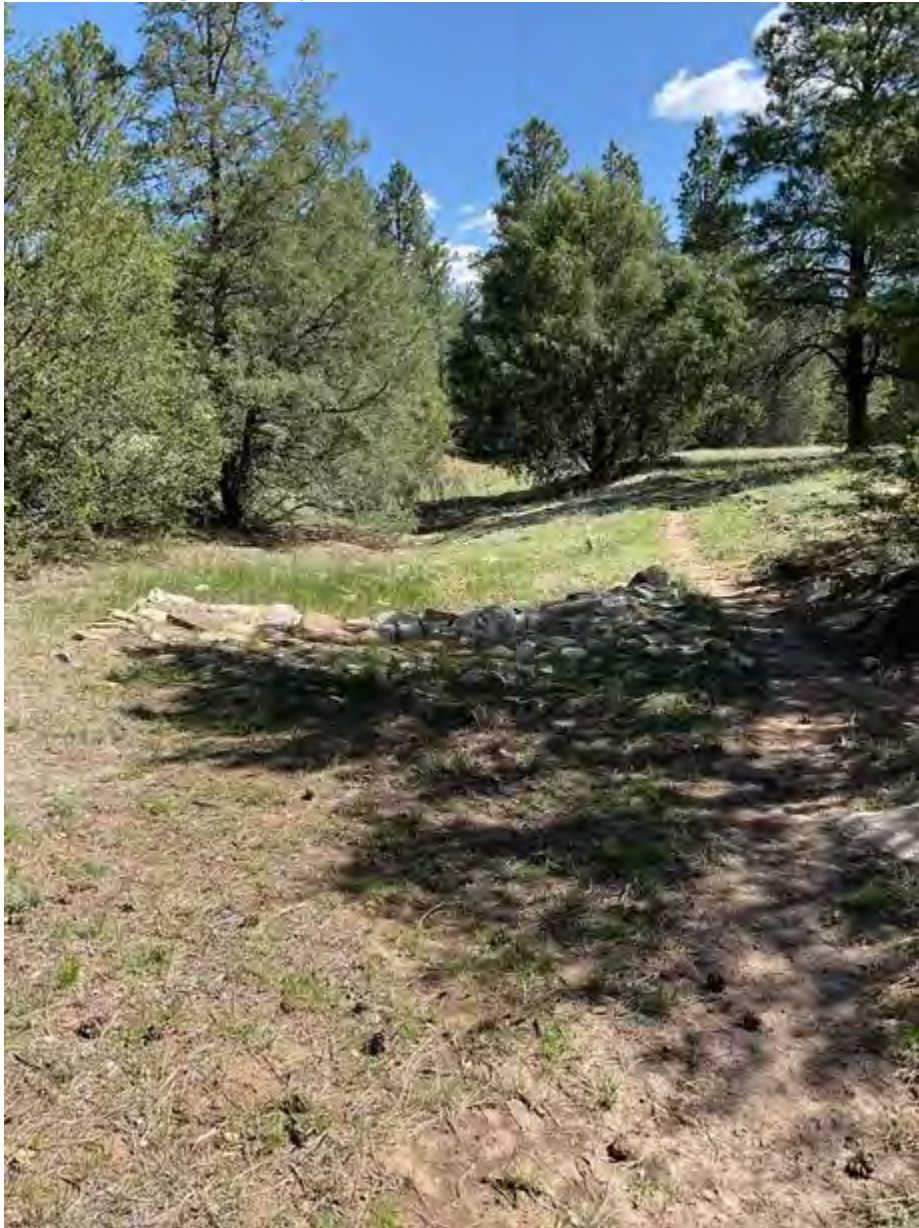
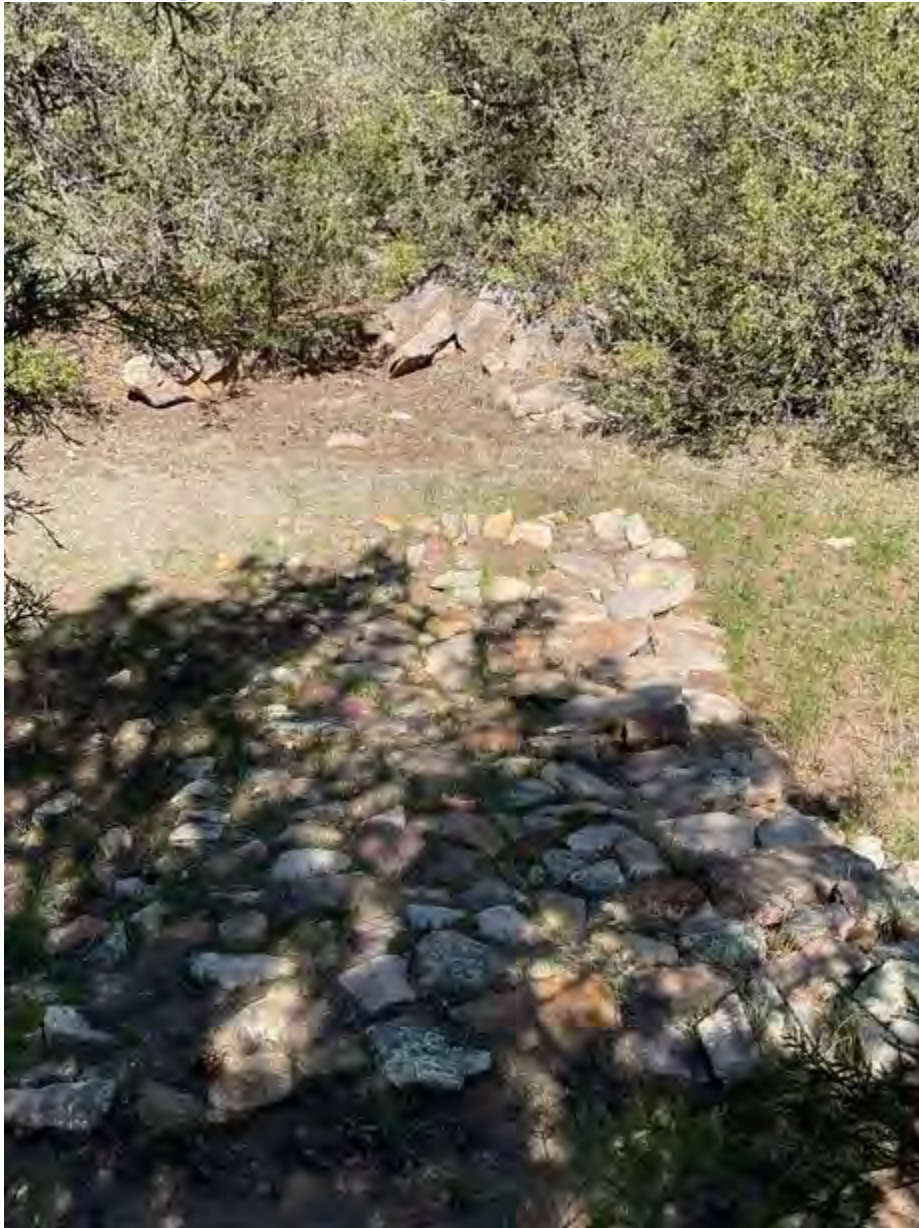
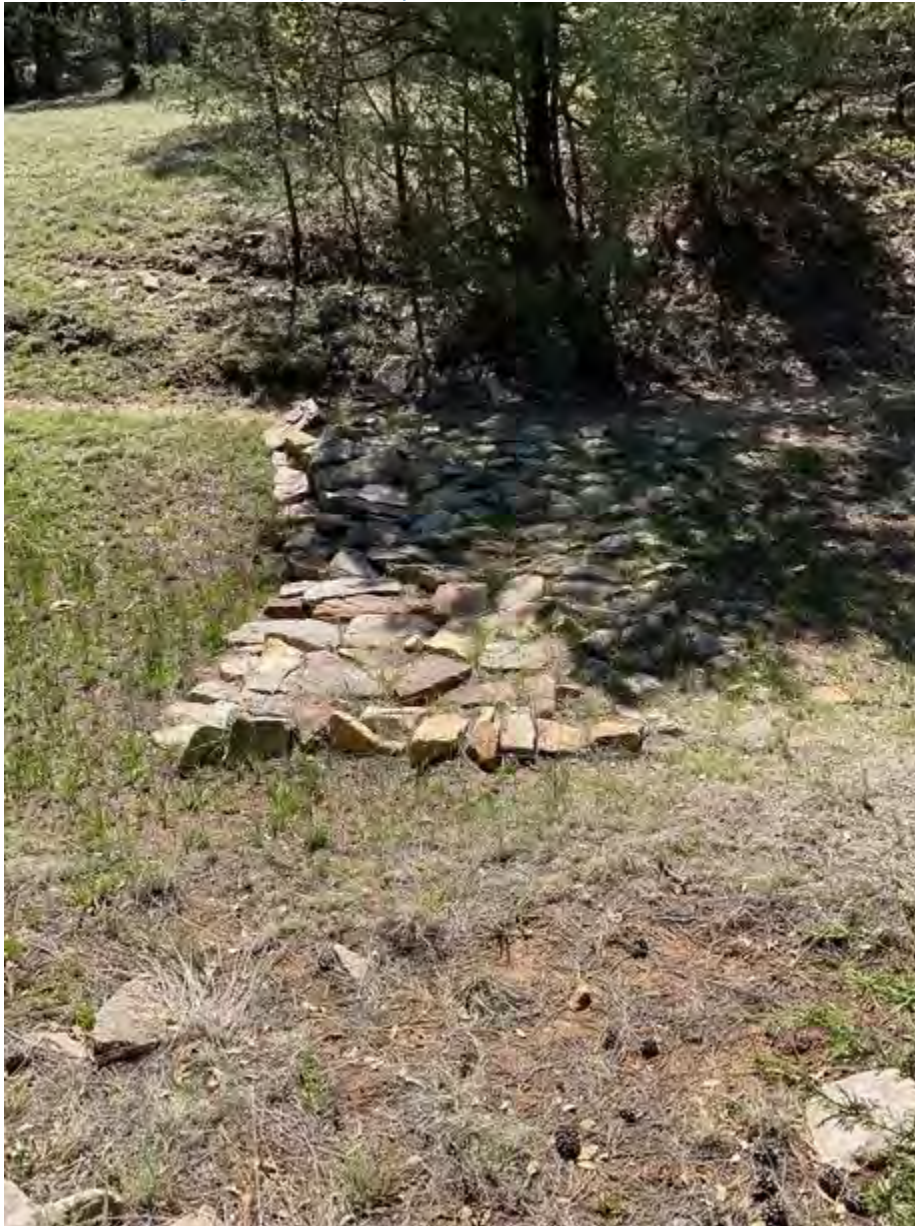
-105.0623845 35.83162323

All rocks intact

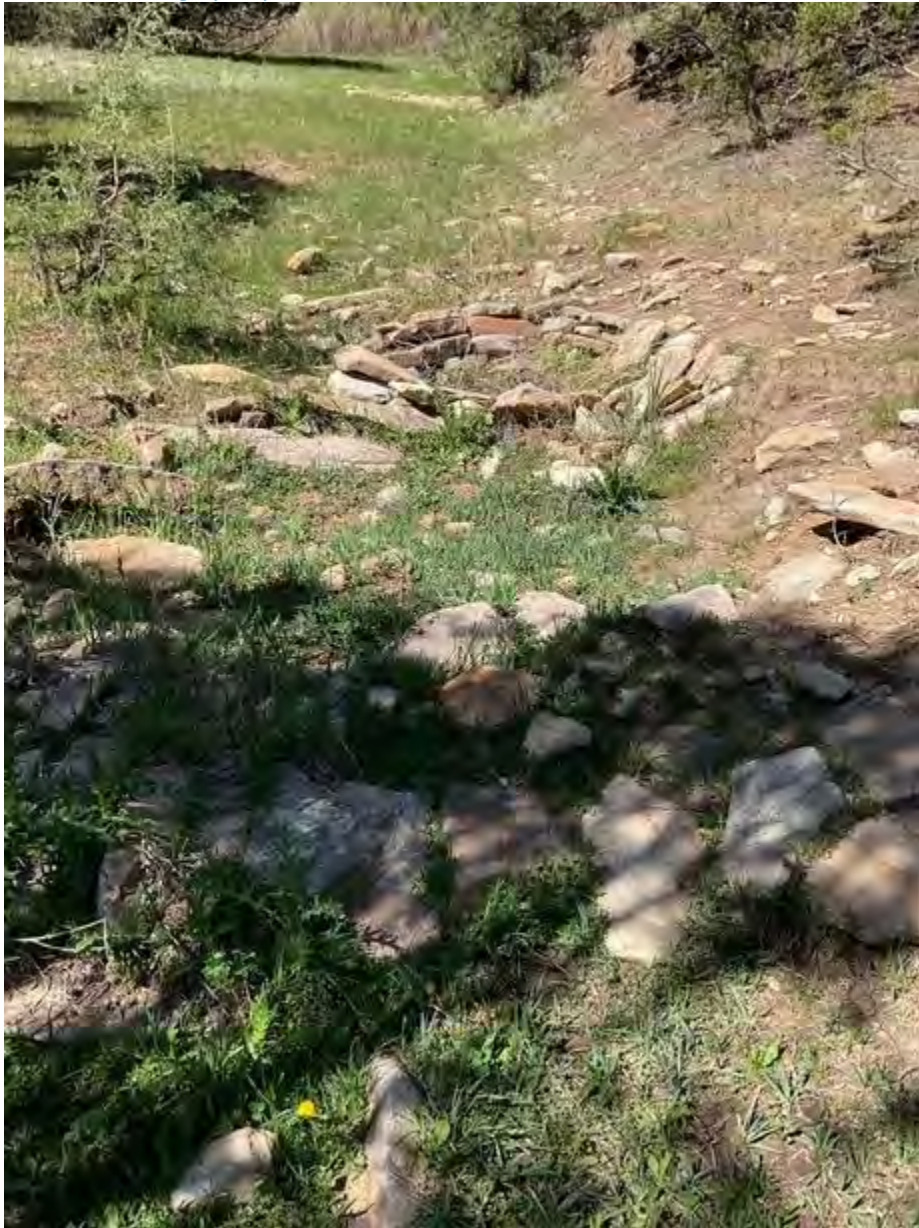
-105.0626758 35.8308562

Some rocks dislodged or broken
