**Zuni Bowl and One Rock Check Dam Research –
Phase 1**

Final Report

December 2024

Rio Grande Return for the New Mexico Department of Transportation Research Bureau

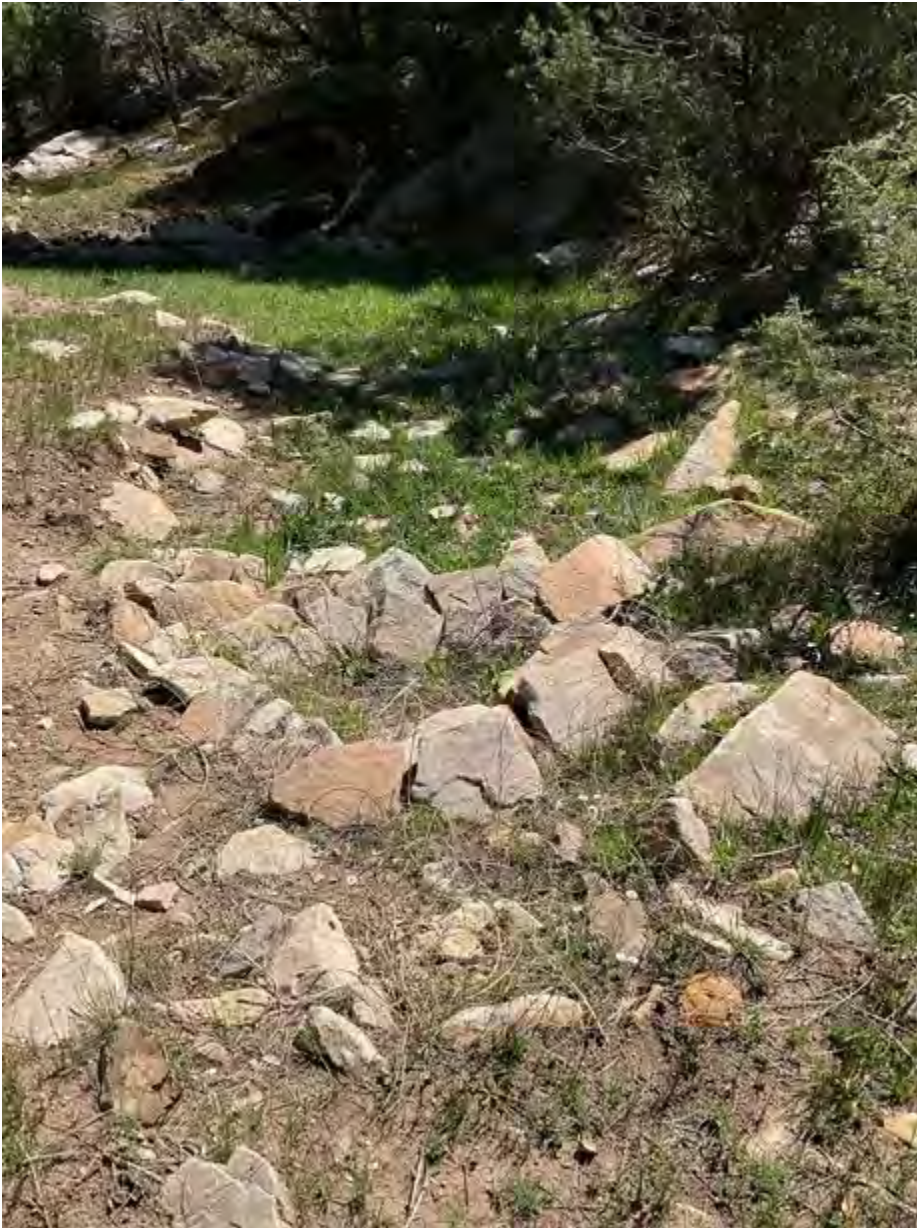
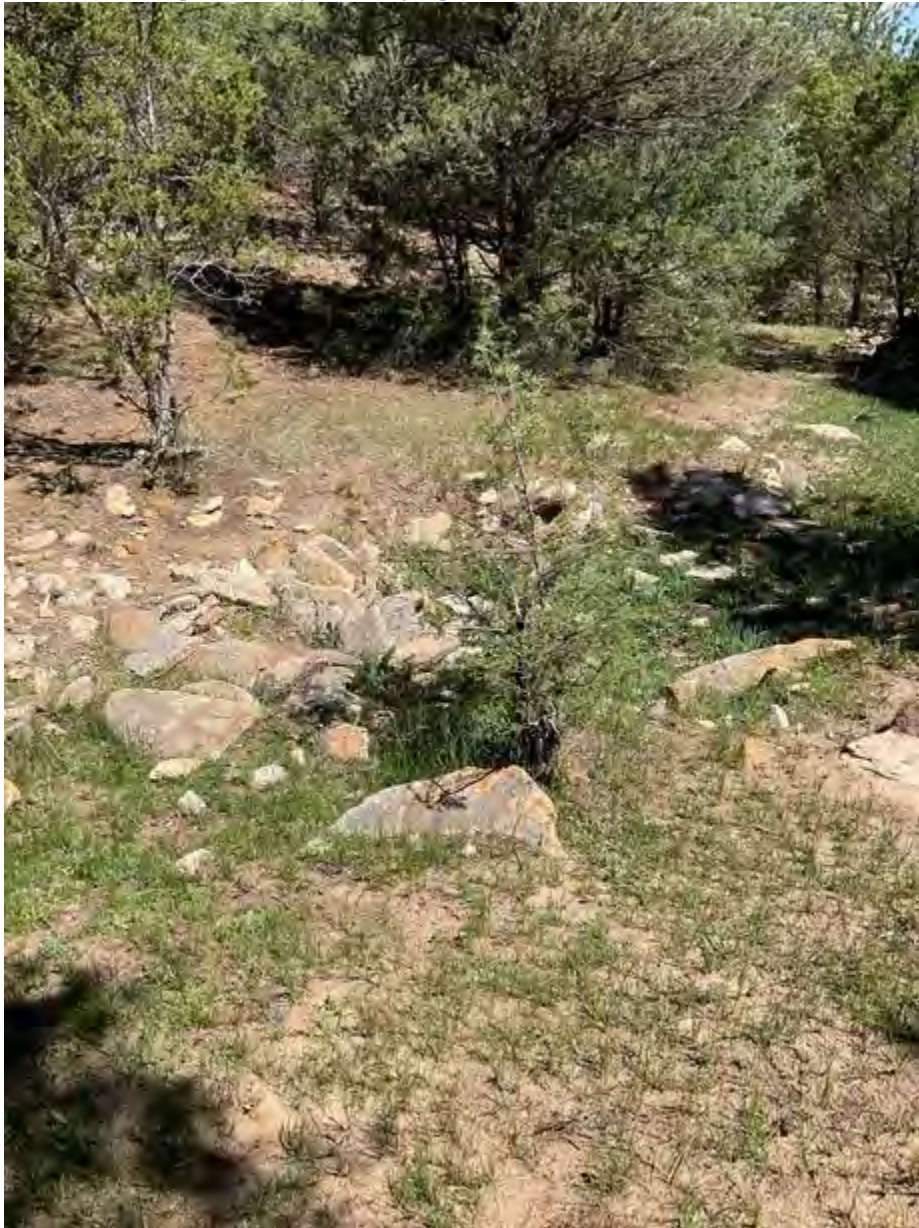
Some rocks dislodged or broken

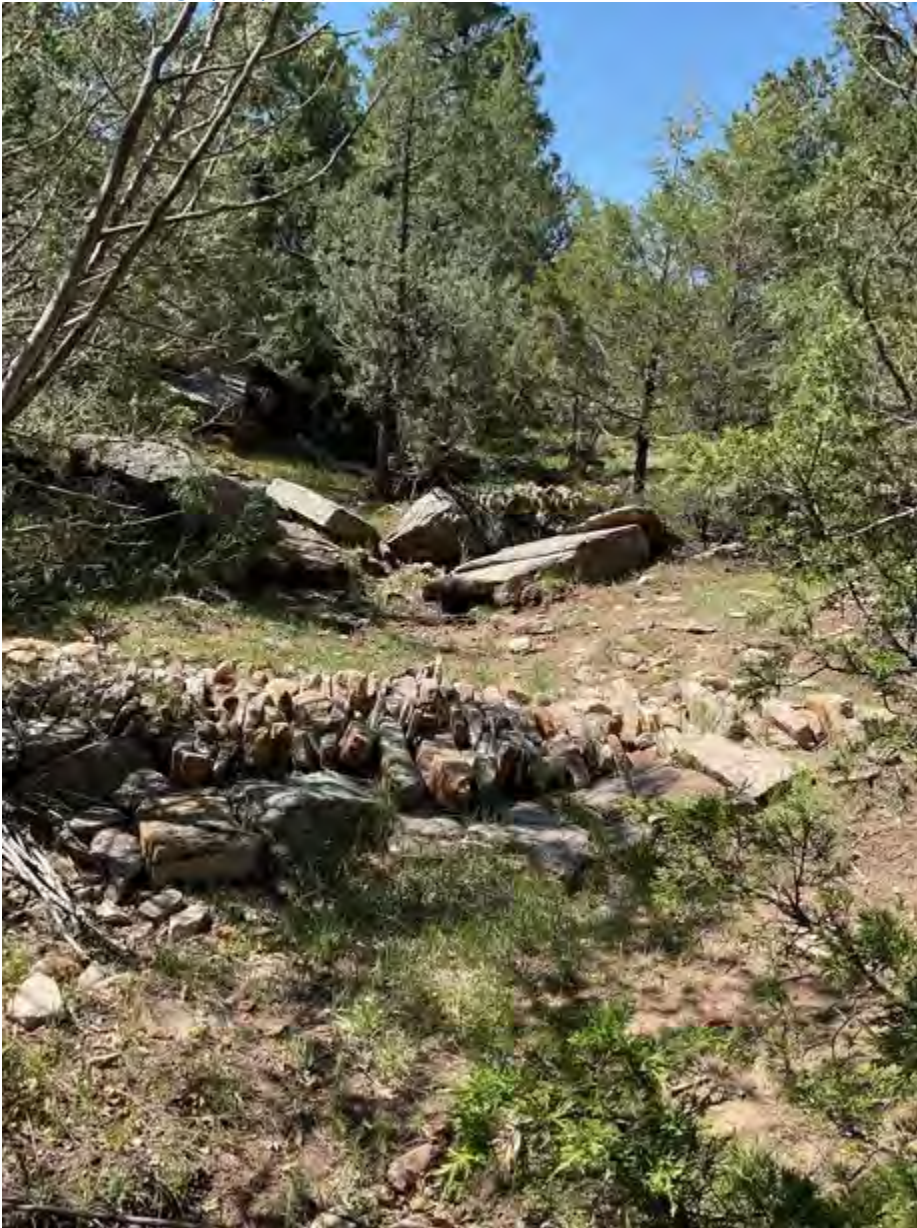
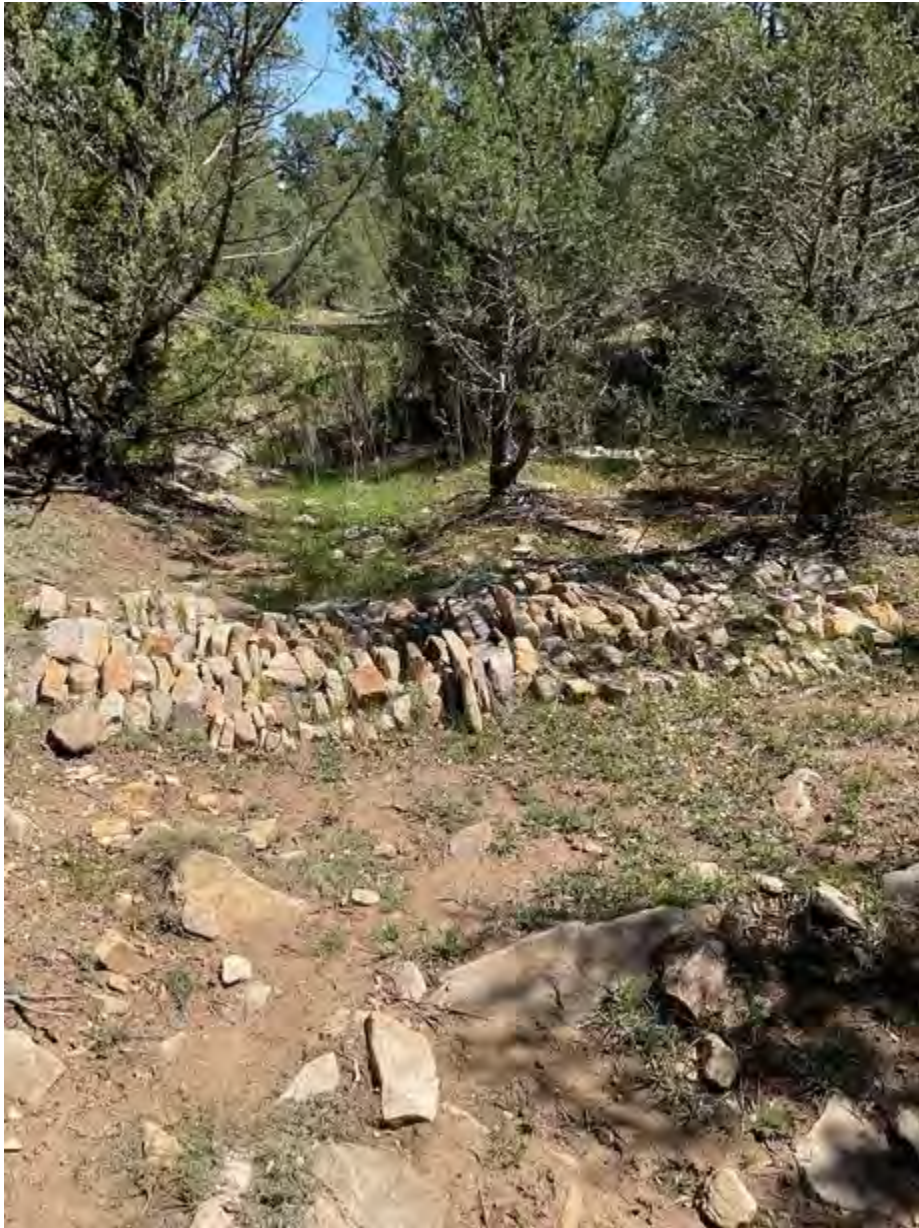
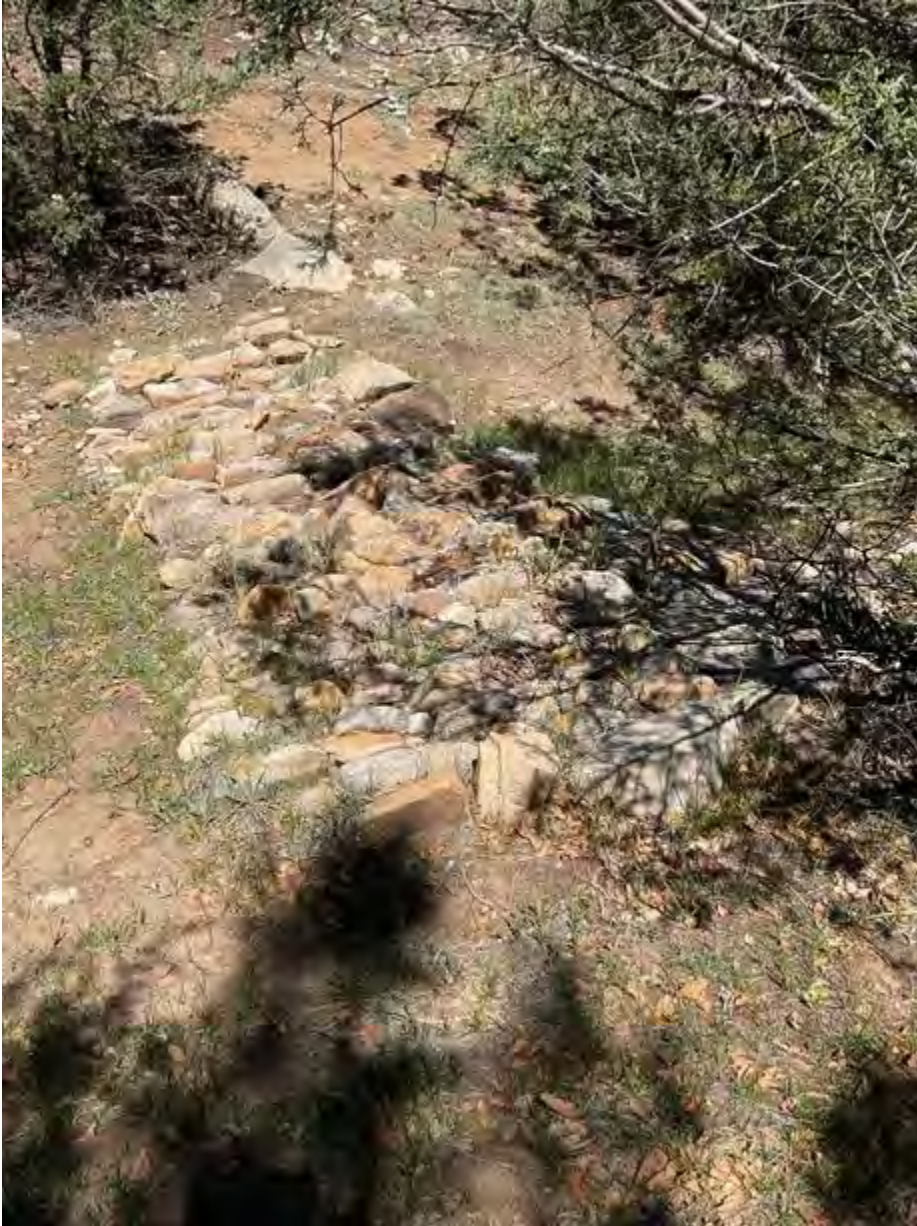
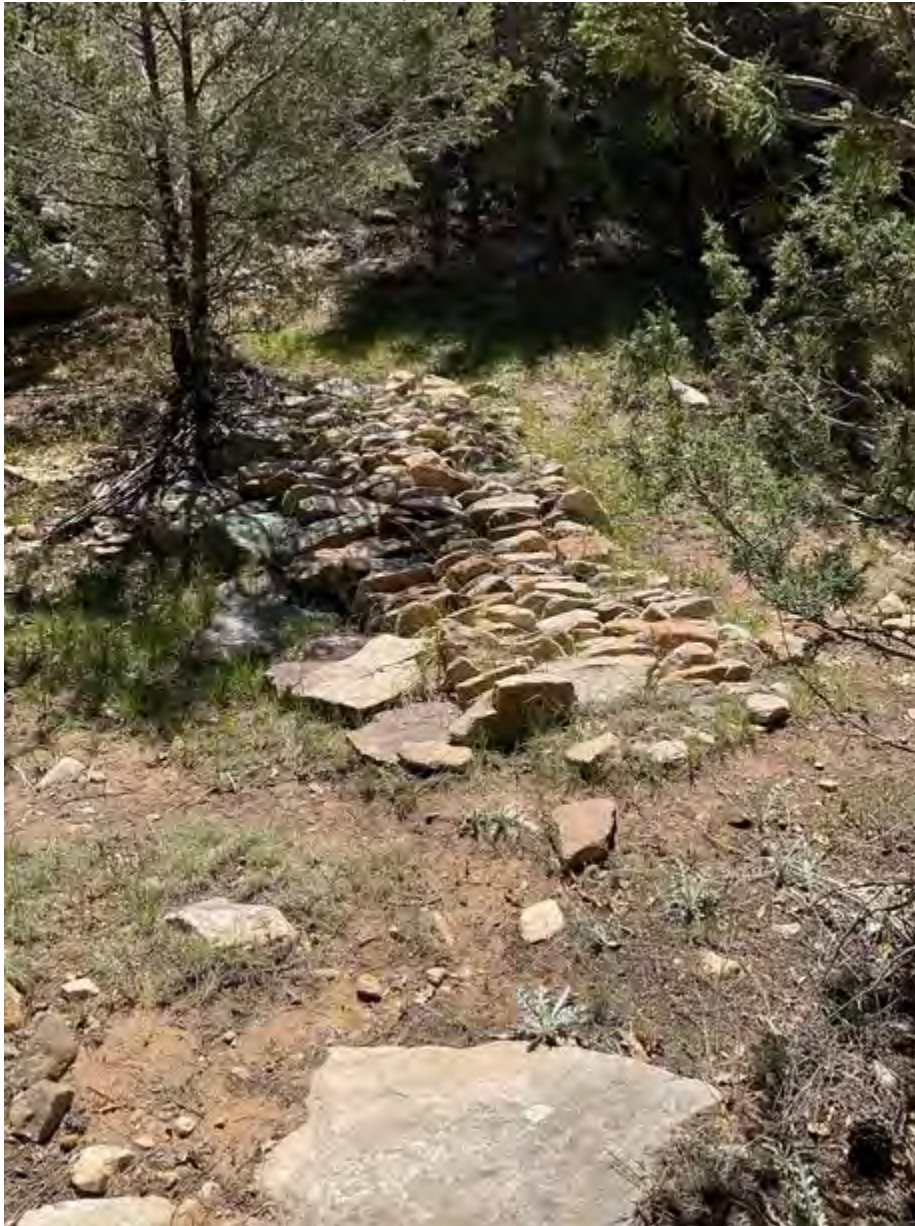
-105.0625779 35.83105572

All rocks intact

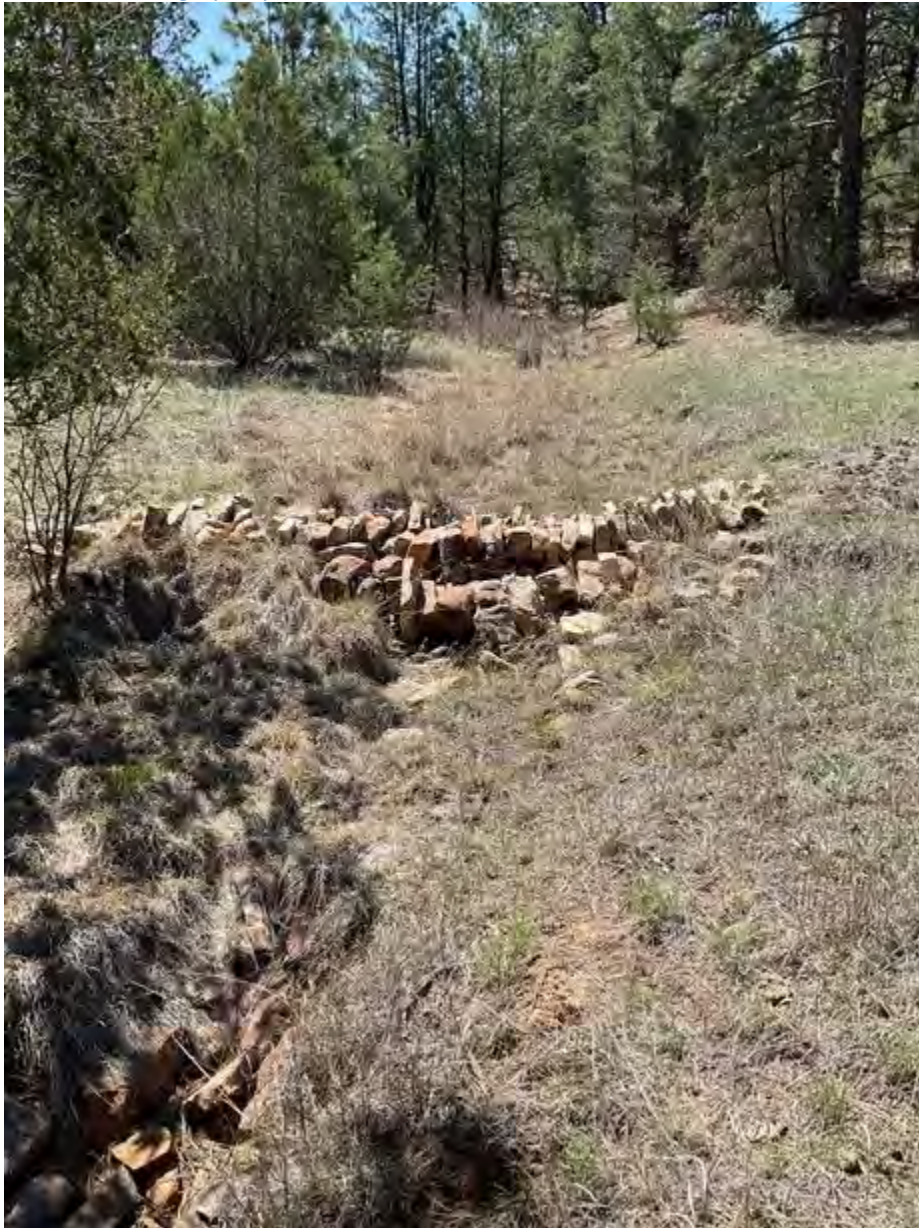
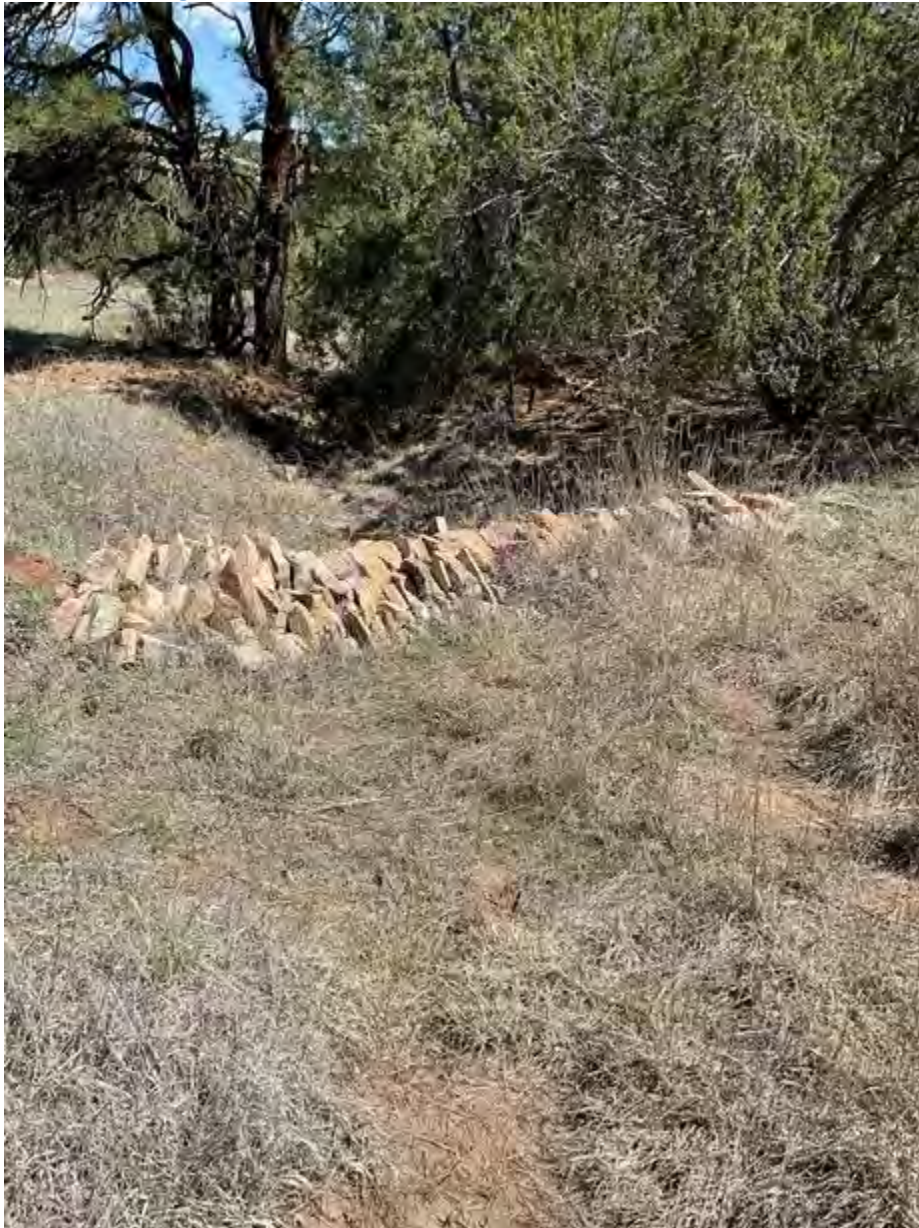
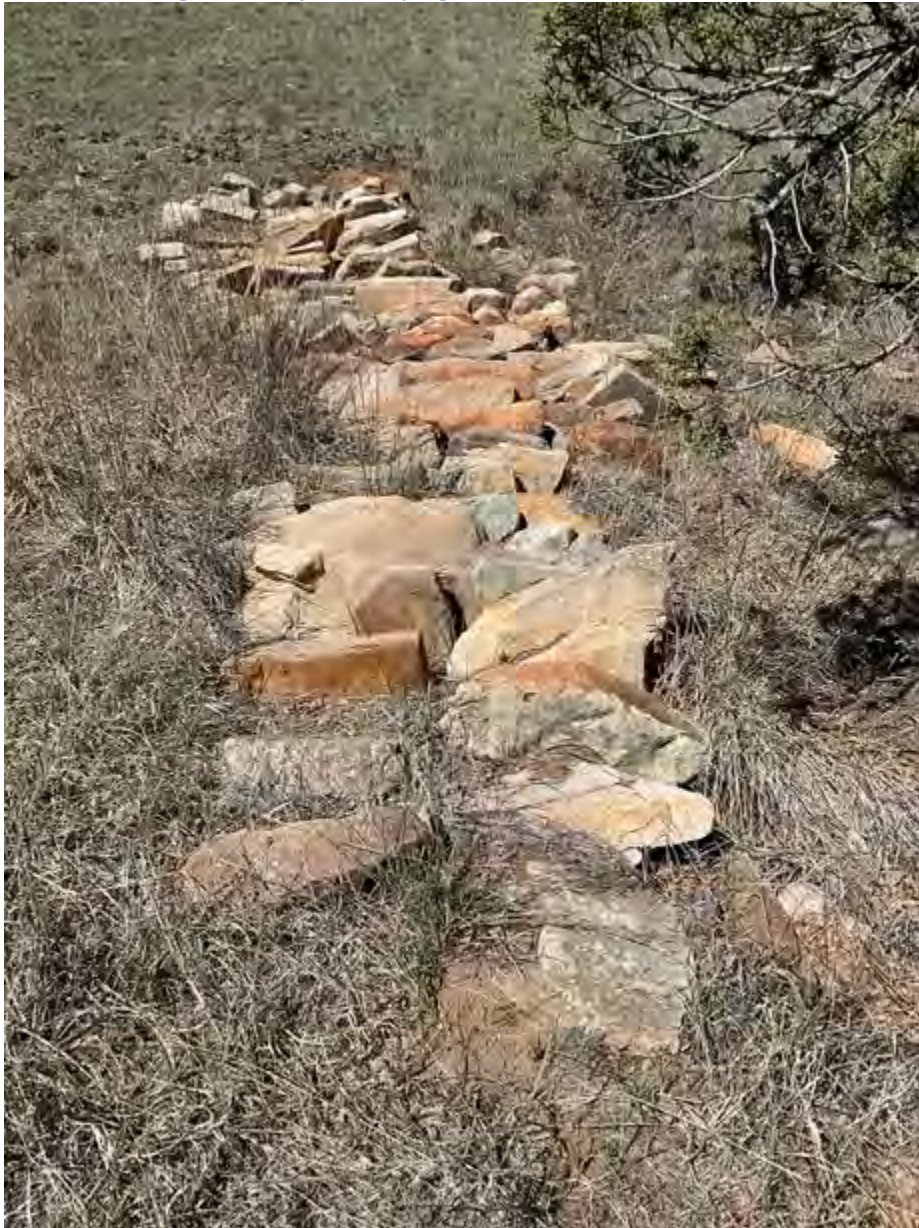
-105.0609064 35.83294335

Some rocks dislodged or broken

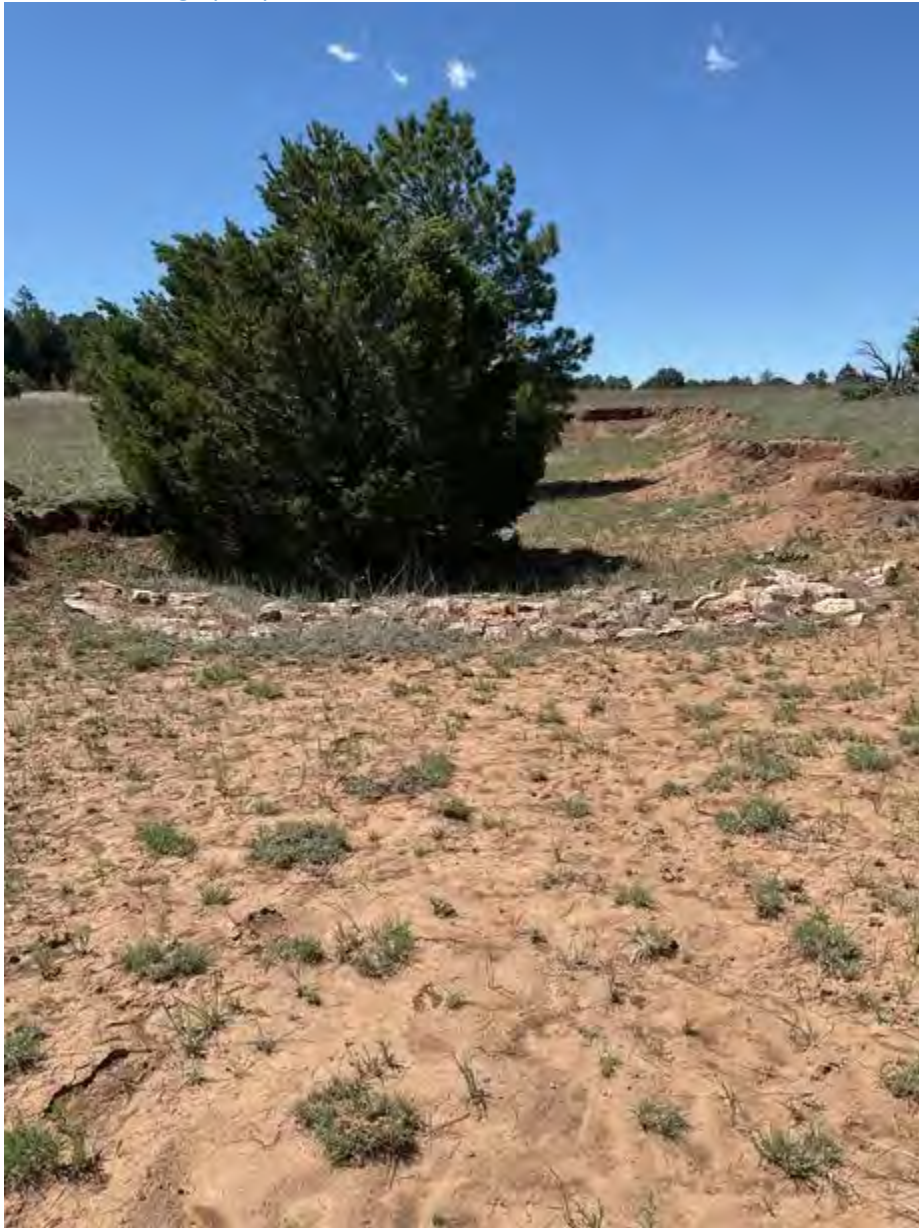
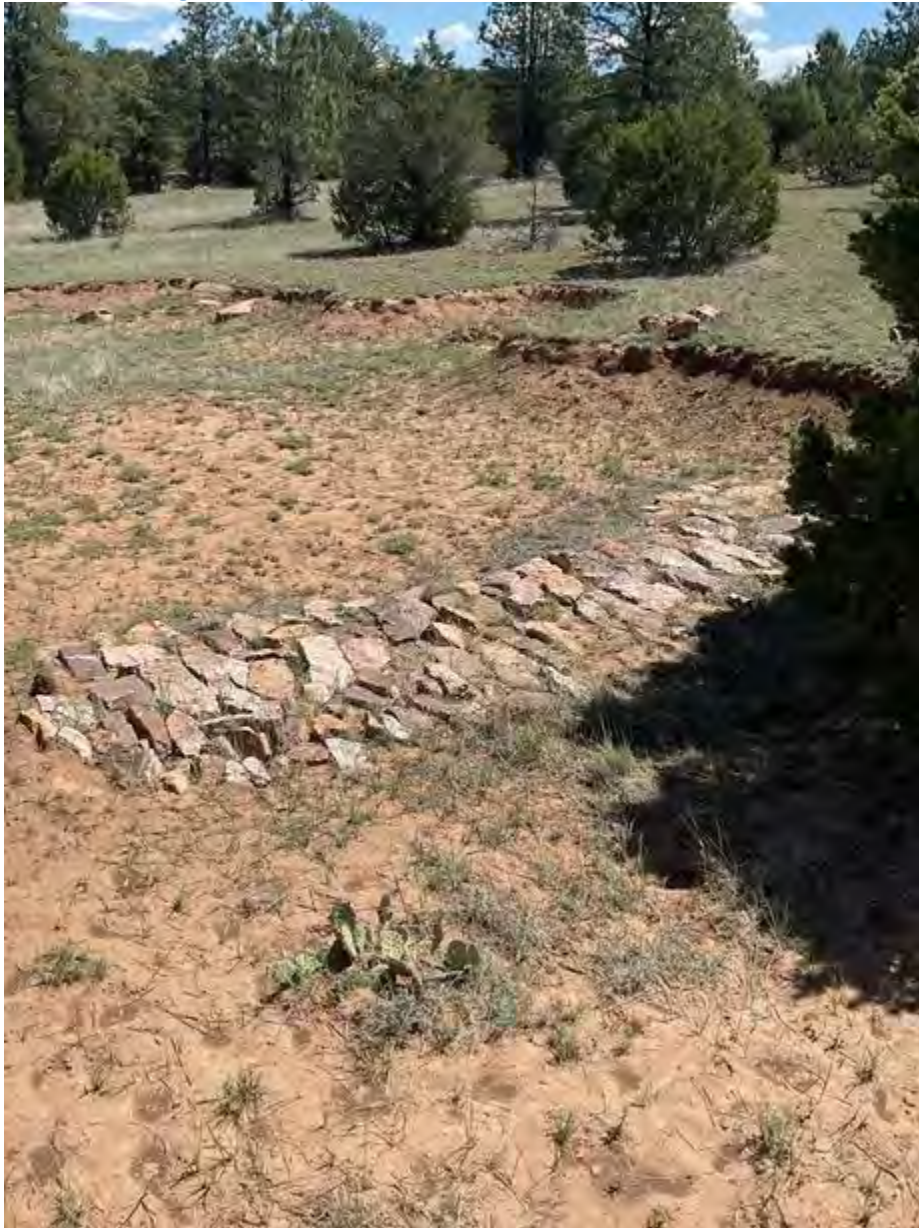
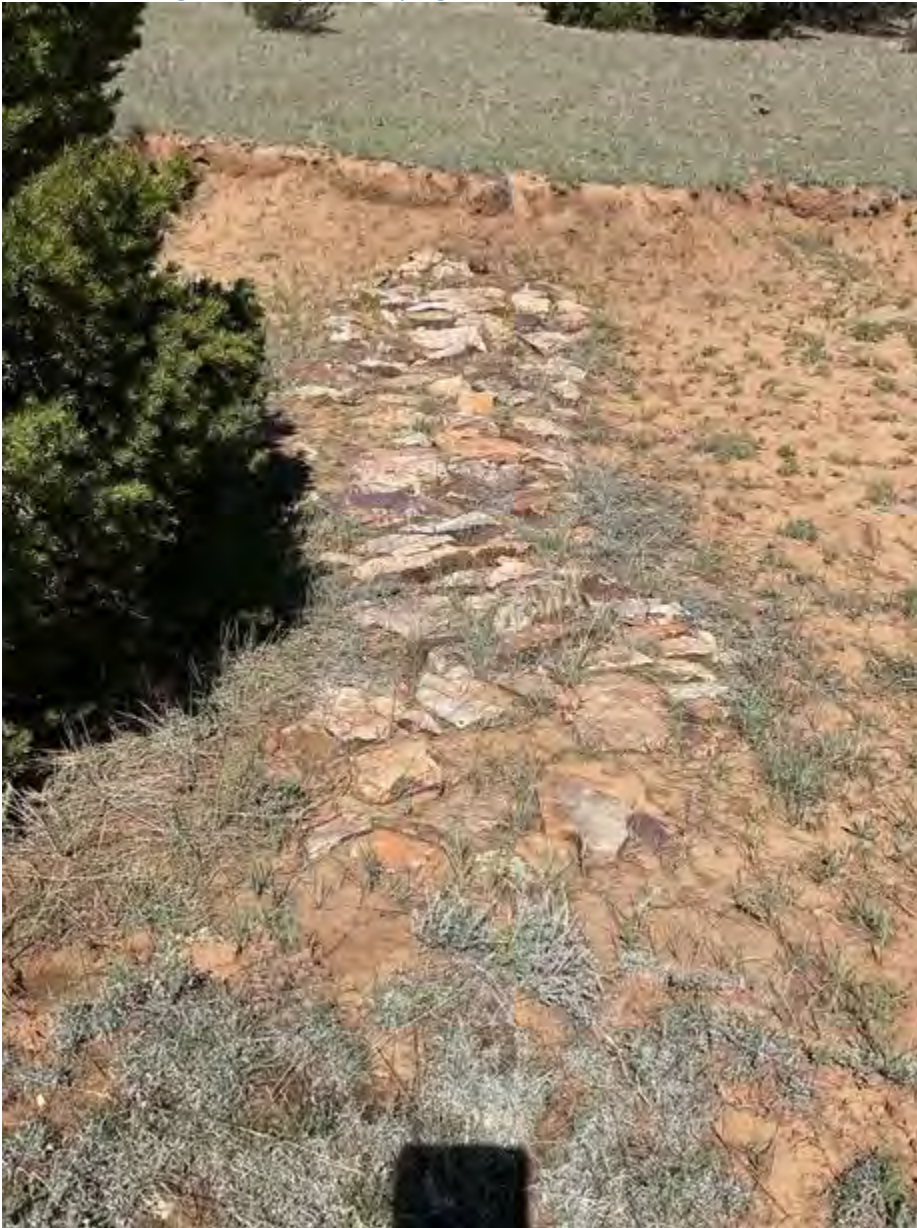
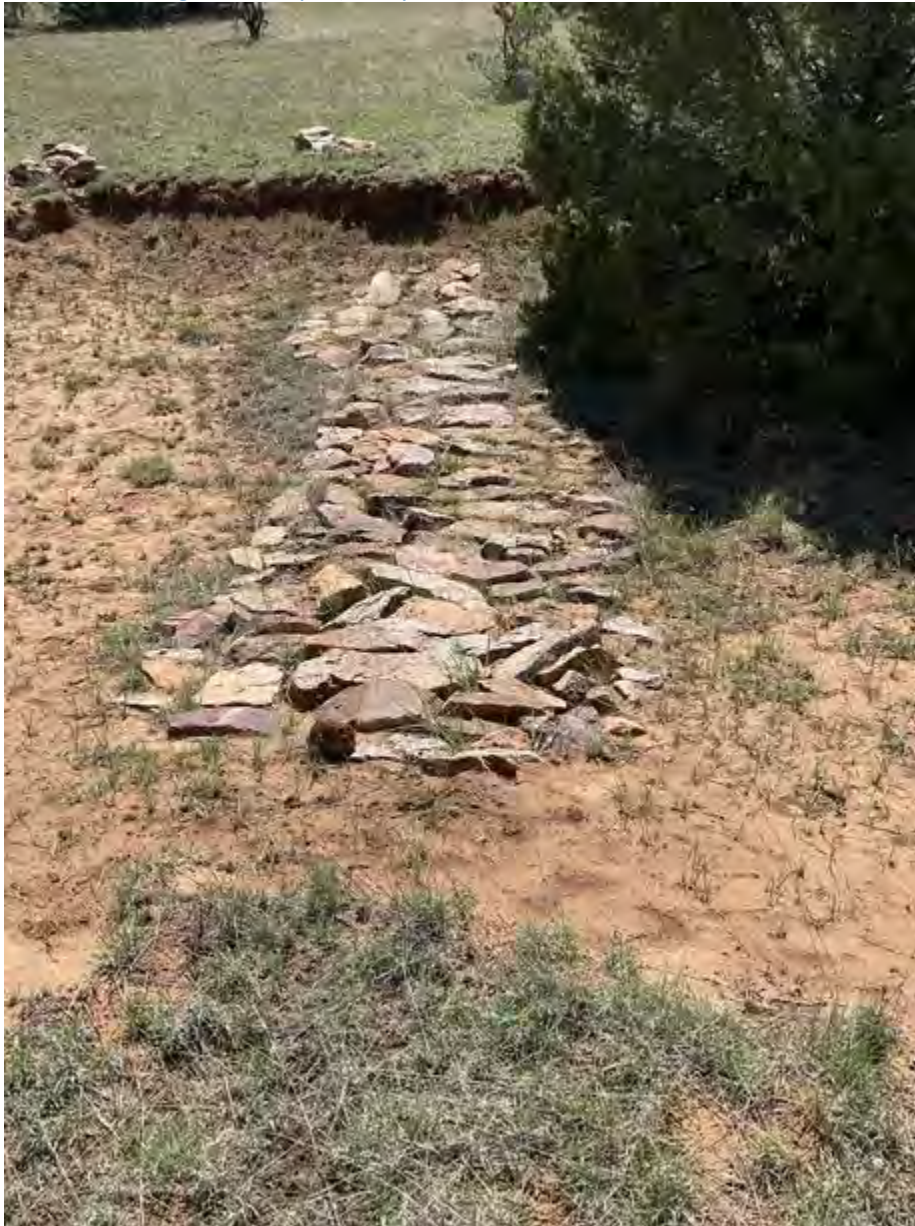
-105.0591178 35.82943648

All rocks intact

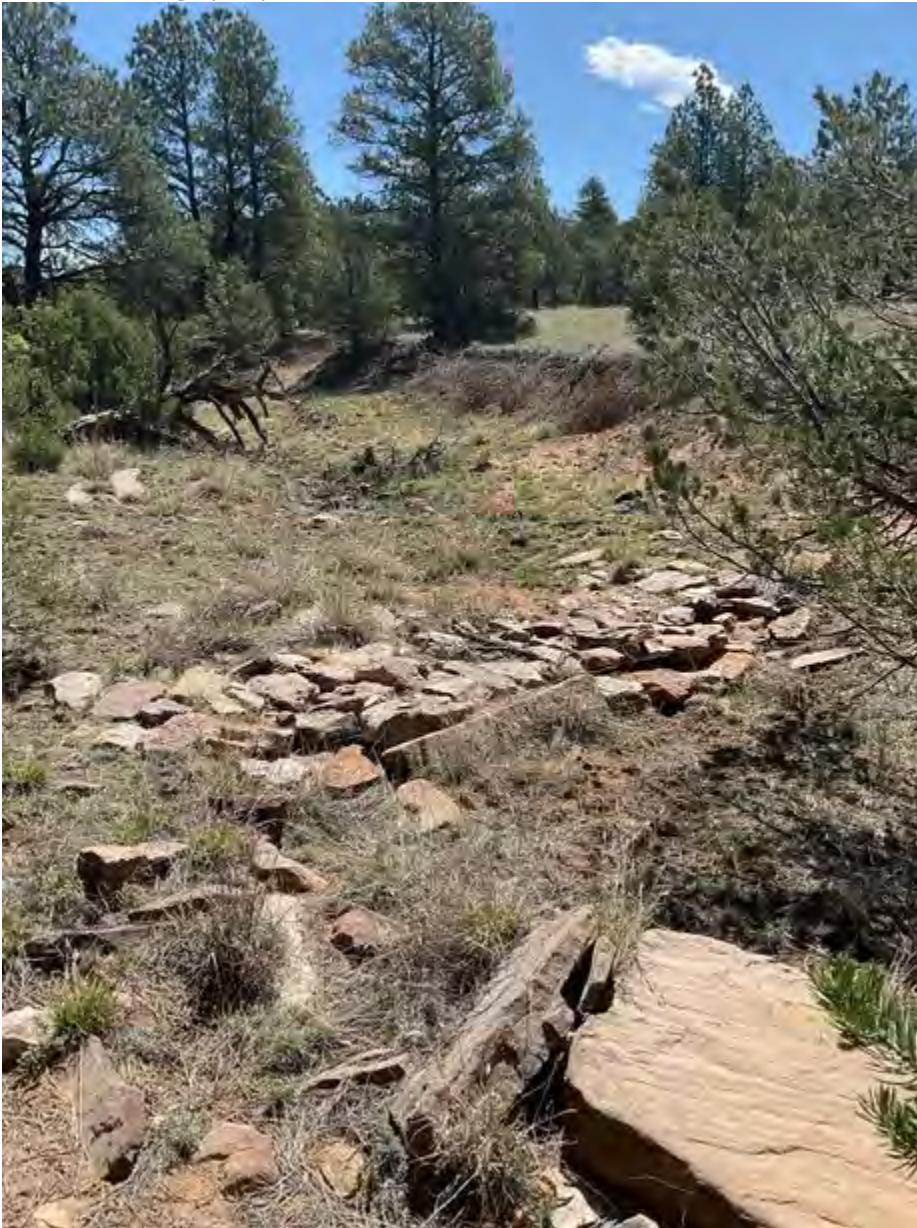
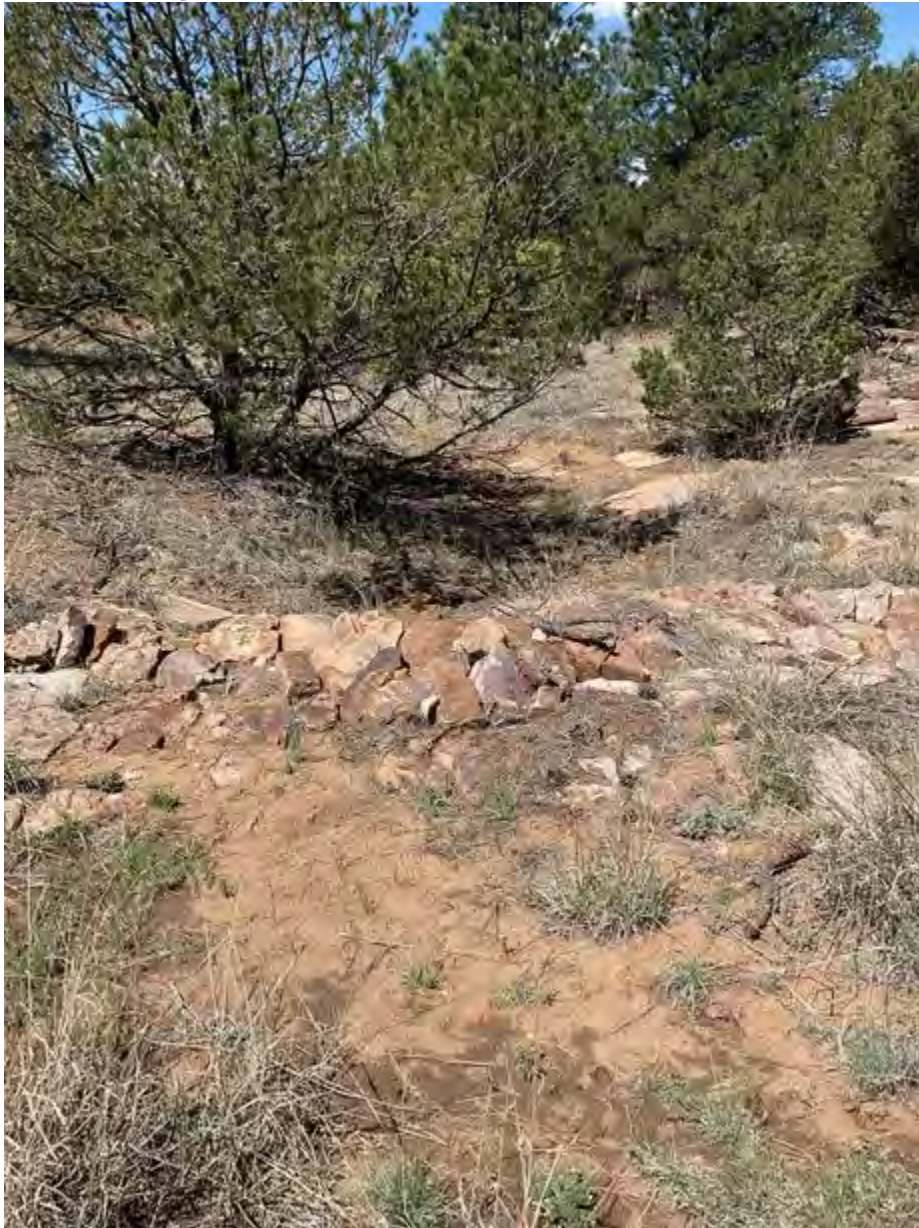
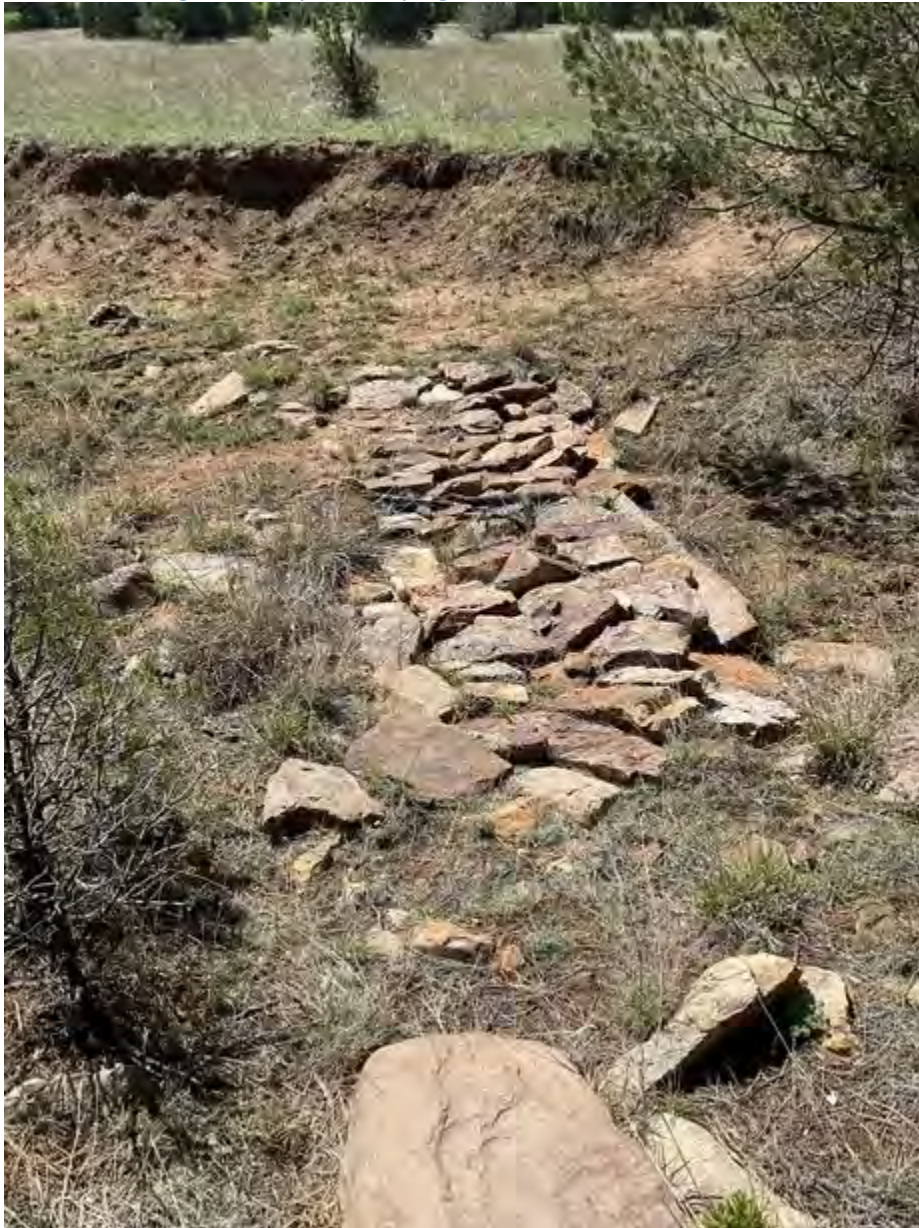
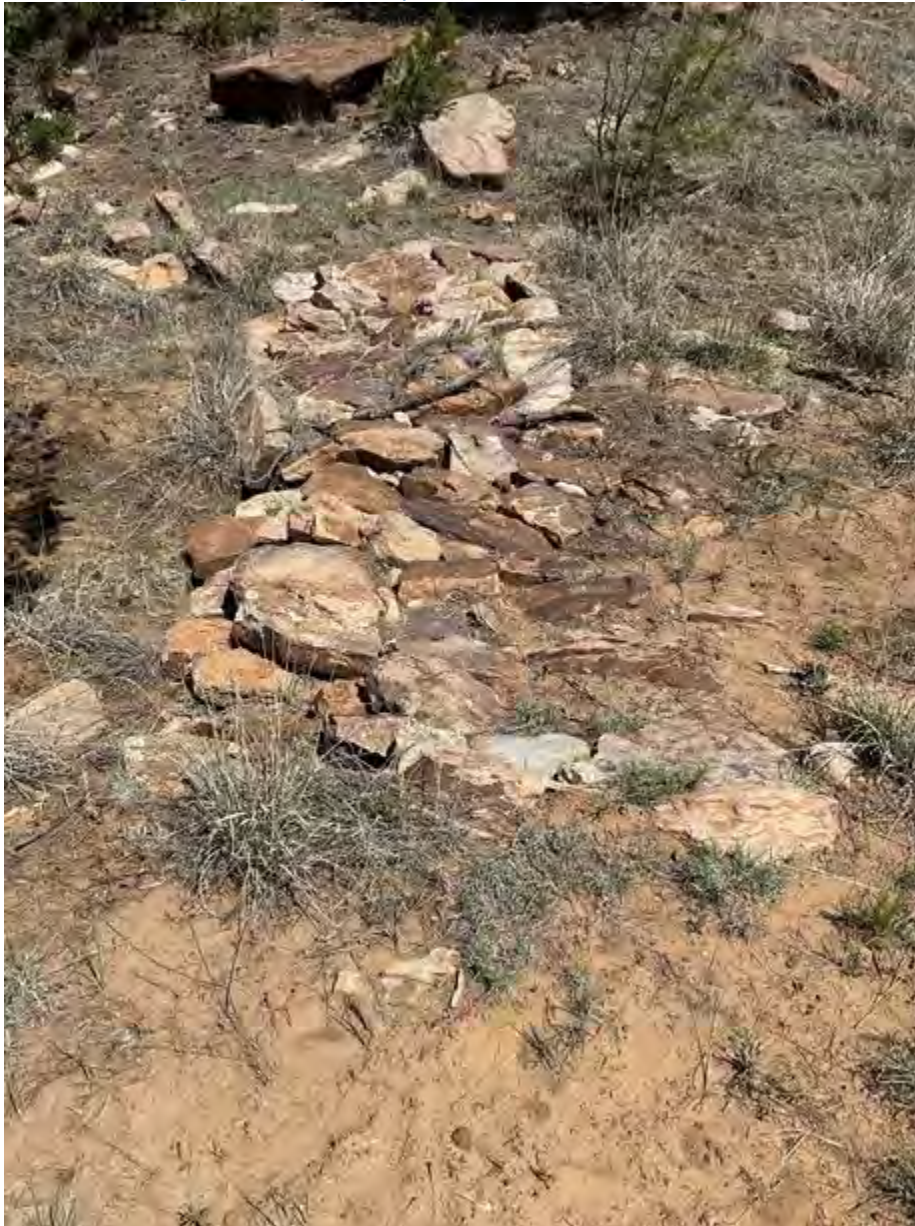
-105.058157 35.8298955

All rocks intact
