**Zuni Bowl and One Rock Check Dam Research –
Phase 1**

Final Report

December 2024

Rio Grande Return for the New Mexico Department of Transportation Research Bureau

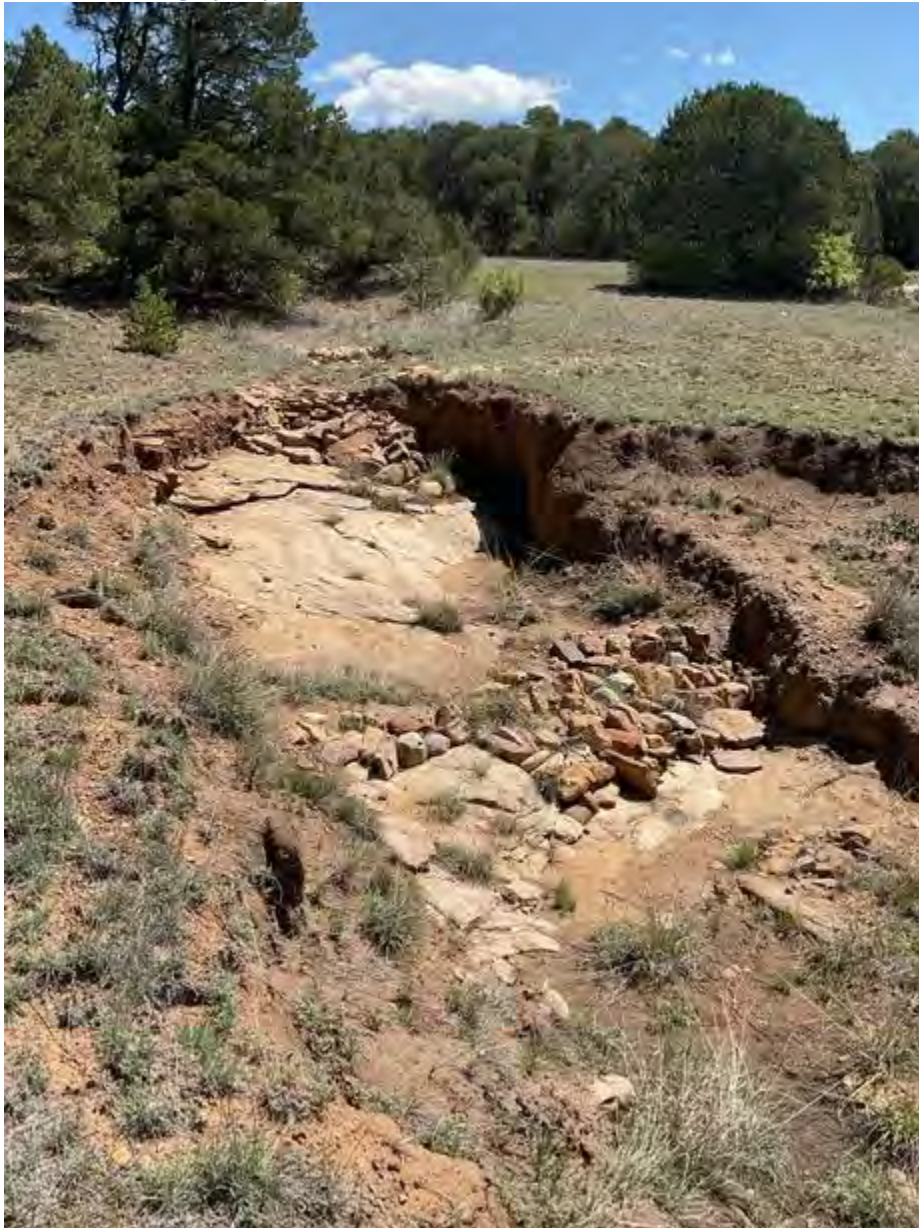
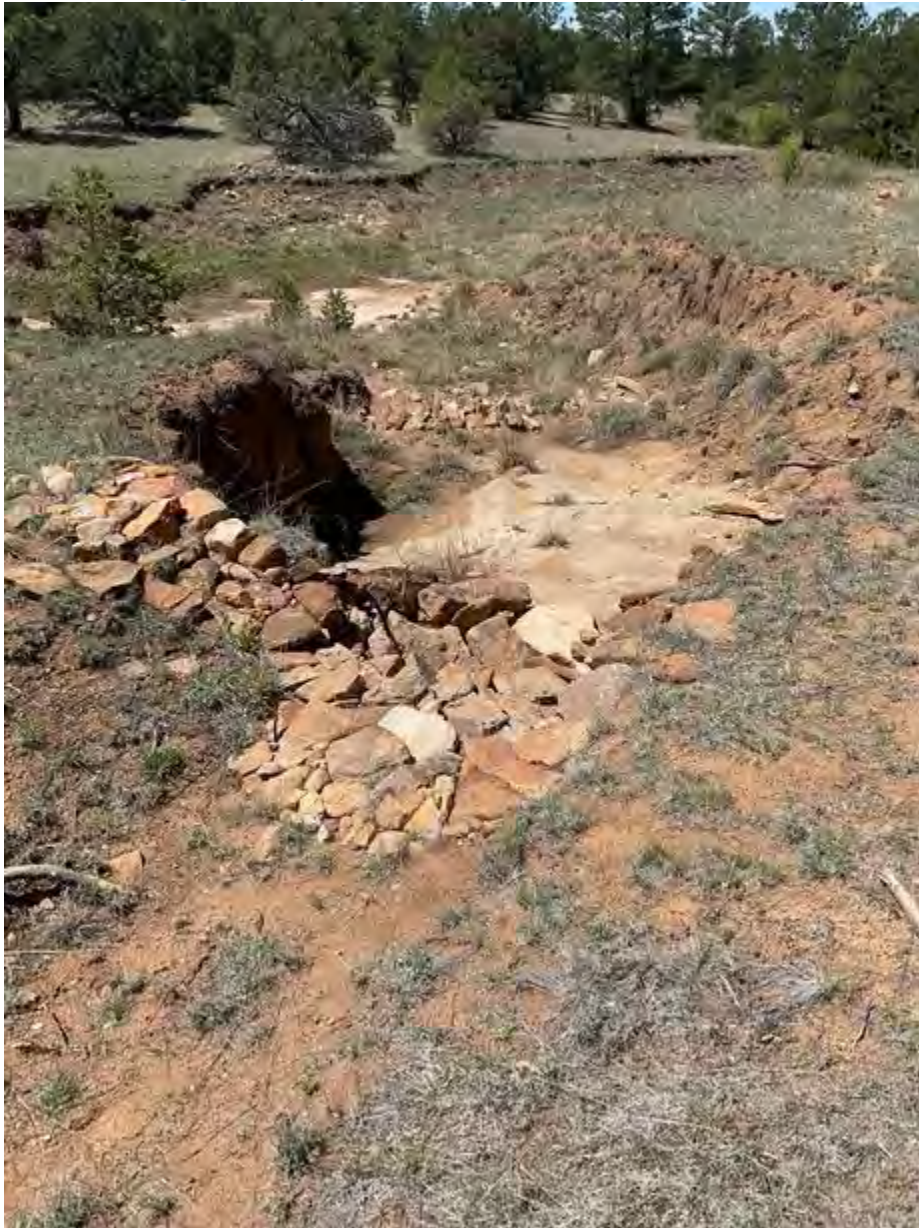
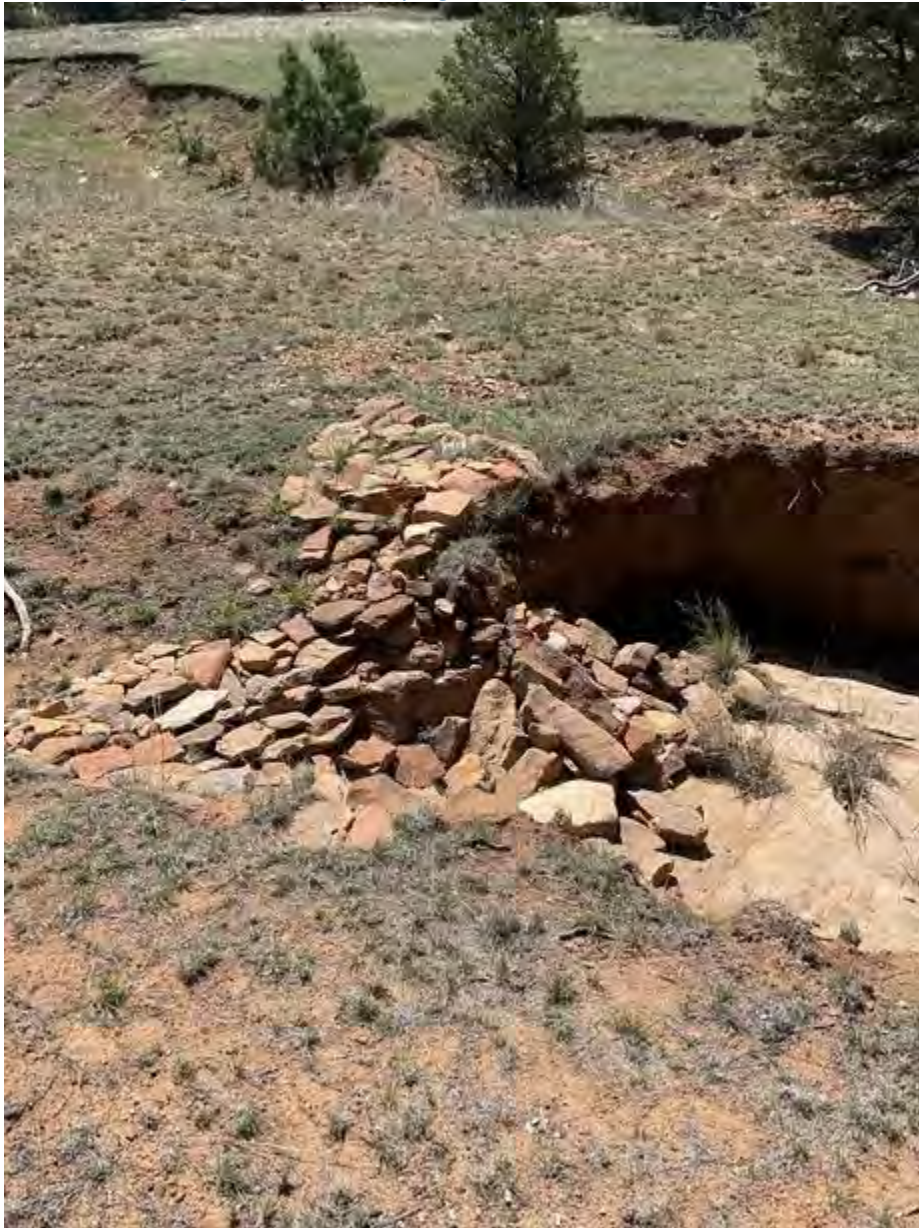
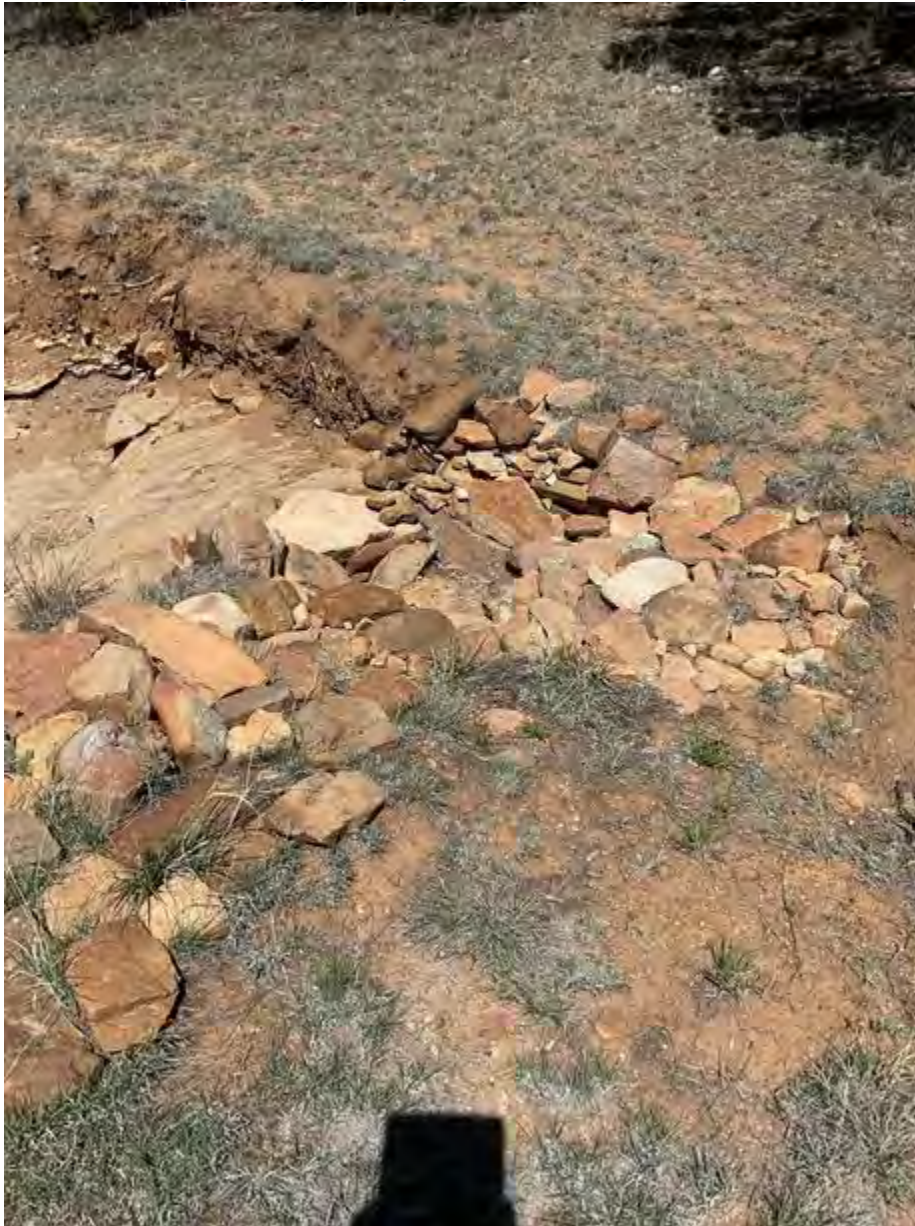
-105.0570489 35.83039503

All rocks intact

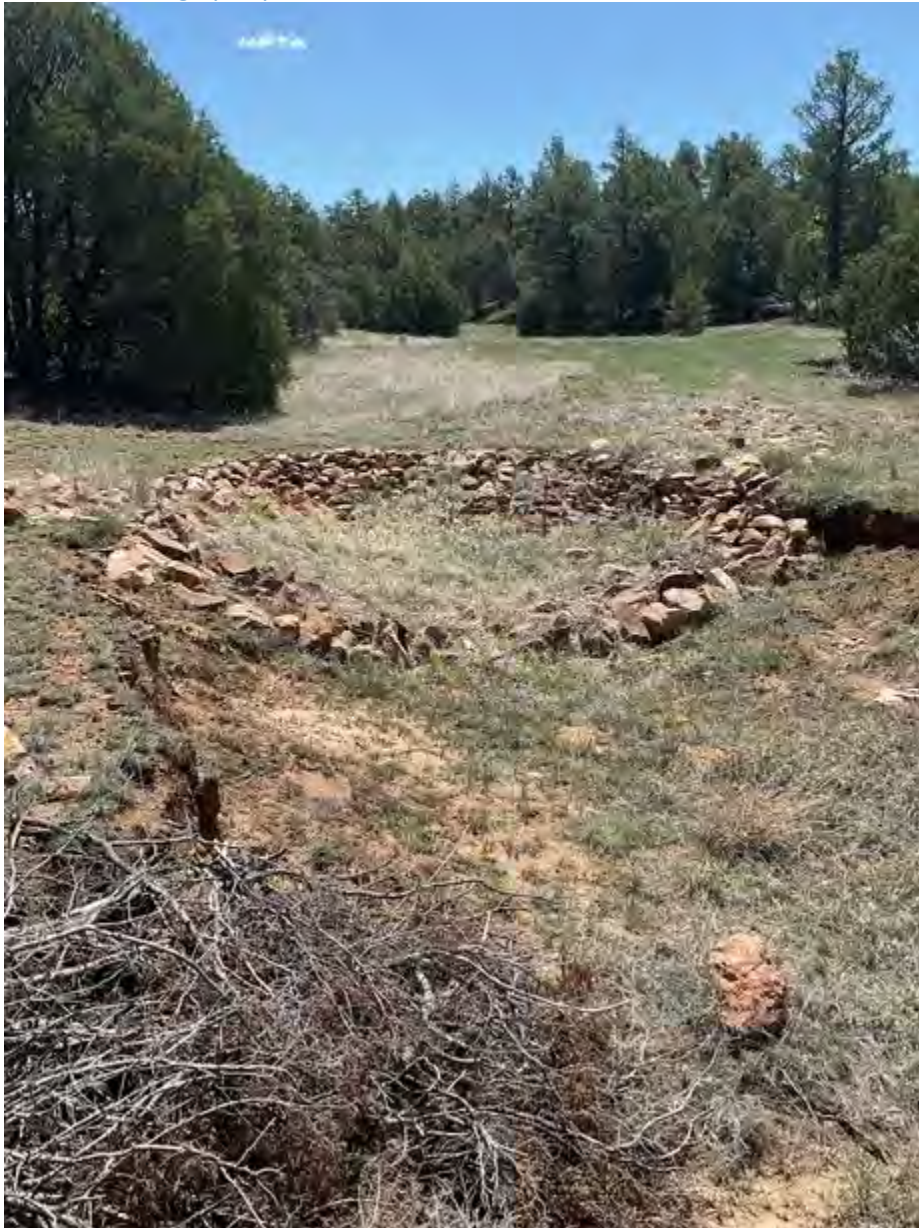
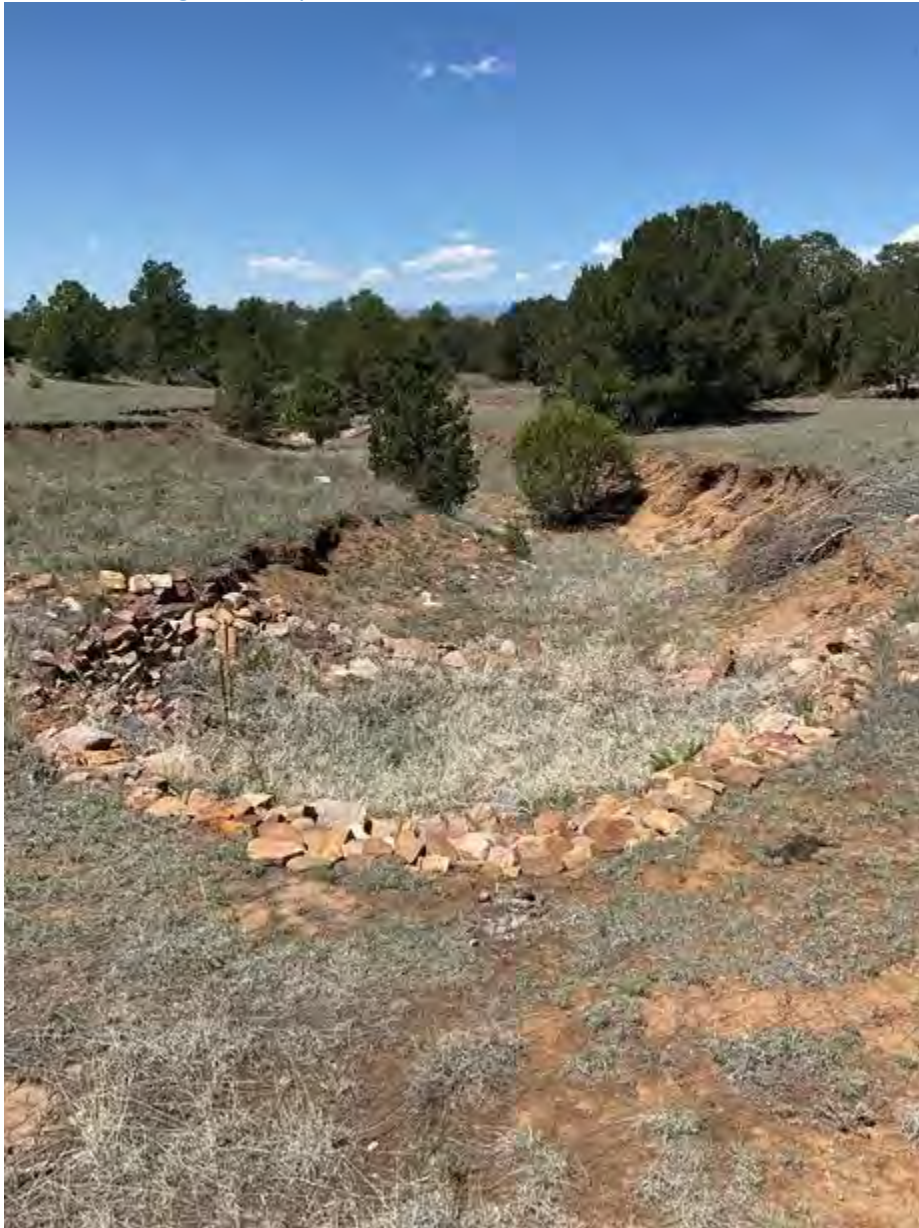
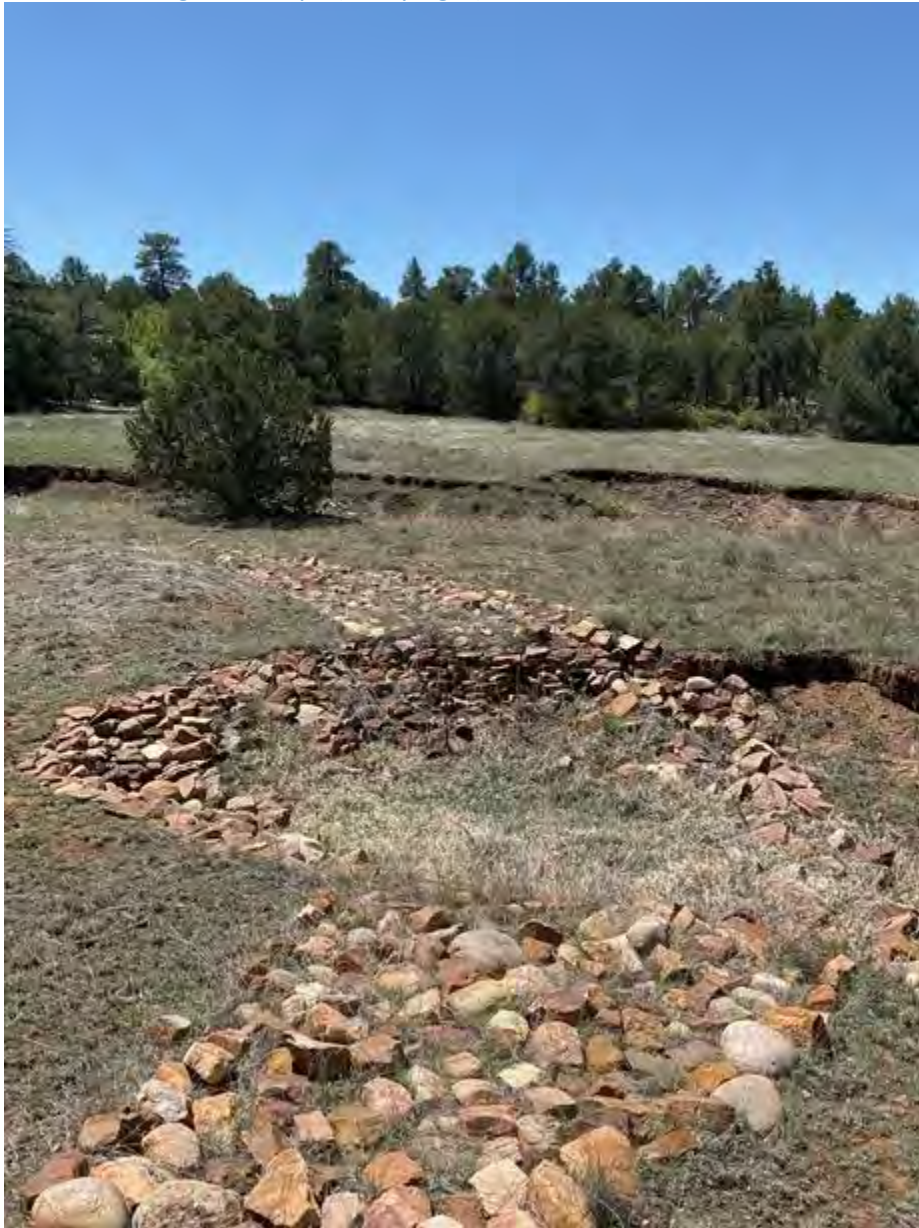
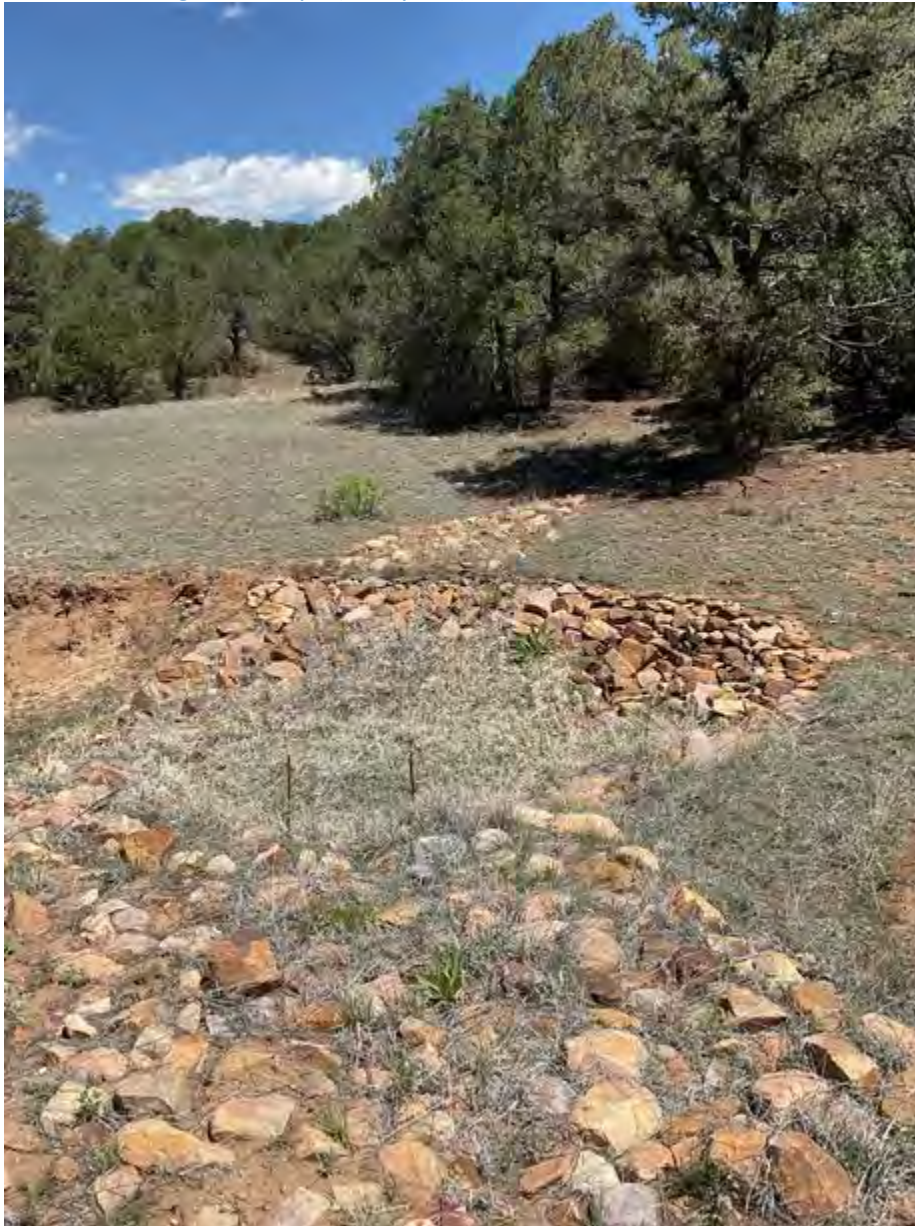
-105.0564703 35.83043095

All rocks intact

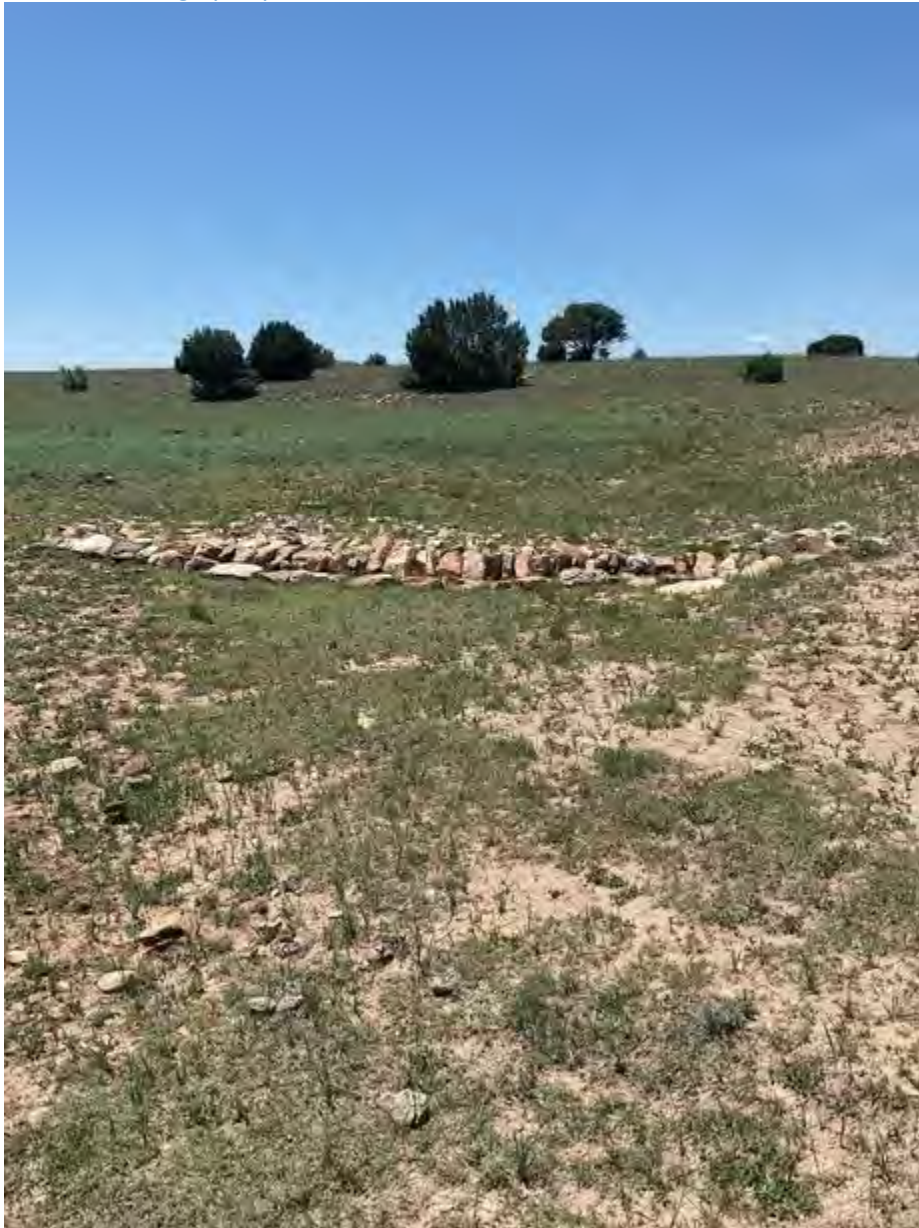
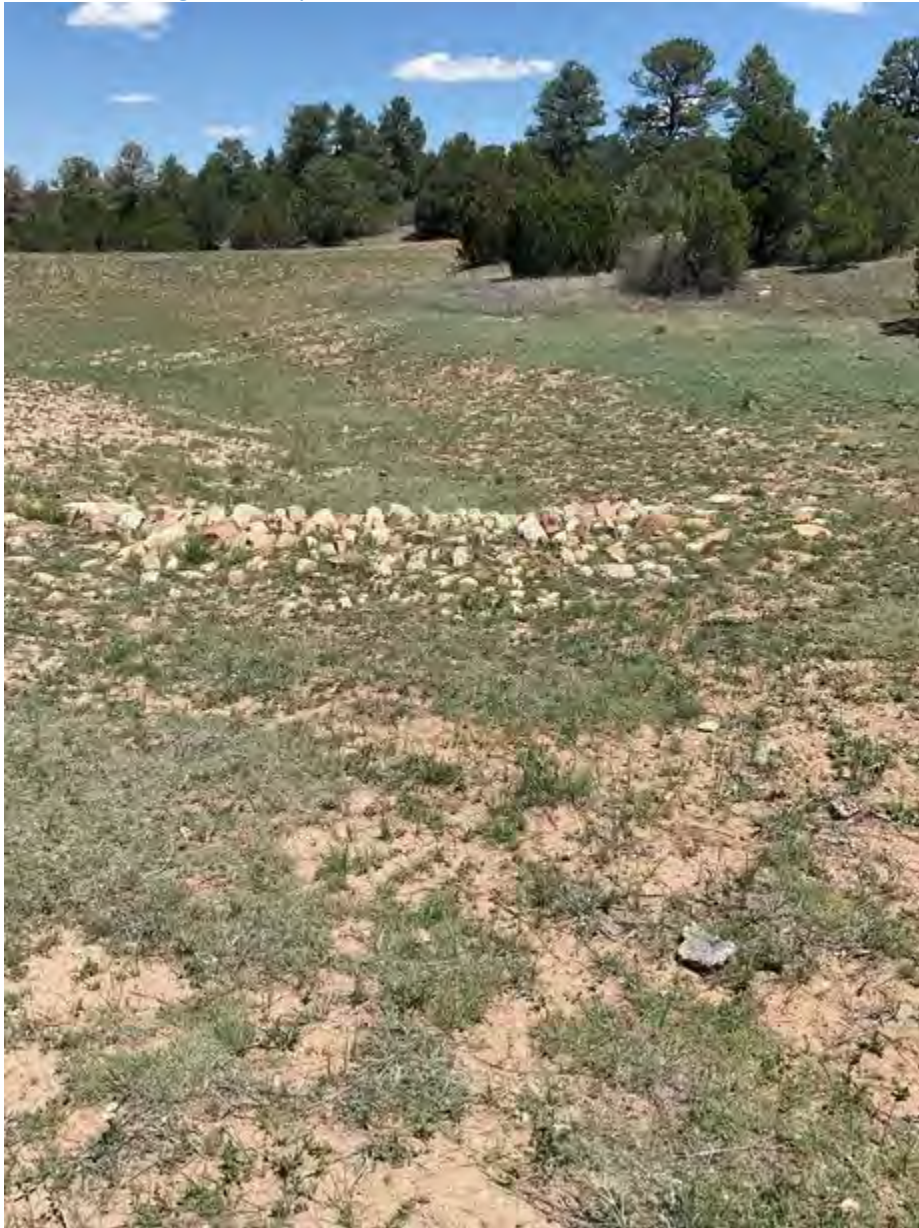
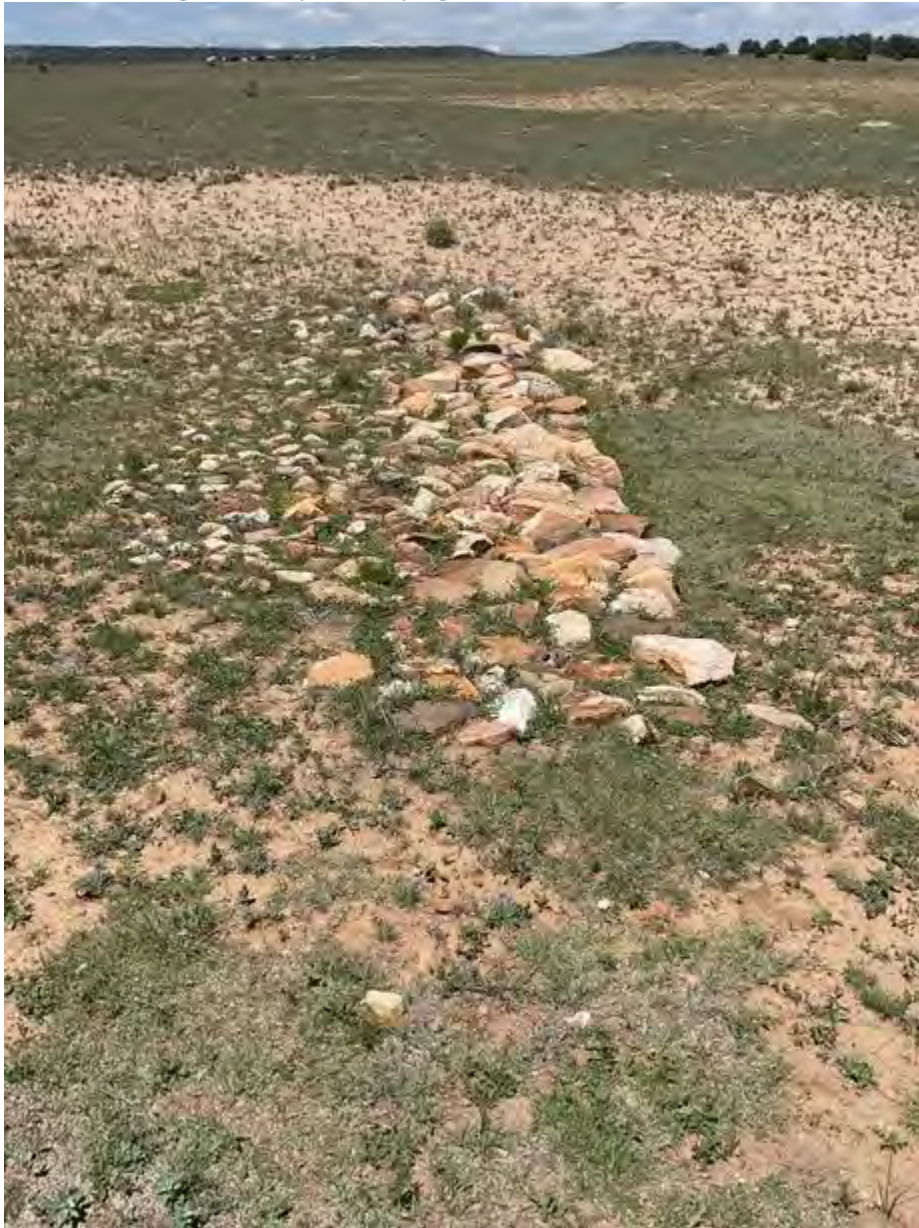
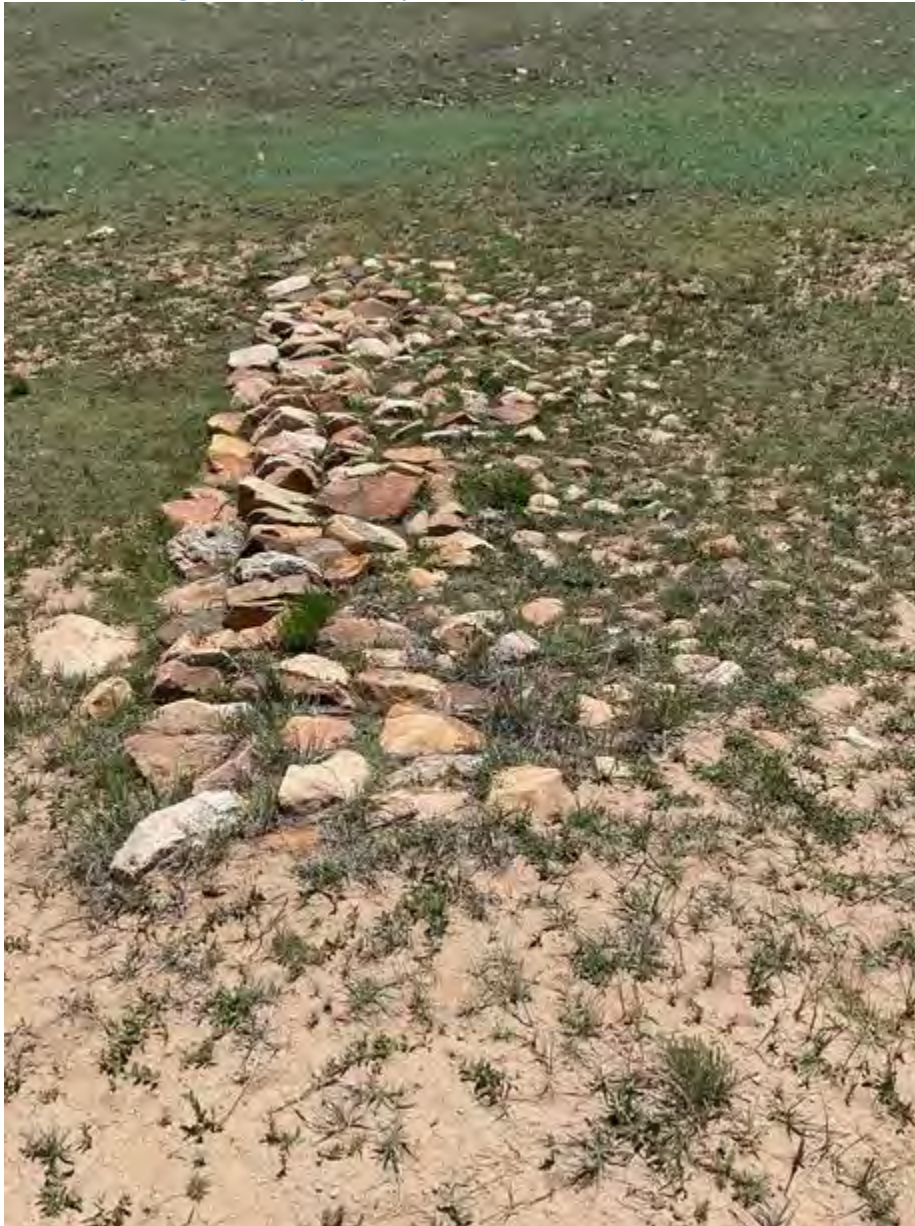
-105.0739468 35.83258072

All rocks intact

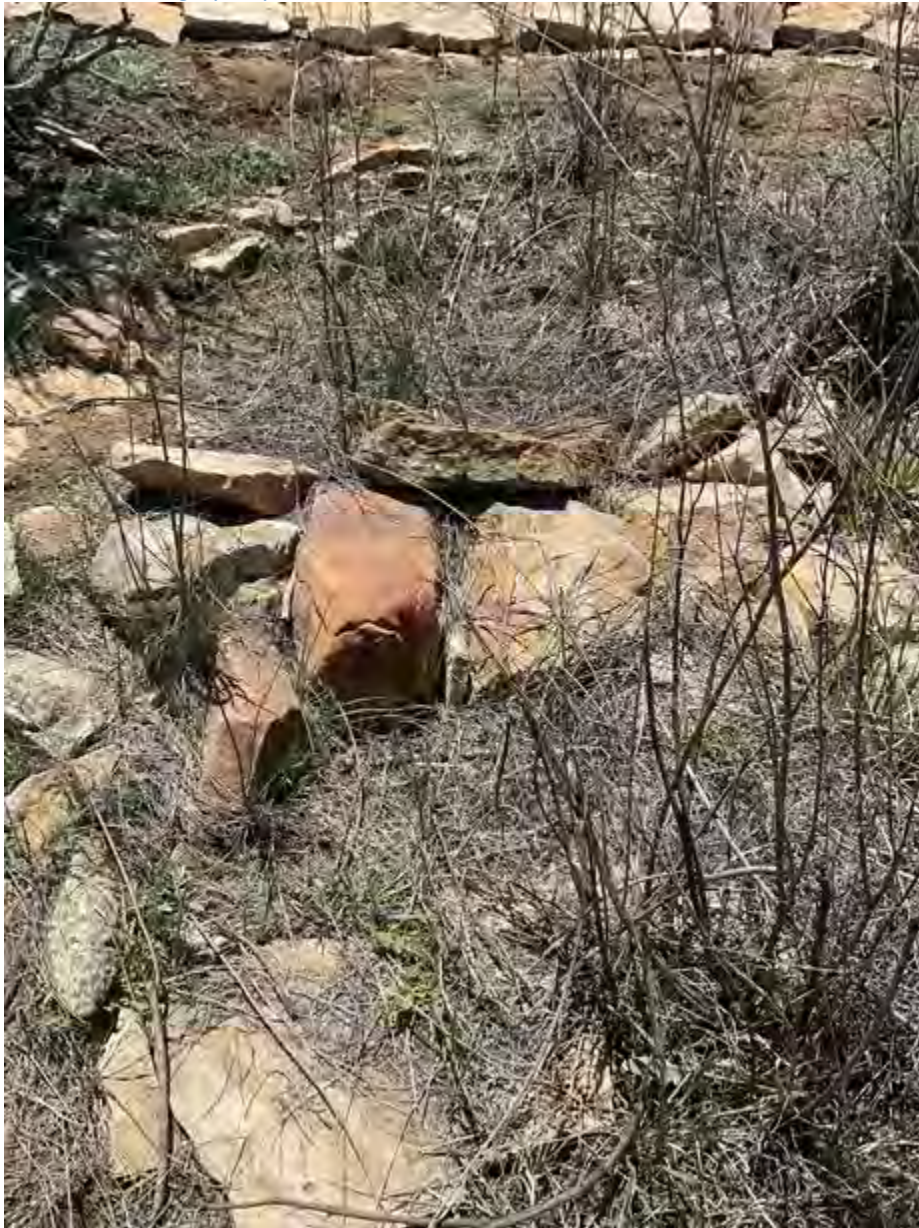
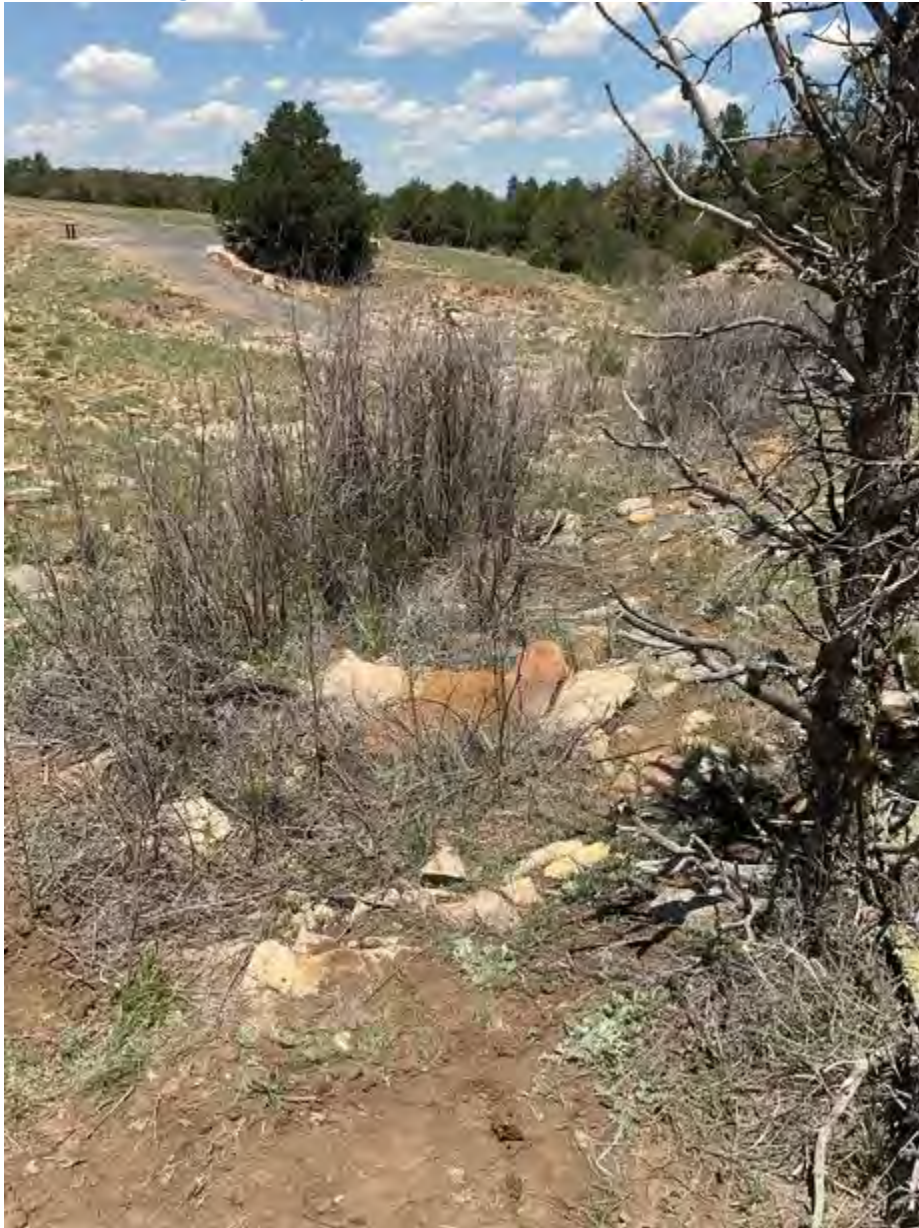
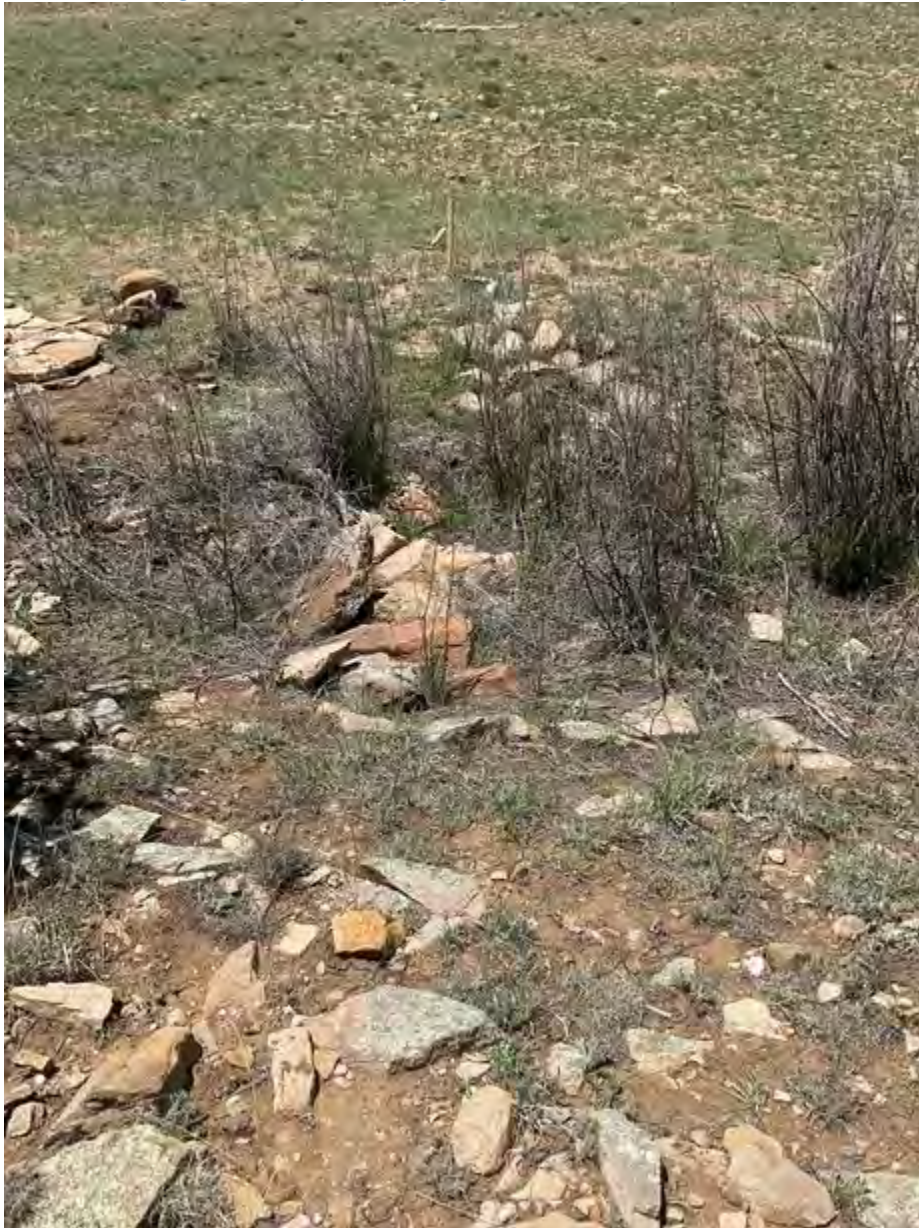
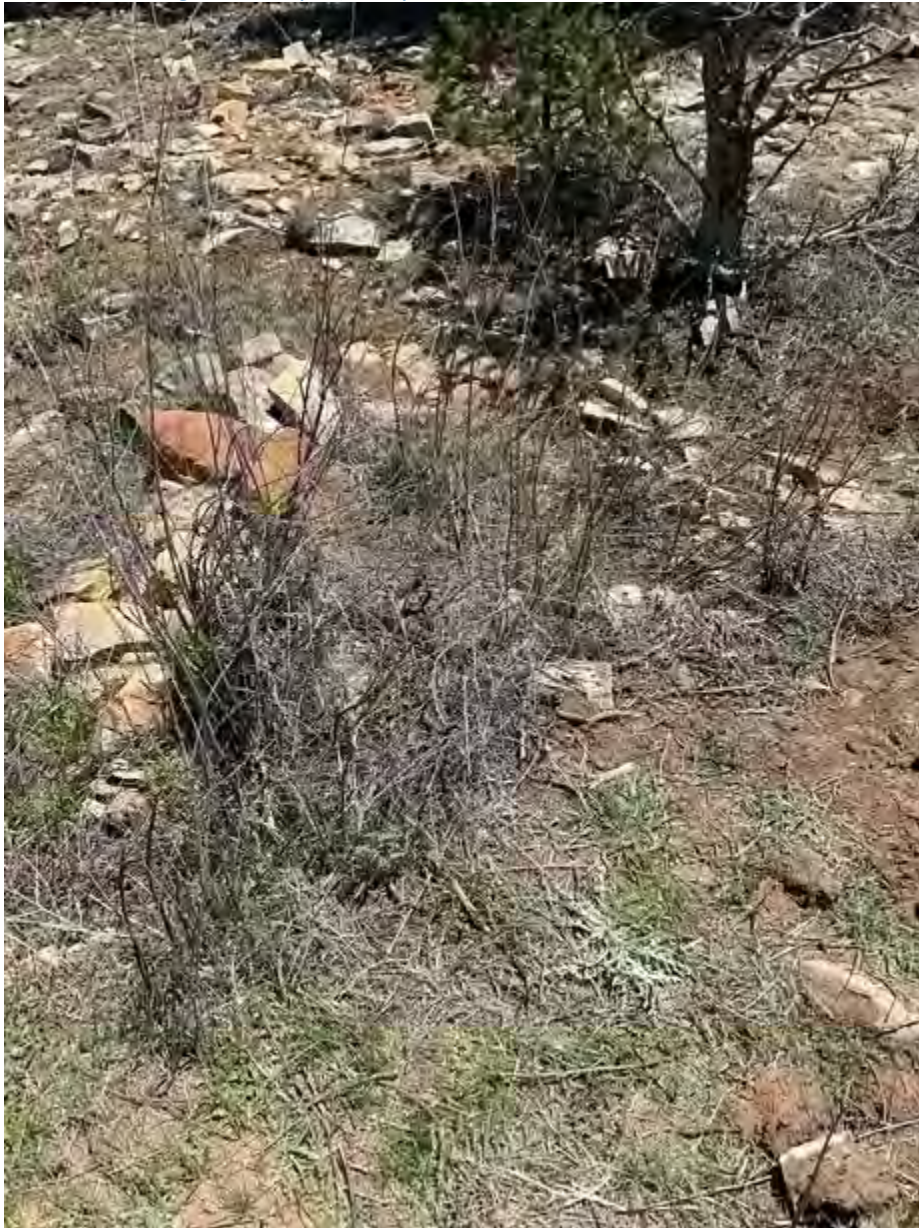
-105.073796 35.83369238

All rocks intact

Difference between ZB and ORD Condition
ORD buried and willow recruitment

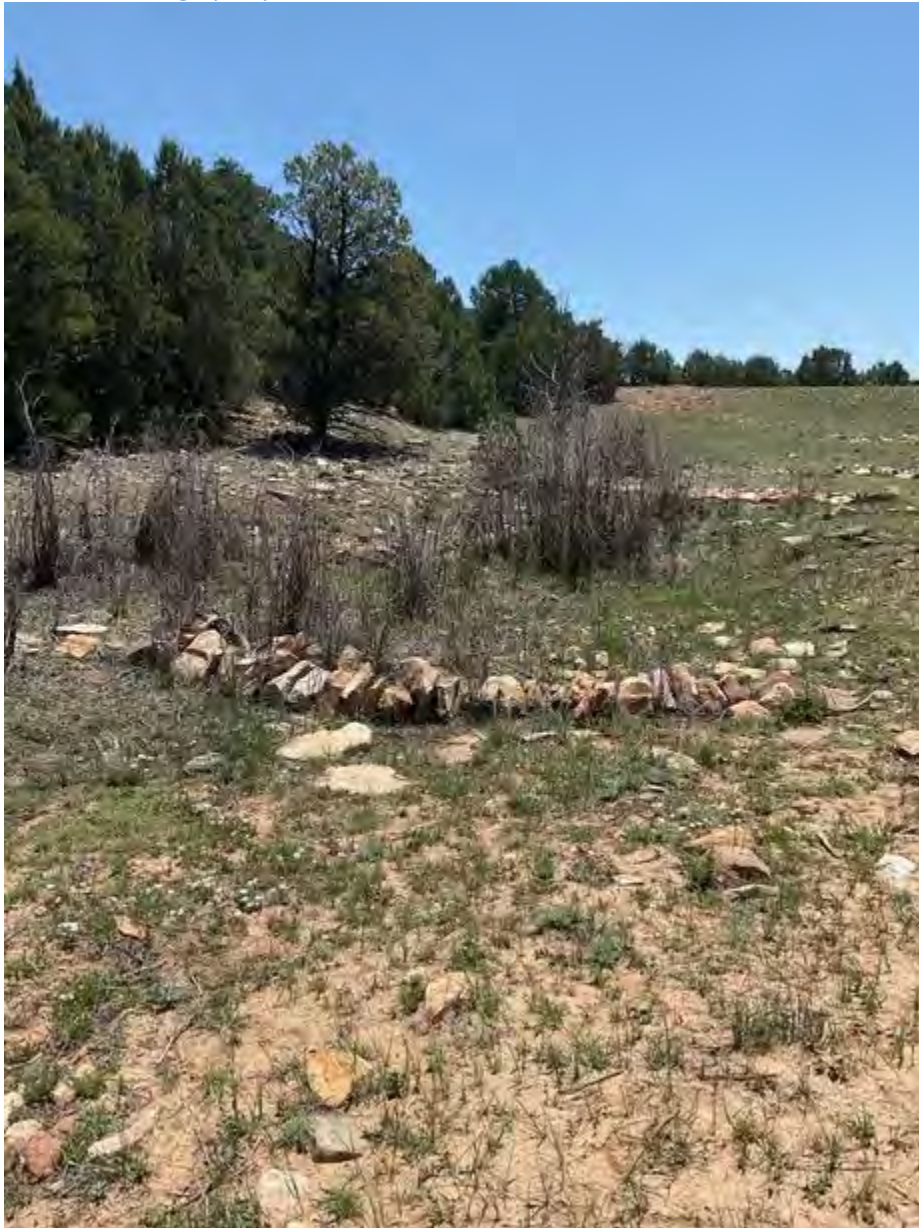
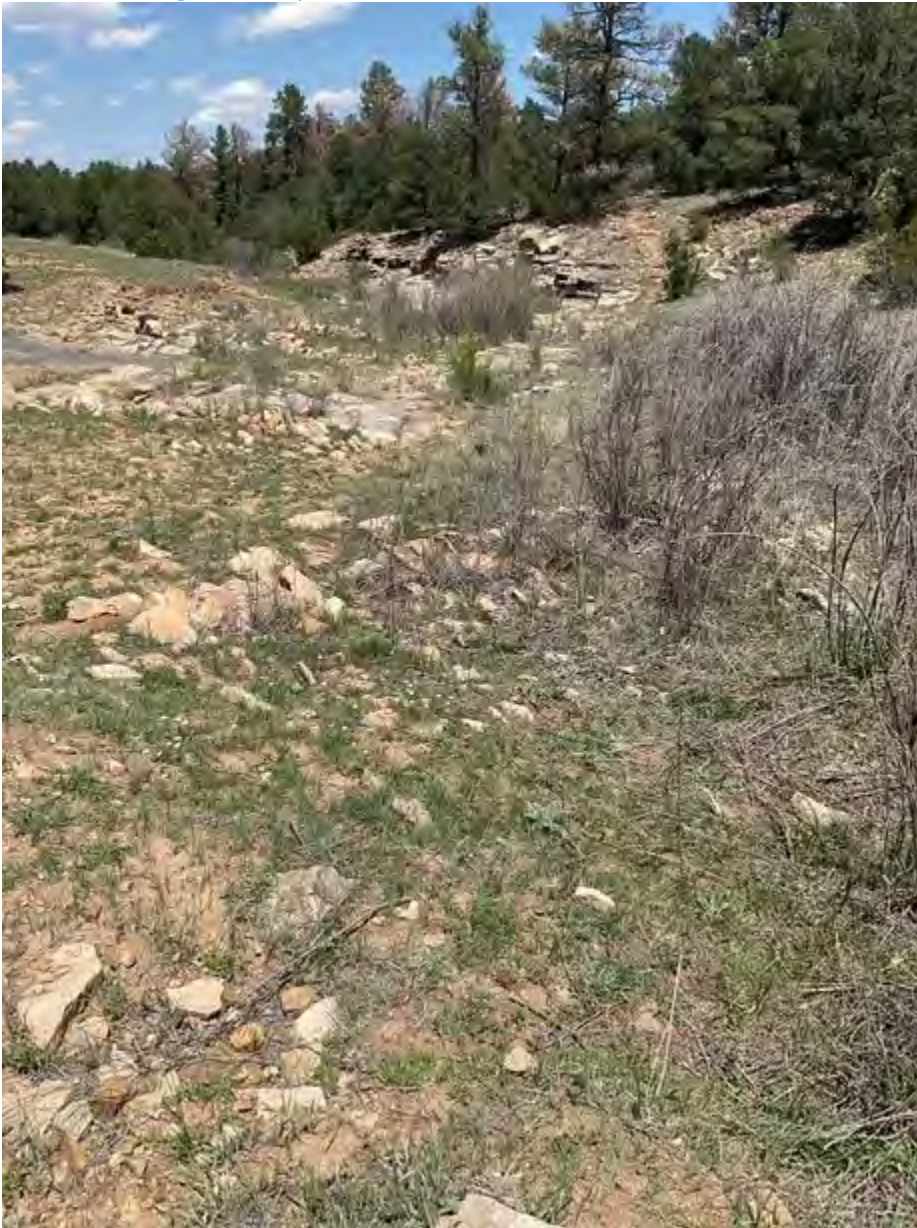
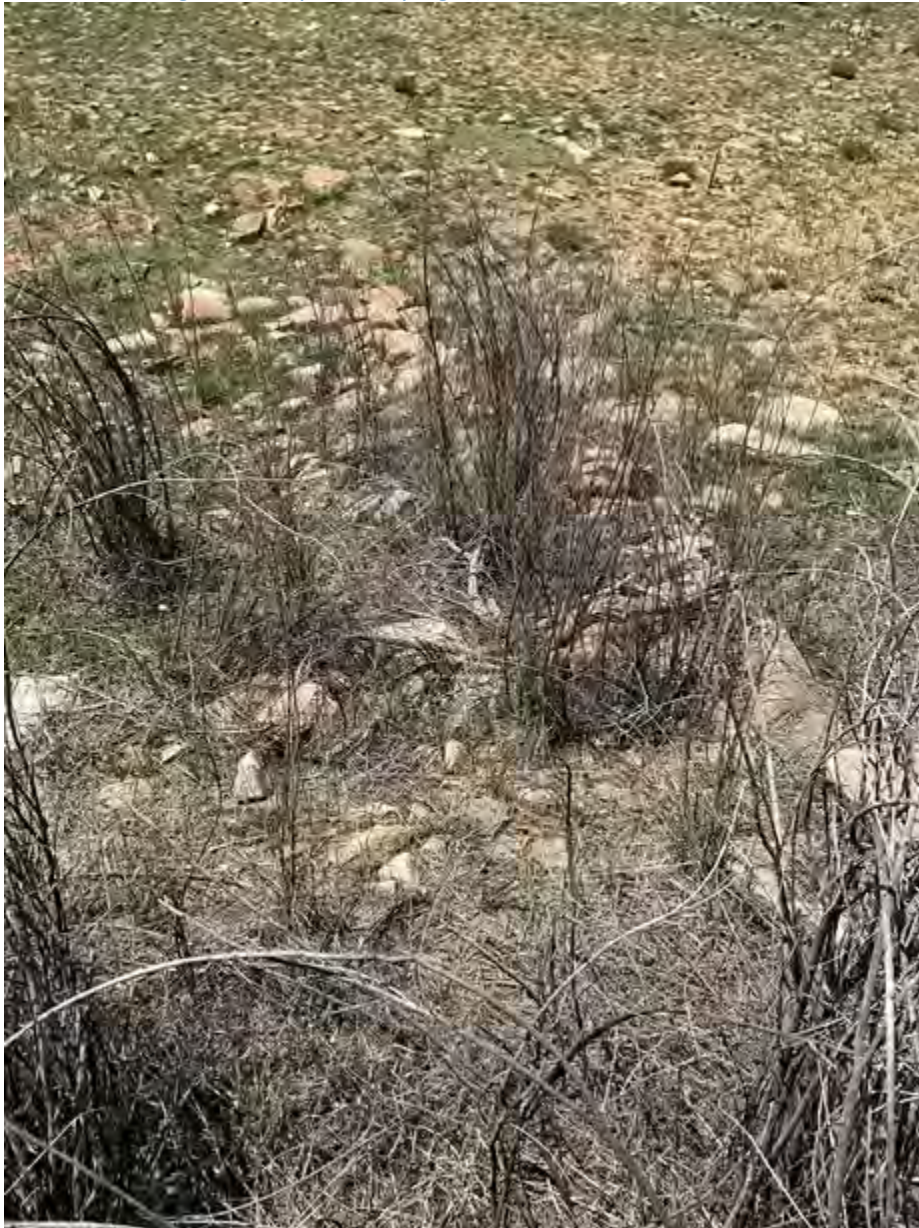
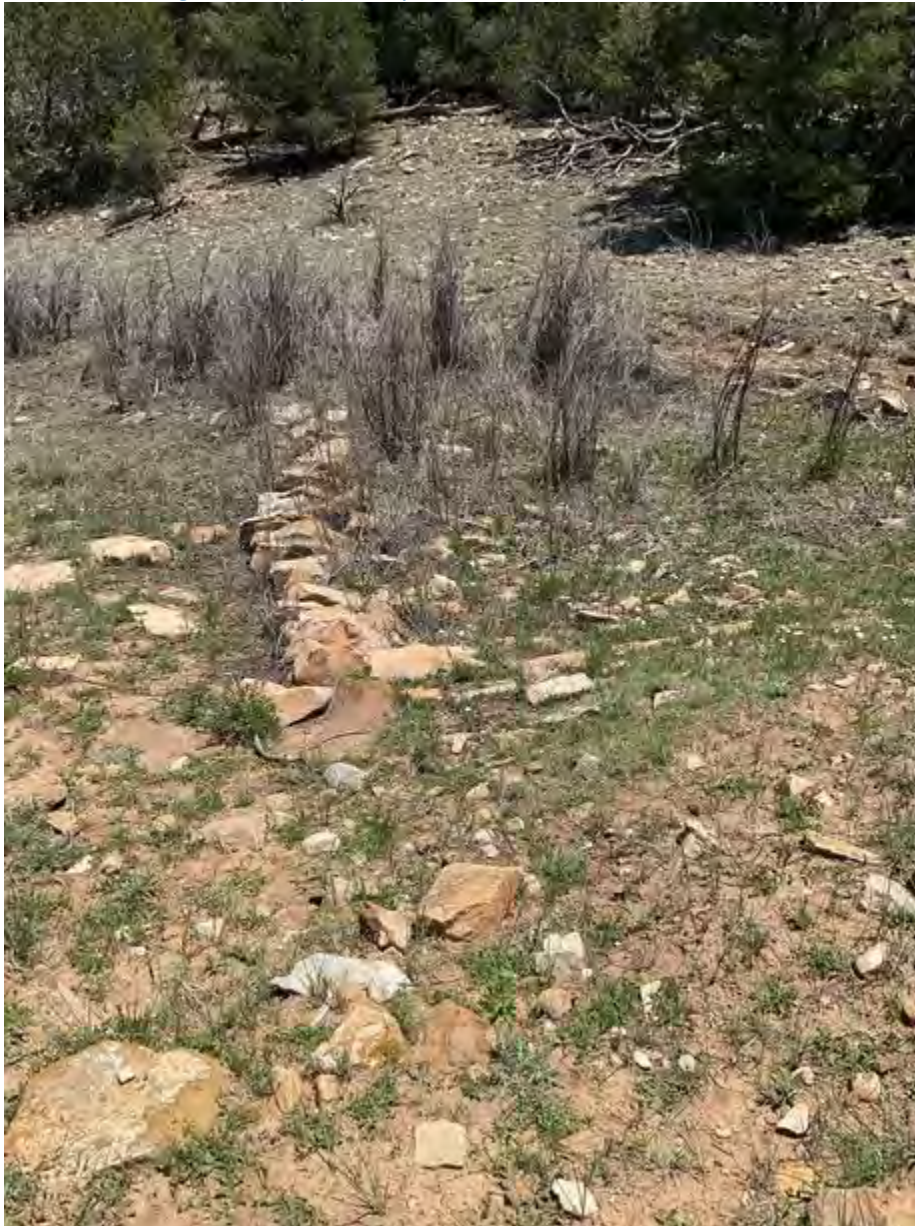
-105.0738315 35.83372785

All rocks intact
