**Zuni Bowl and One Rock Check Dam Research –
Phase 1**

Final Report

December 2024

Rio Grande Return for the New Mexico Department of Transportation Research Bureau

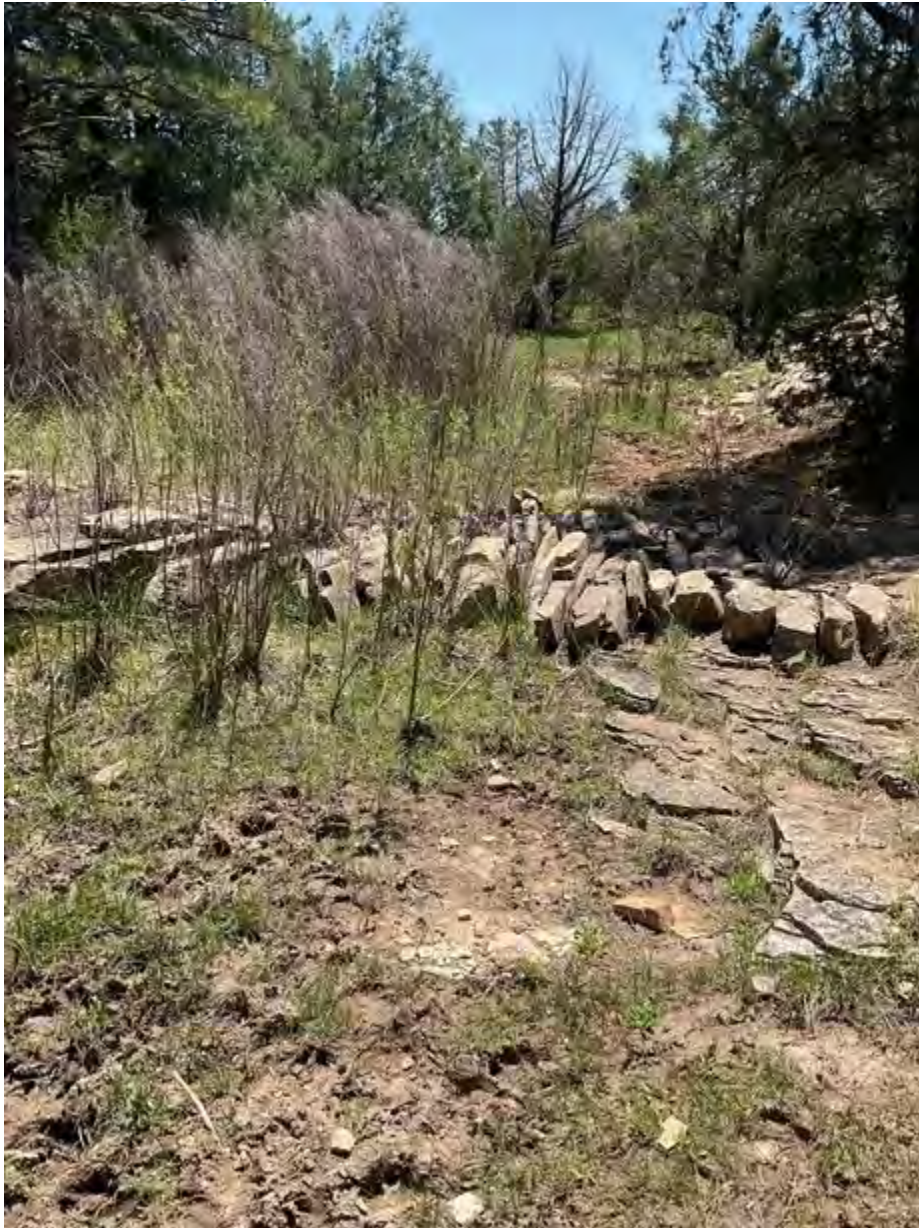
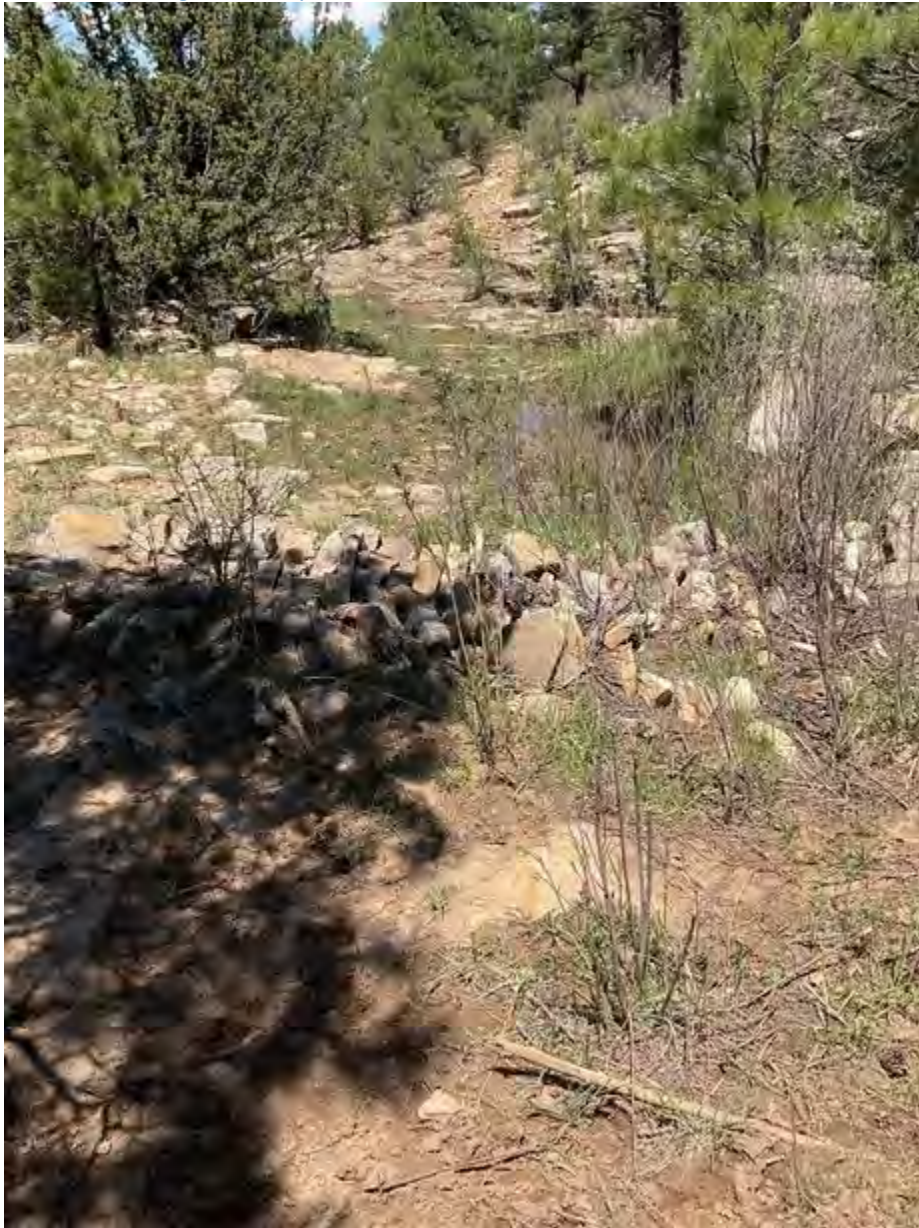
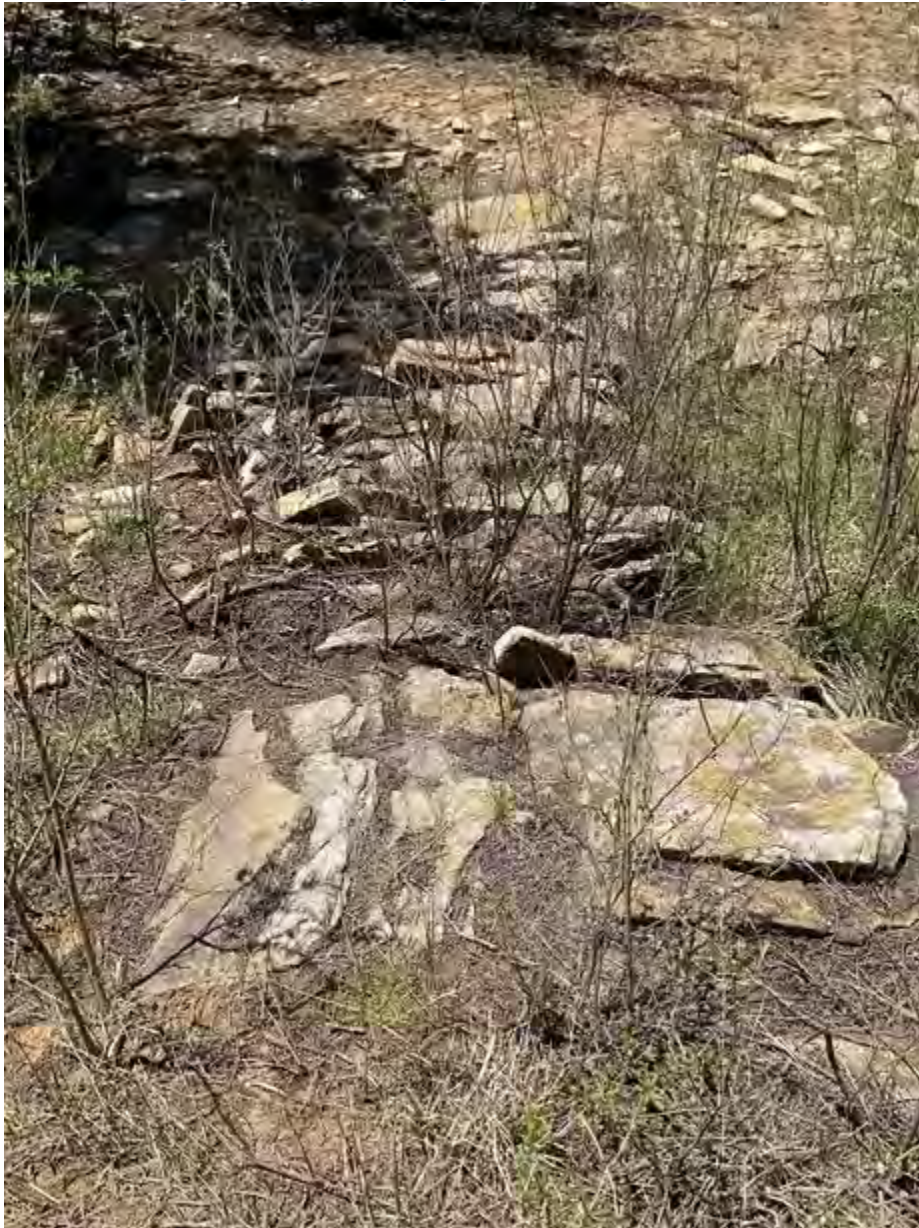
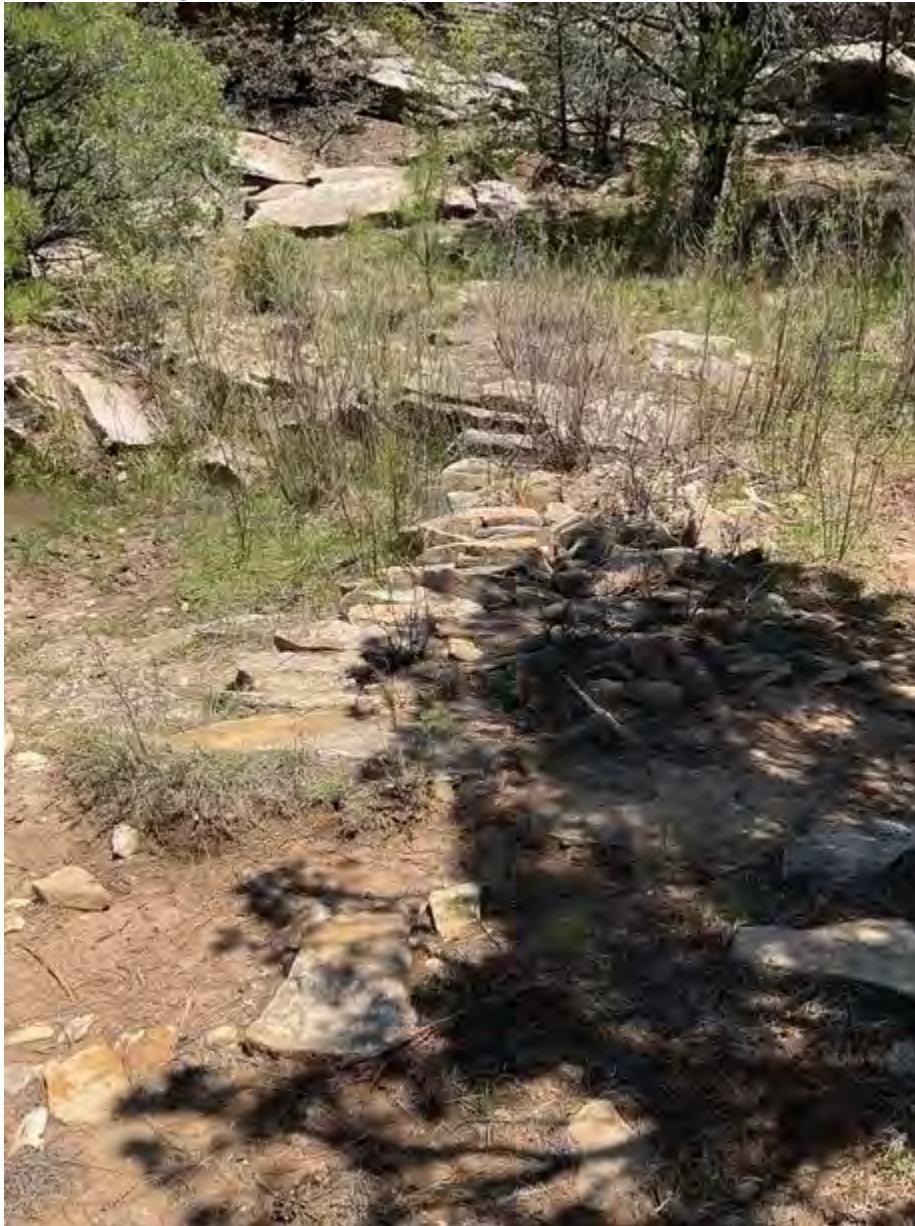
All rocks intact

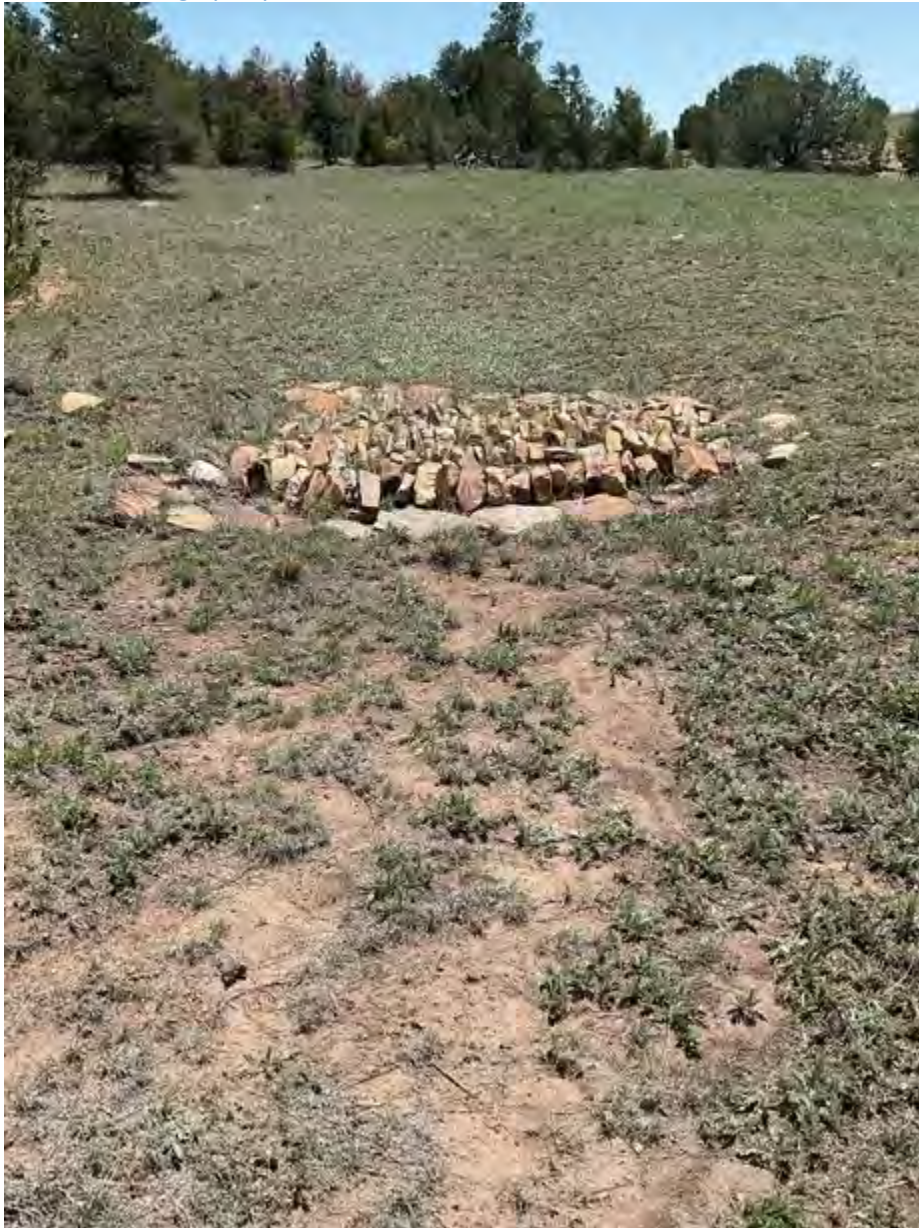
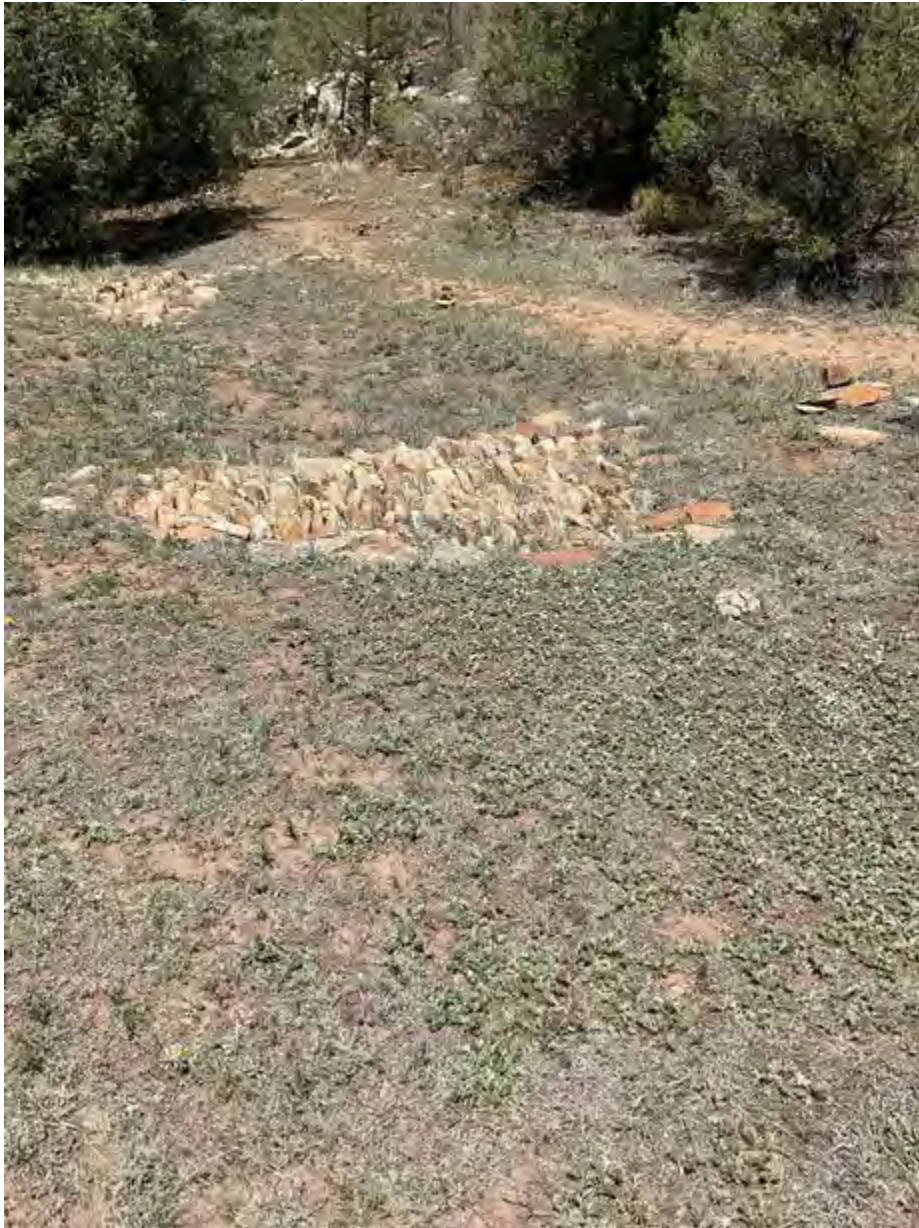
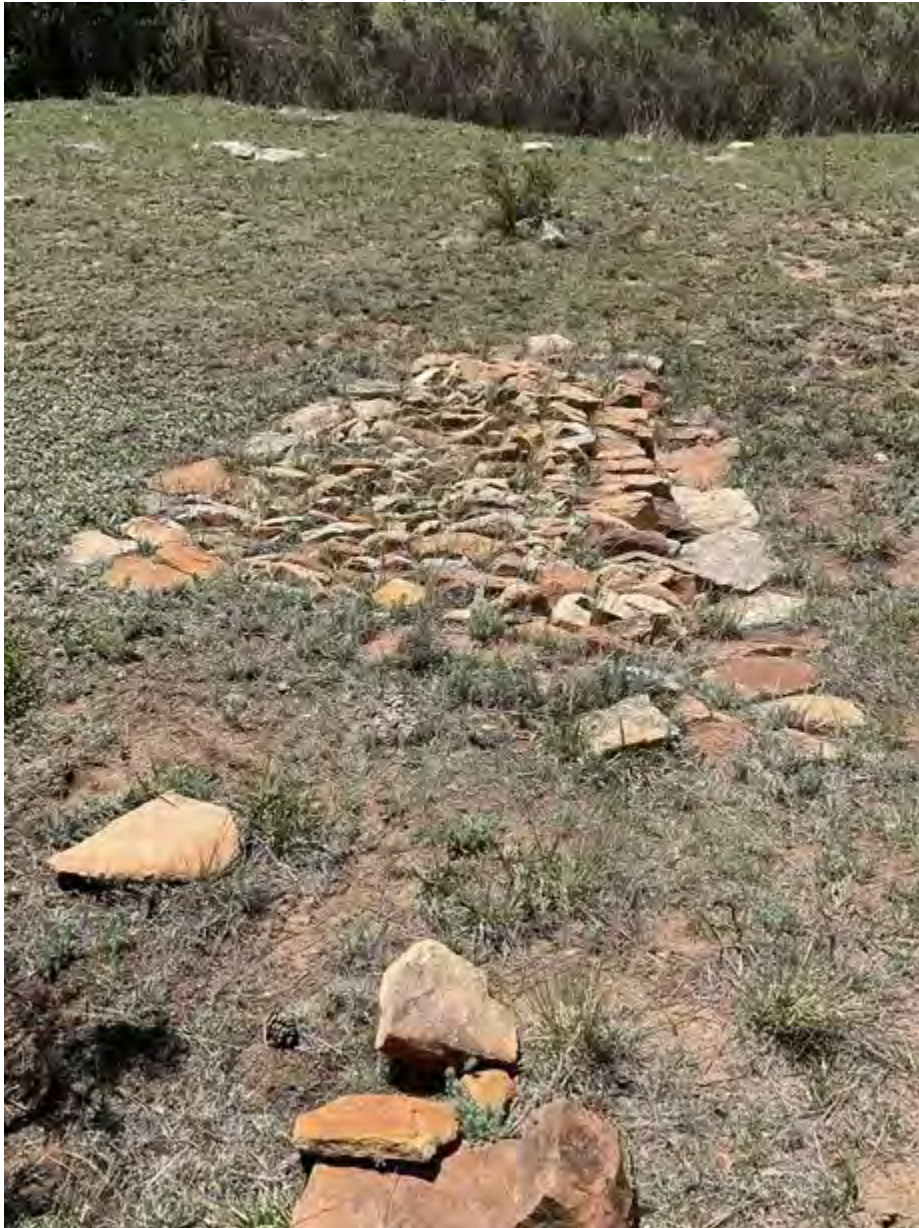
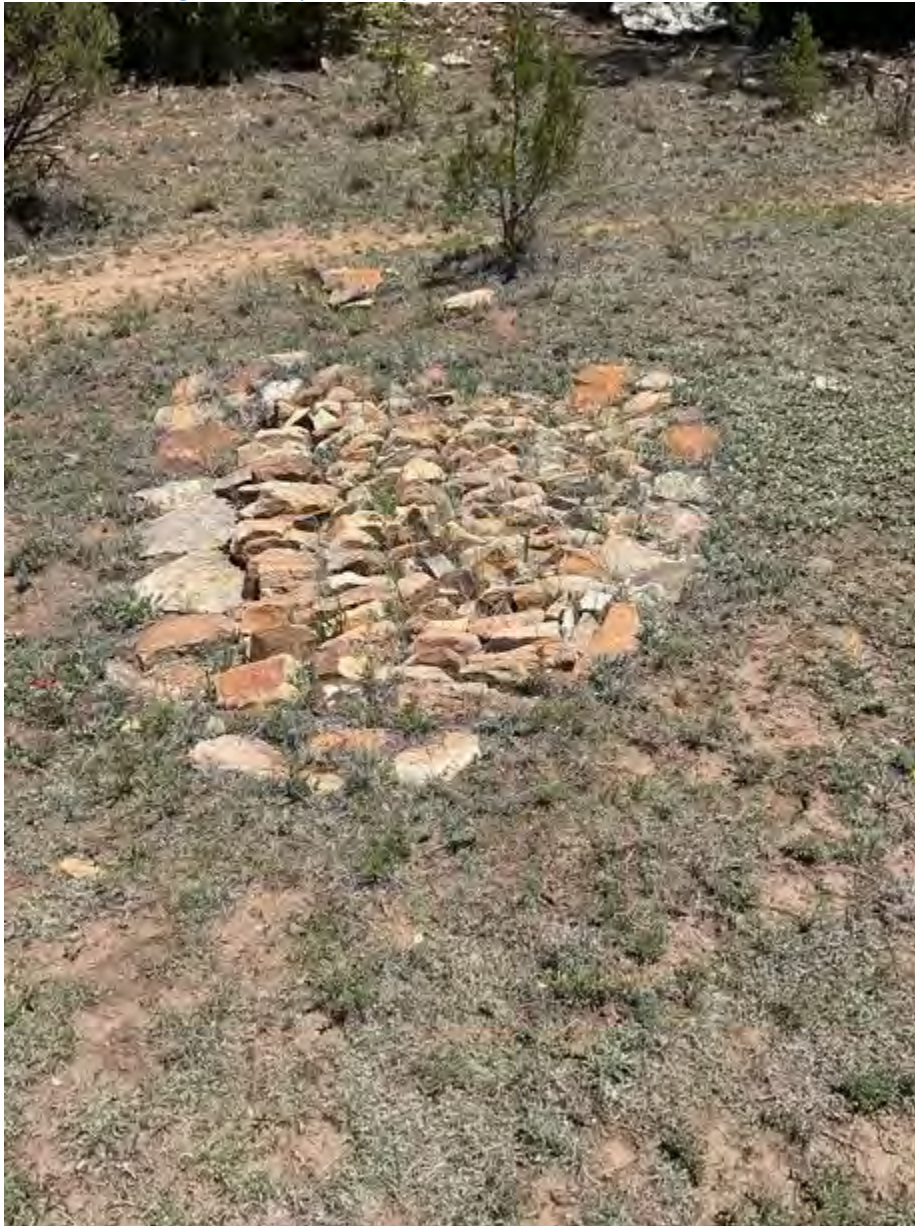
All rocks intact

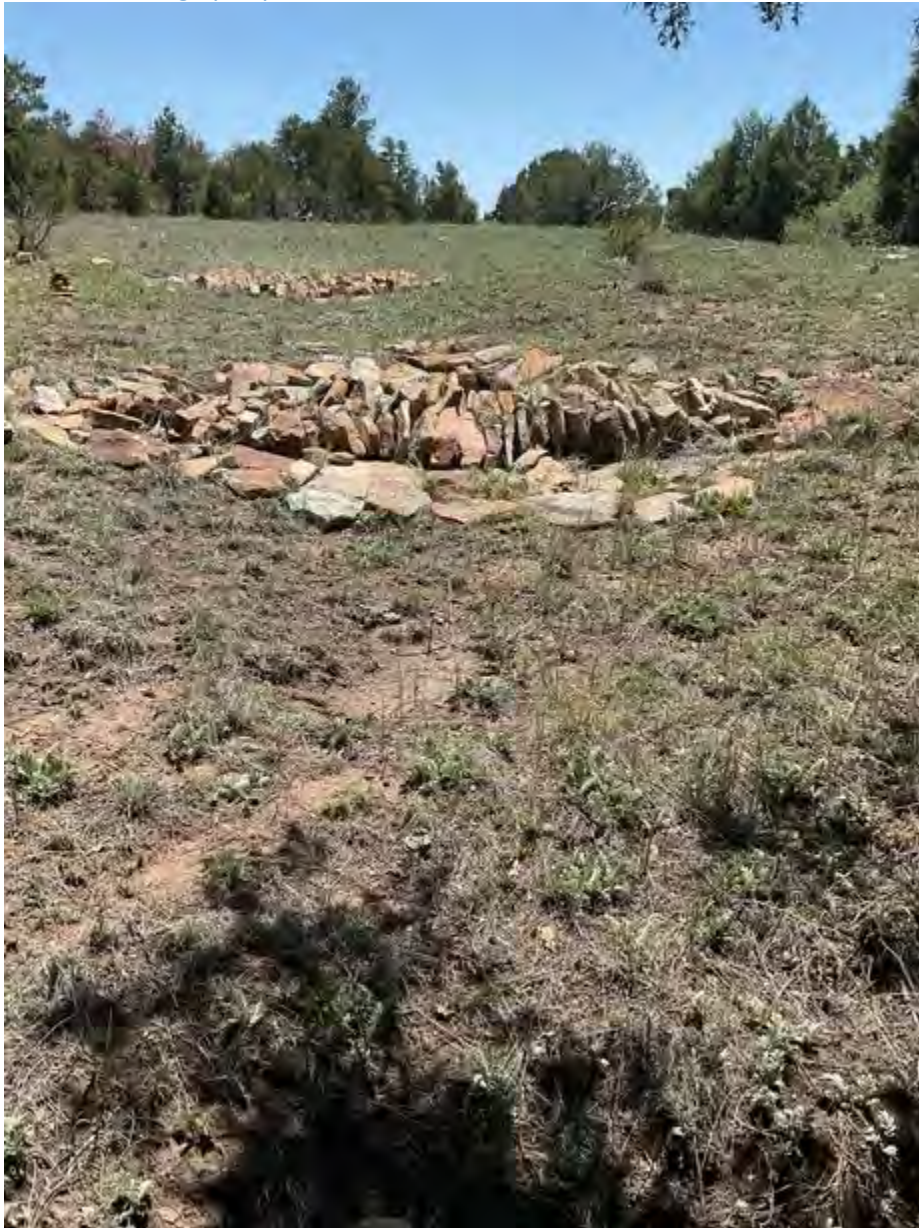
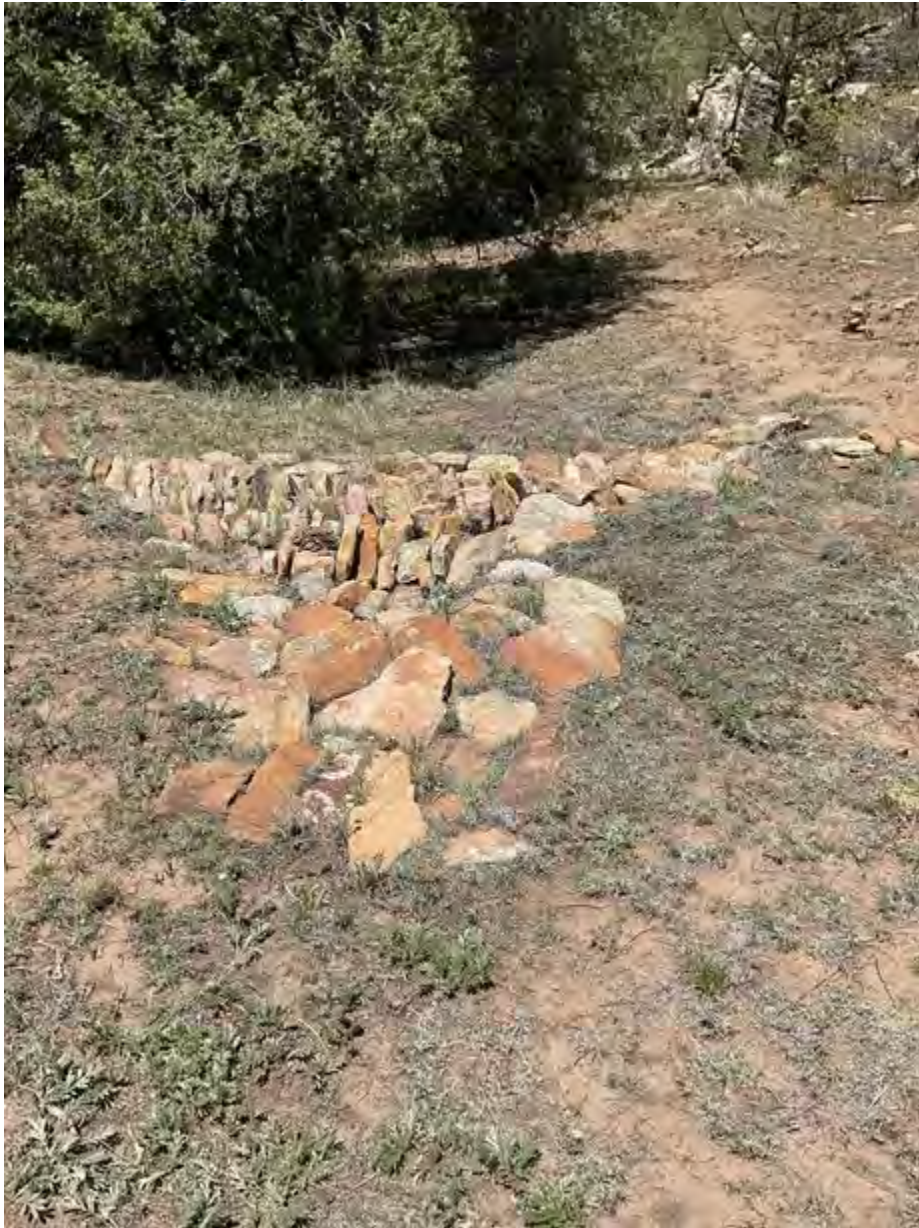
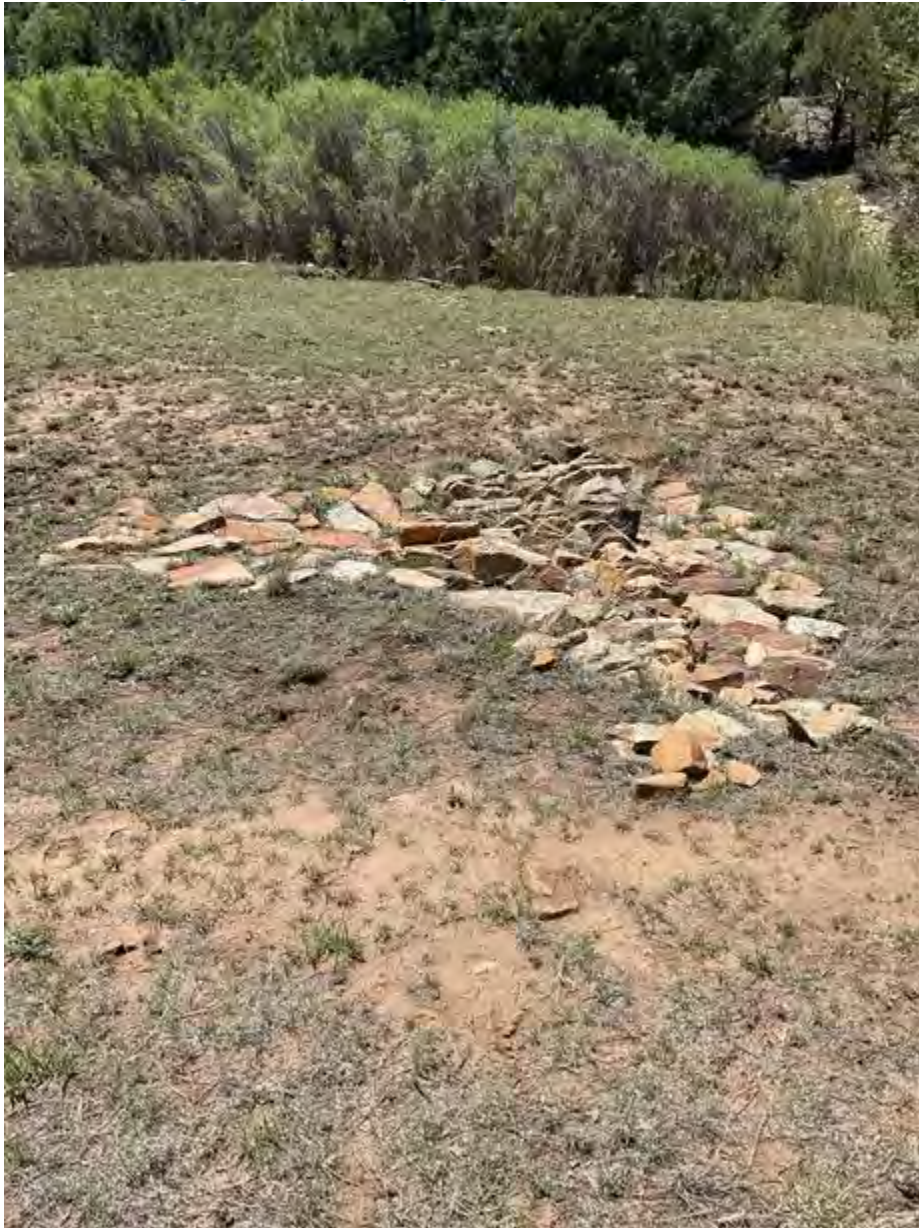
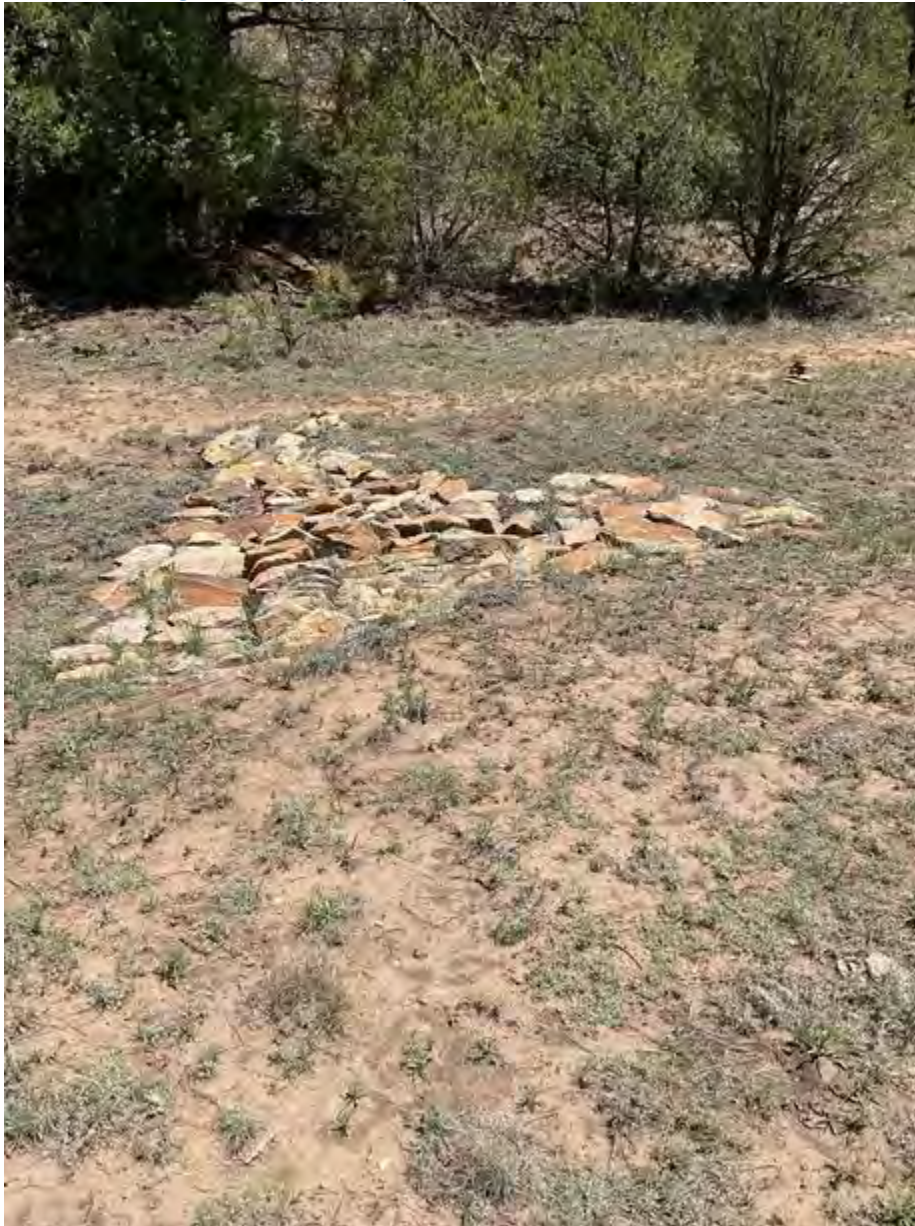
All rocks intact

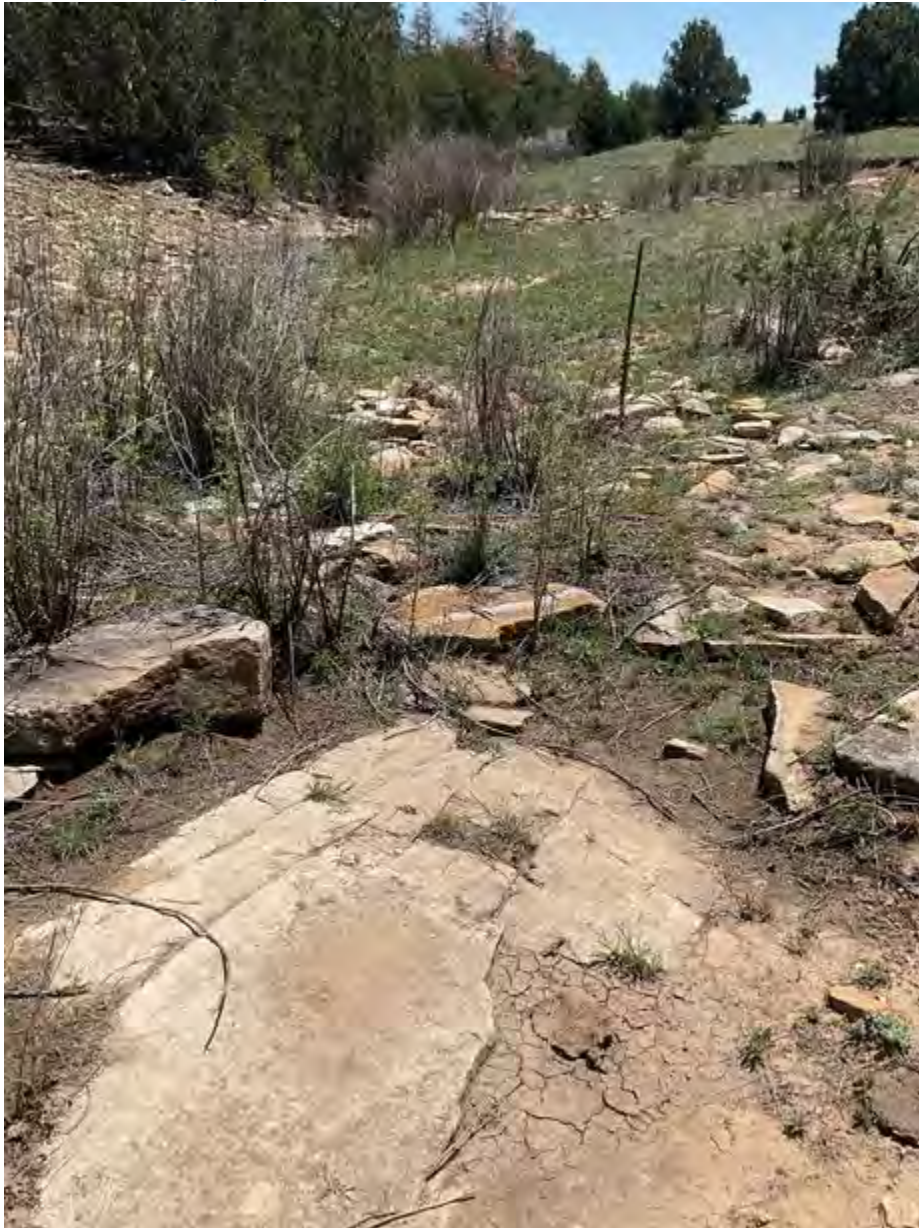
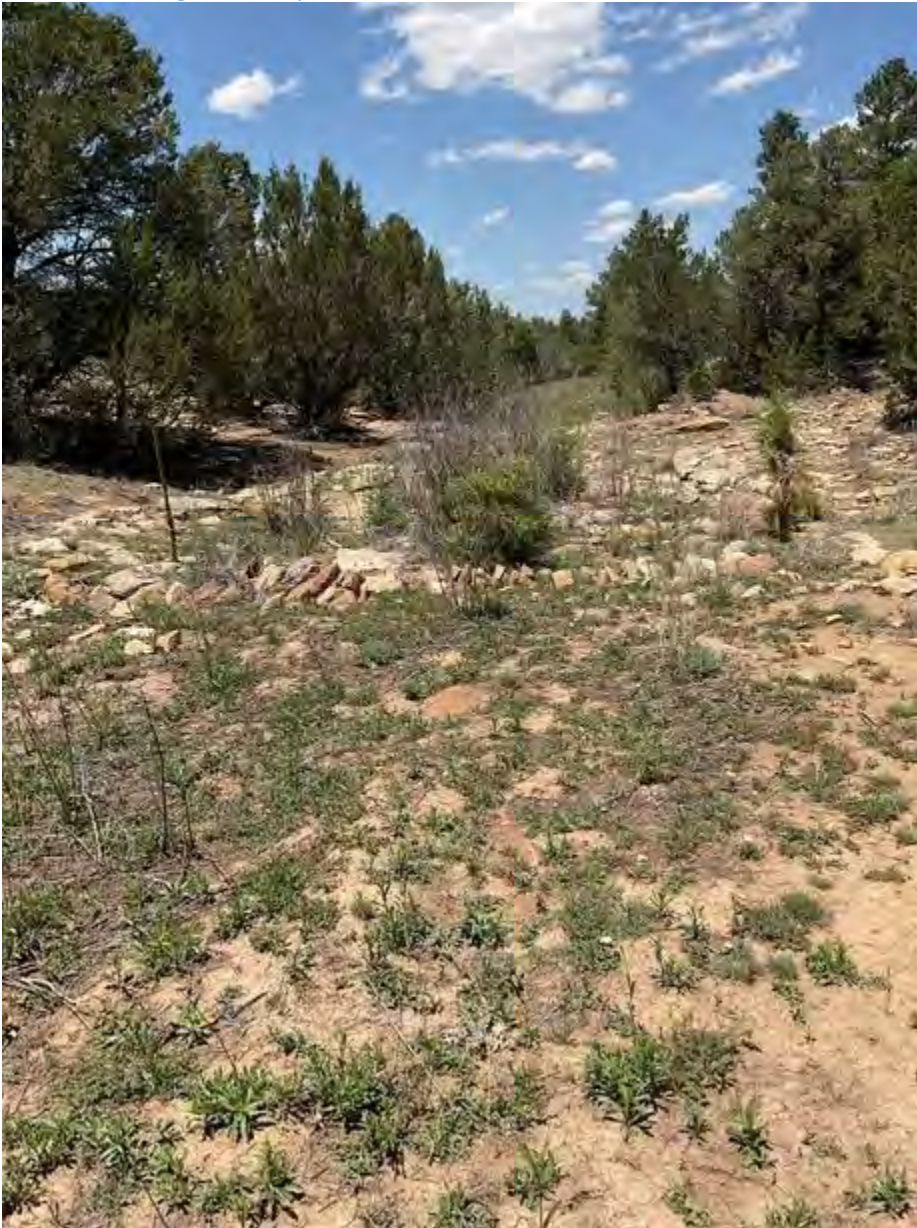
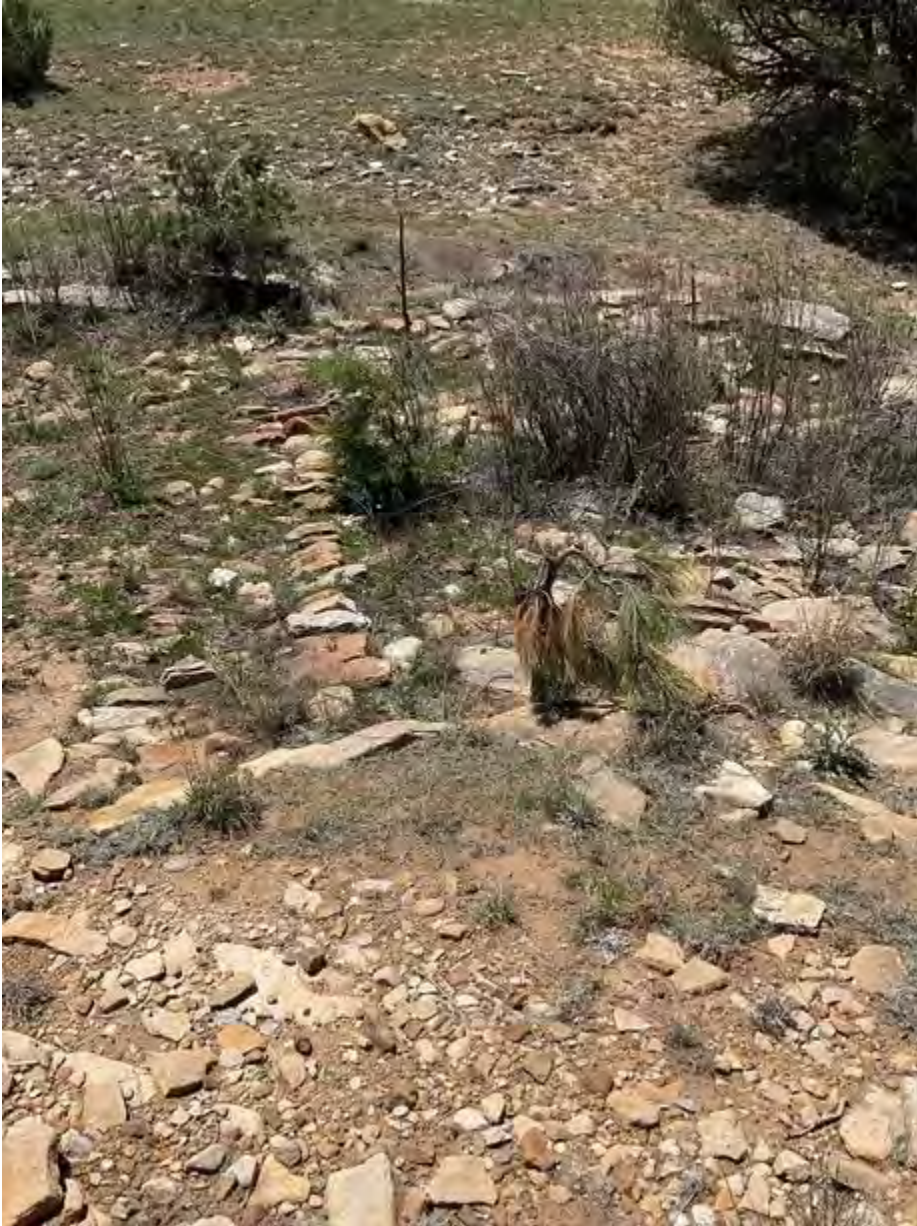
Some rocks dislodged or broken

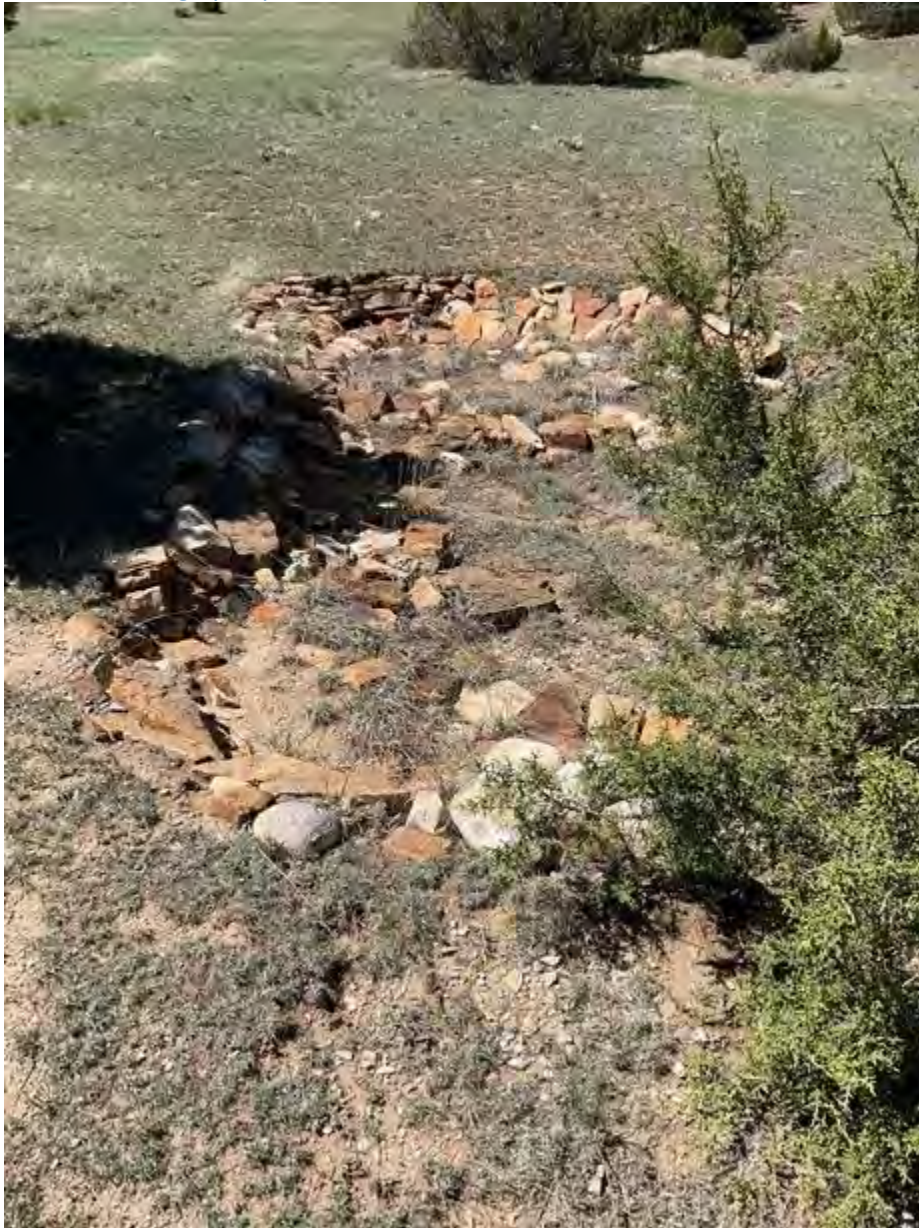
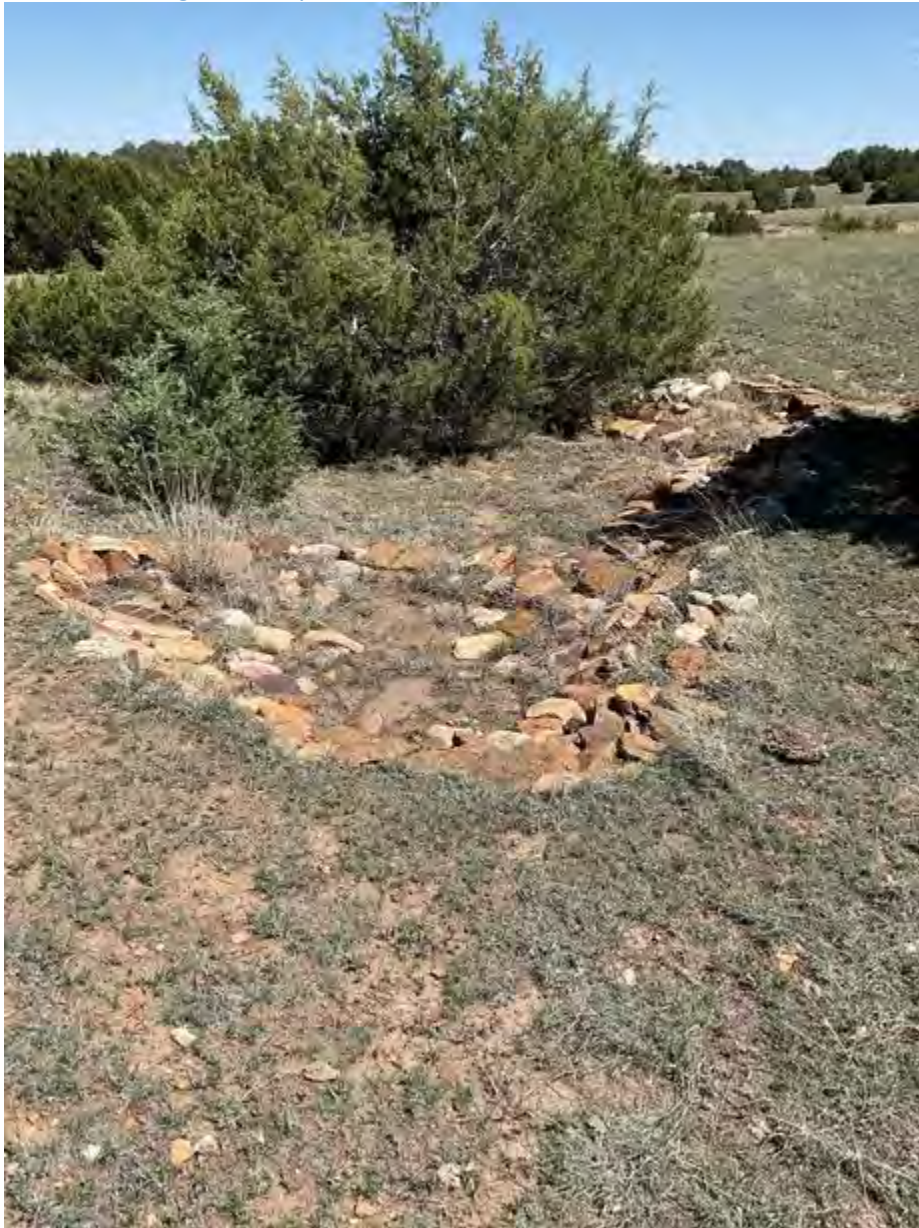
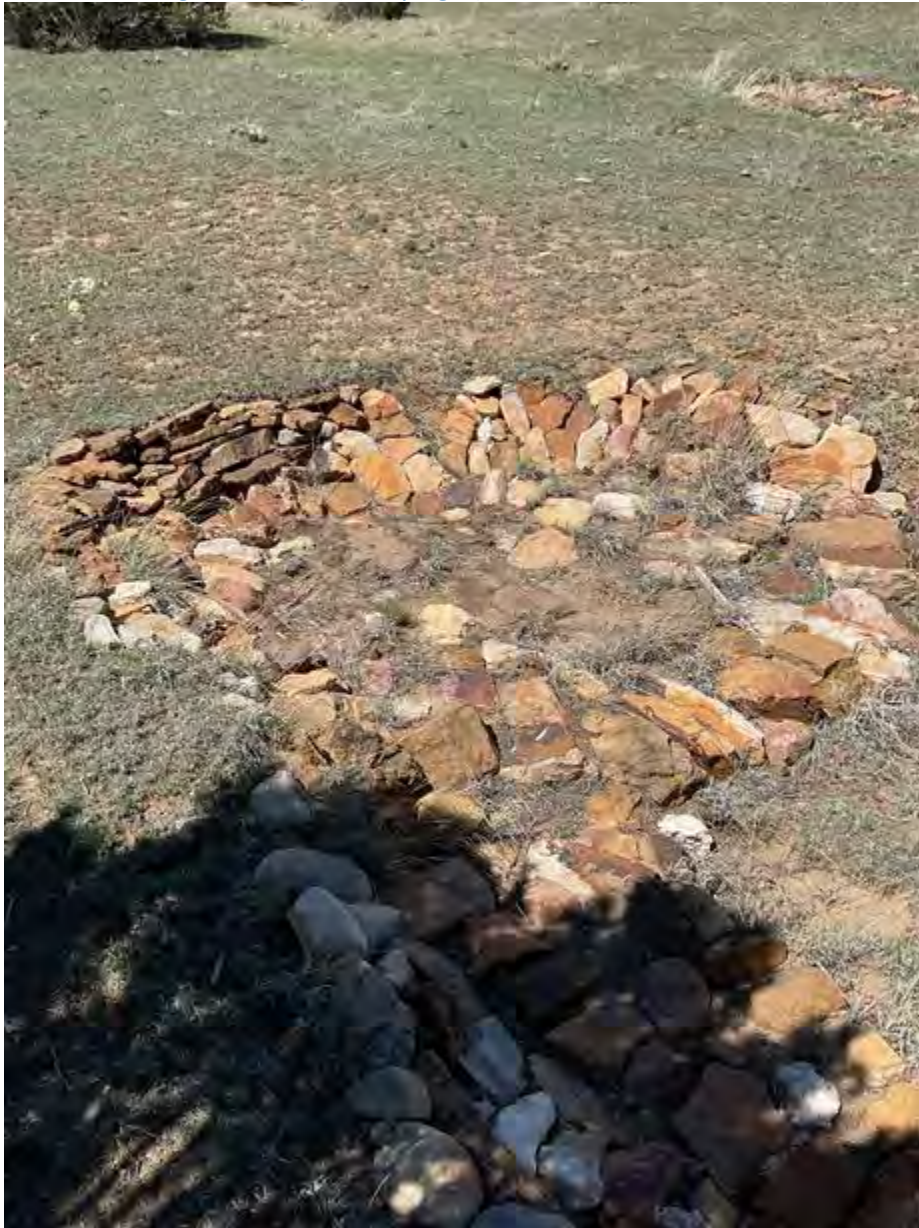
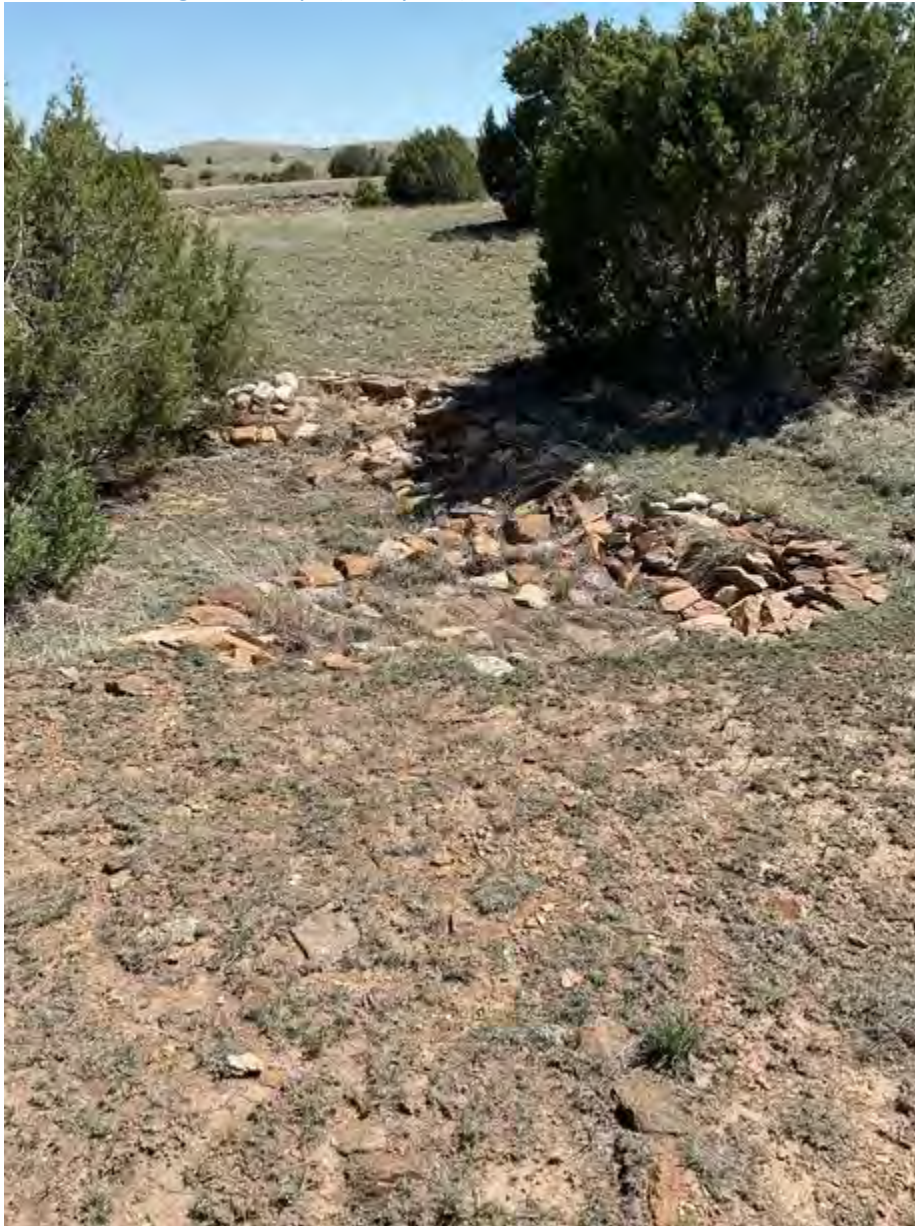
All rocks intact
