**Zuni Bowl and One Rock Check Dam Research –
Phase 1**

Final Report

December 2024

Rio Grande Return for the New Mexico Department of Transportation Research Bureau

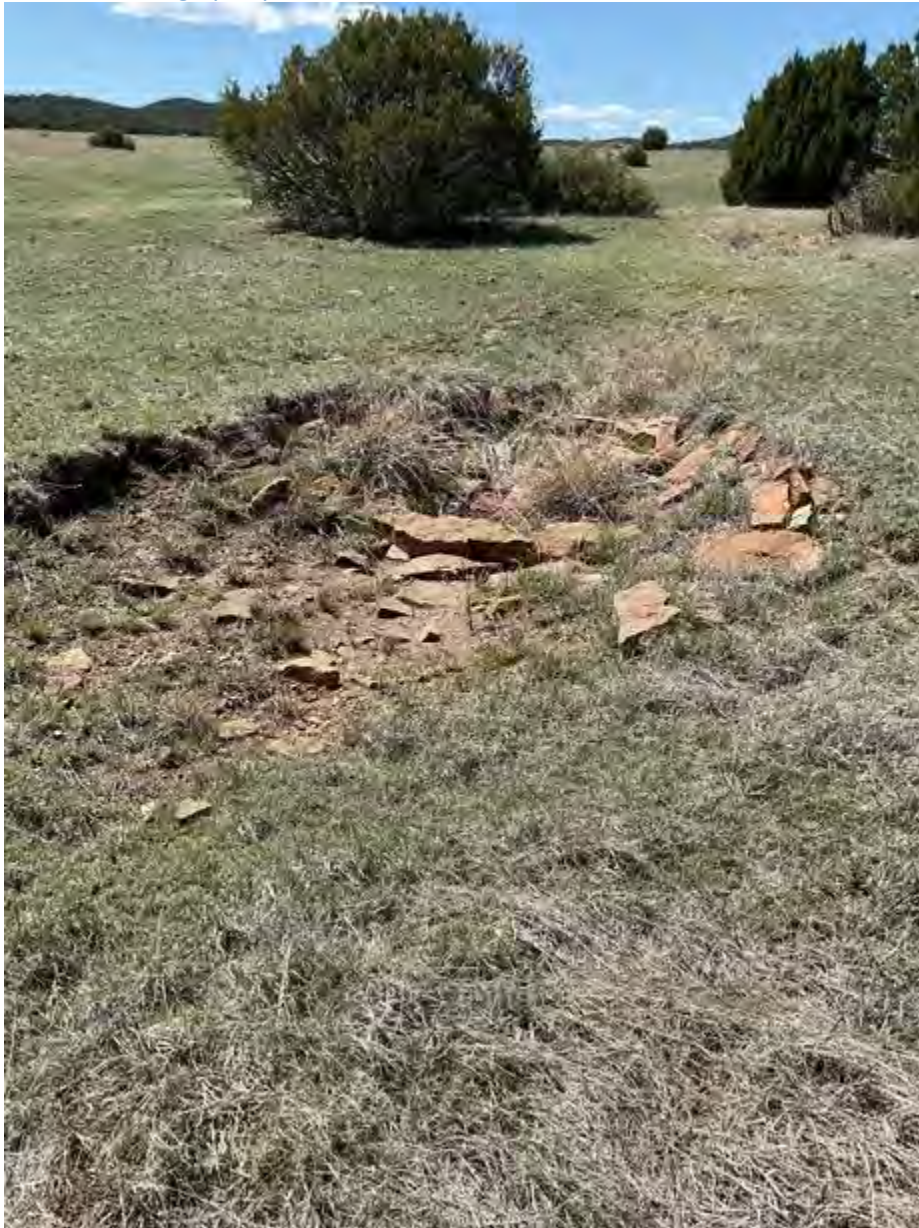
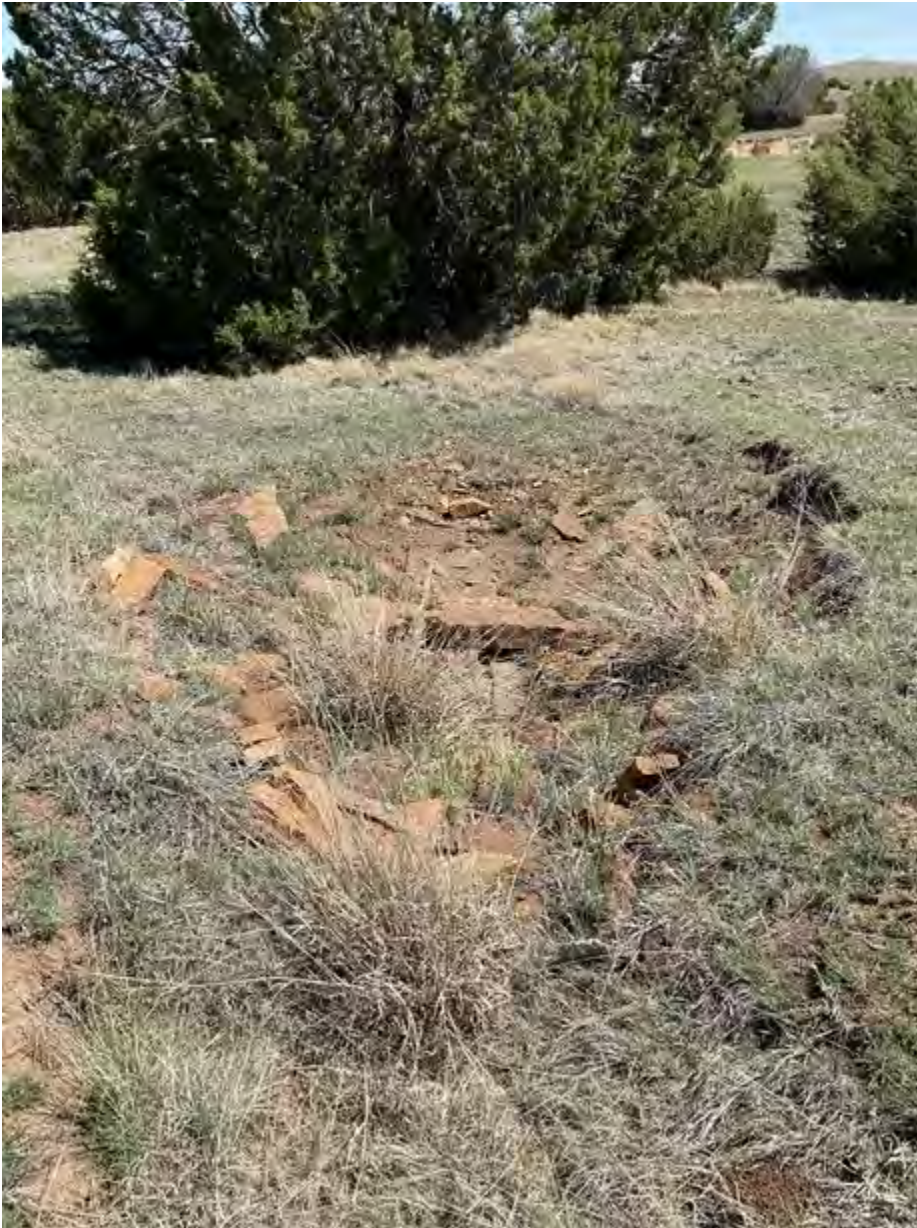
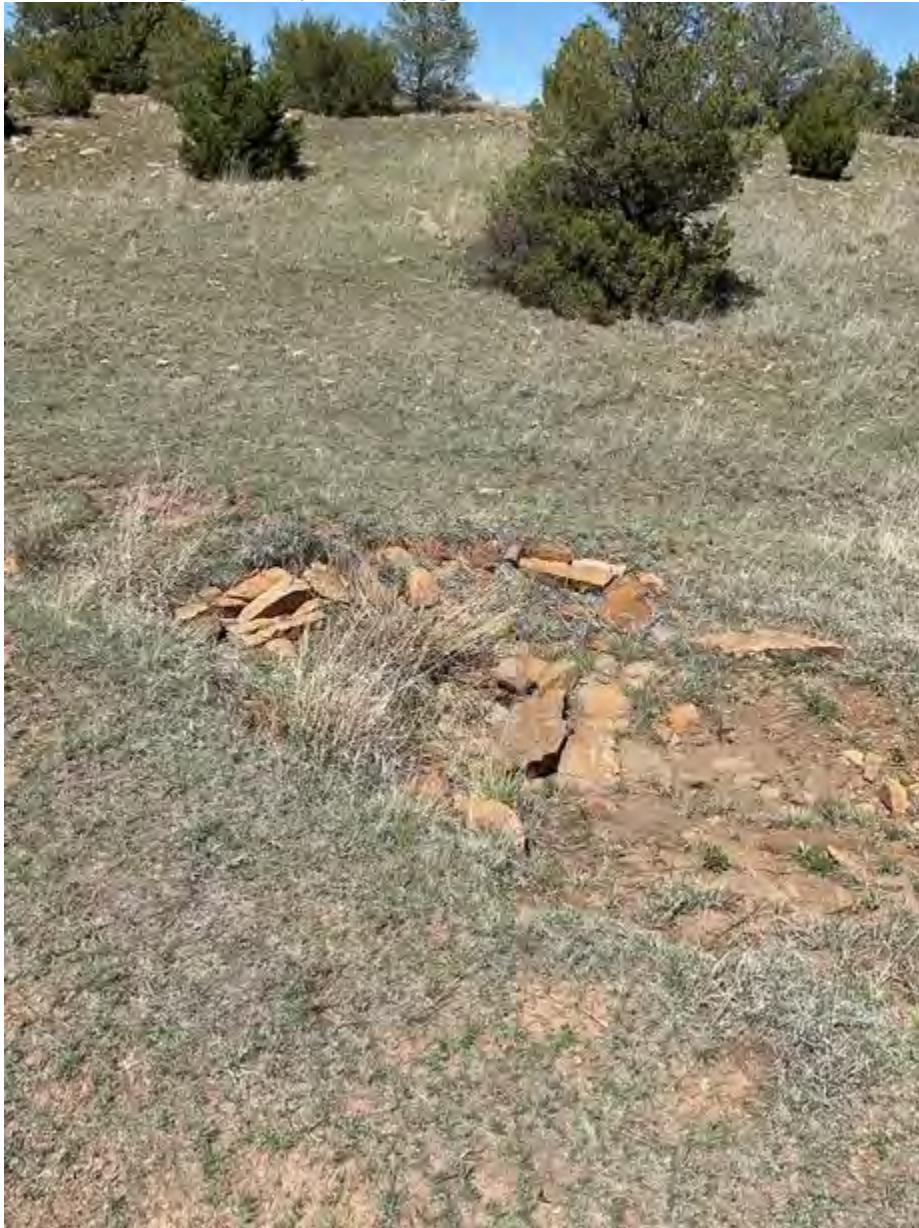
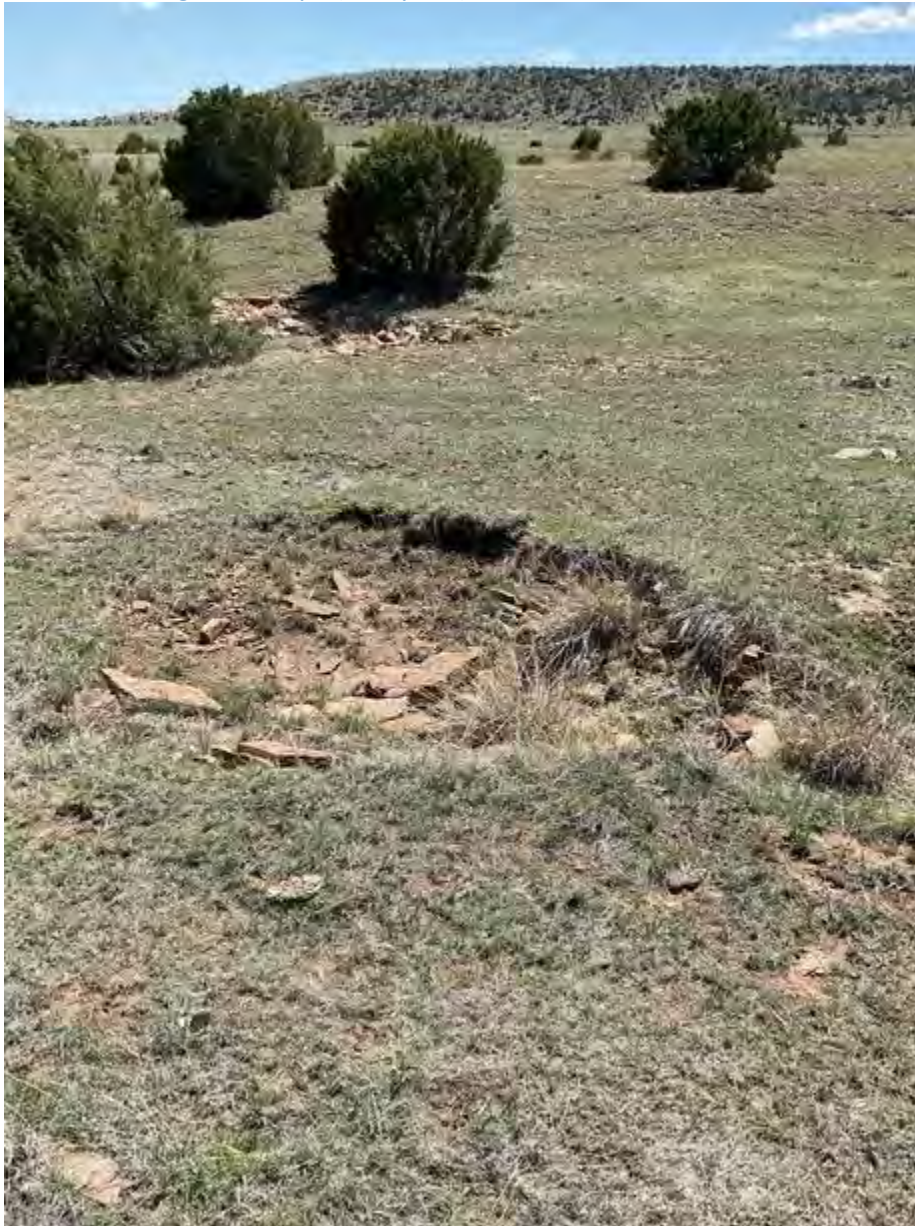
All rocks intact

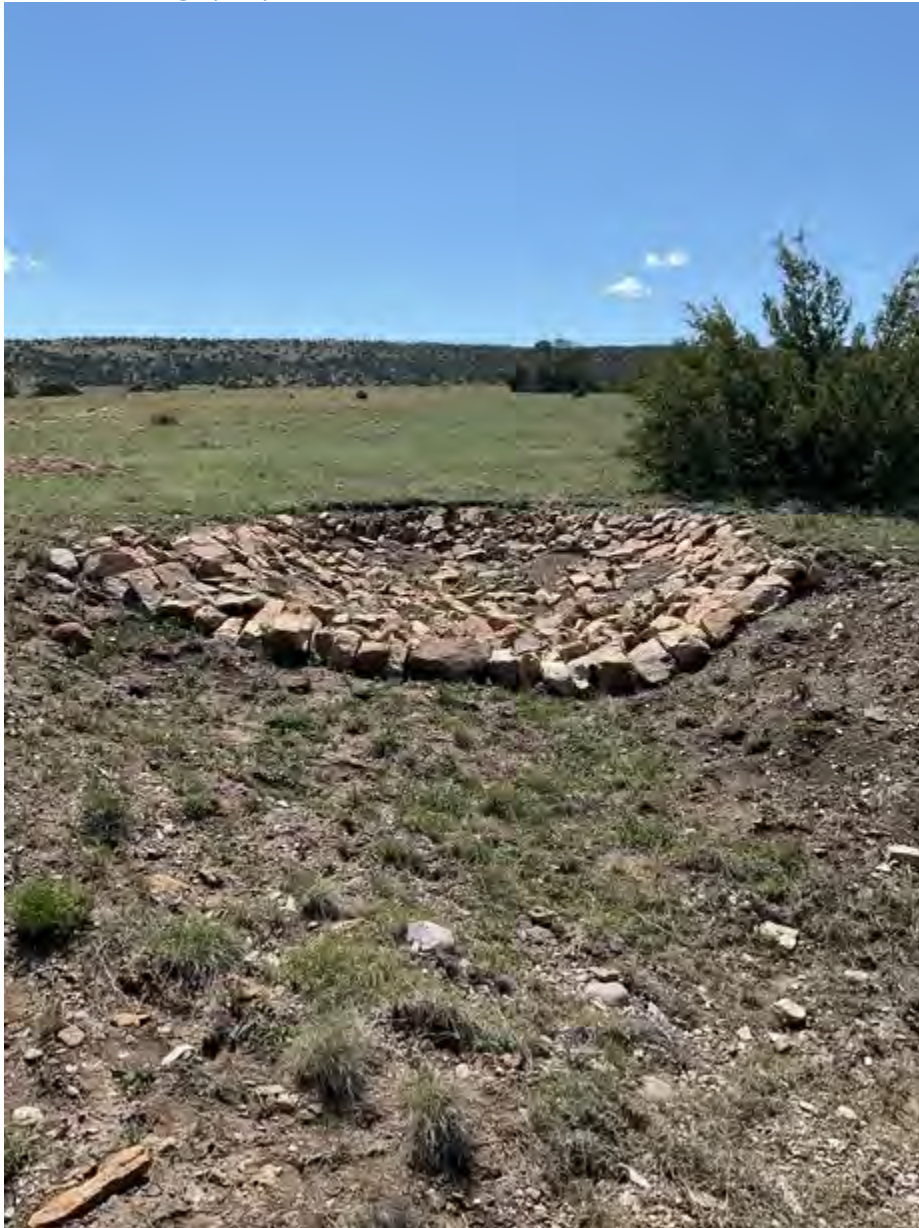
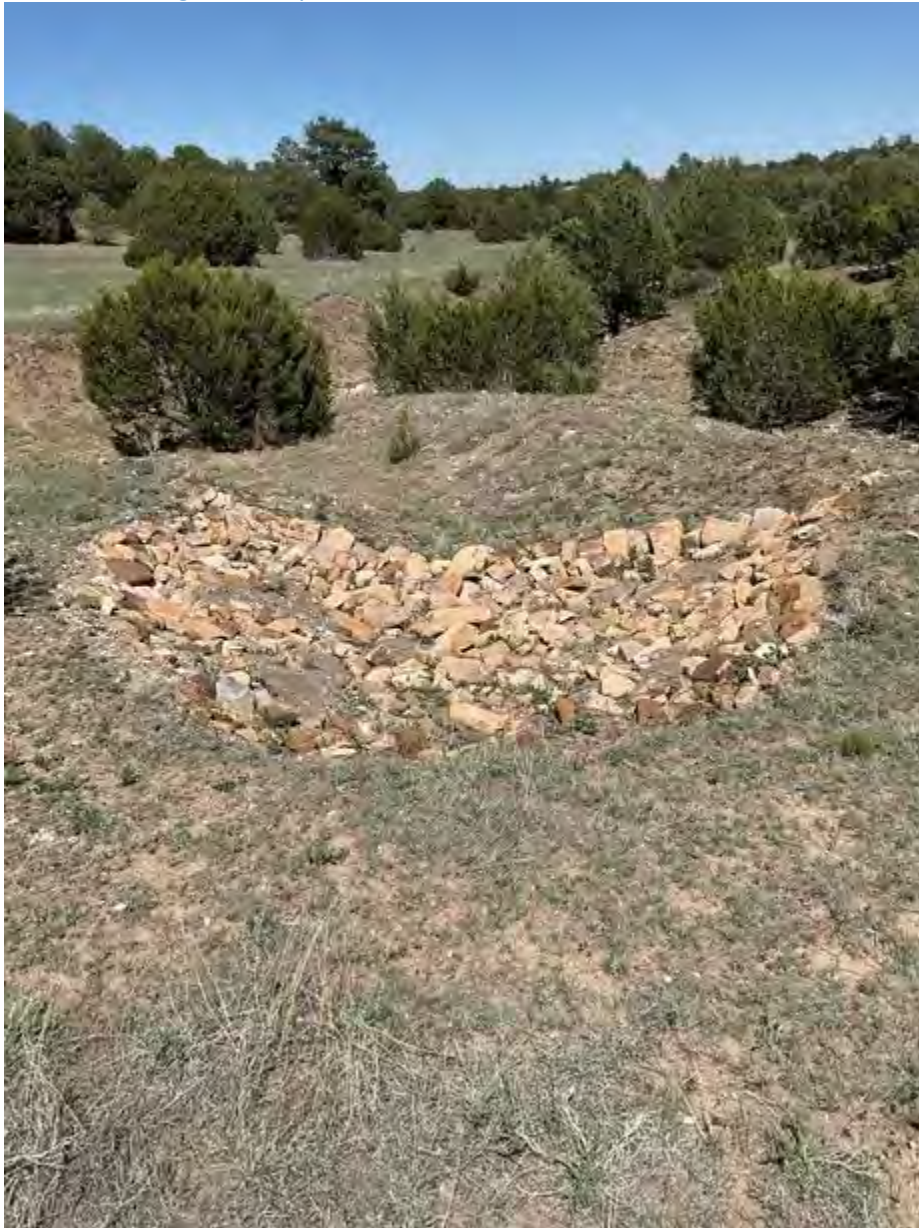
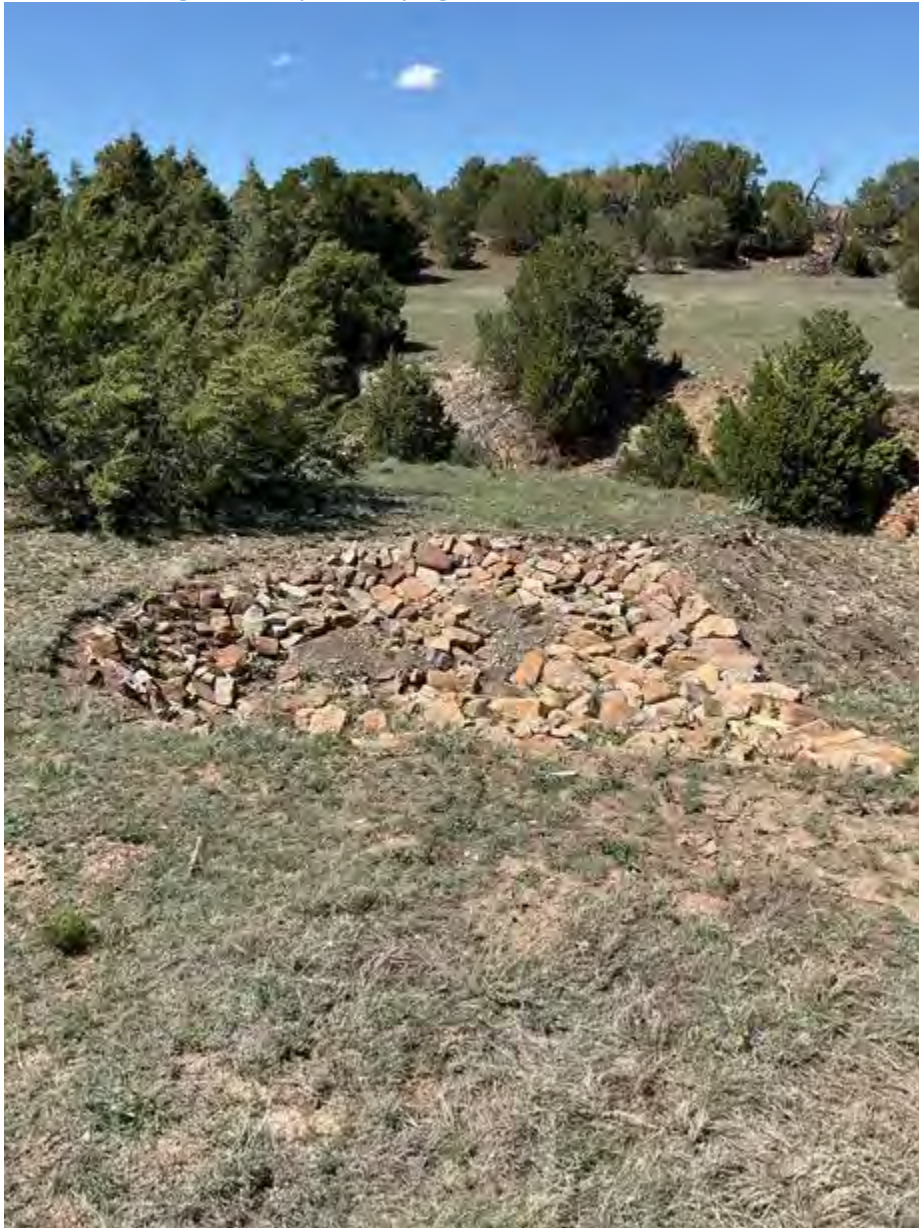
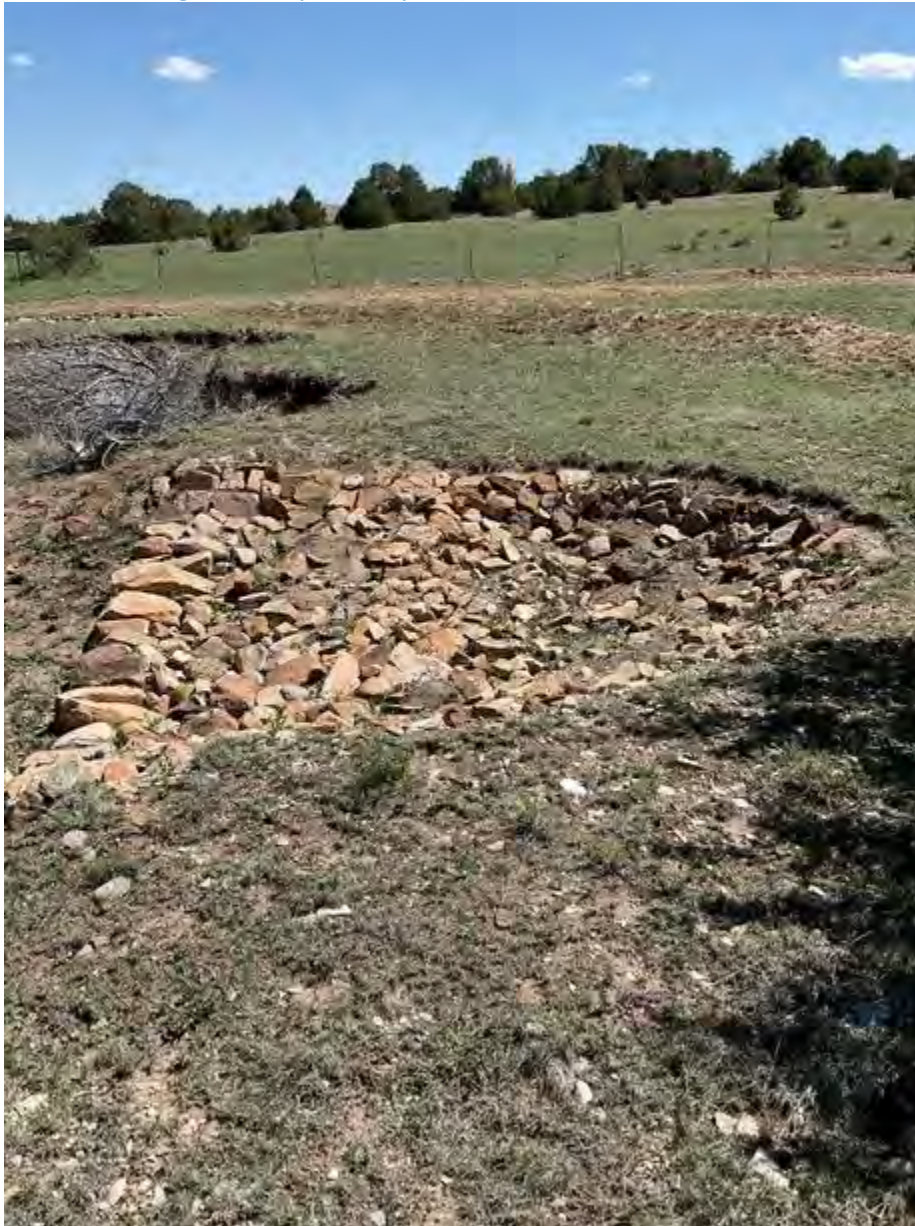
All rocks intact

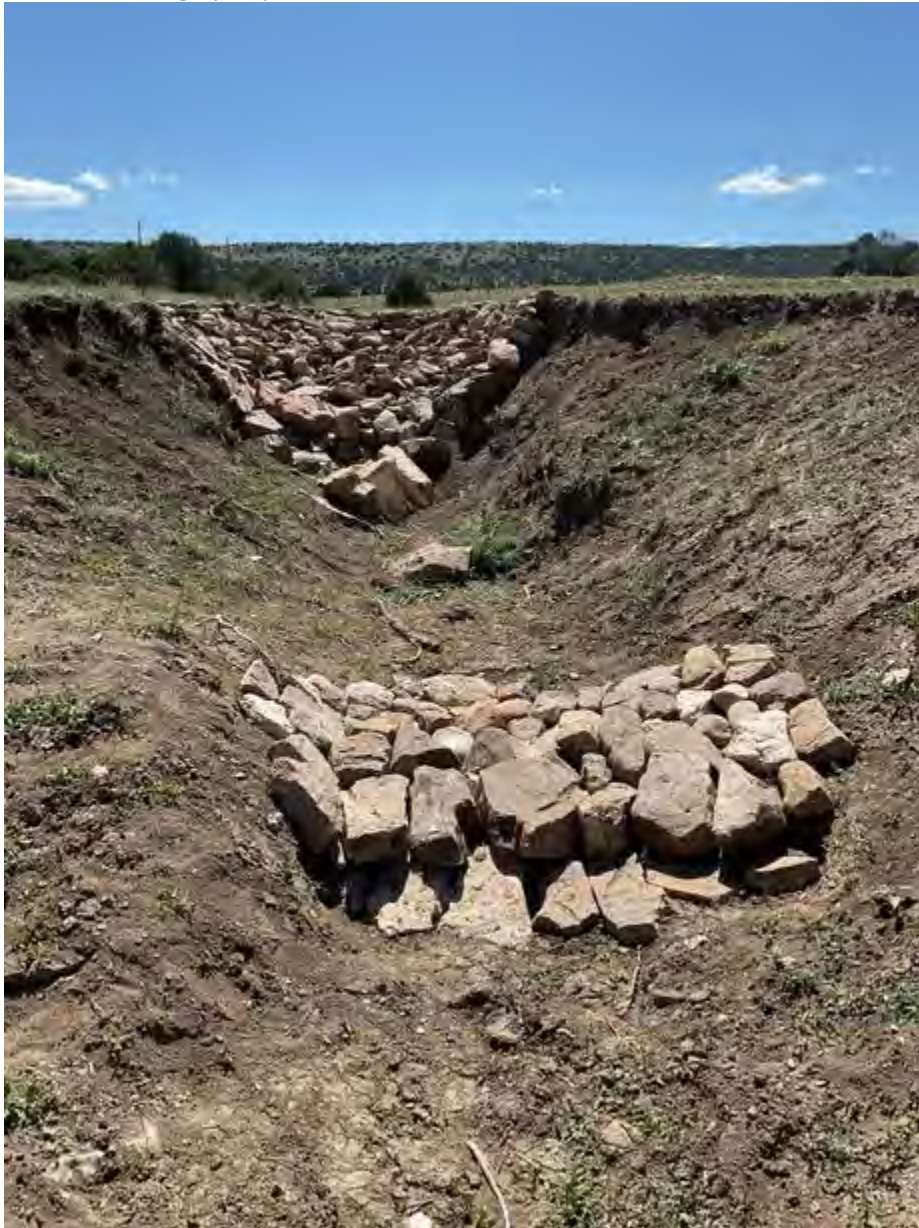
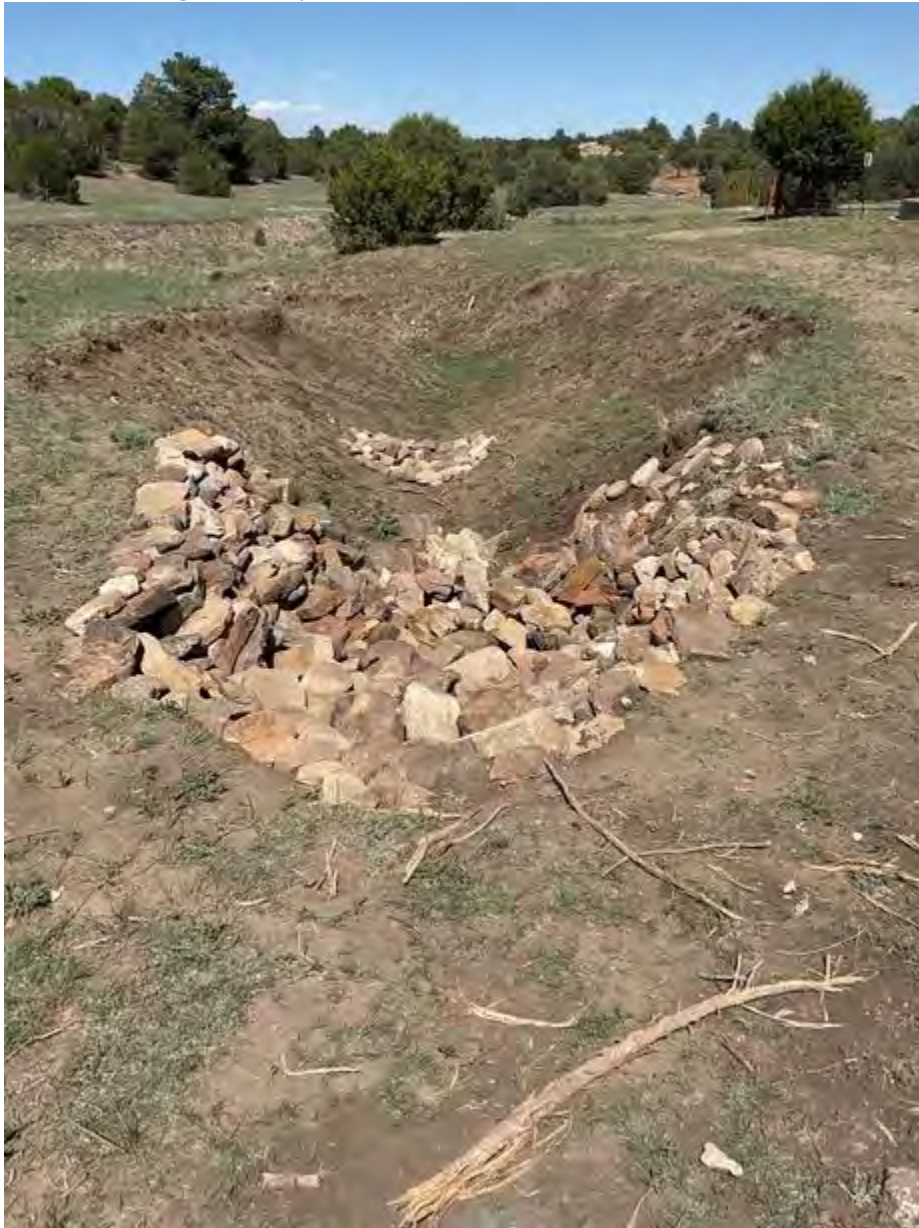
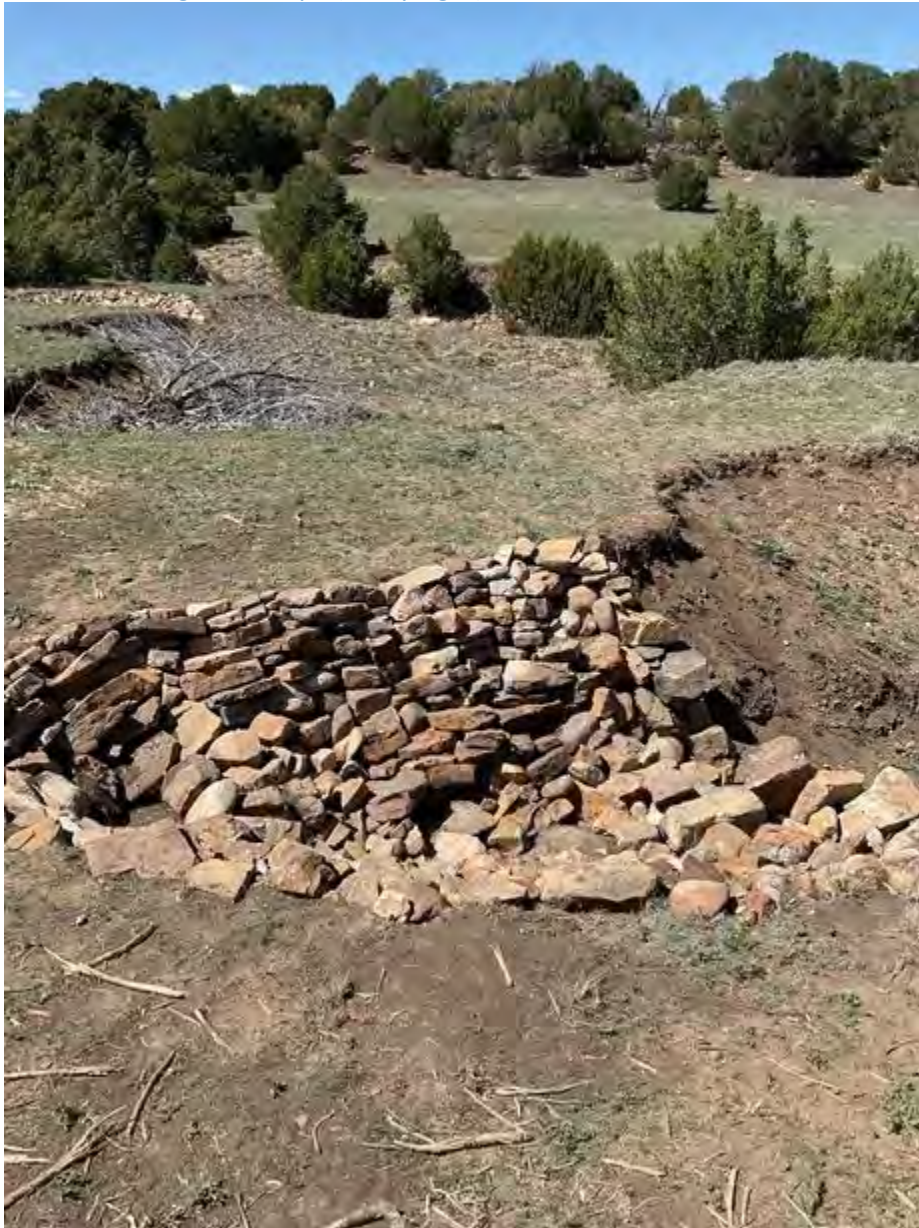
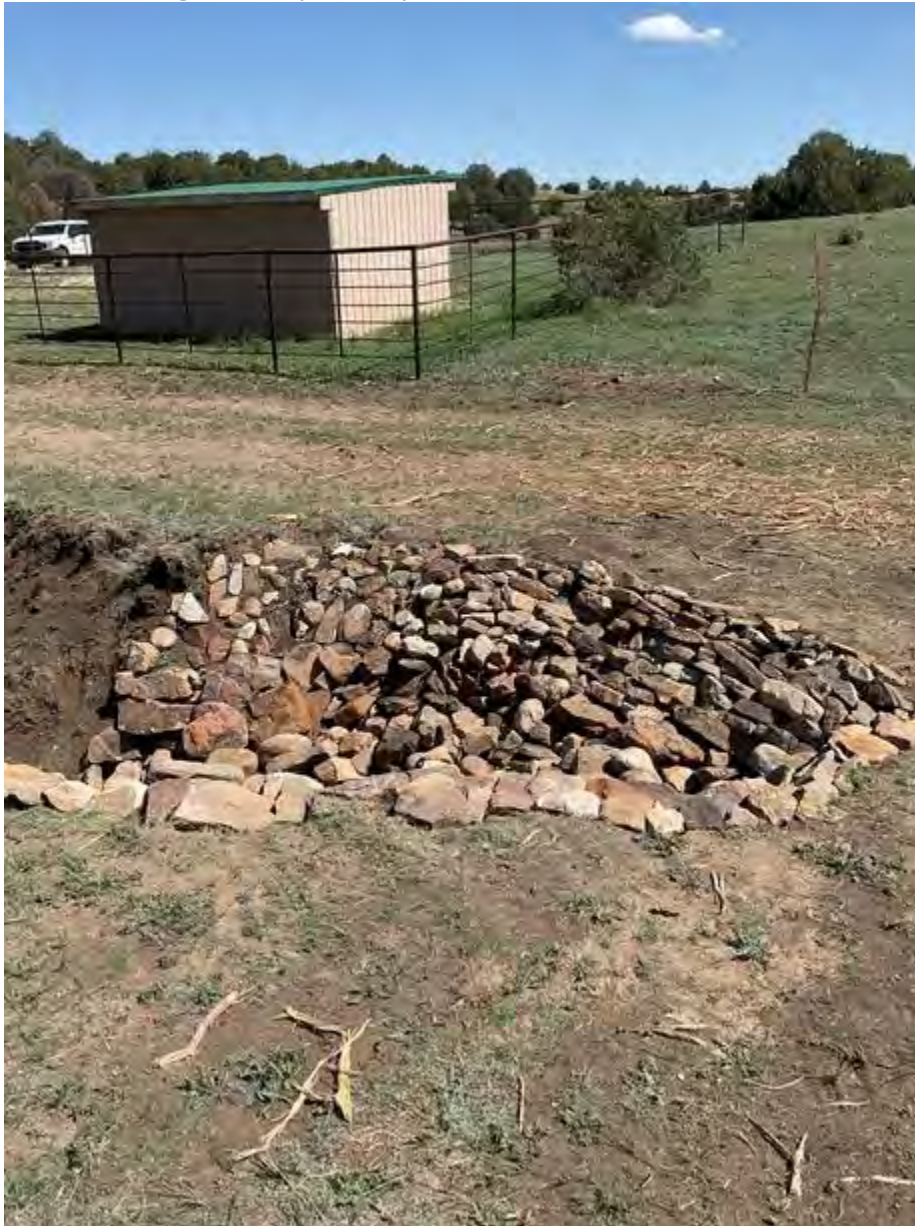
Some rocks dislodged or broken

Original ZB repaired in 2024

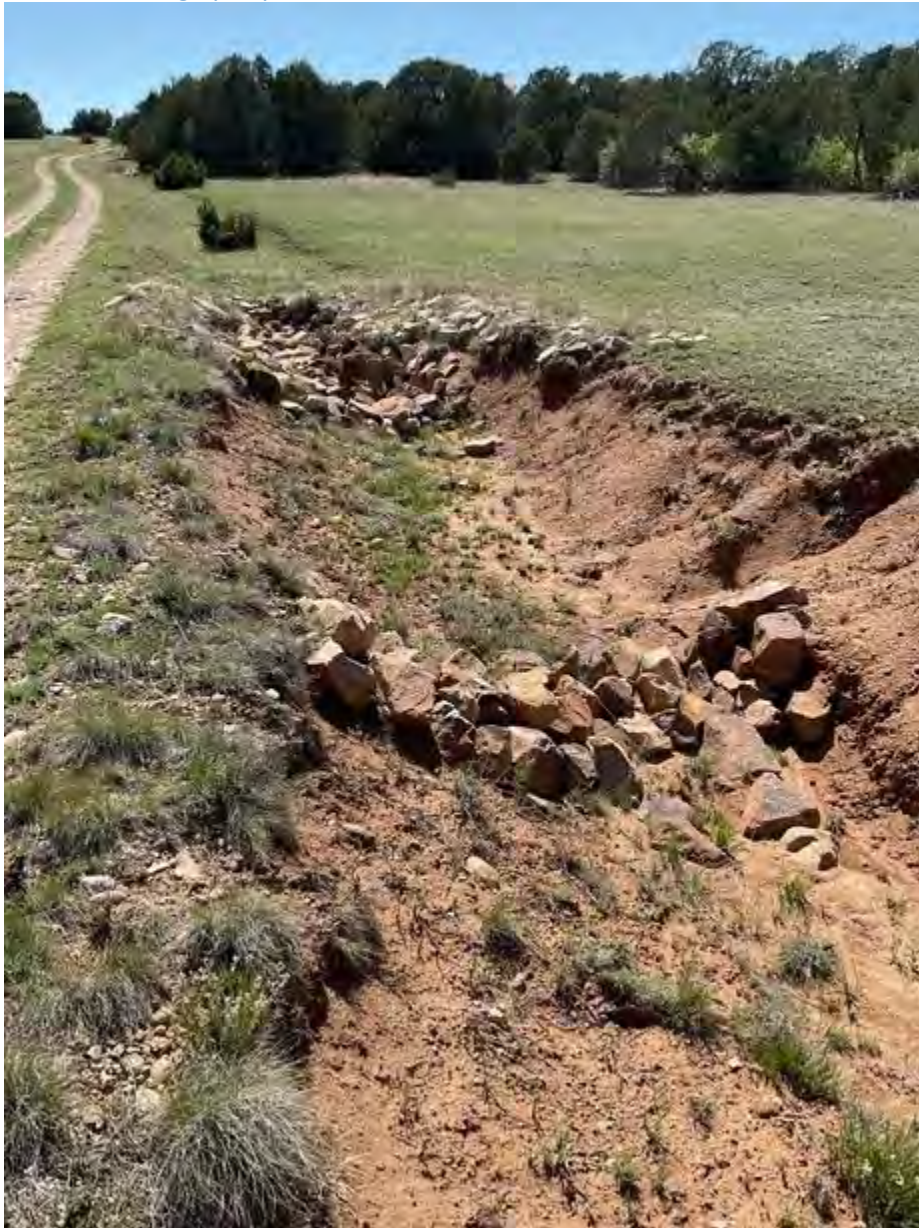
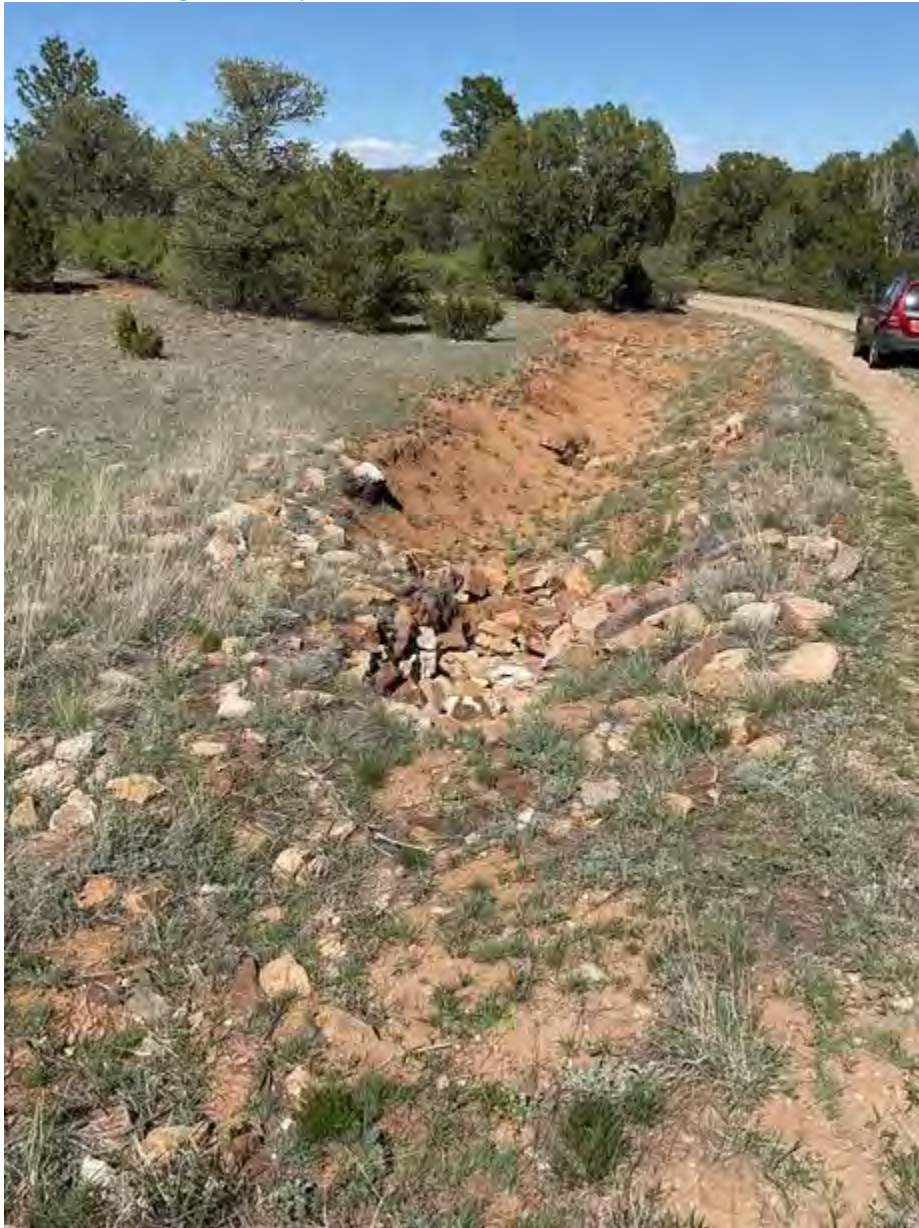
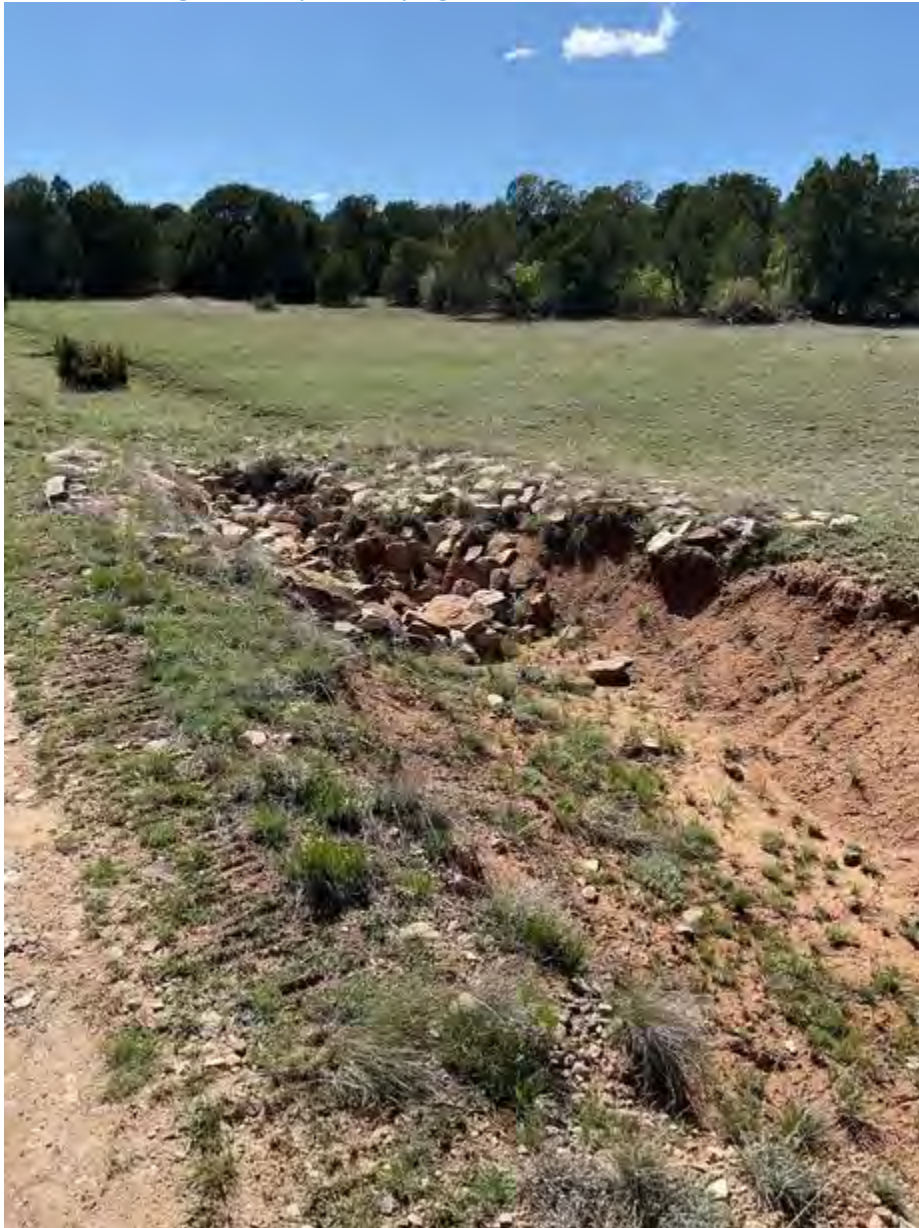
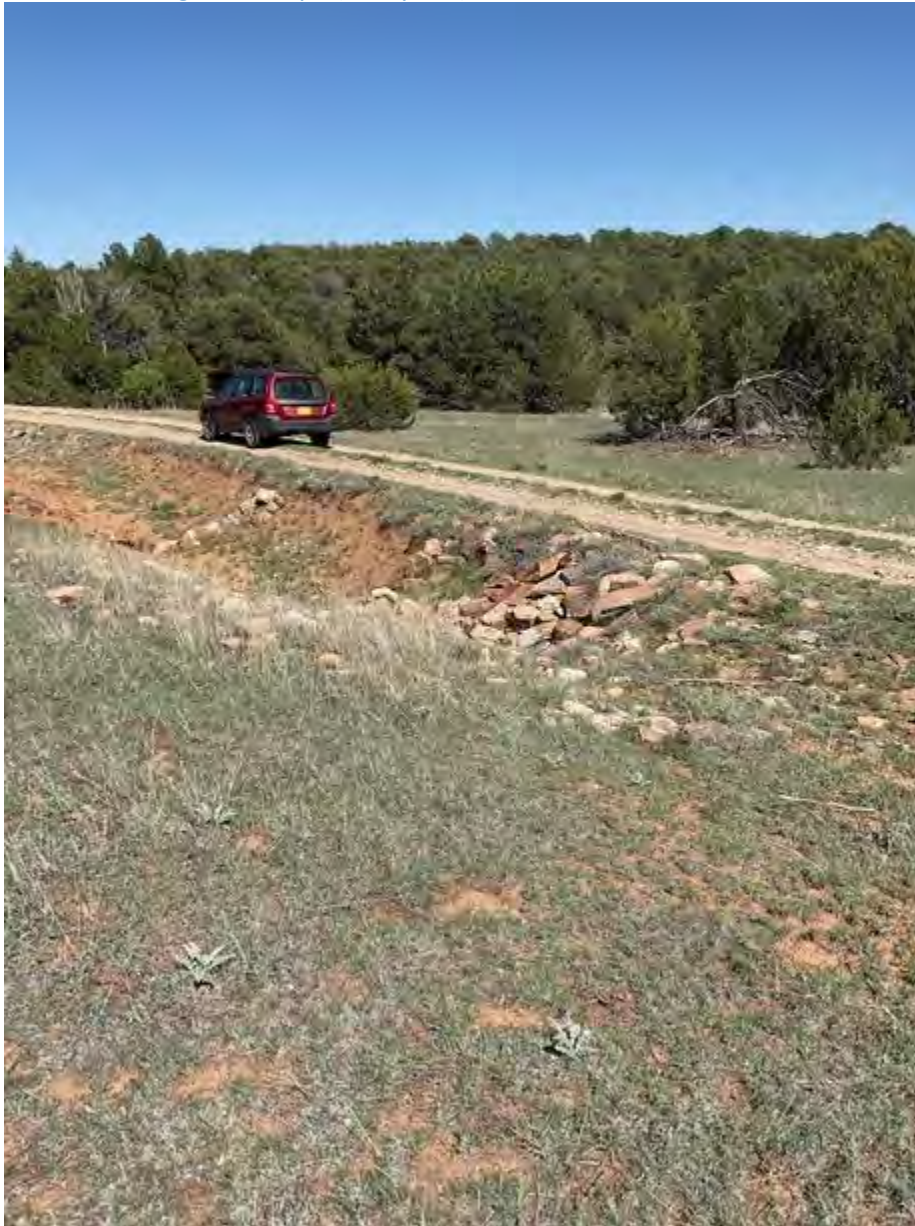
Some rocks dislodged or broken

Appears repairs made after original structure eroded

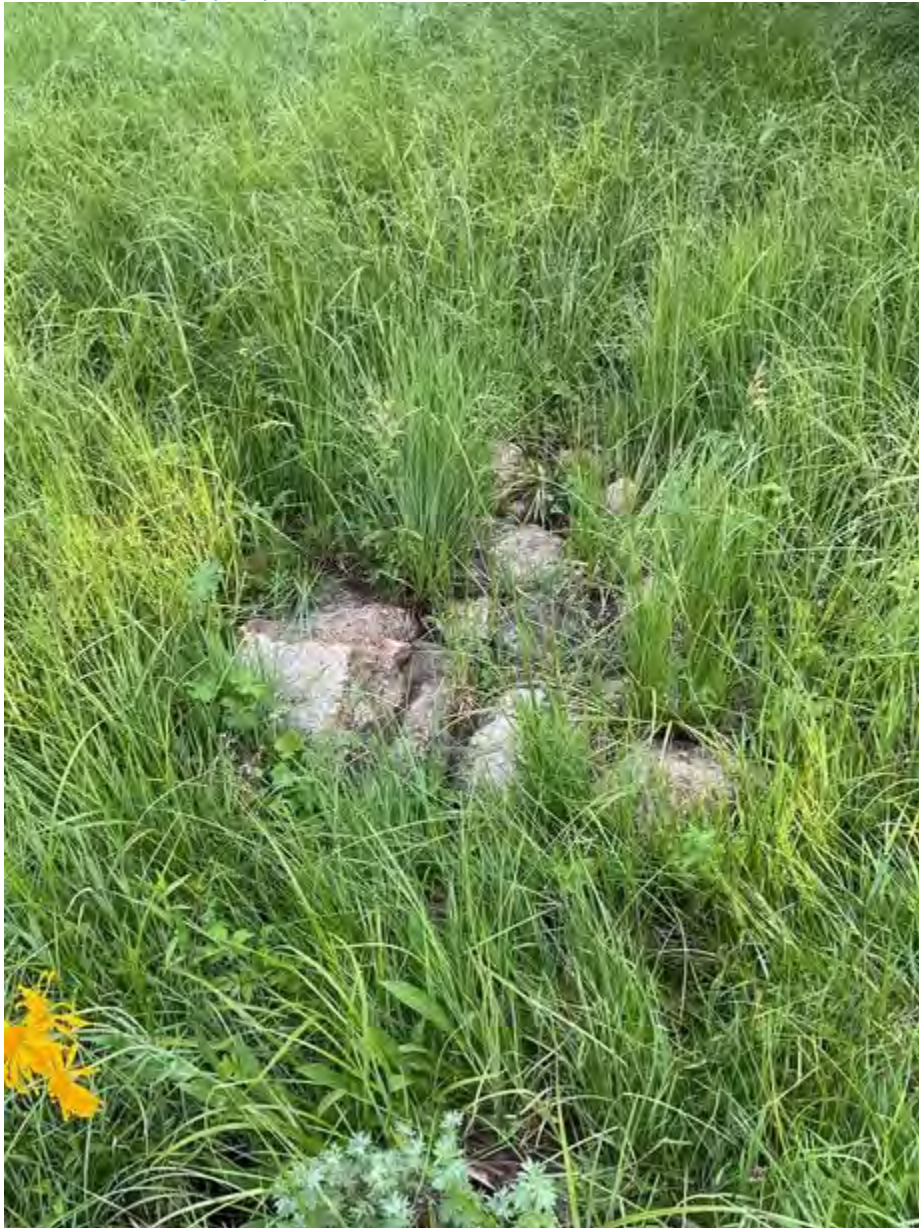
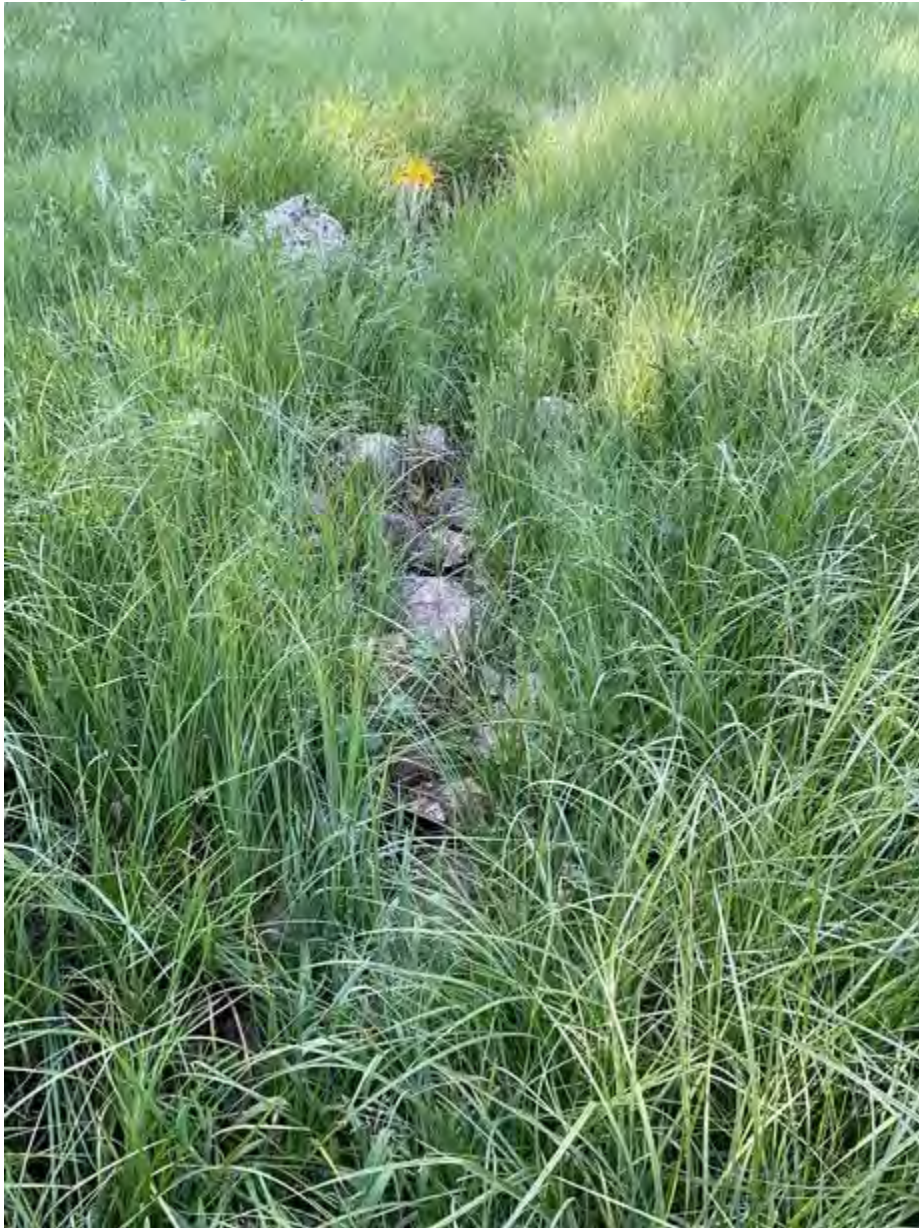
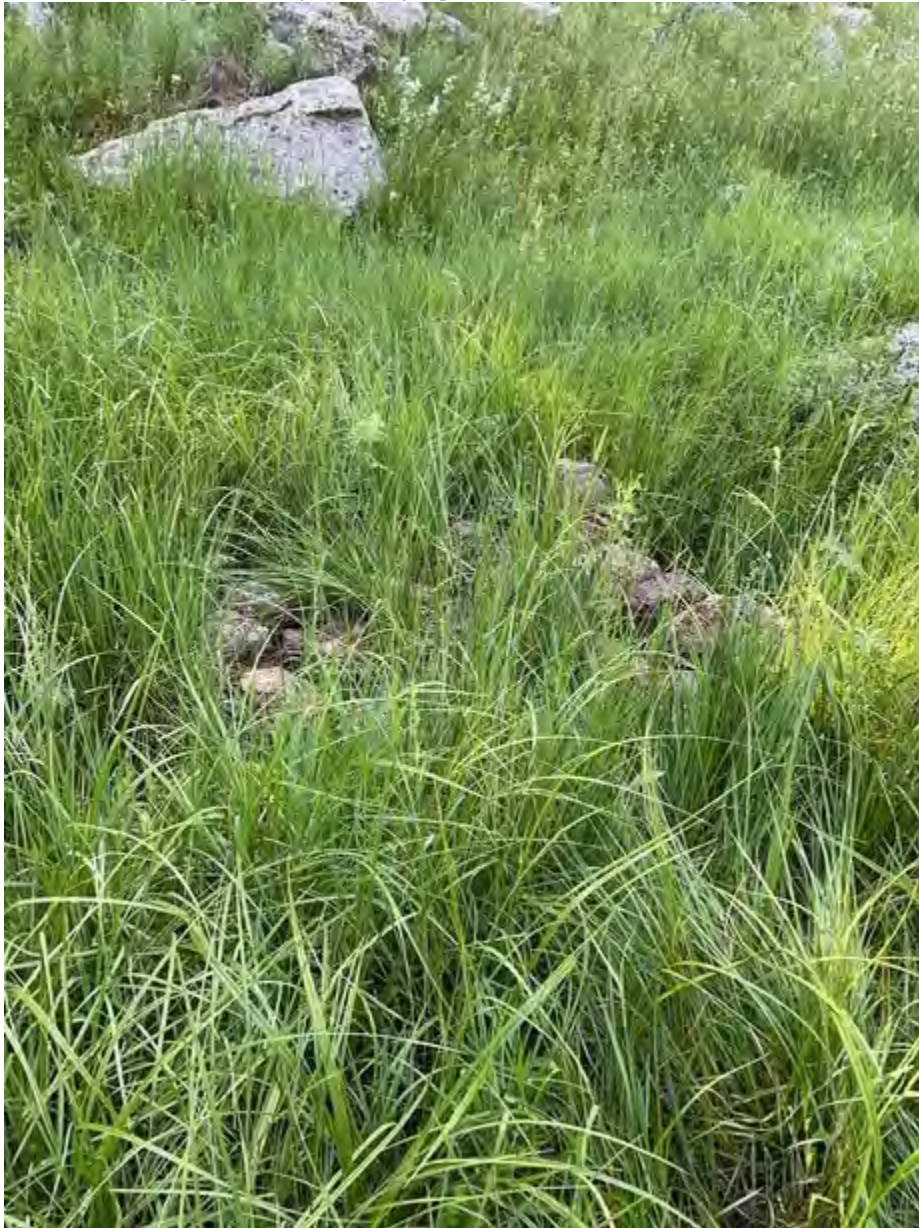
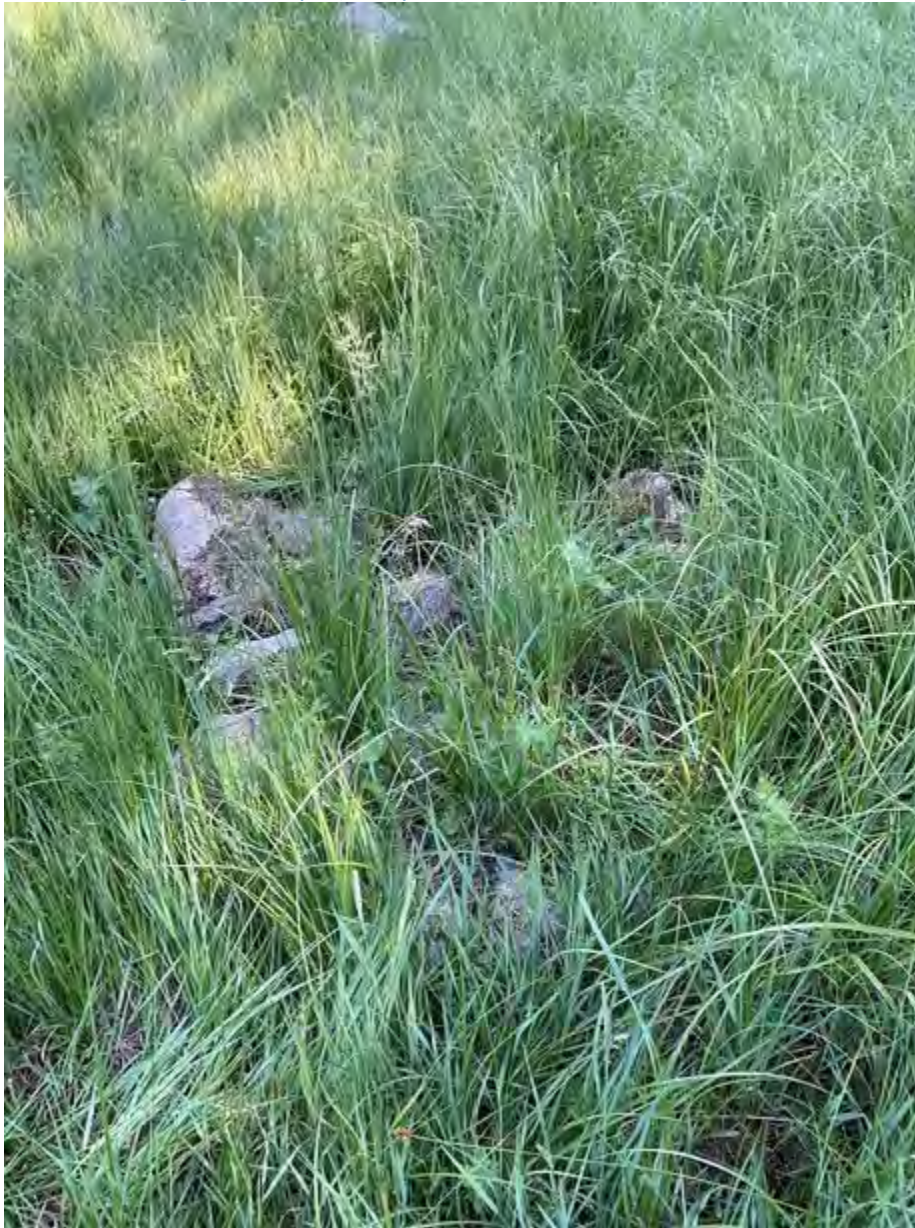
All rocks intact
