**Zuni Bowl and One Rock Check Dam Research –
Phase 1**

Final Report

December 2024

Rio Grande Return for the New Mexico Department of Transportation Research Bureau

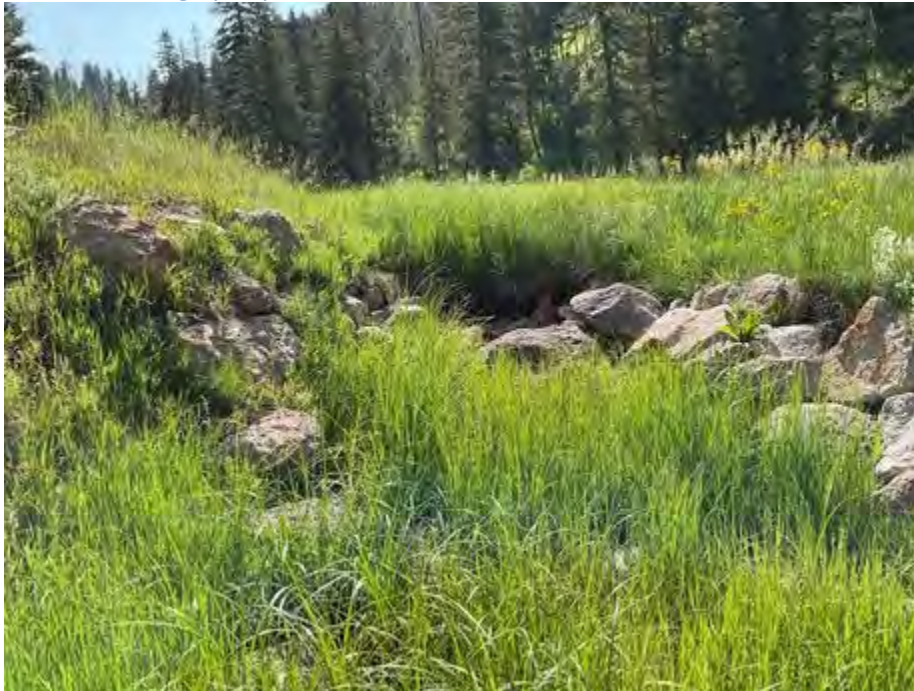
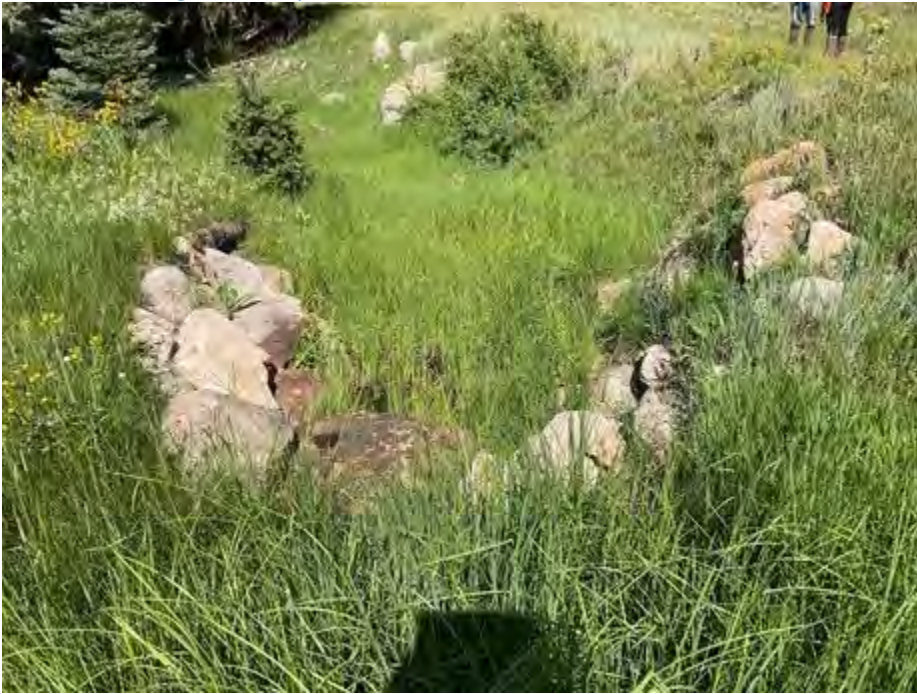
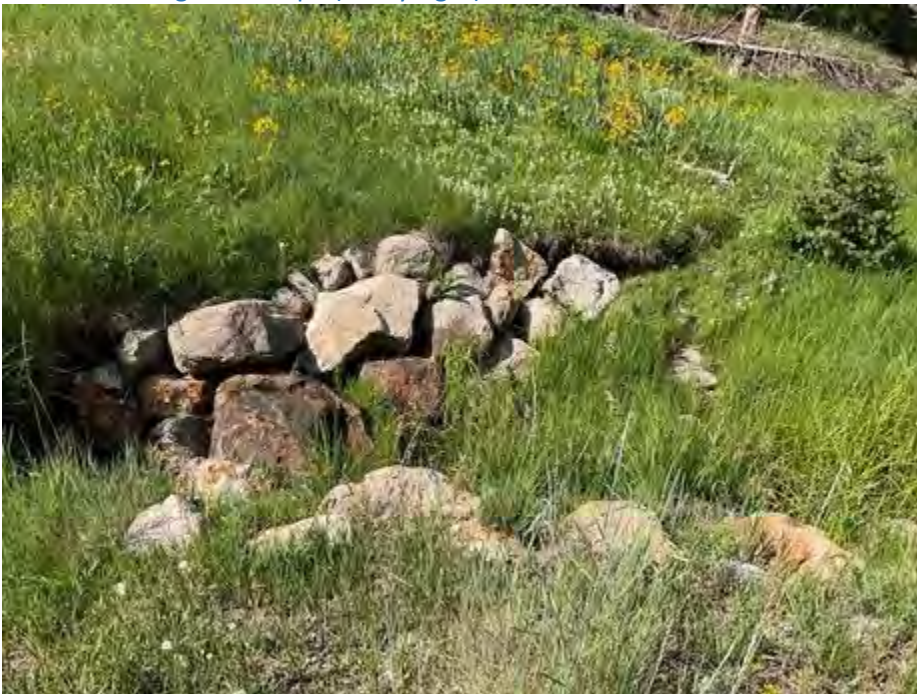
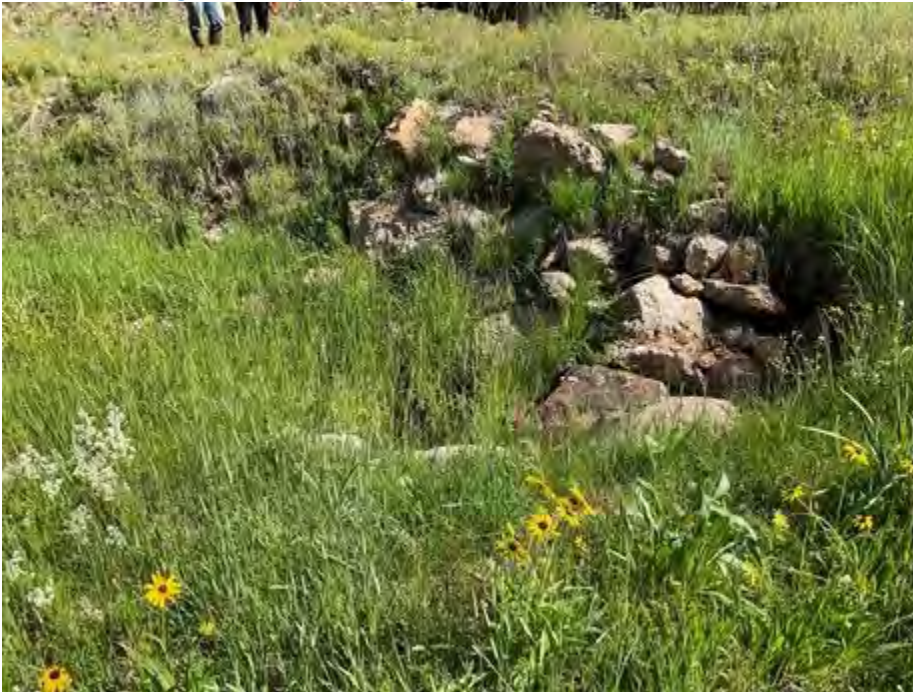
-106.6014258 35.9241155

Some rocks dislodged or broken

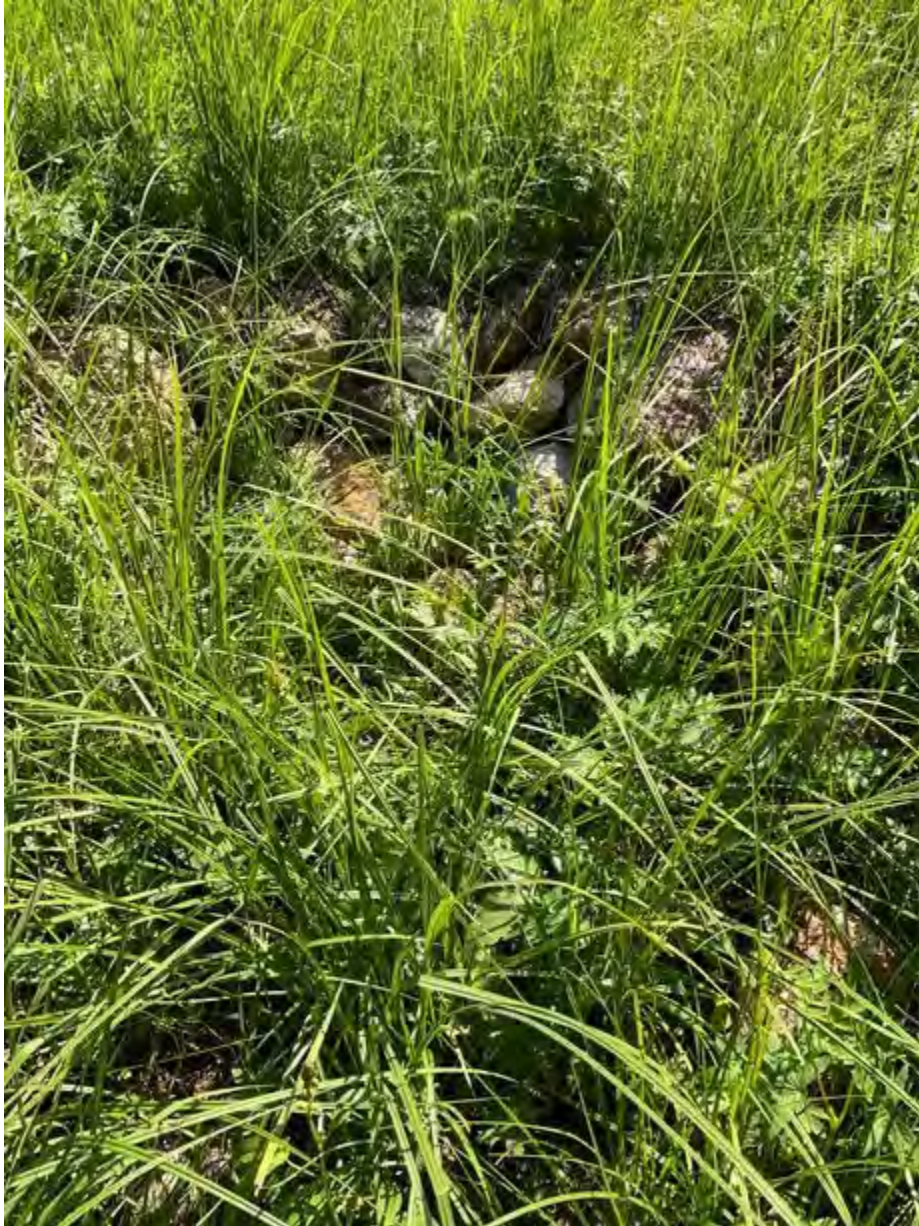
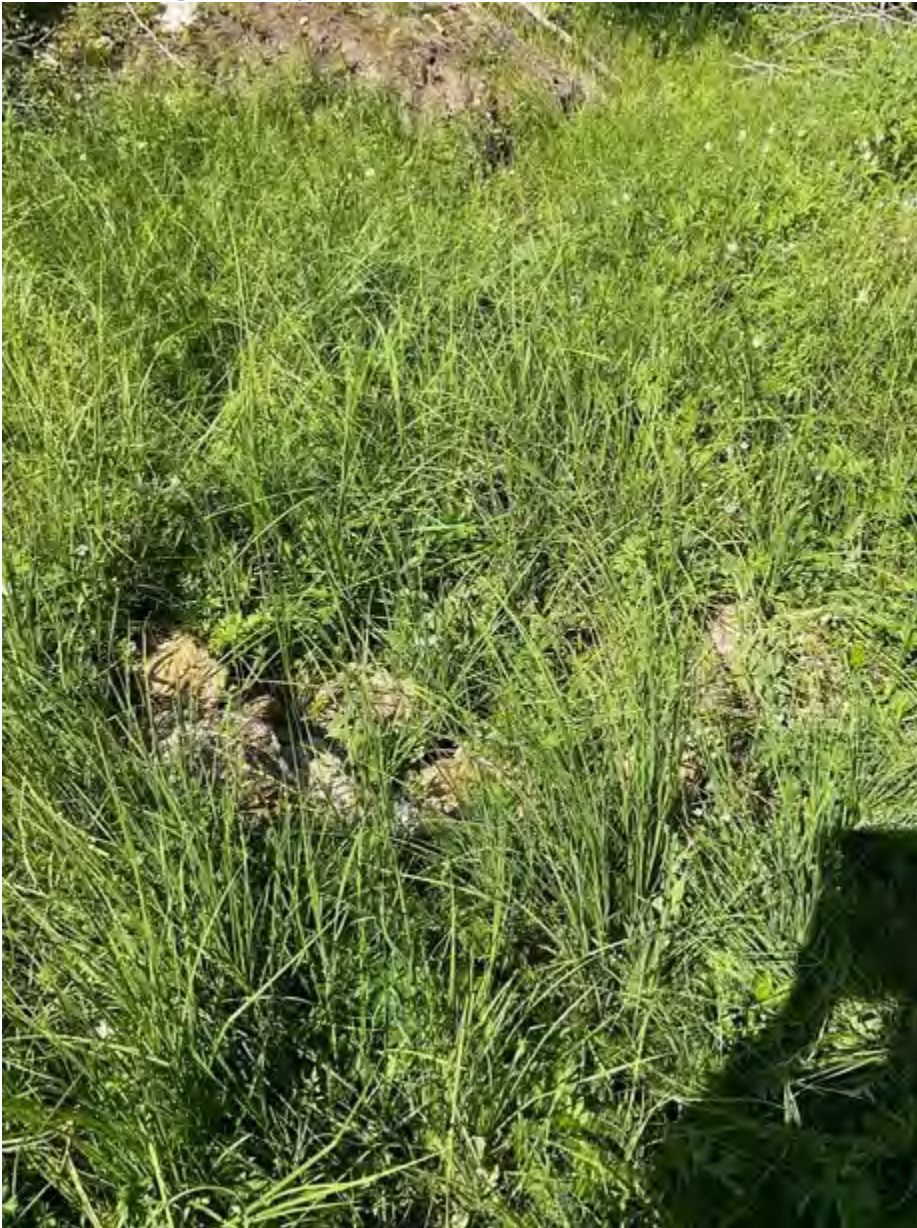
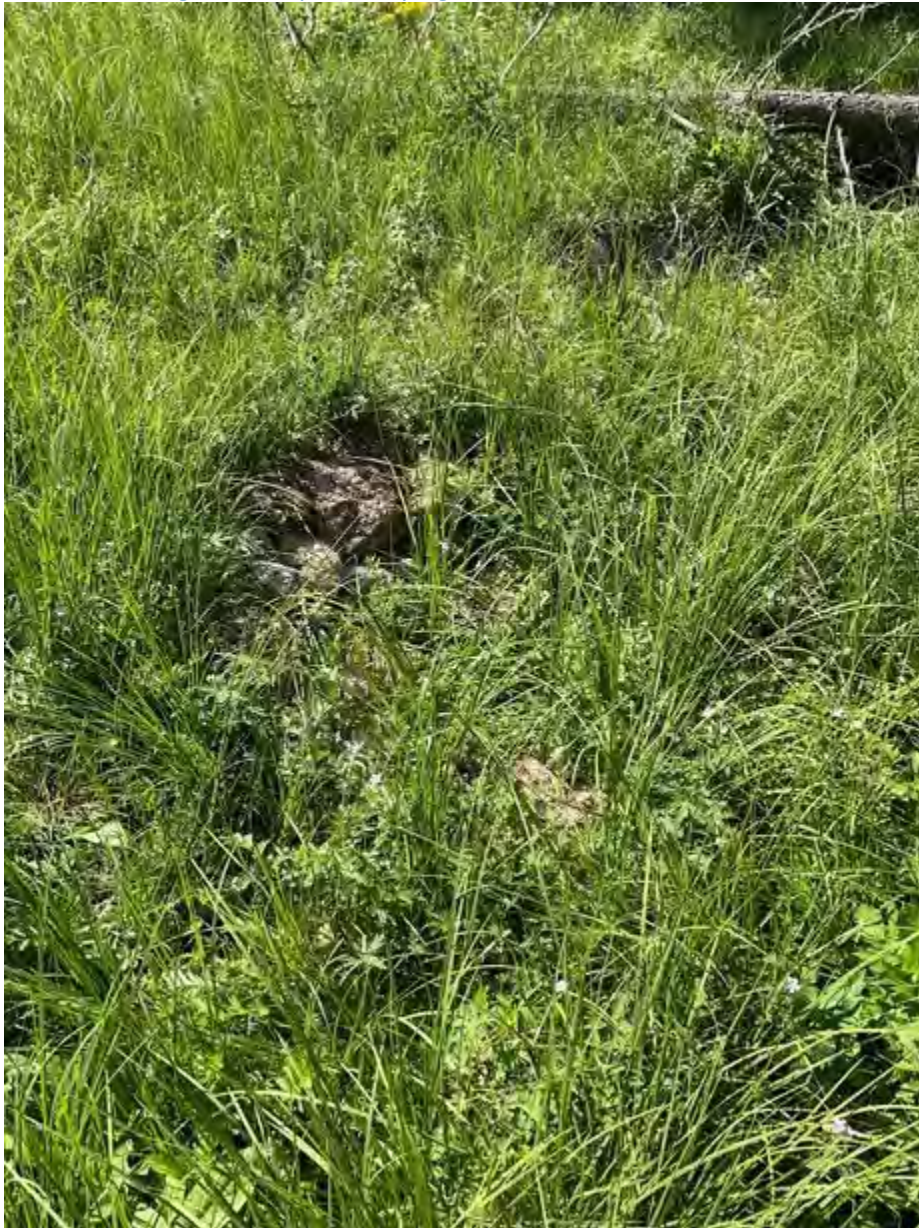
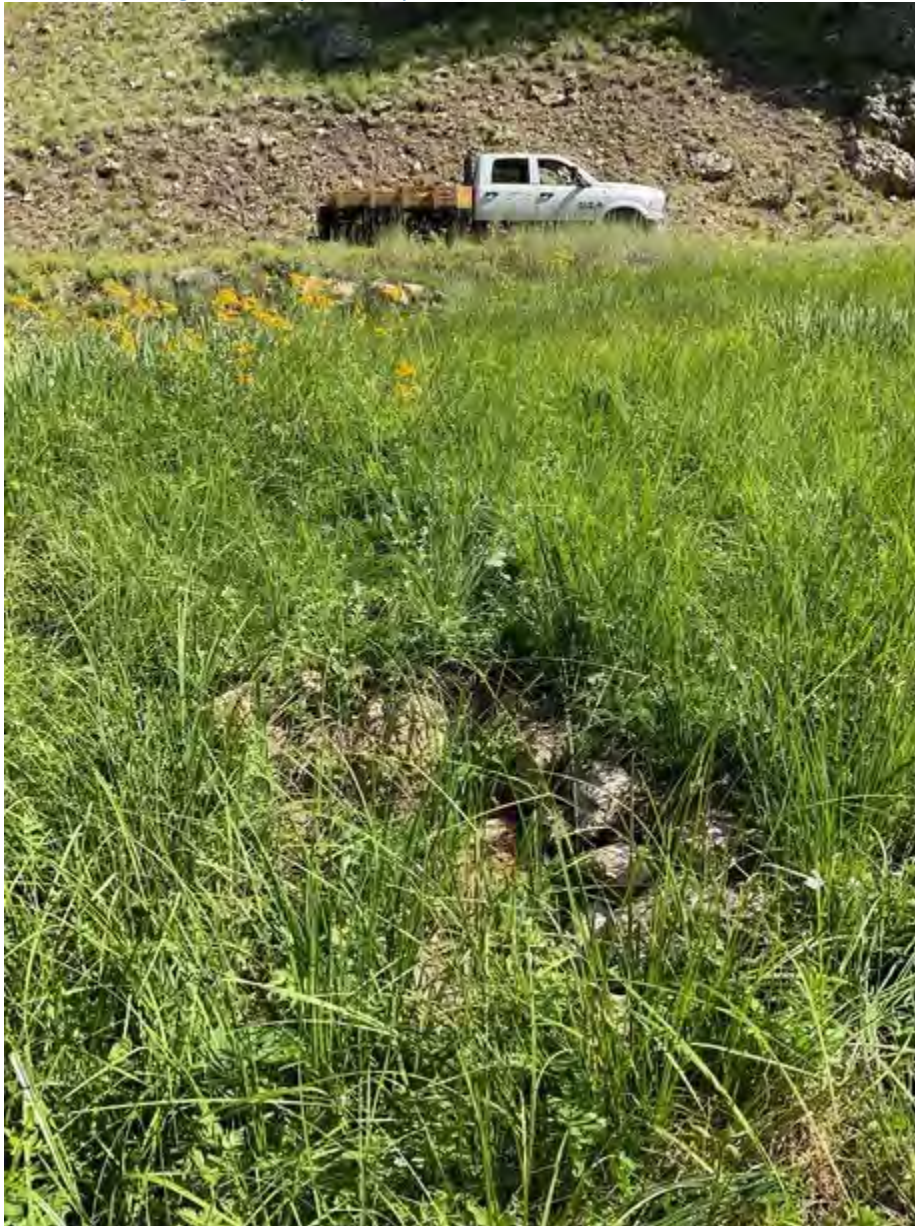
-106.6013747 35.9240822

All rocks intact

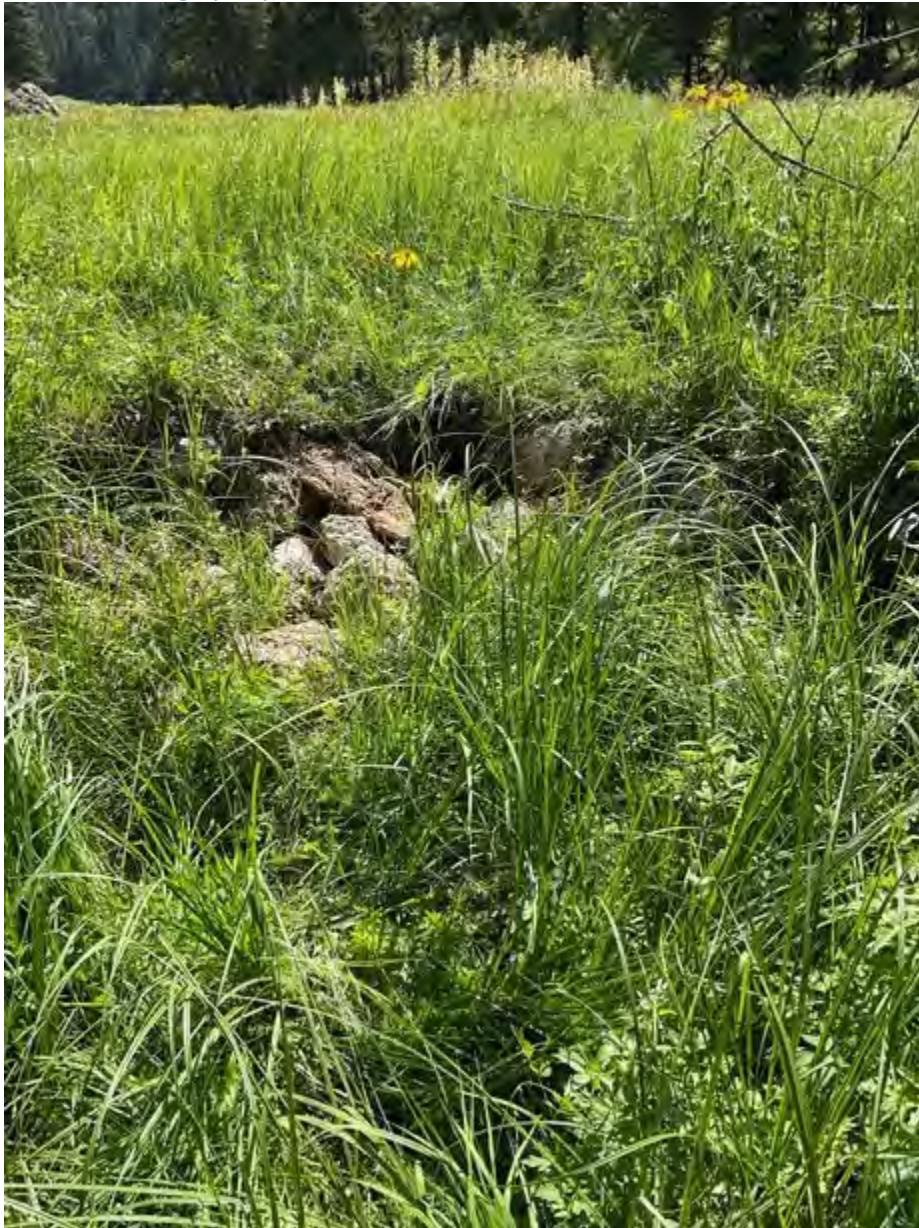
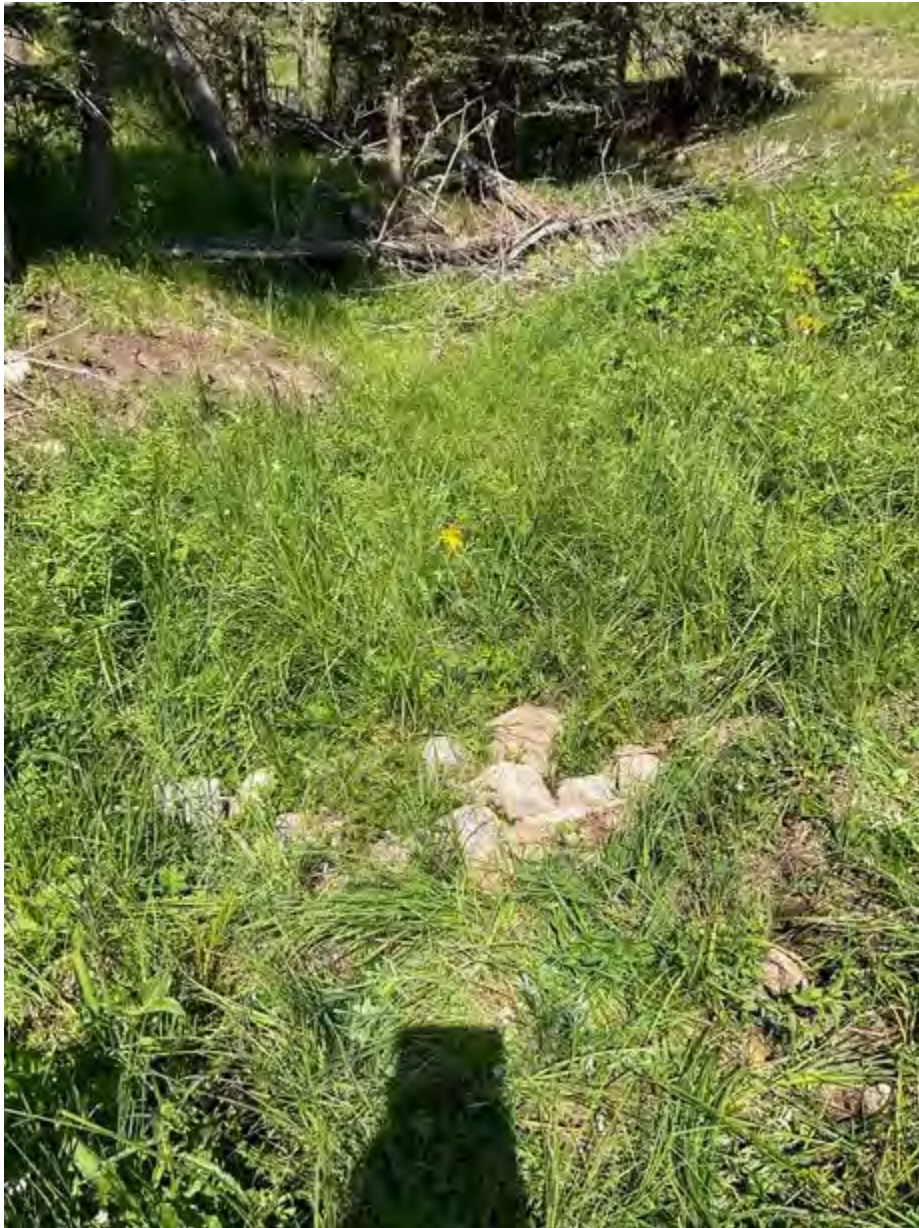
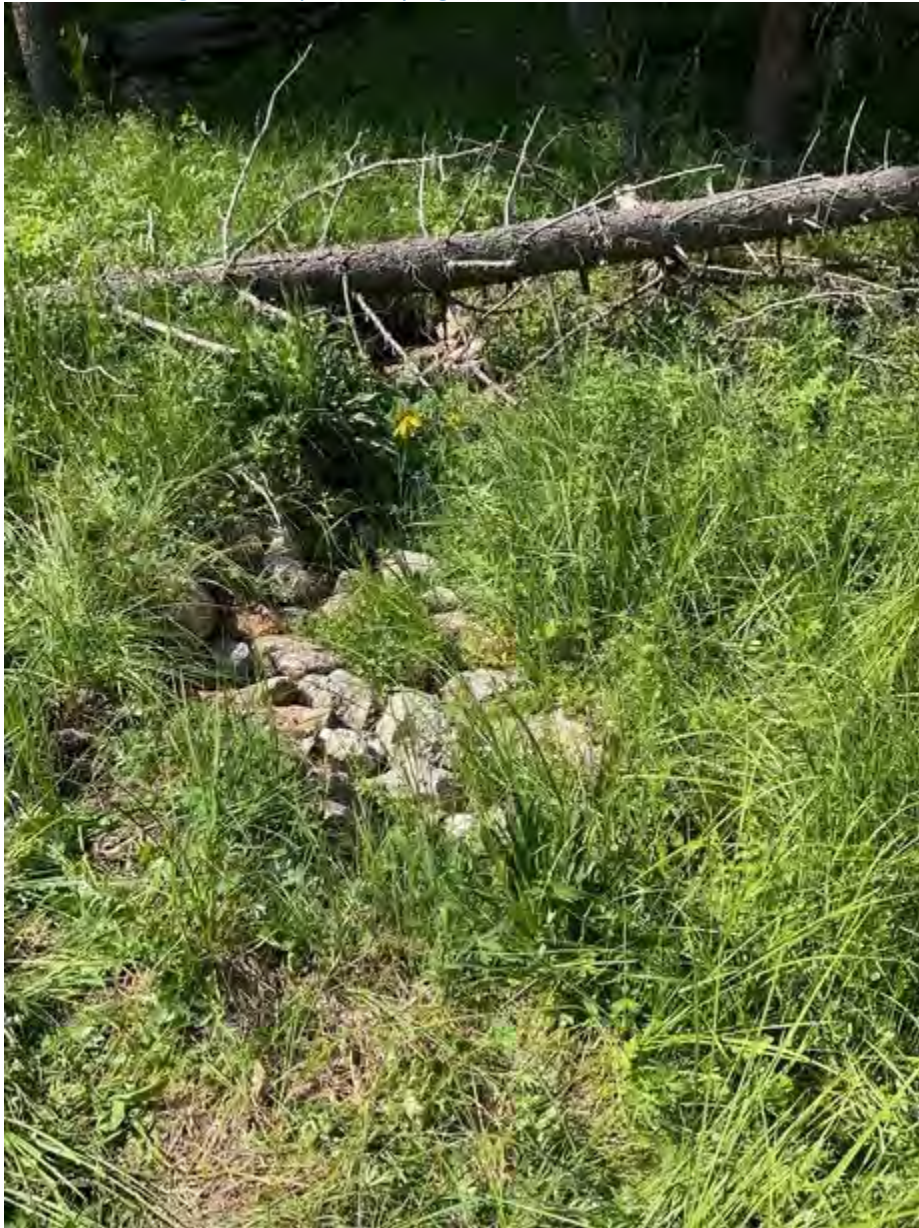
-106.6013722 35.9239816

Some rocks dislodged or broken

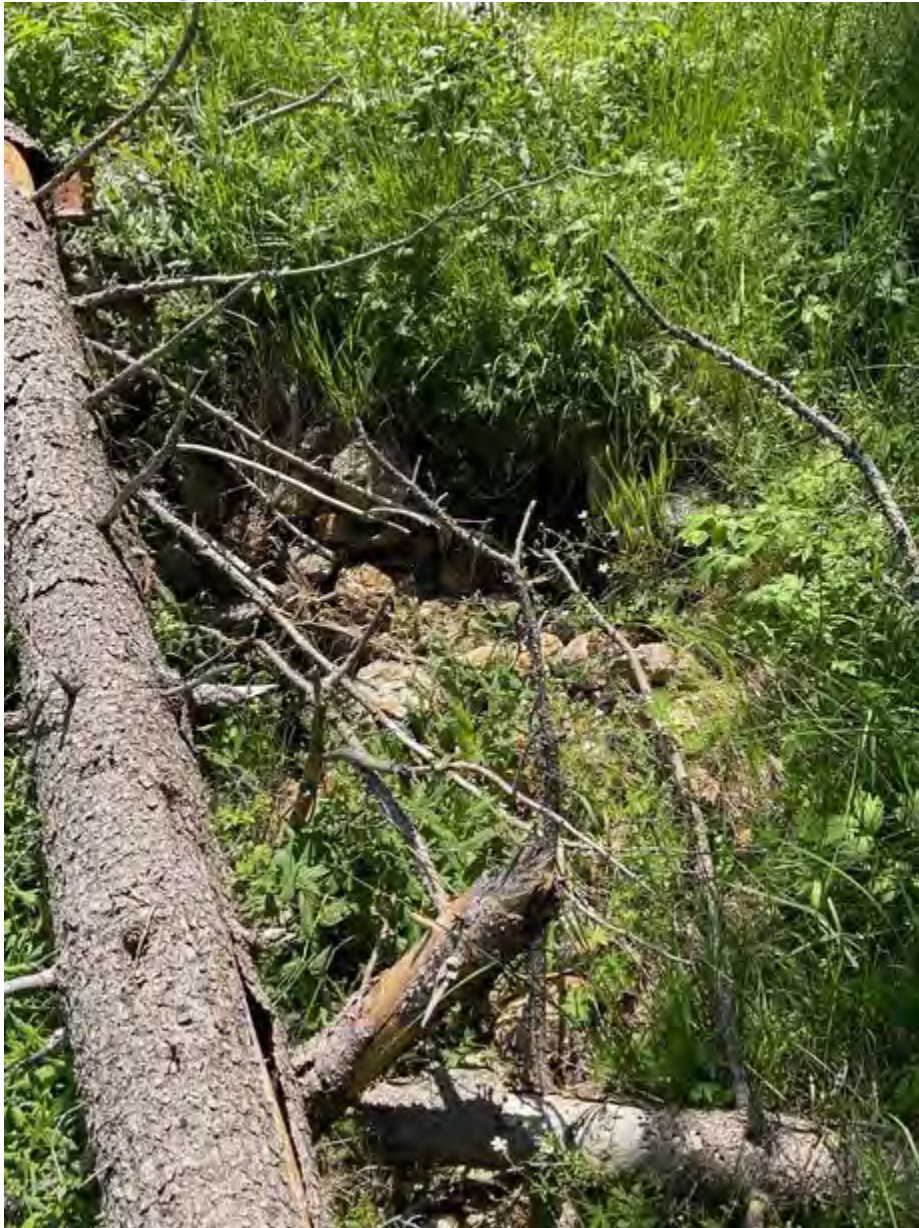
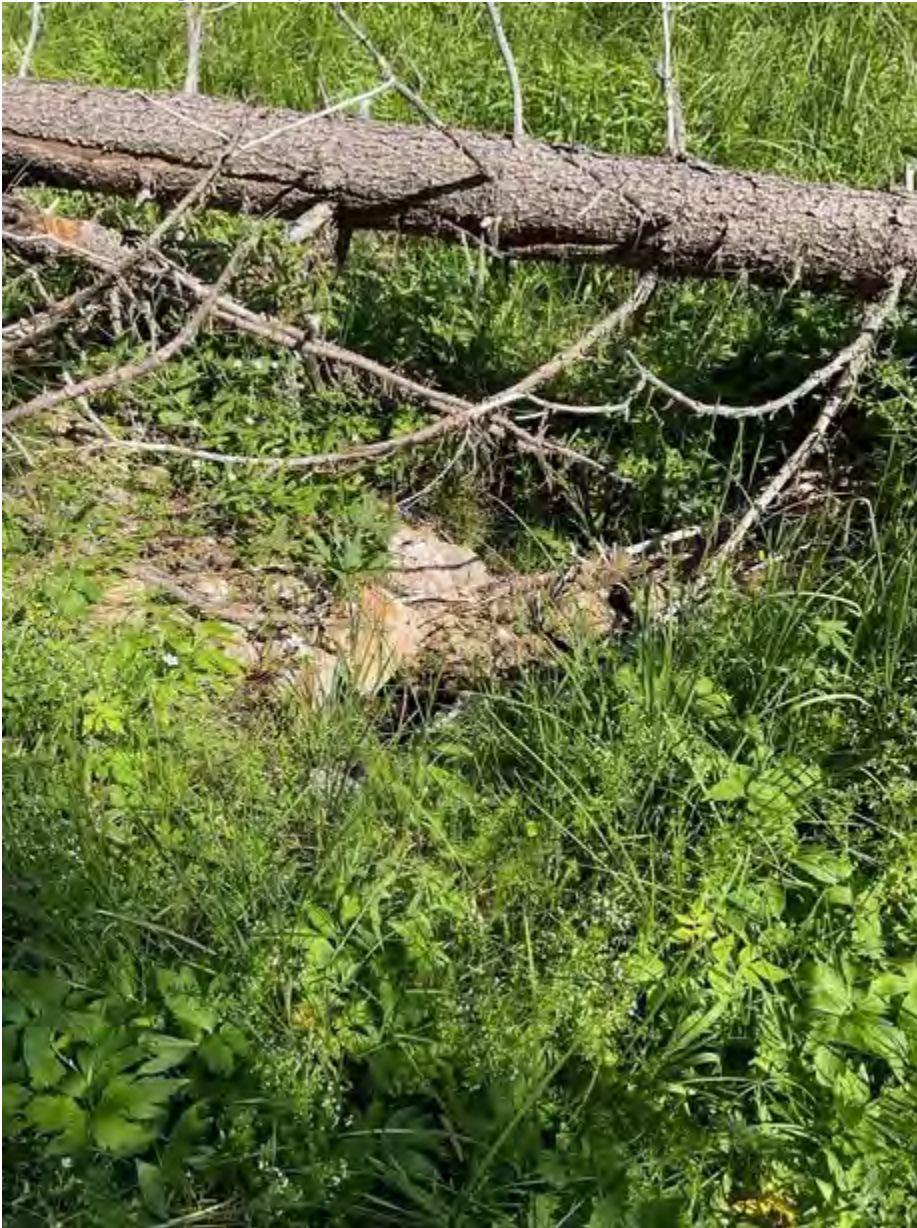
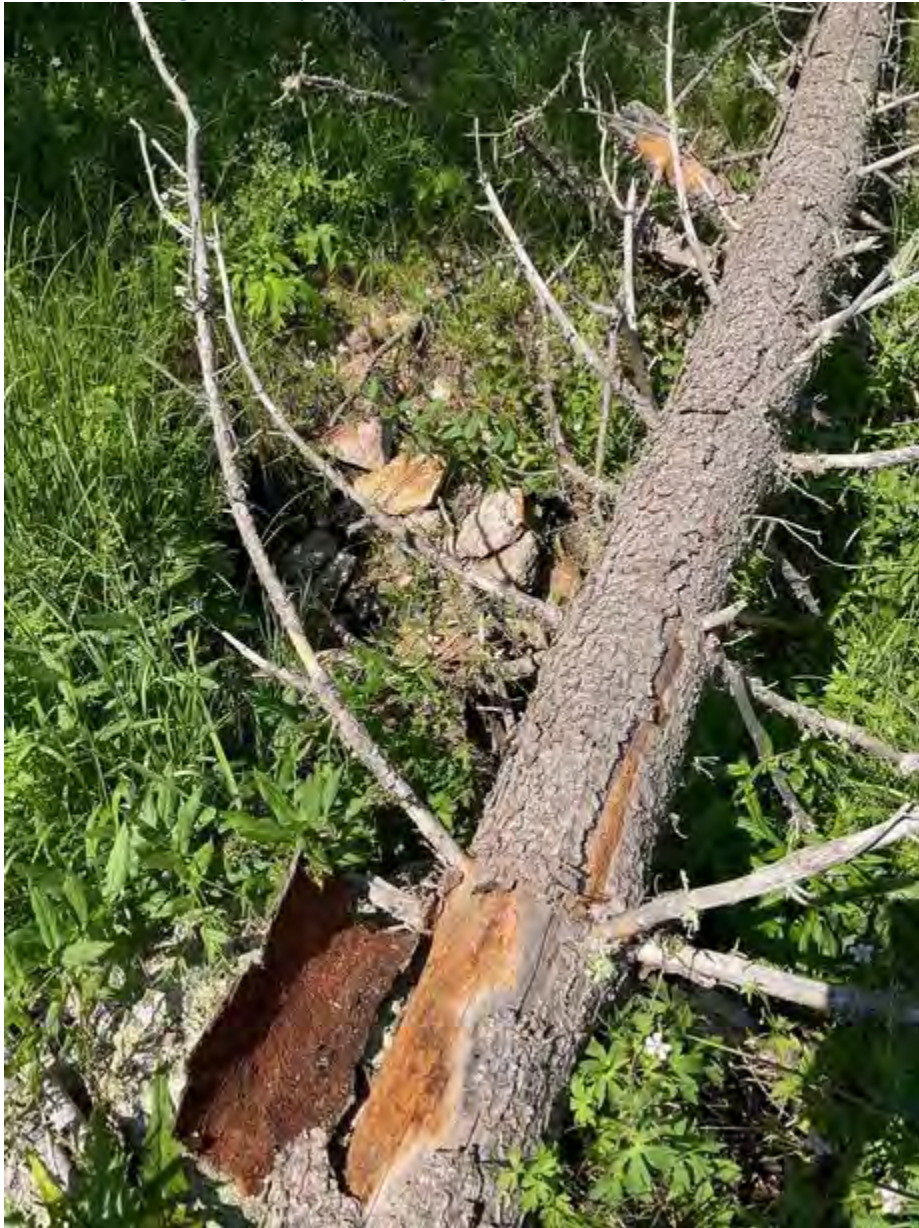
-106.6013507 35.92396522

Some rocks dislodged or broken

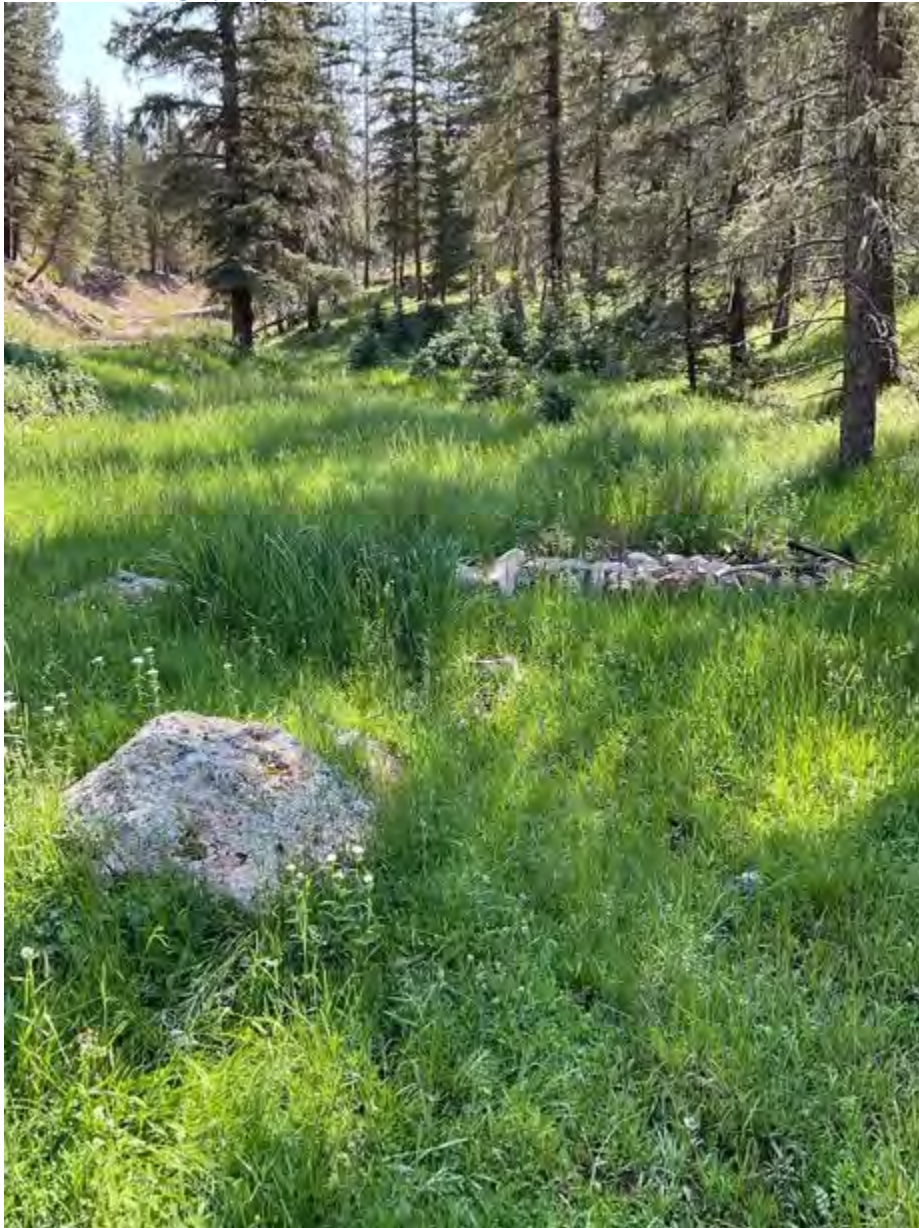
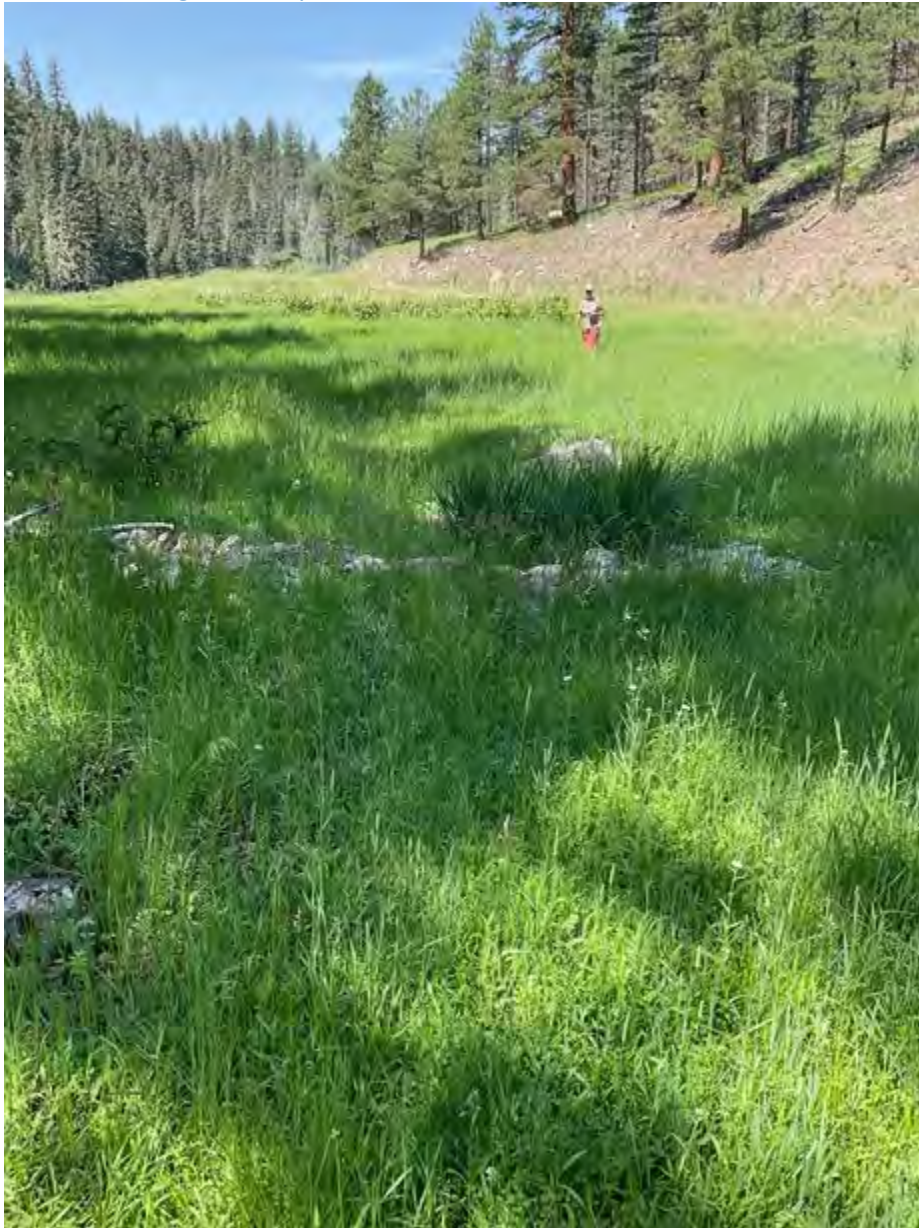
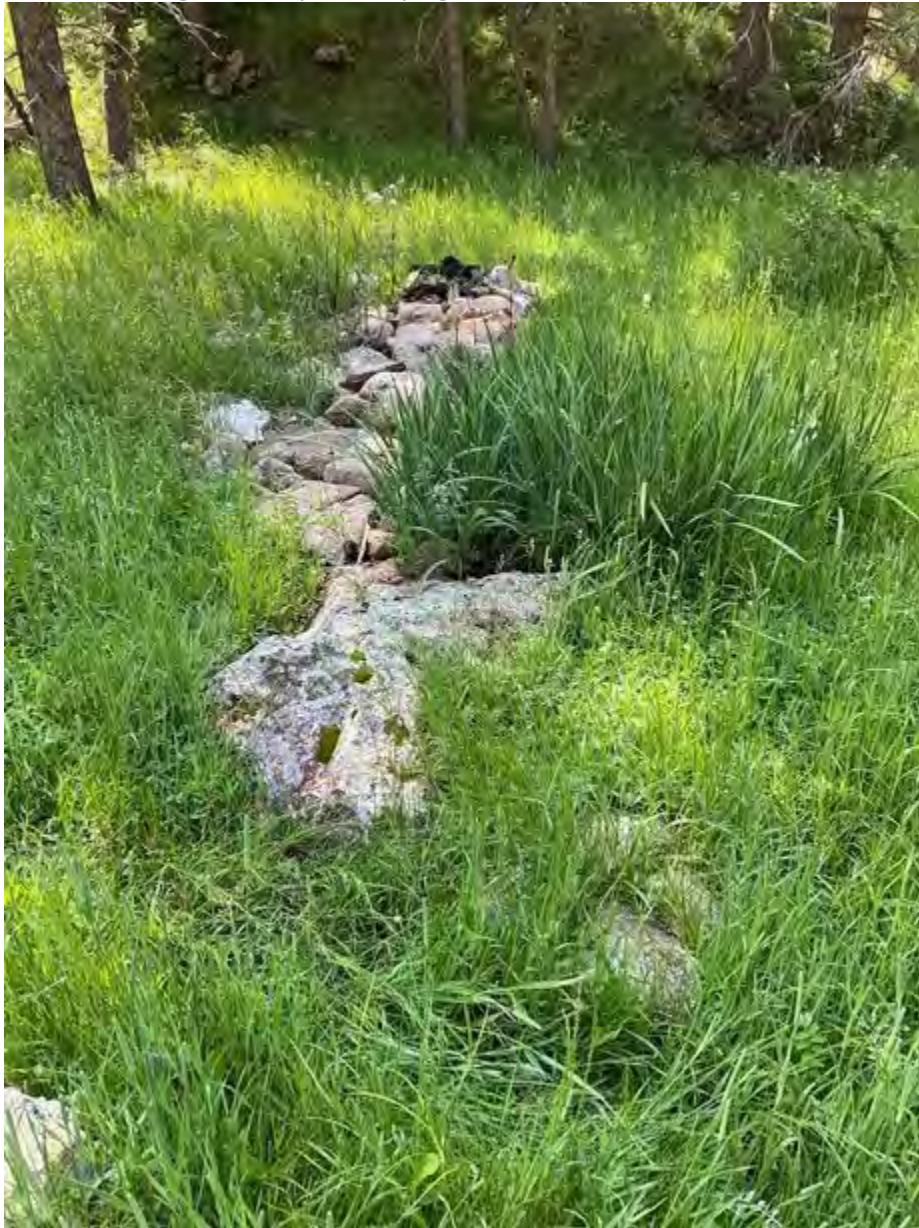
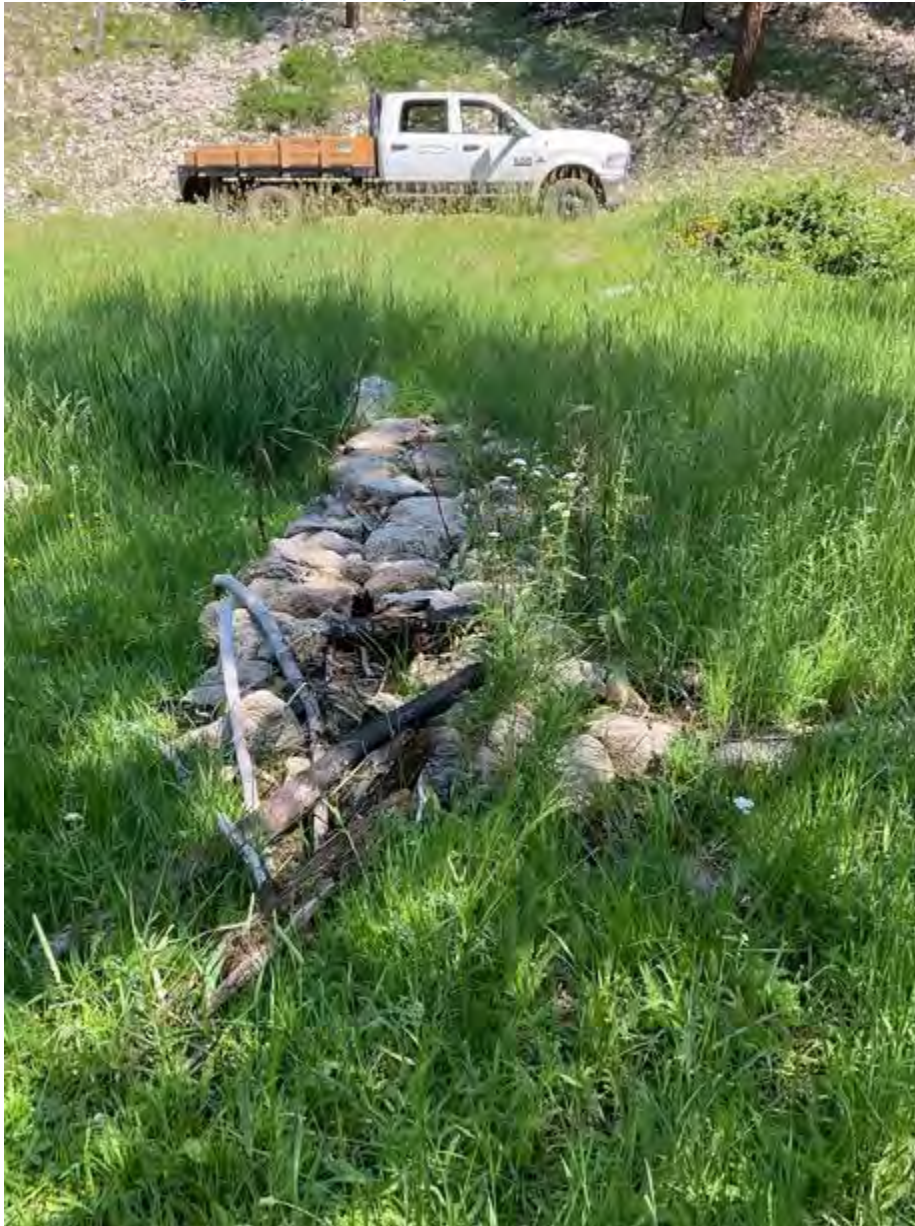
-106.5974051 35.92597653

All rocks intact

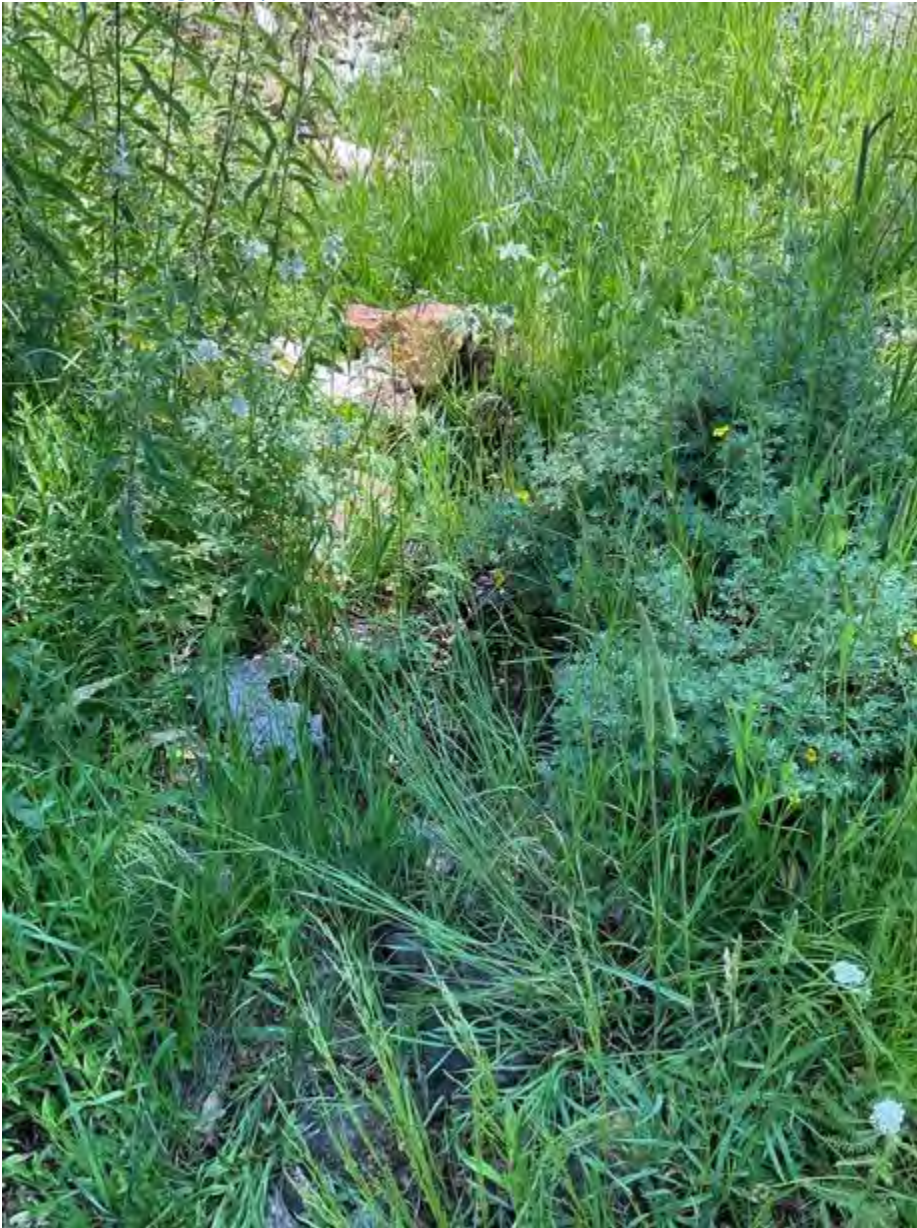
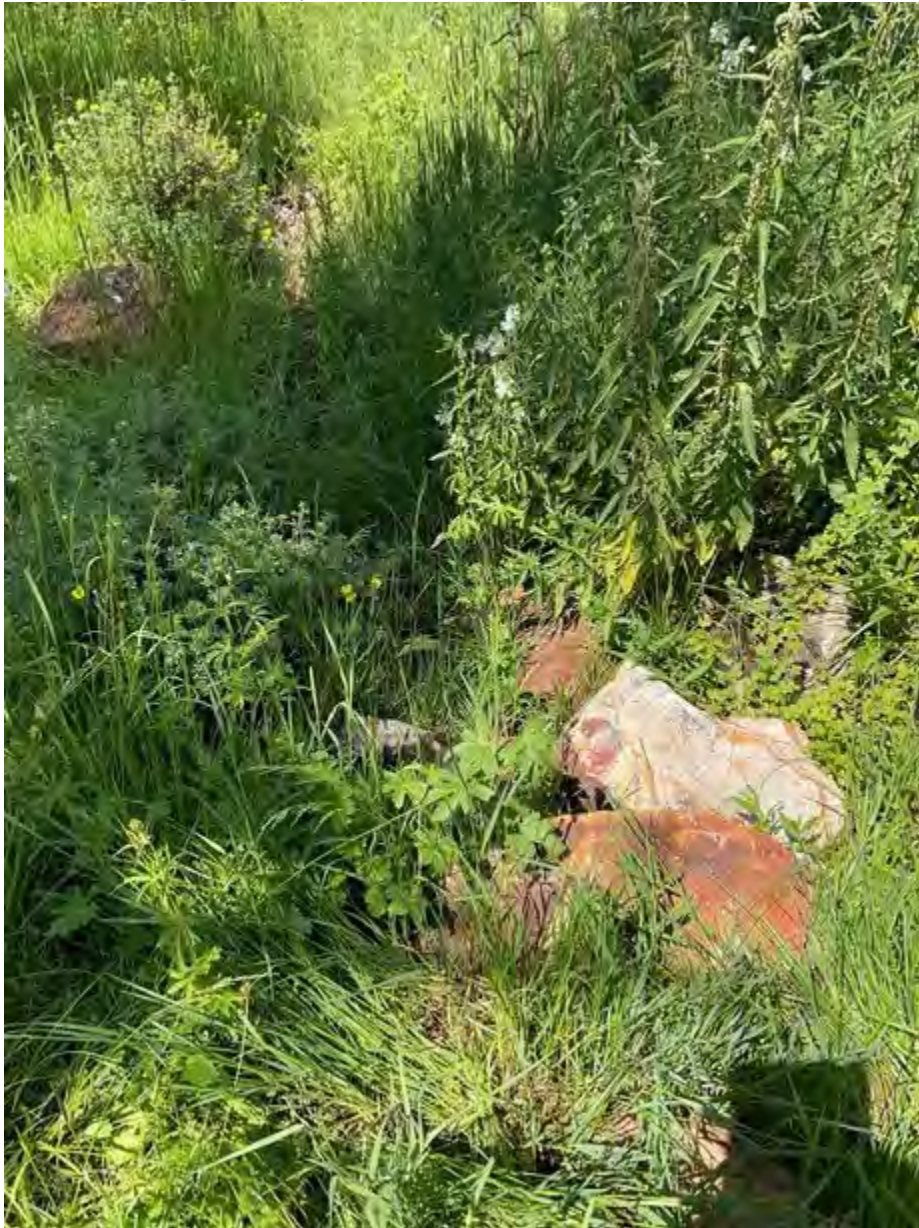
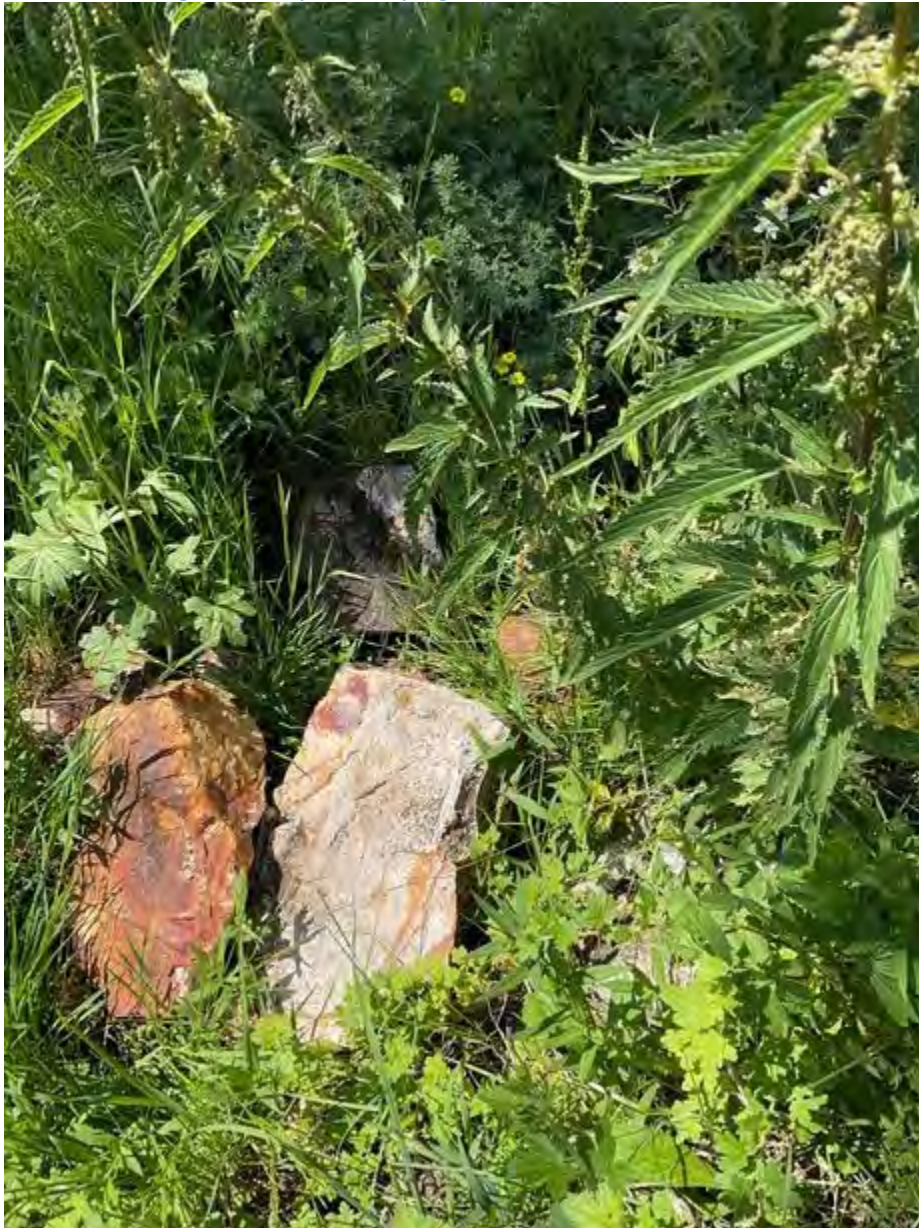
-106.596739 35.92636523

Some rocks dislodged or broken
