**Zuni Bowl and One Rock Check Dam Research –
Phase 1**

Final Report

December 2024

Rio Grande Return for the New Mexico Department of Transportation Research Bureau

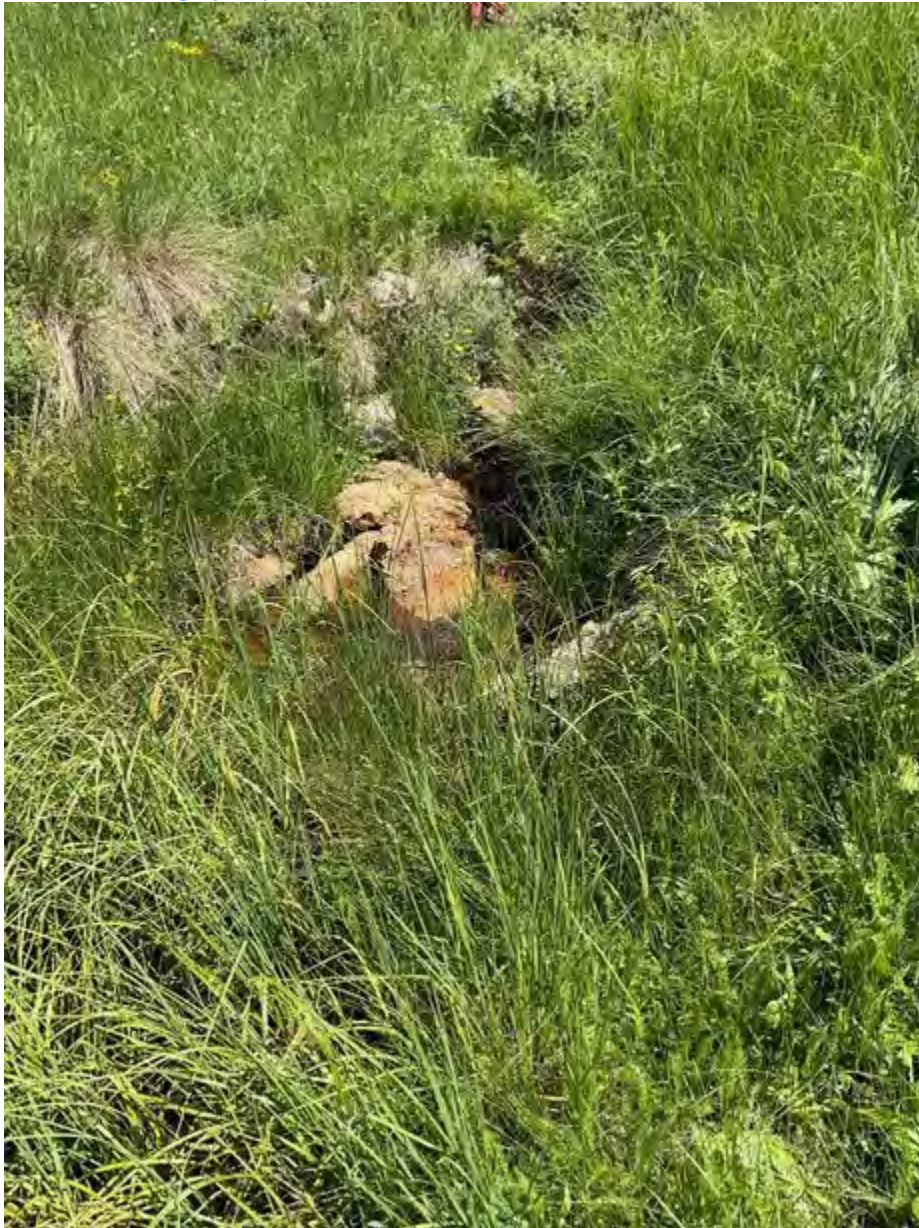
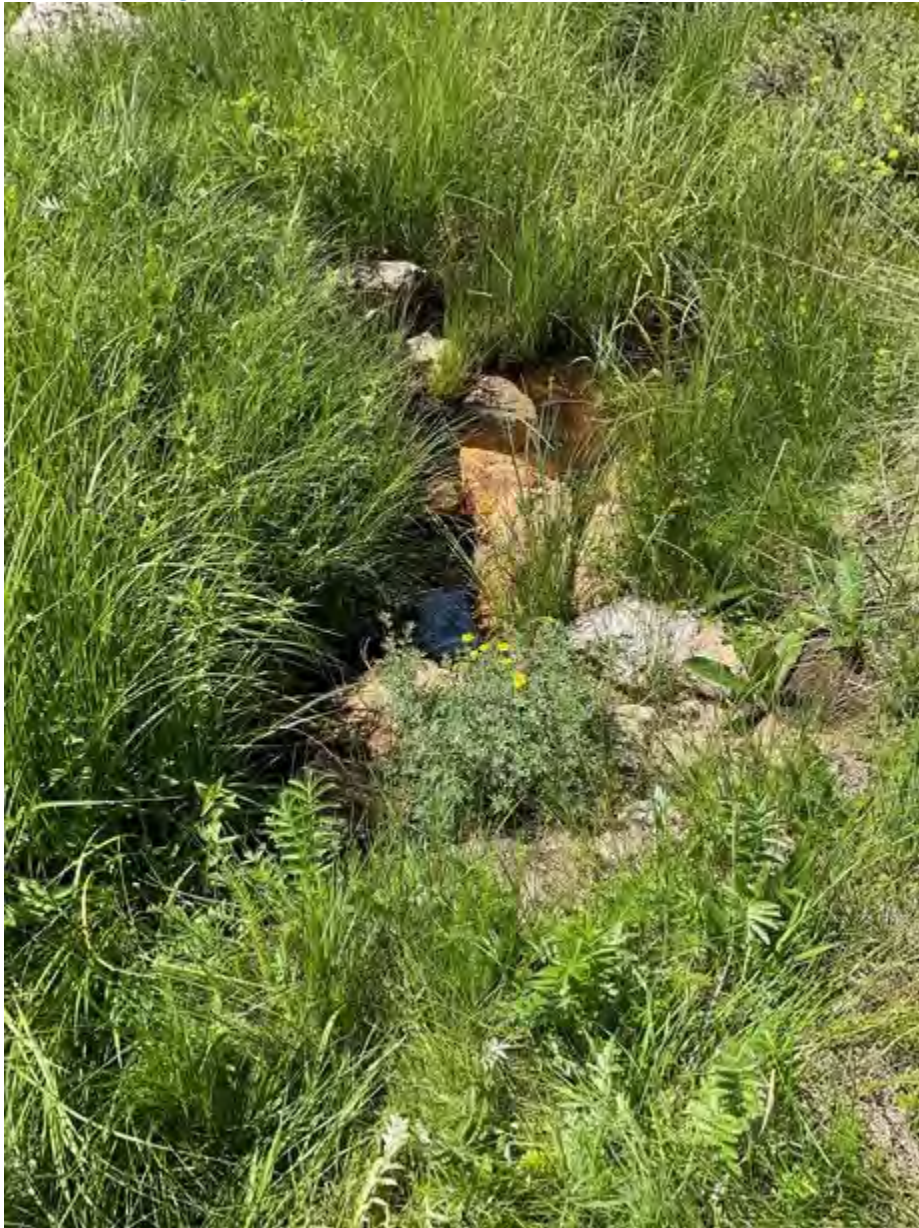
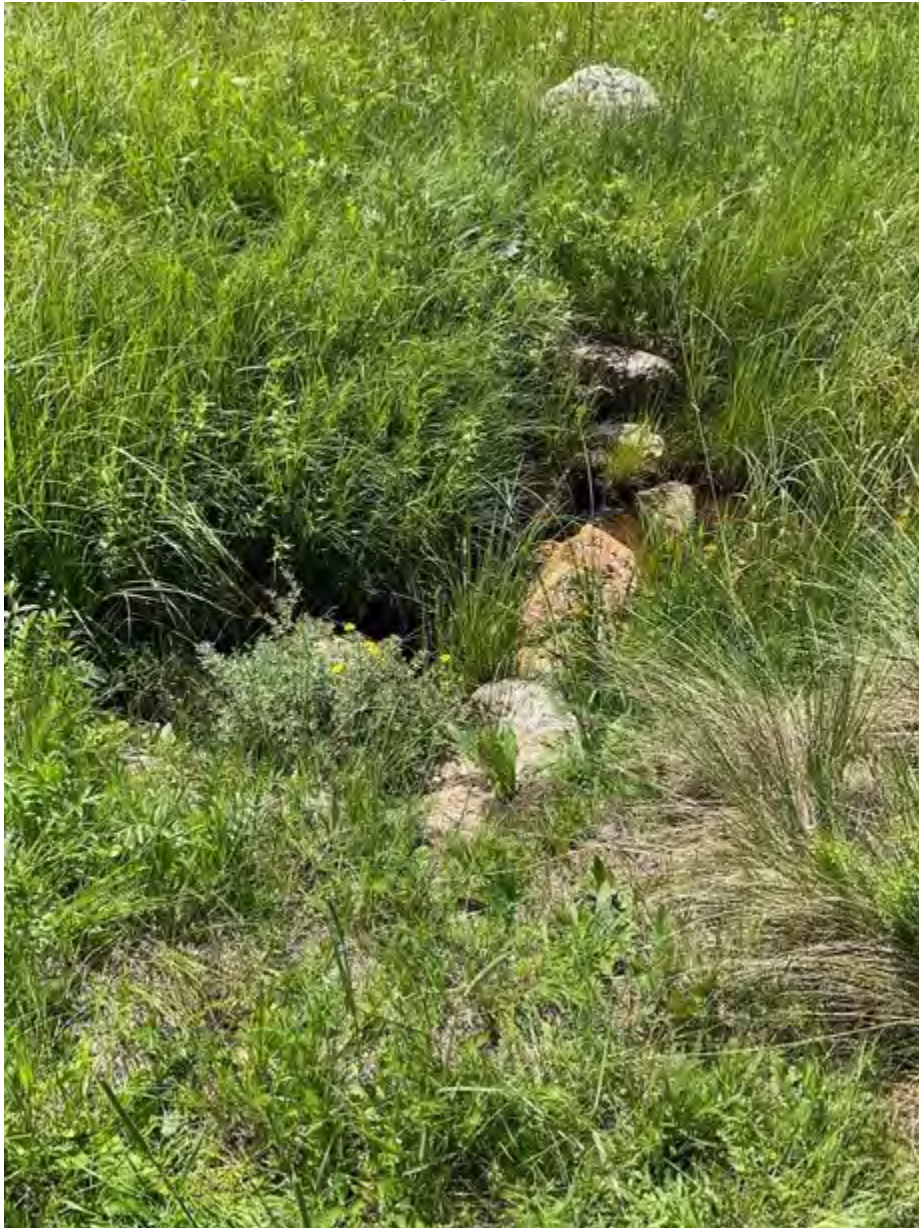
-106.5957161 35.9267053

Some rocks dislodged or broken

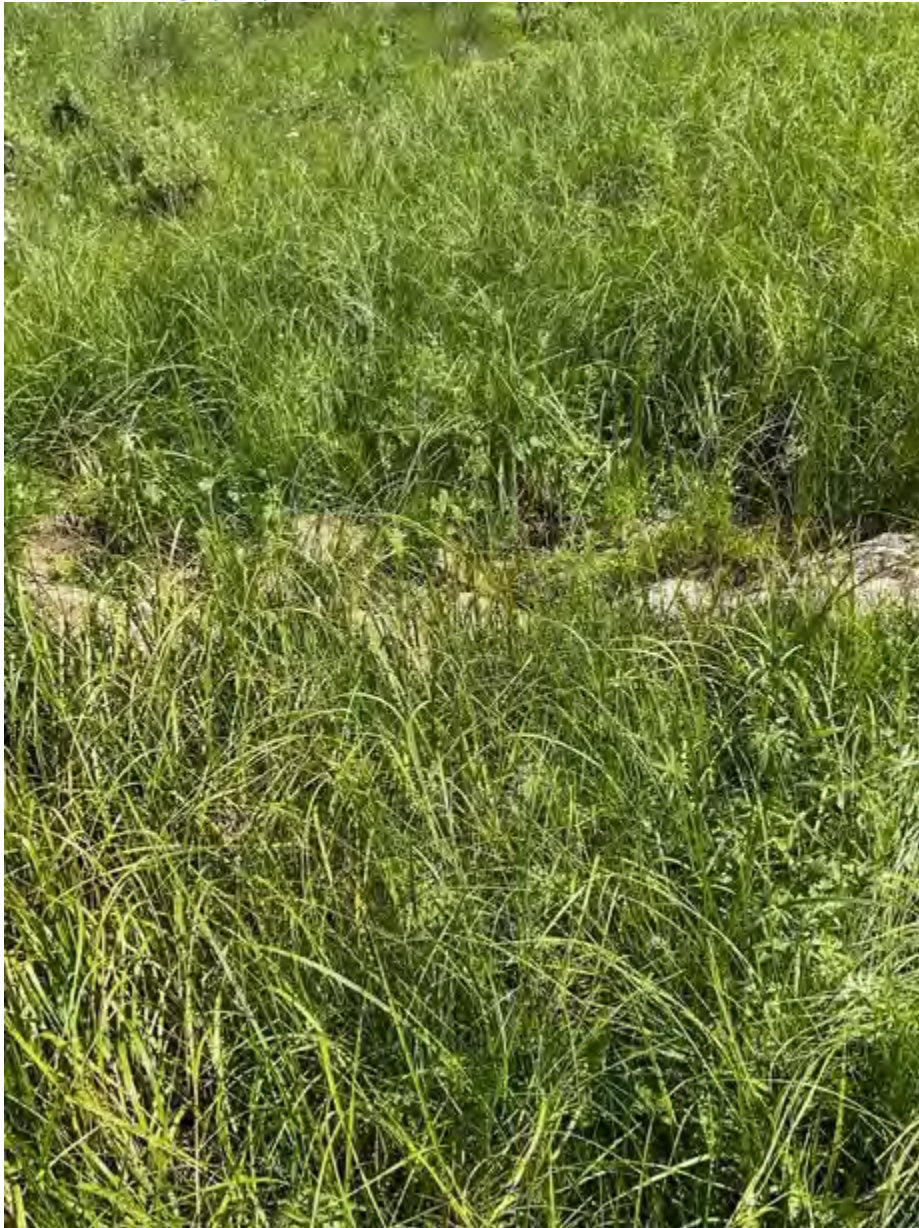
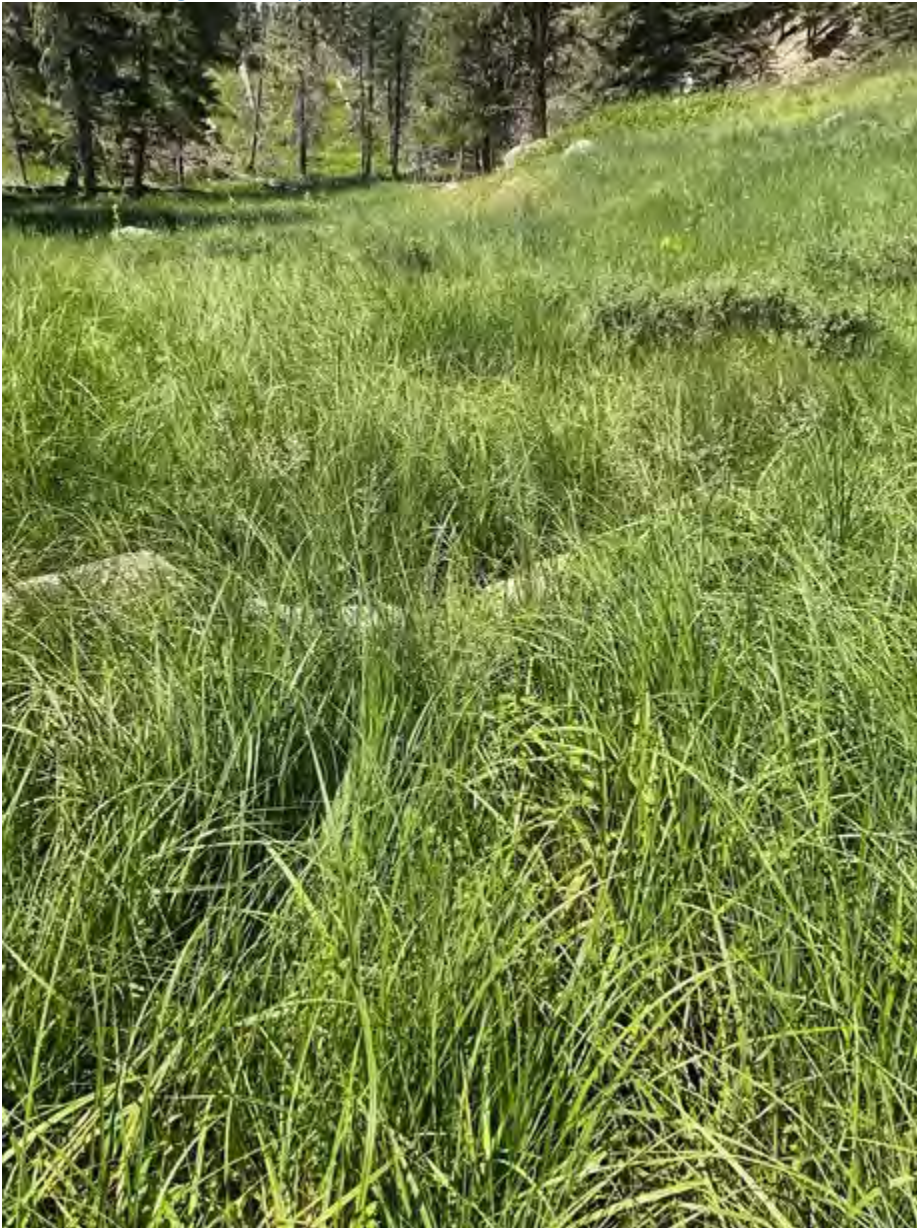
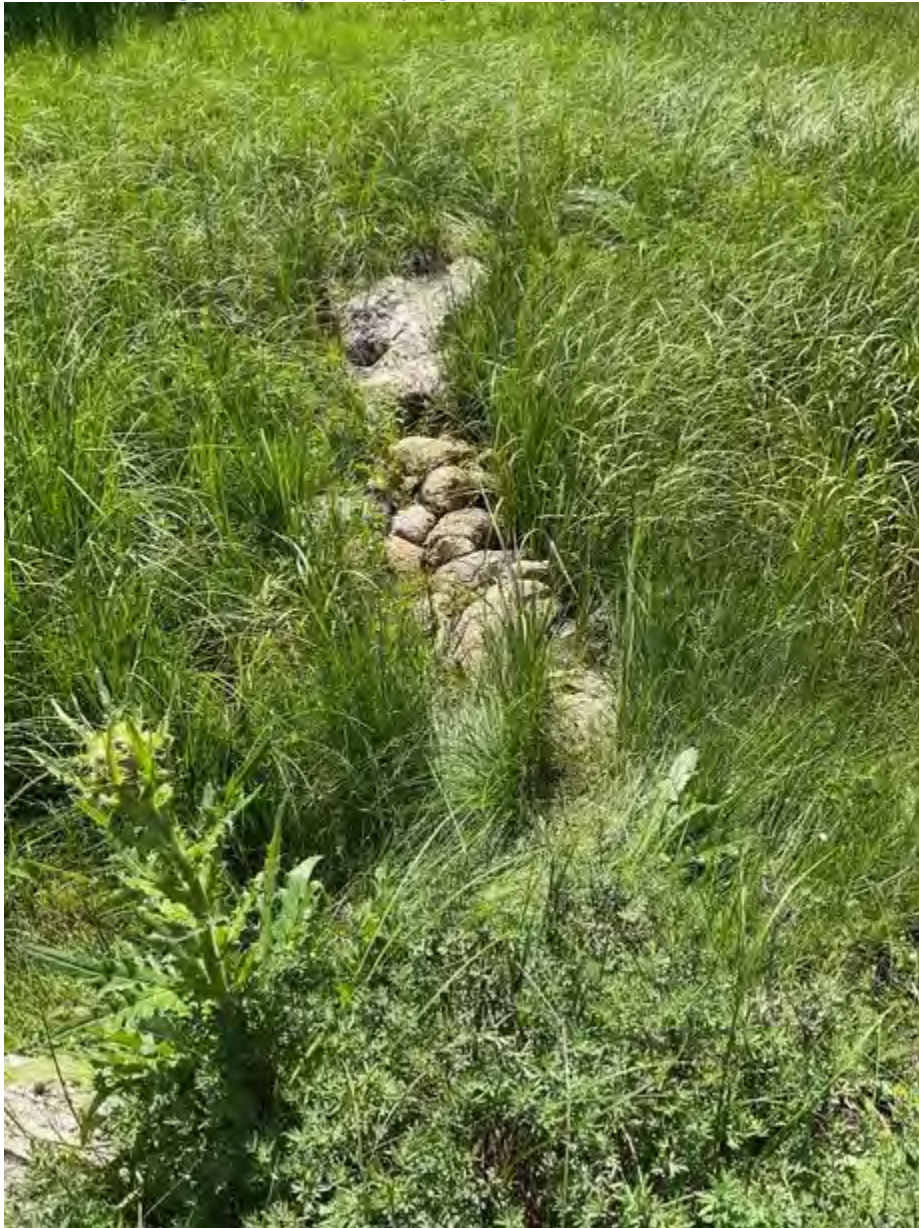
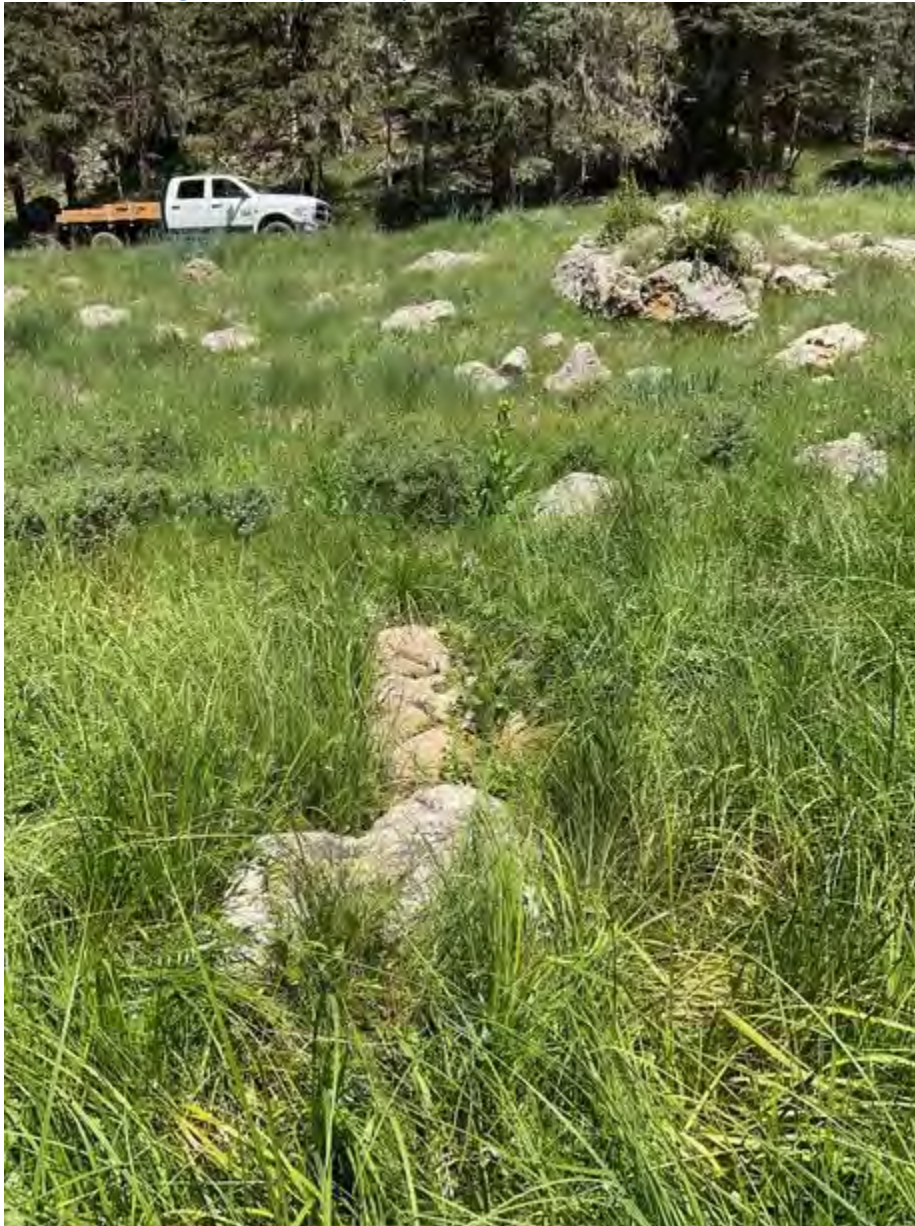
-106.5956386 35.92677082

All rocks intact

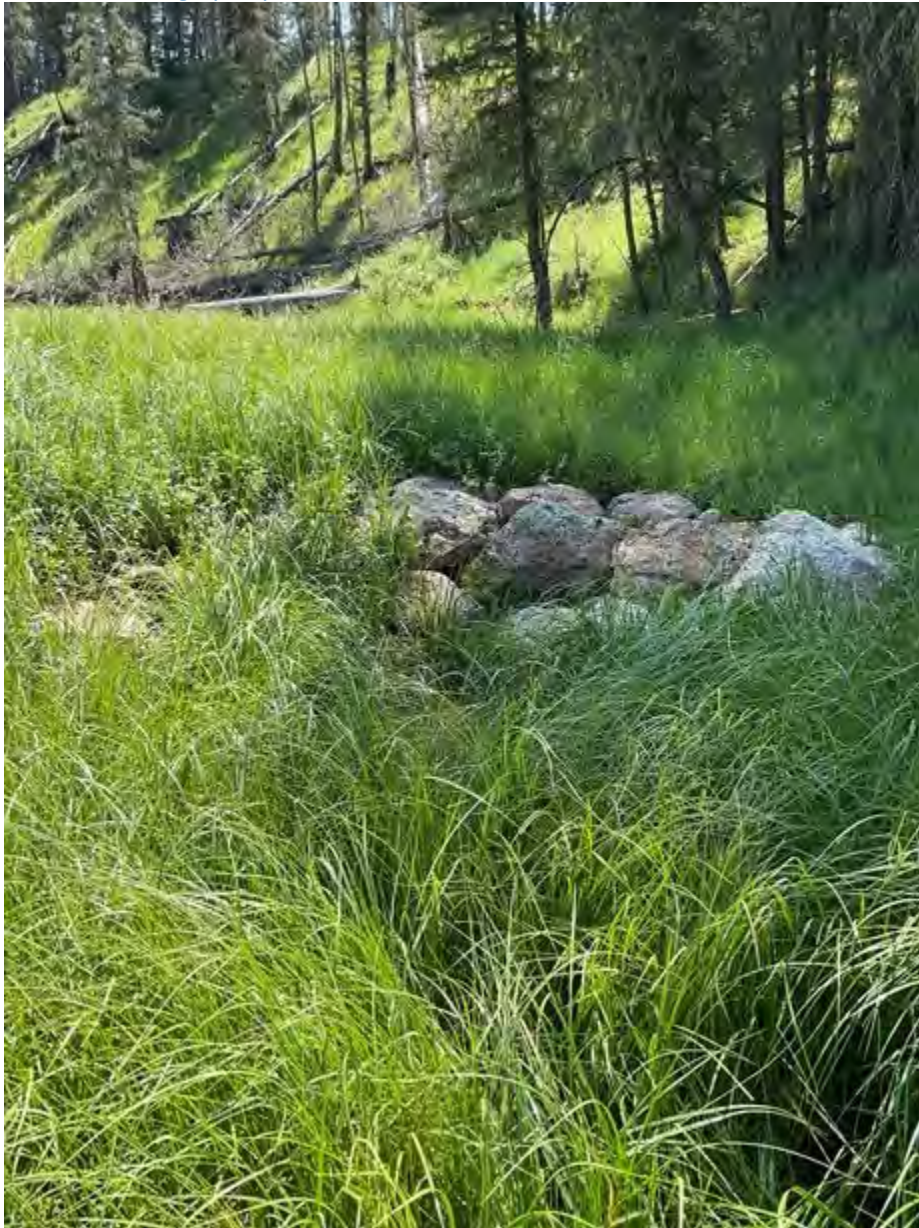
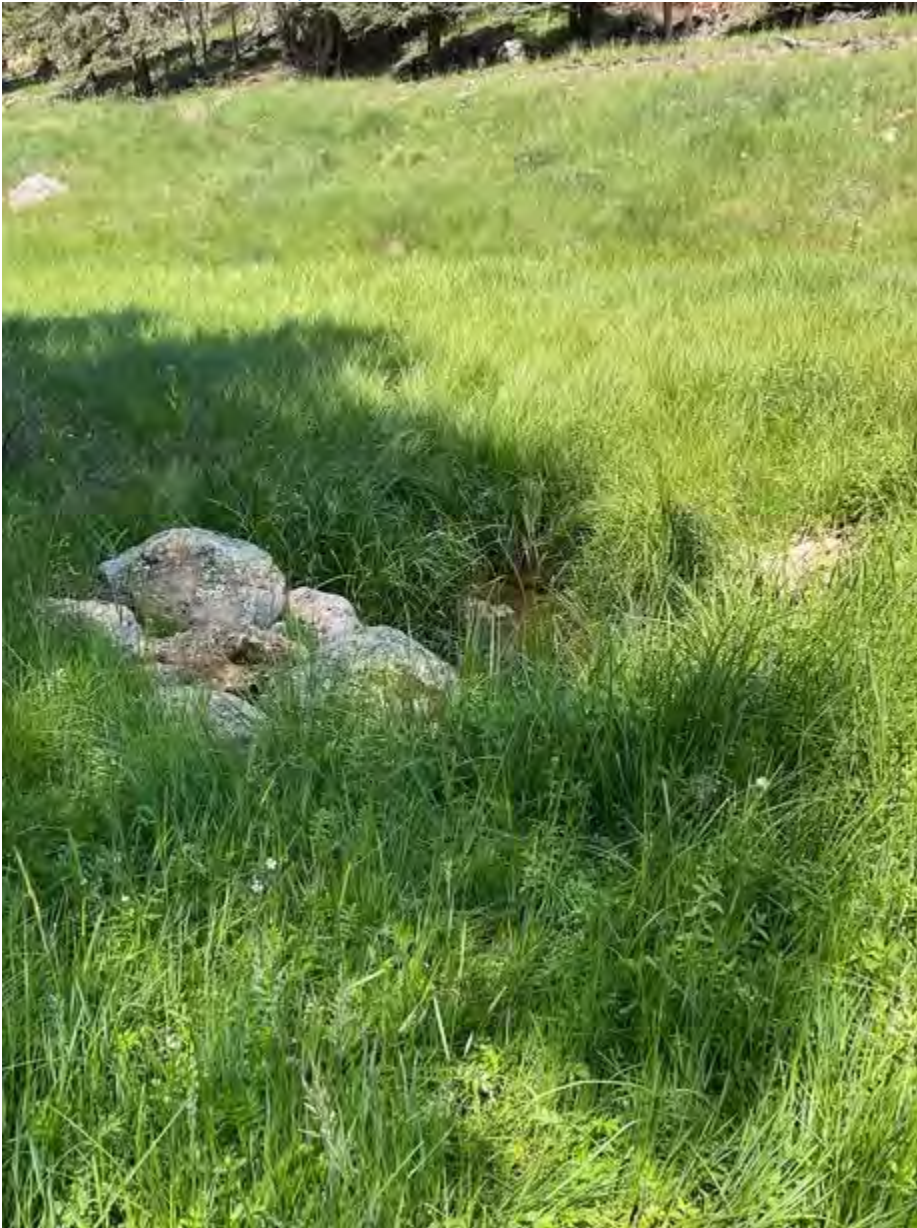
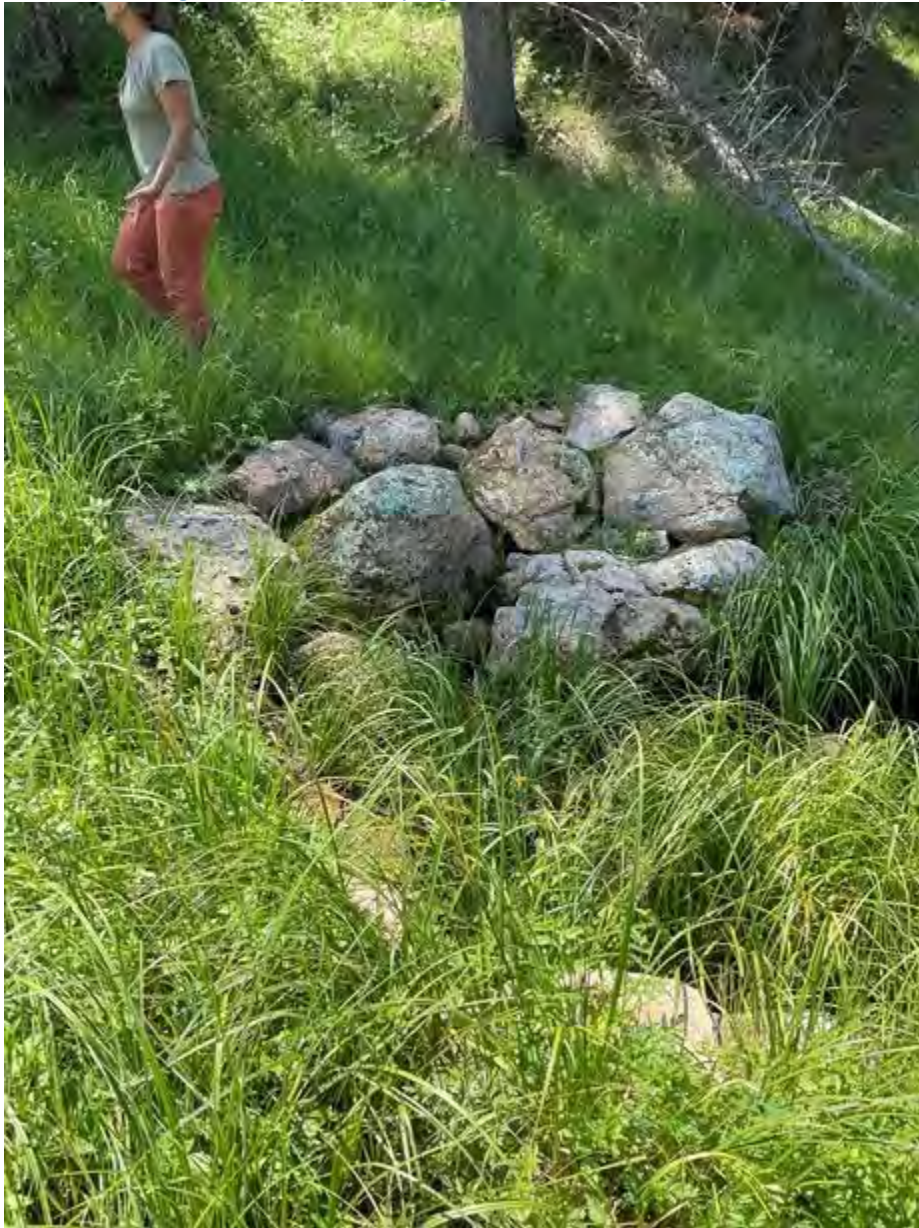
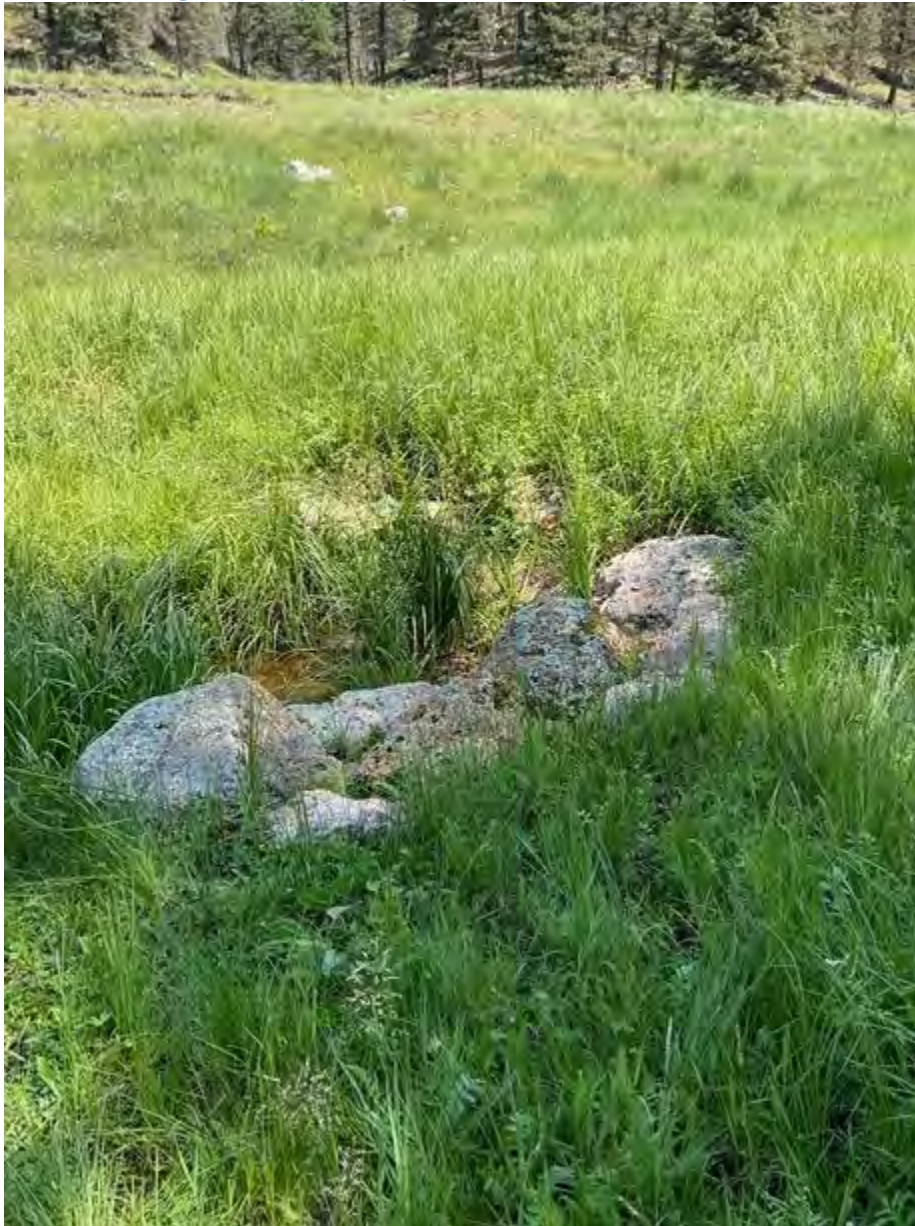
-106.5953365 35.92701612

All rocks intact

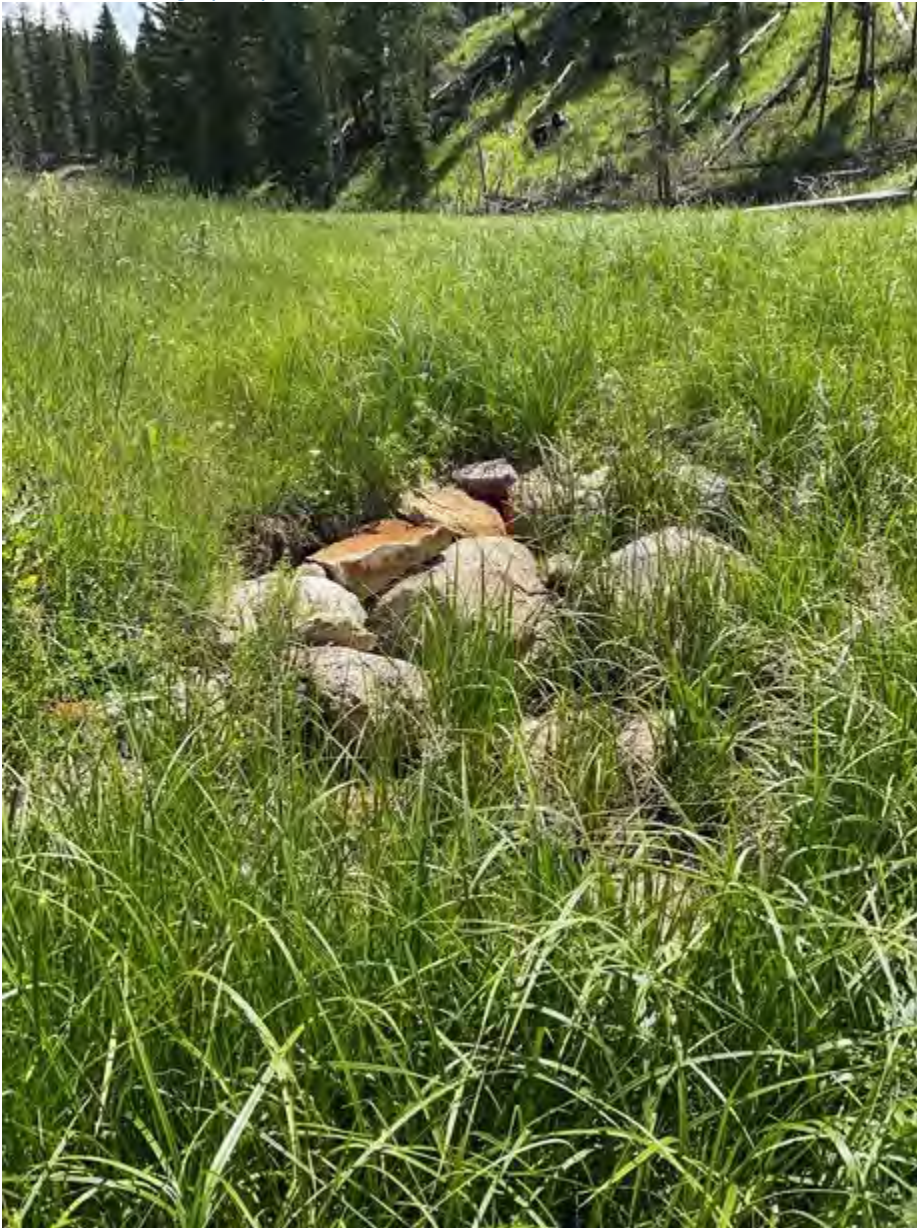
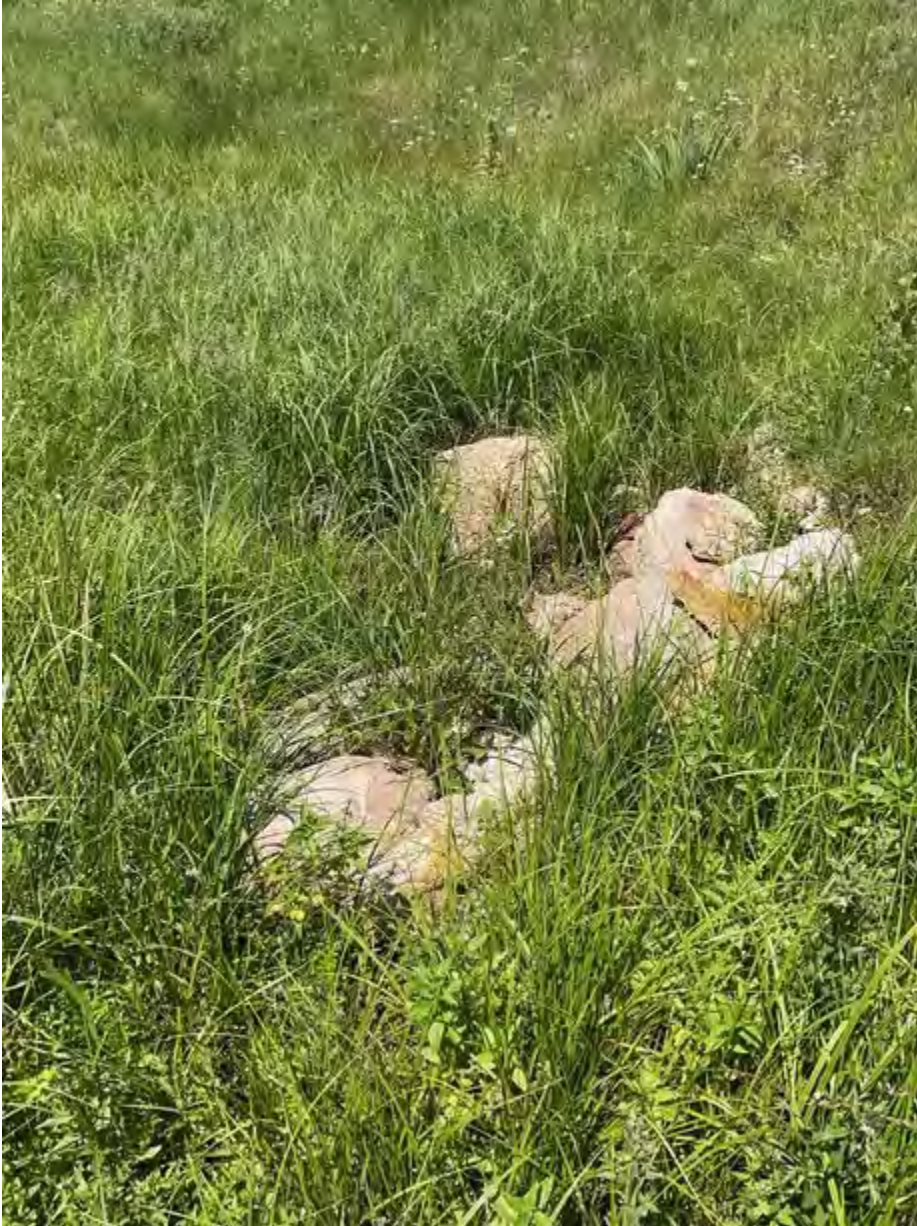
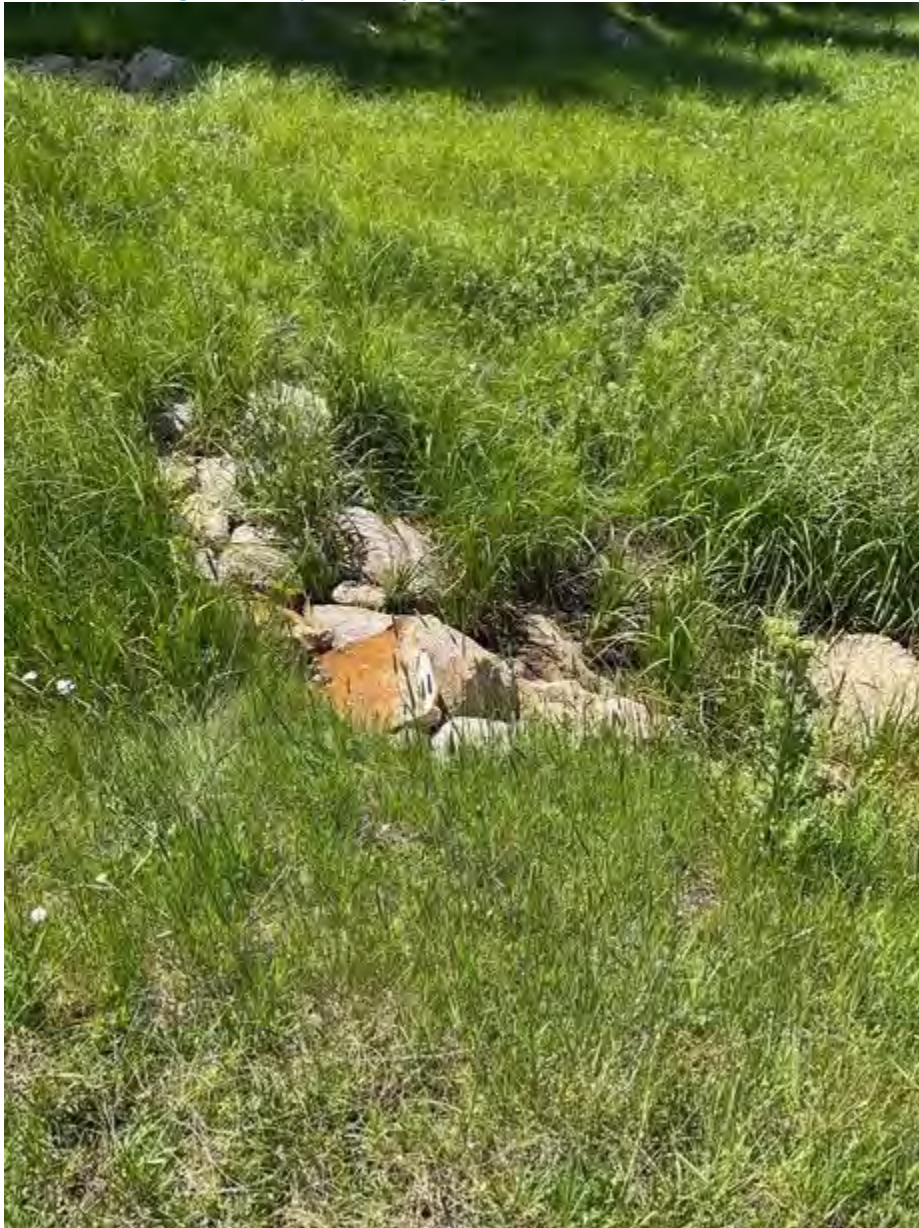
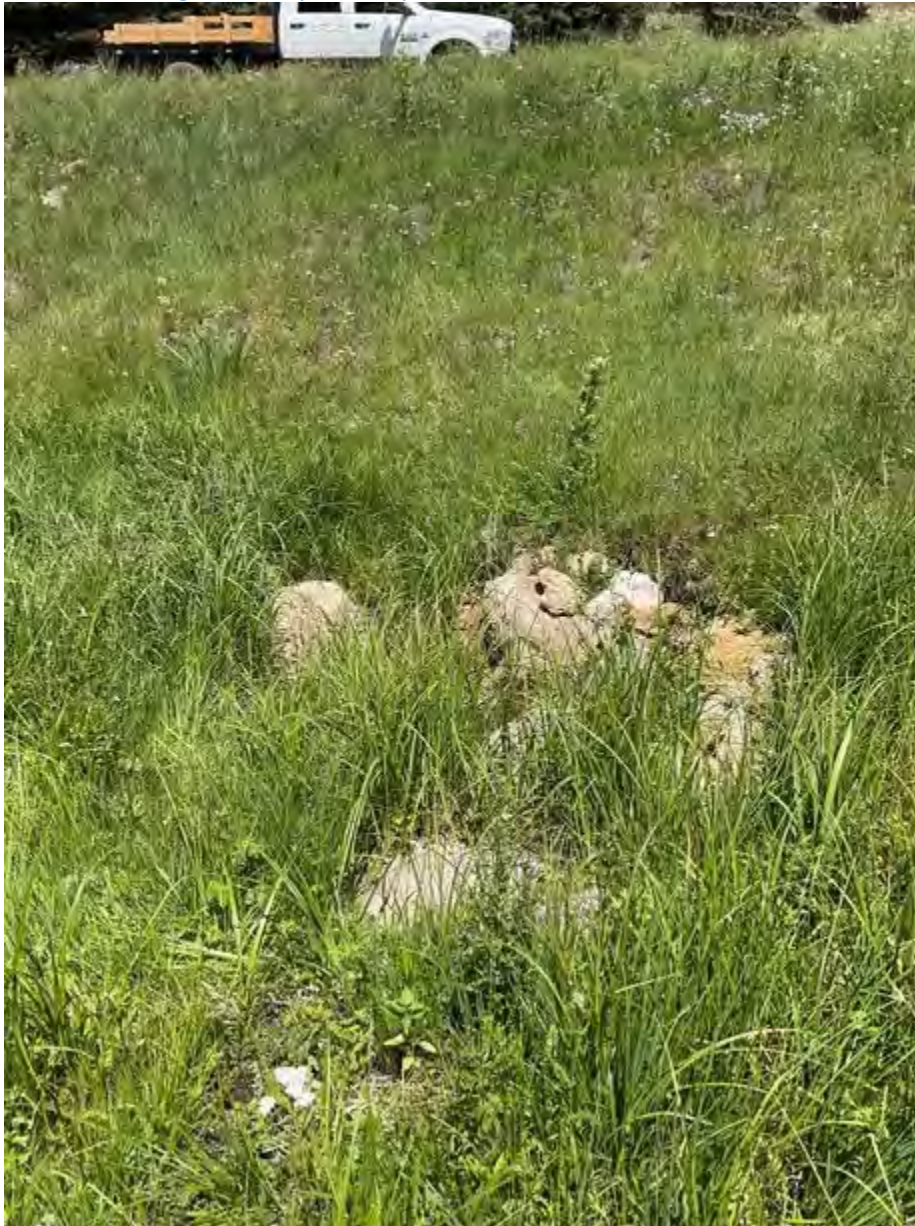
-106.595385 35.92712025

Some rocks dislodged or broken

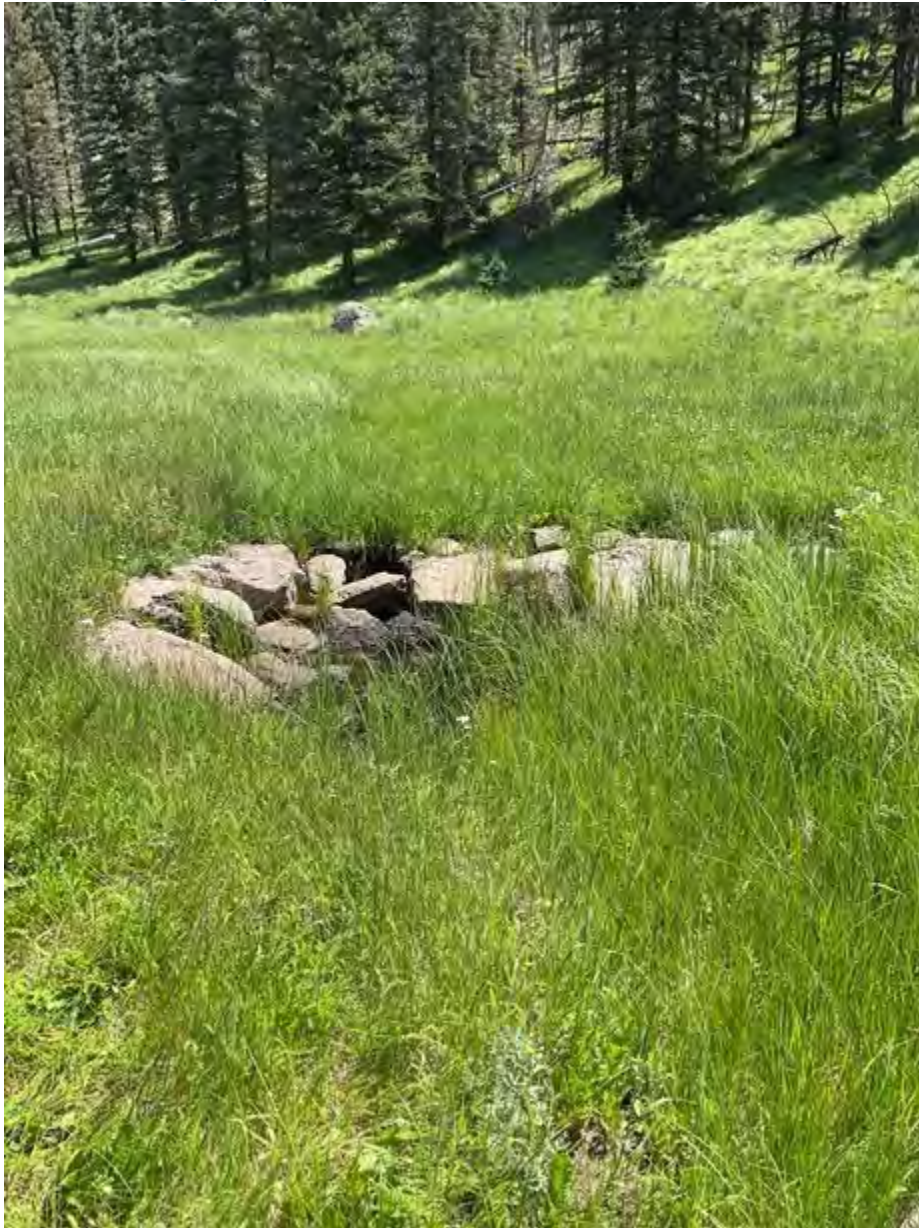
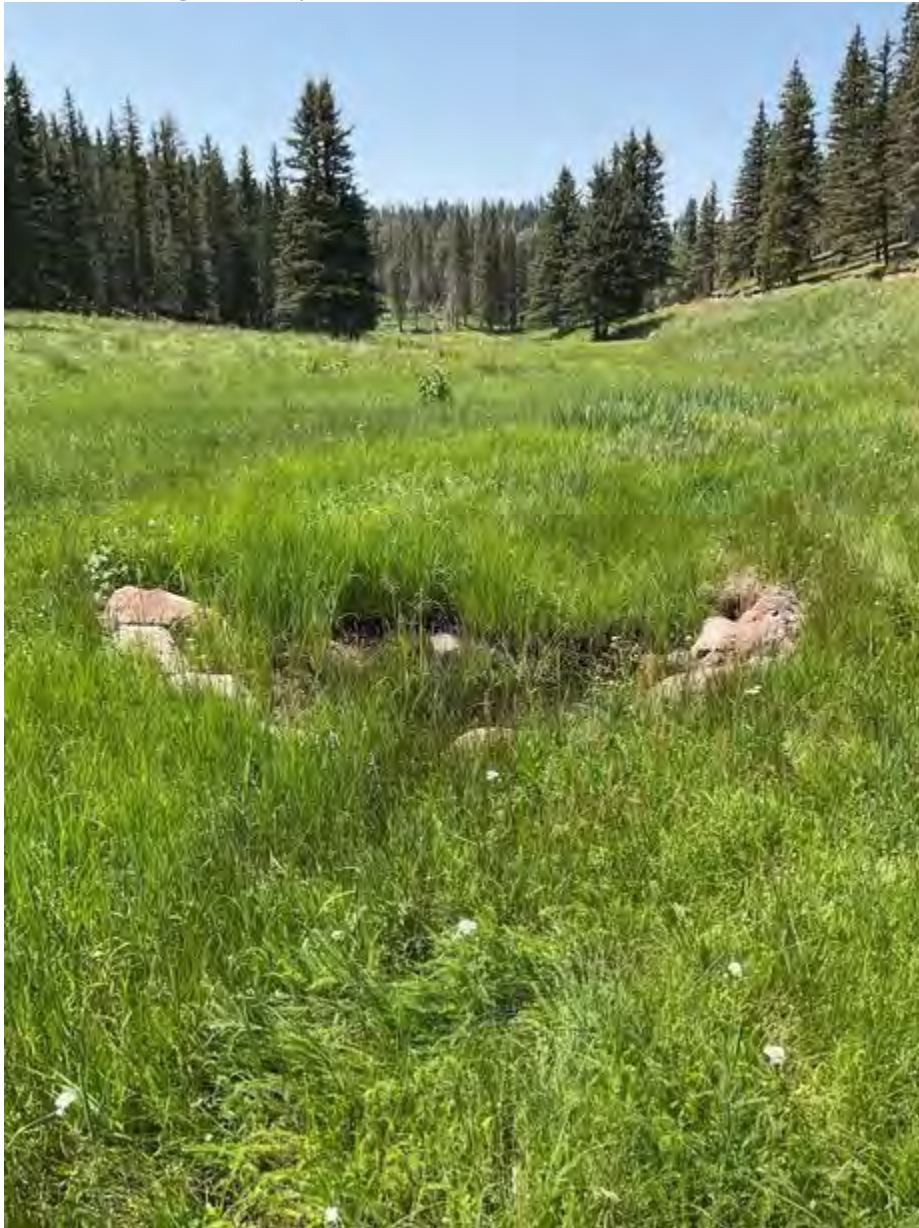
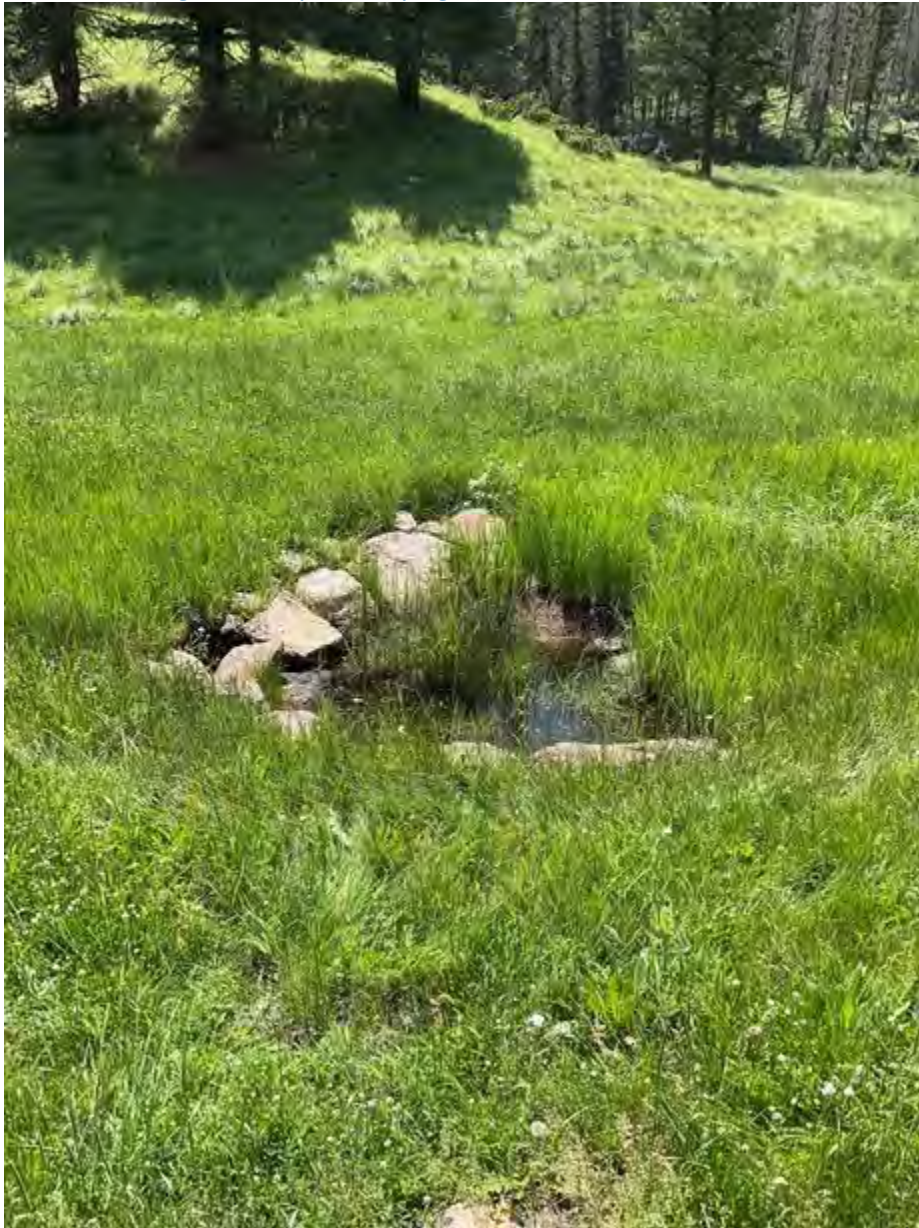
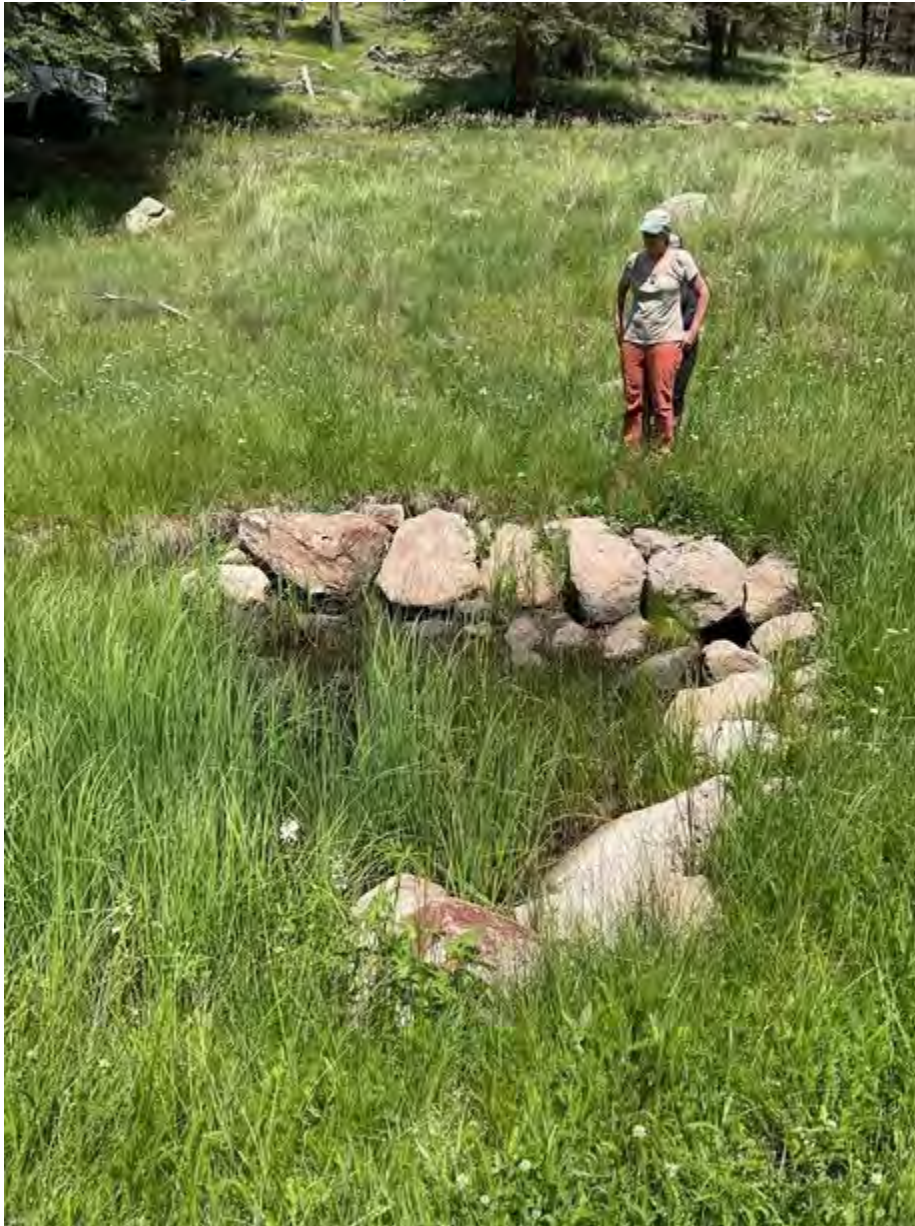
-106.5918327 35.93062668

All rocks intact
