**Zuni Bowl and One Rock Check Dam Research –
Phase 1**

Final Report

December 2024

Rio Grande Return for the New Mexico Department of Transportation Research Bureau

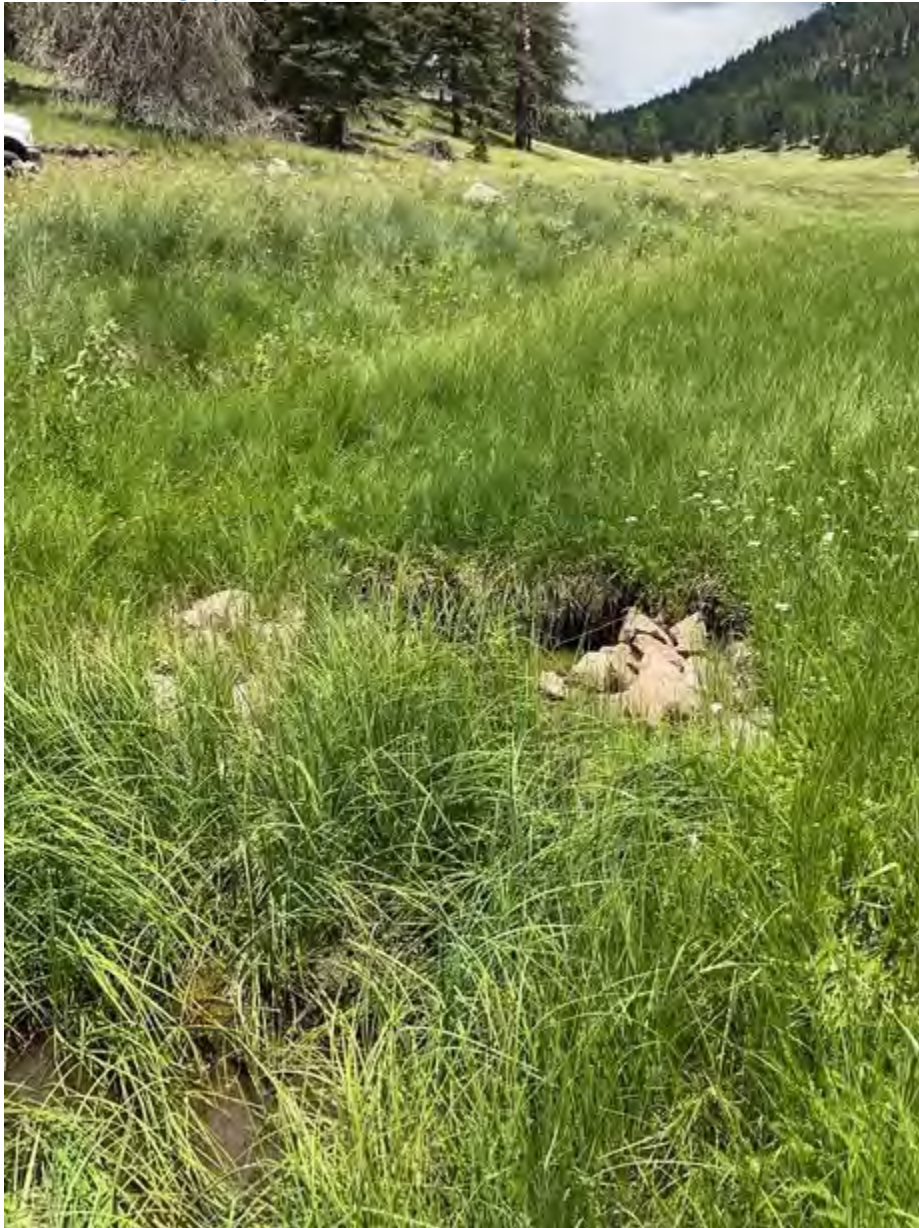
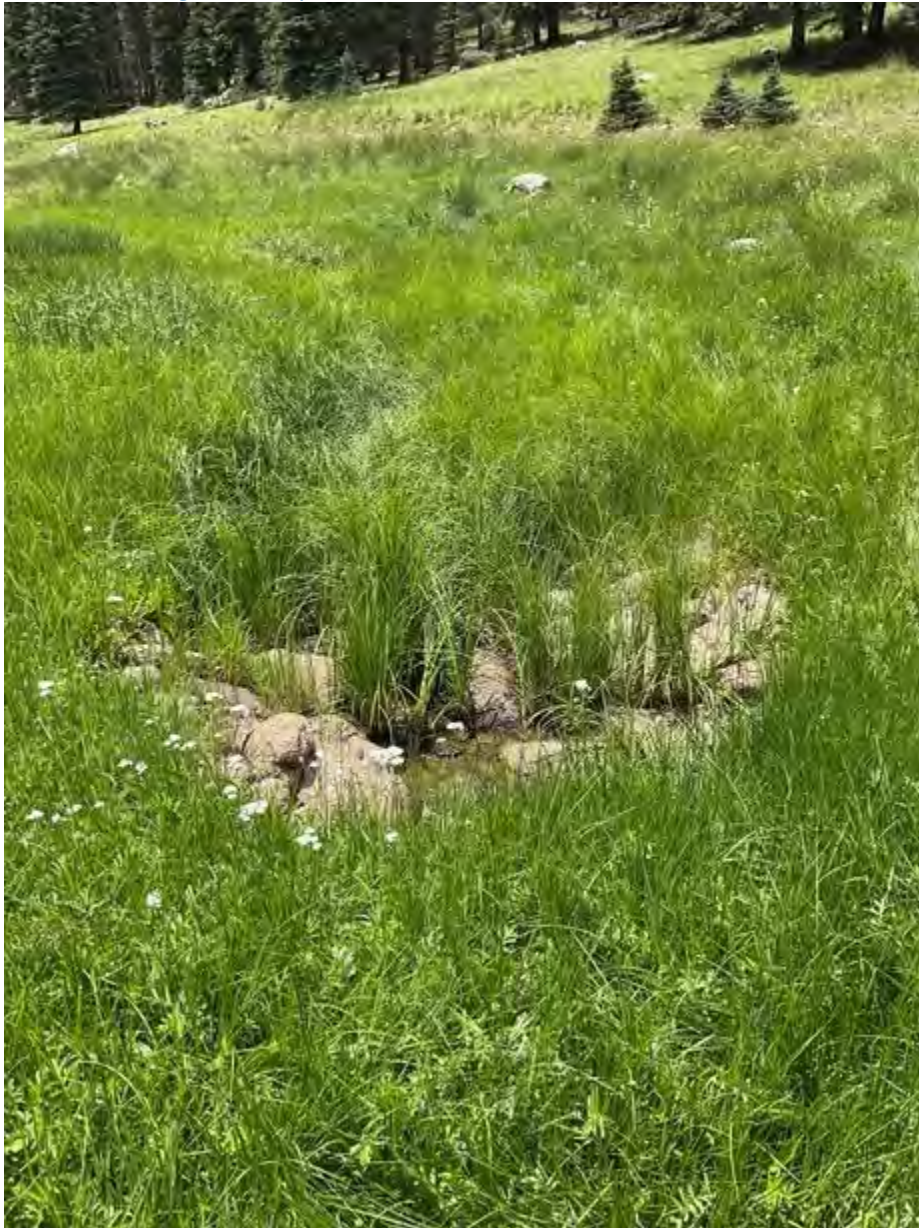
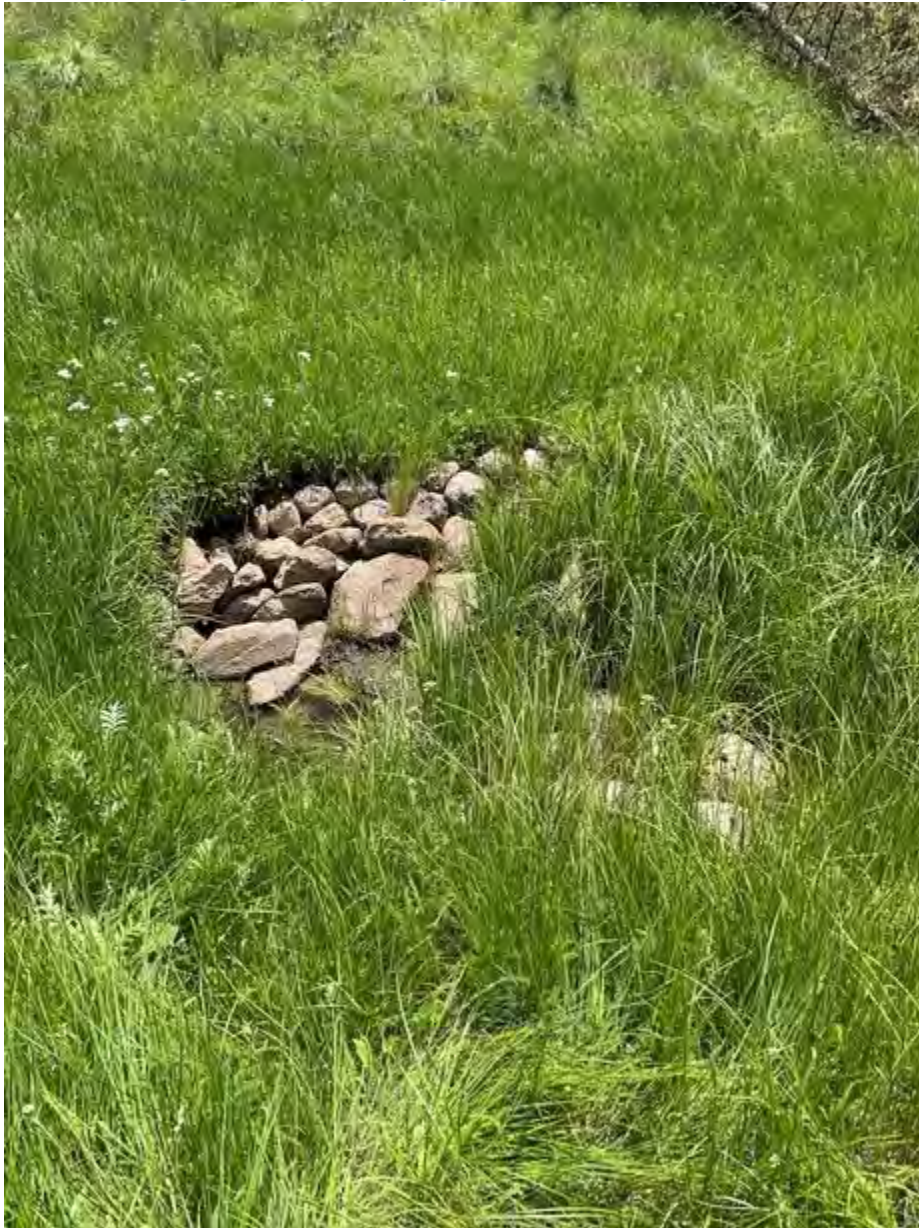
Some rocks dislodged or broken

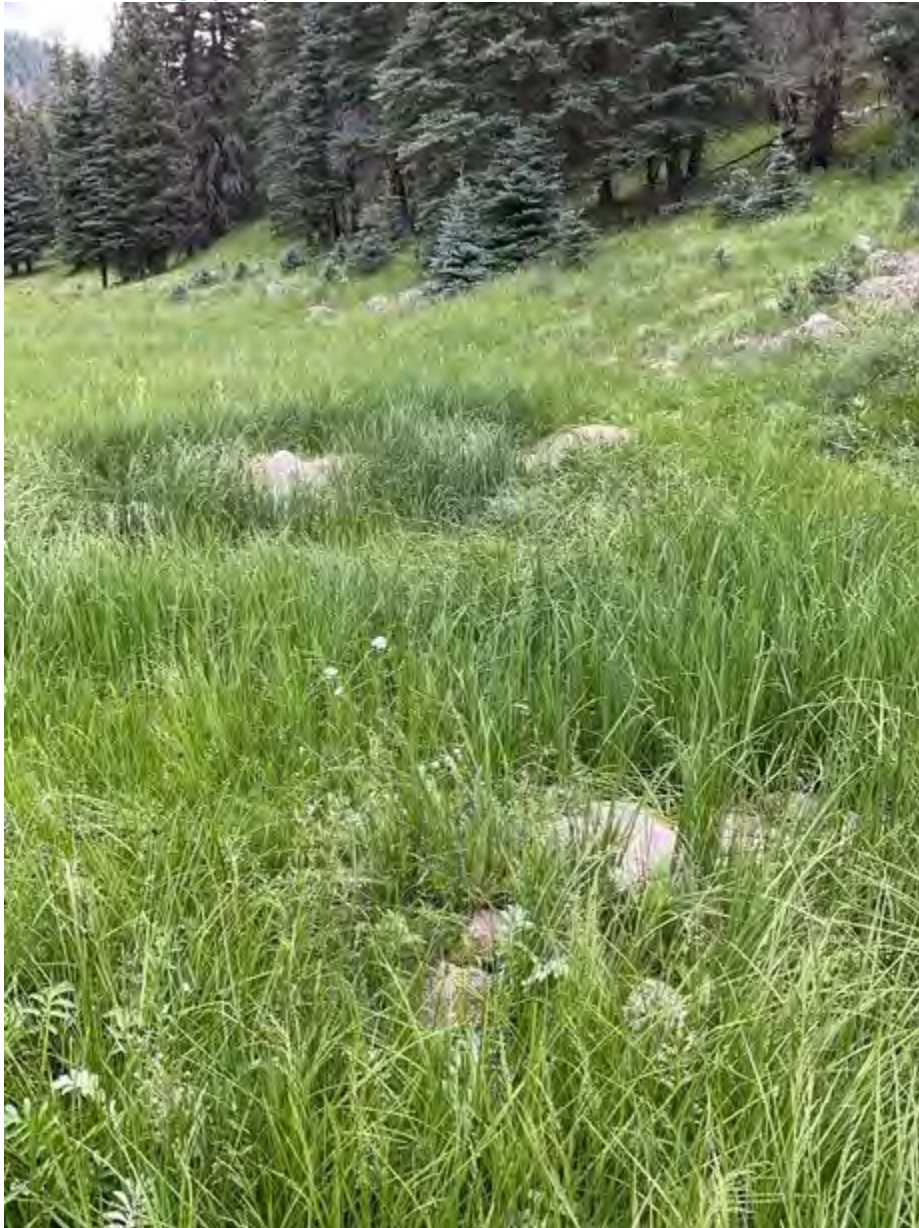
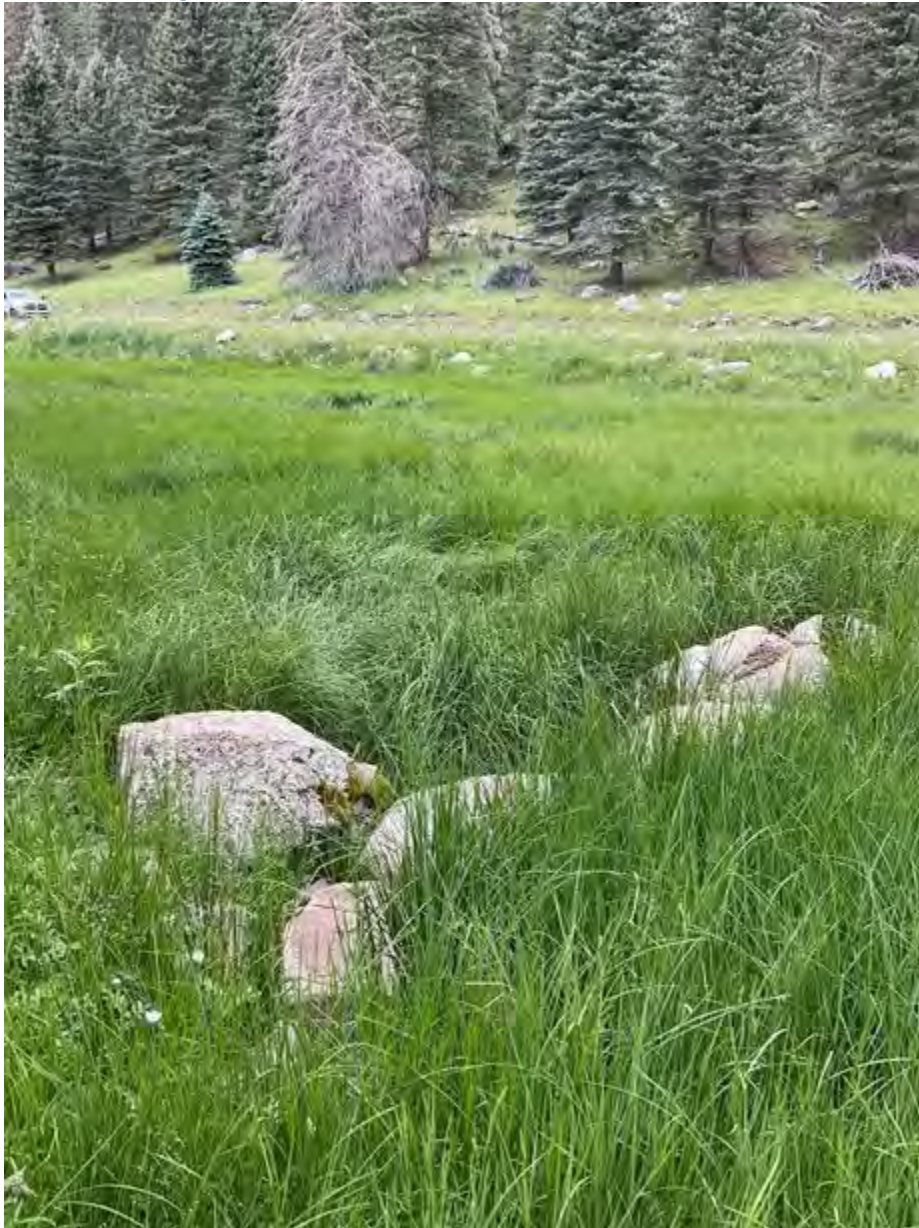
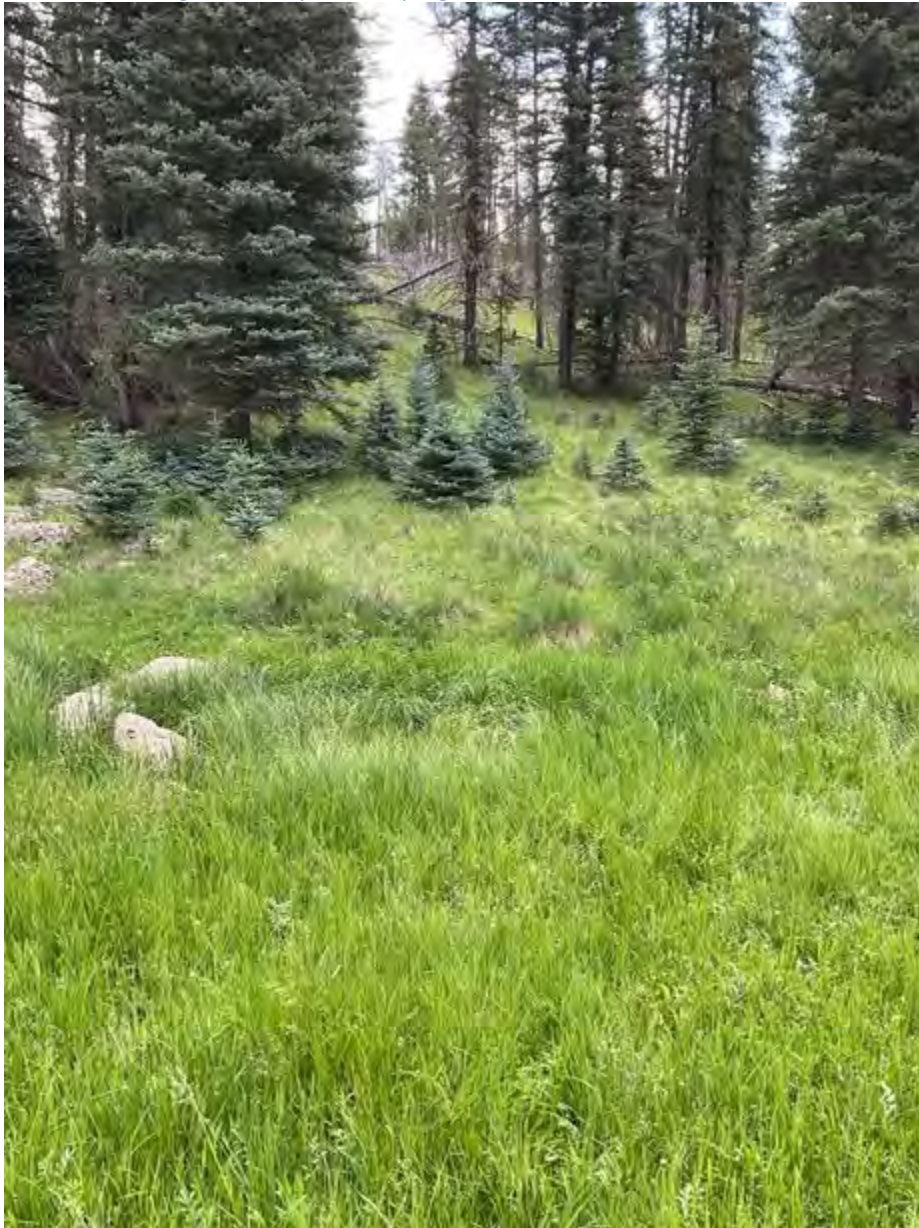
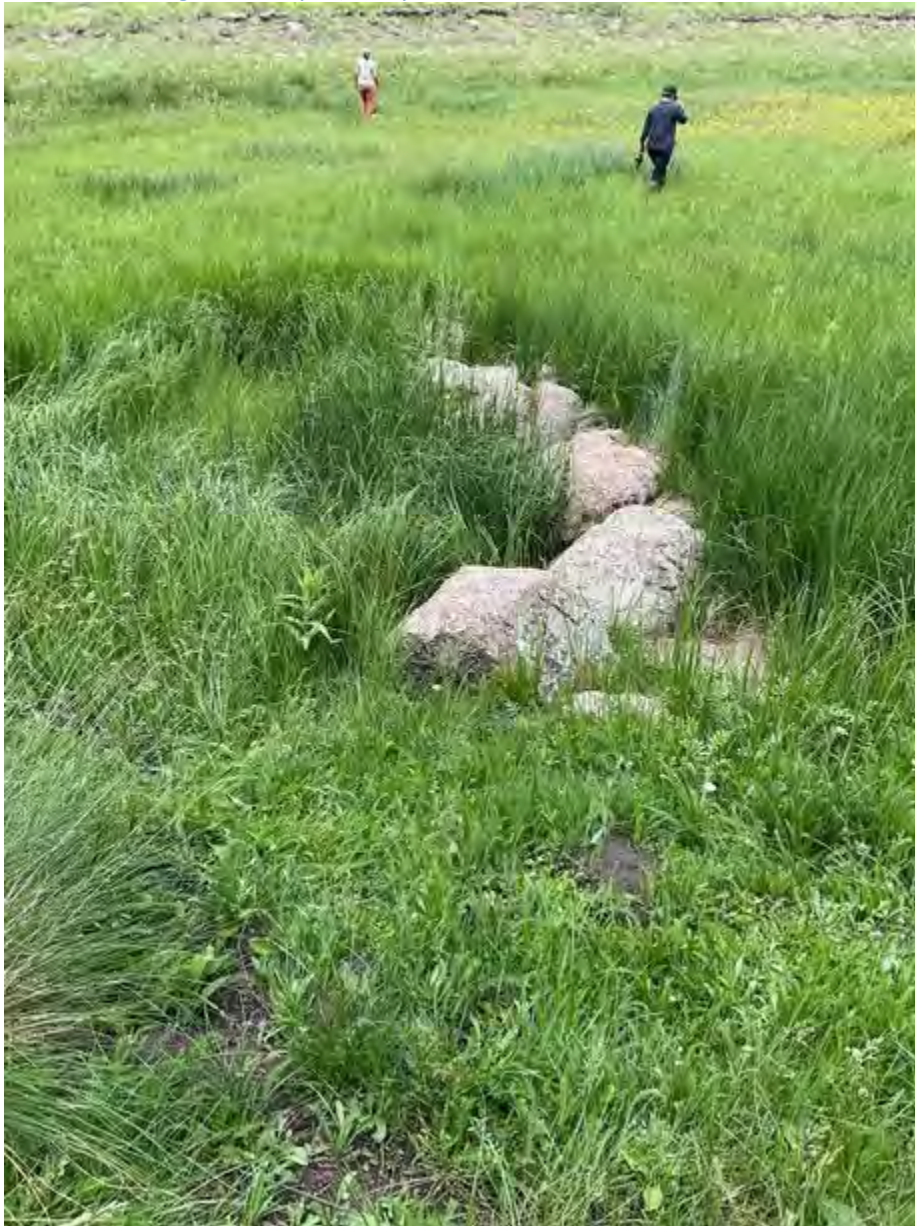
All rocks intact

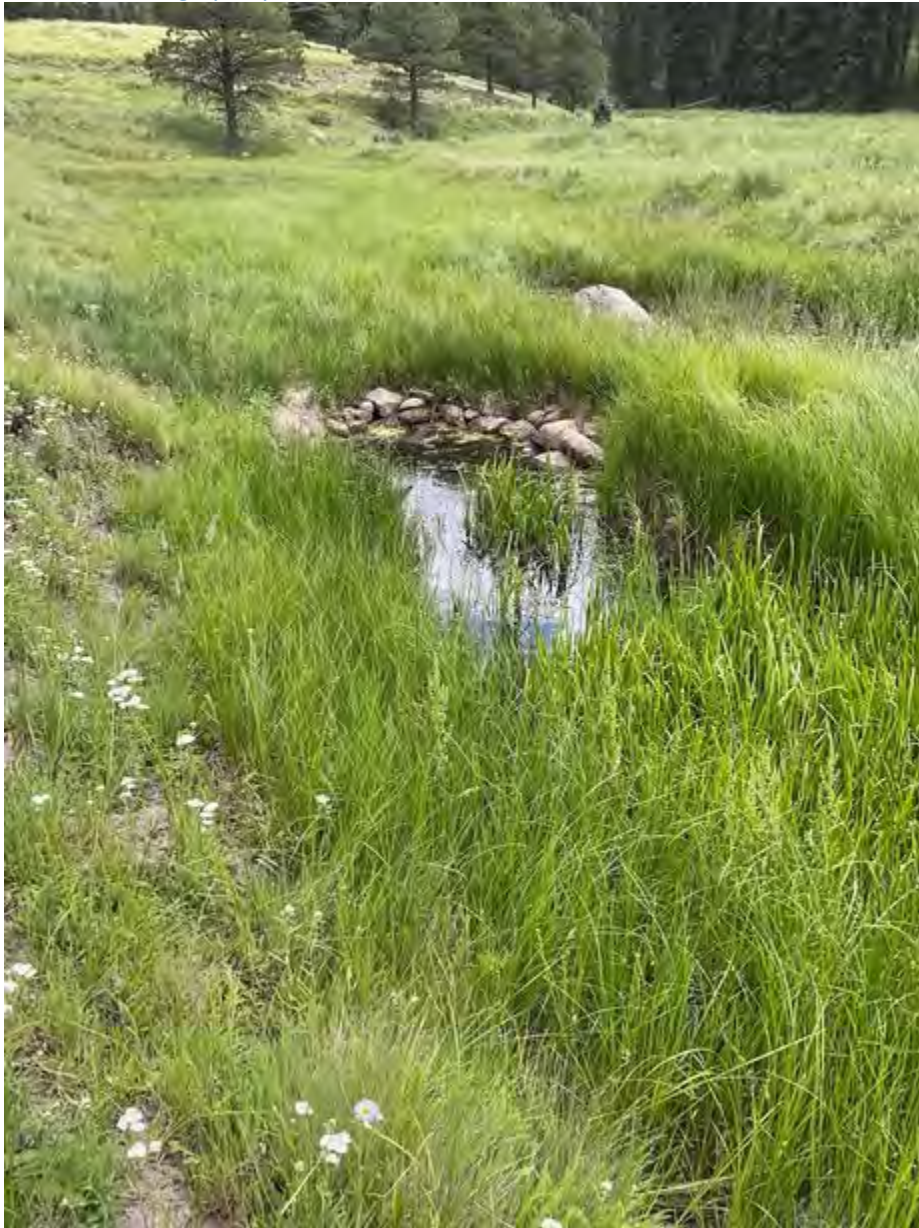
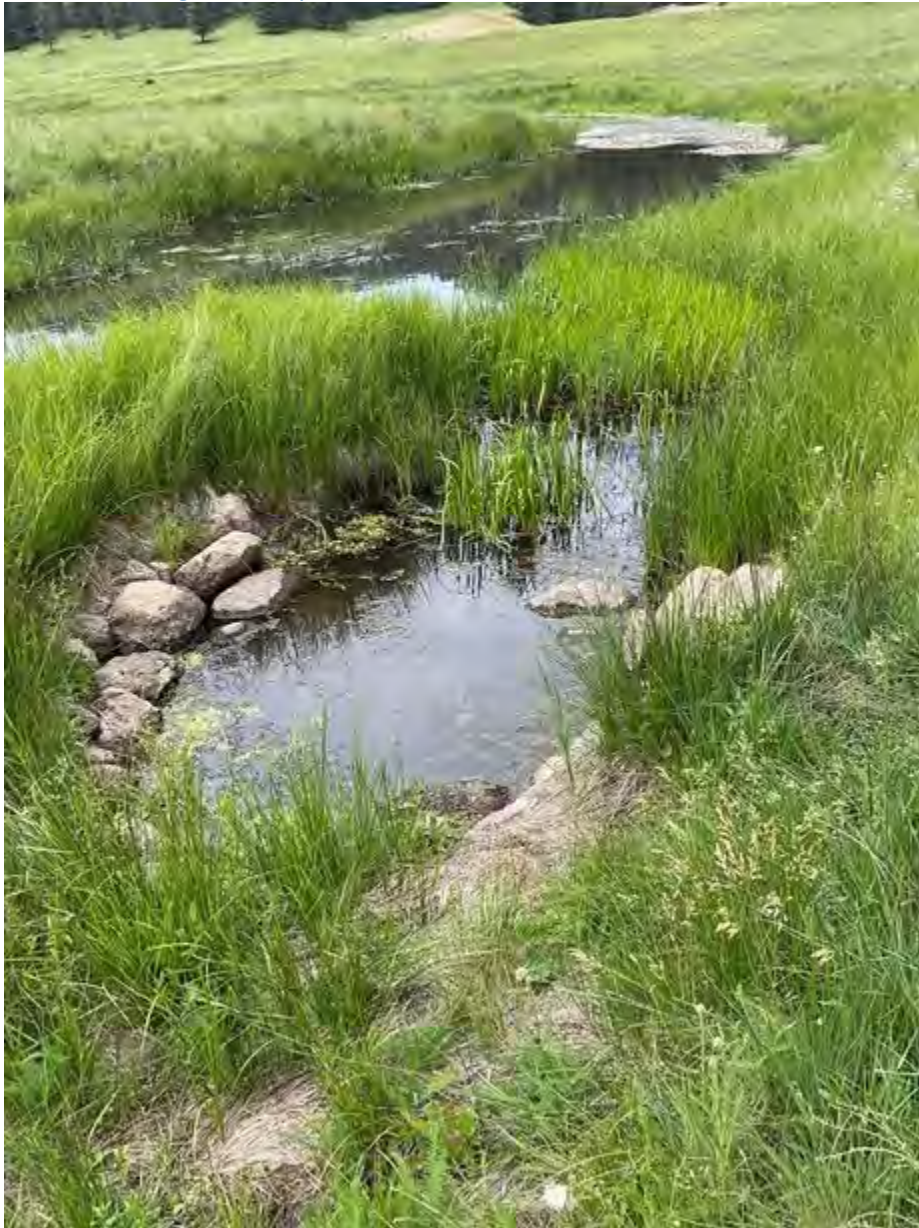
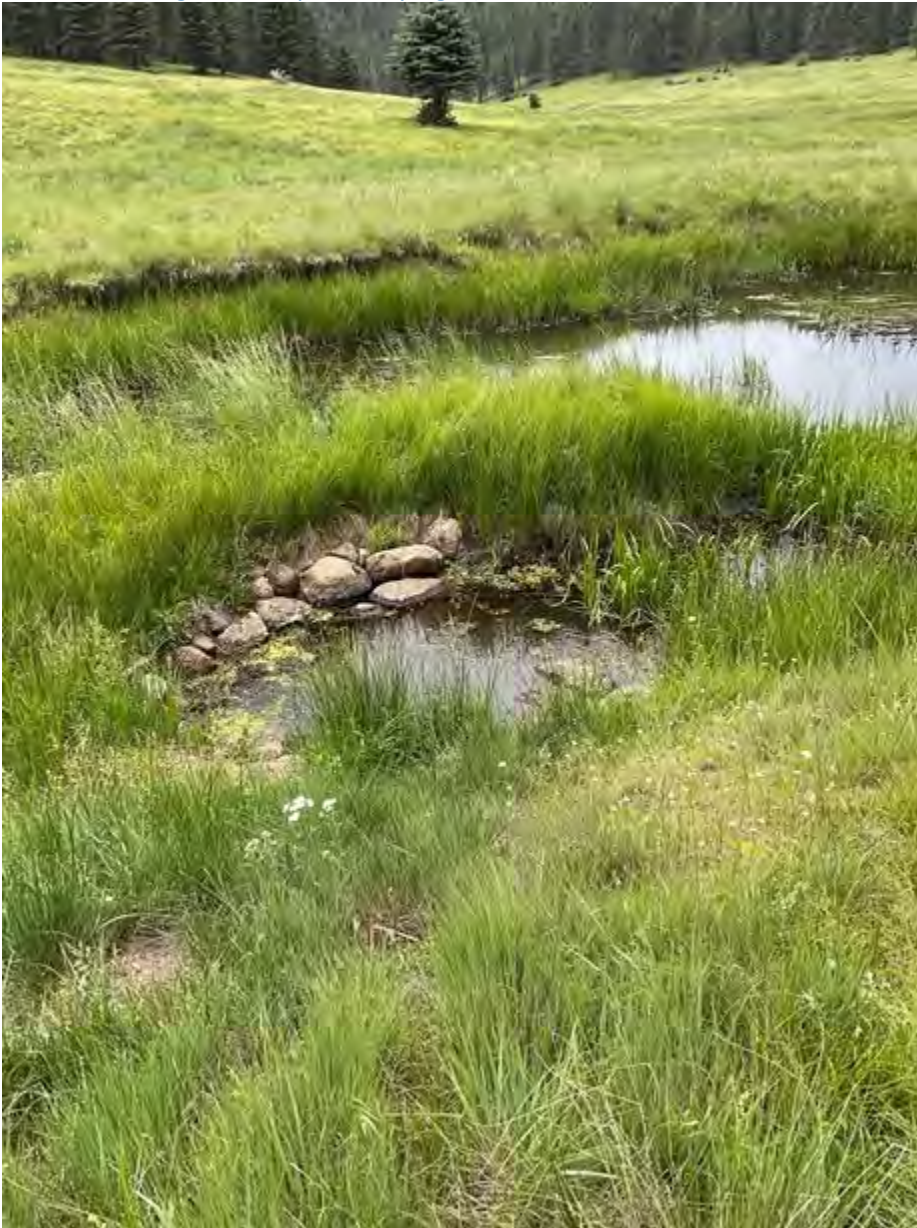
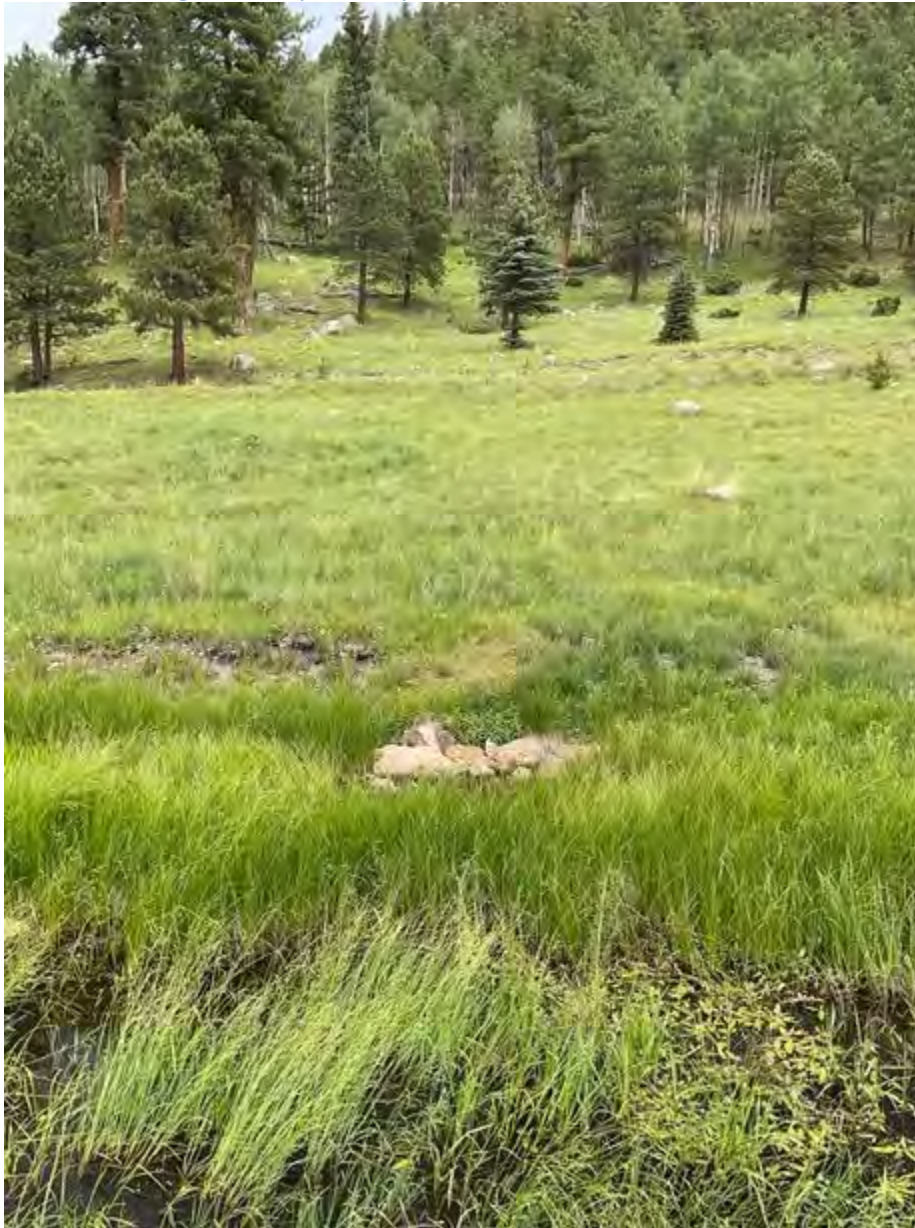
All rocks intact

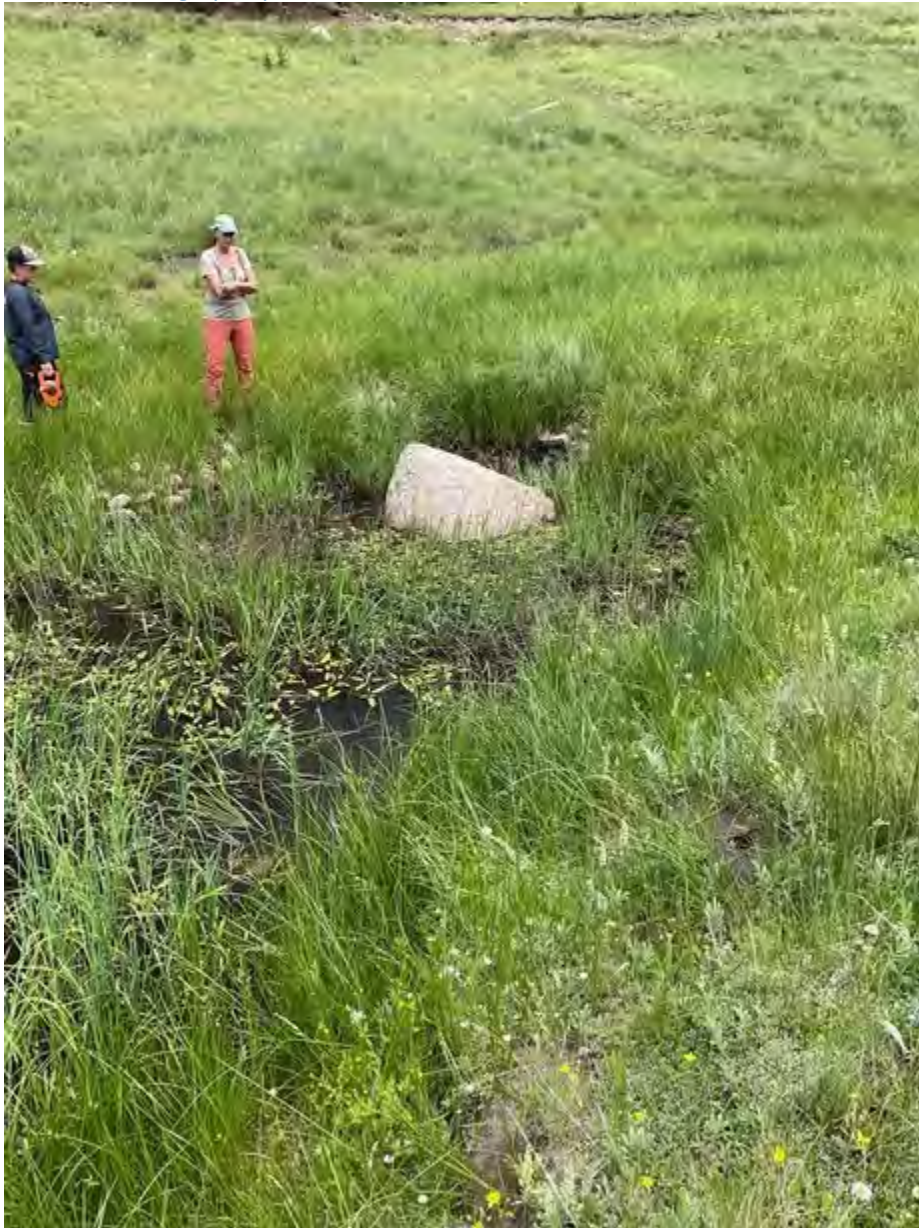
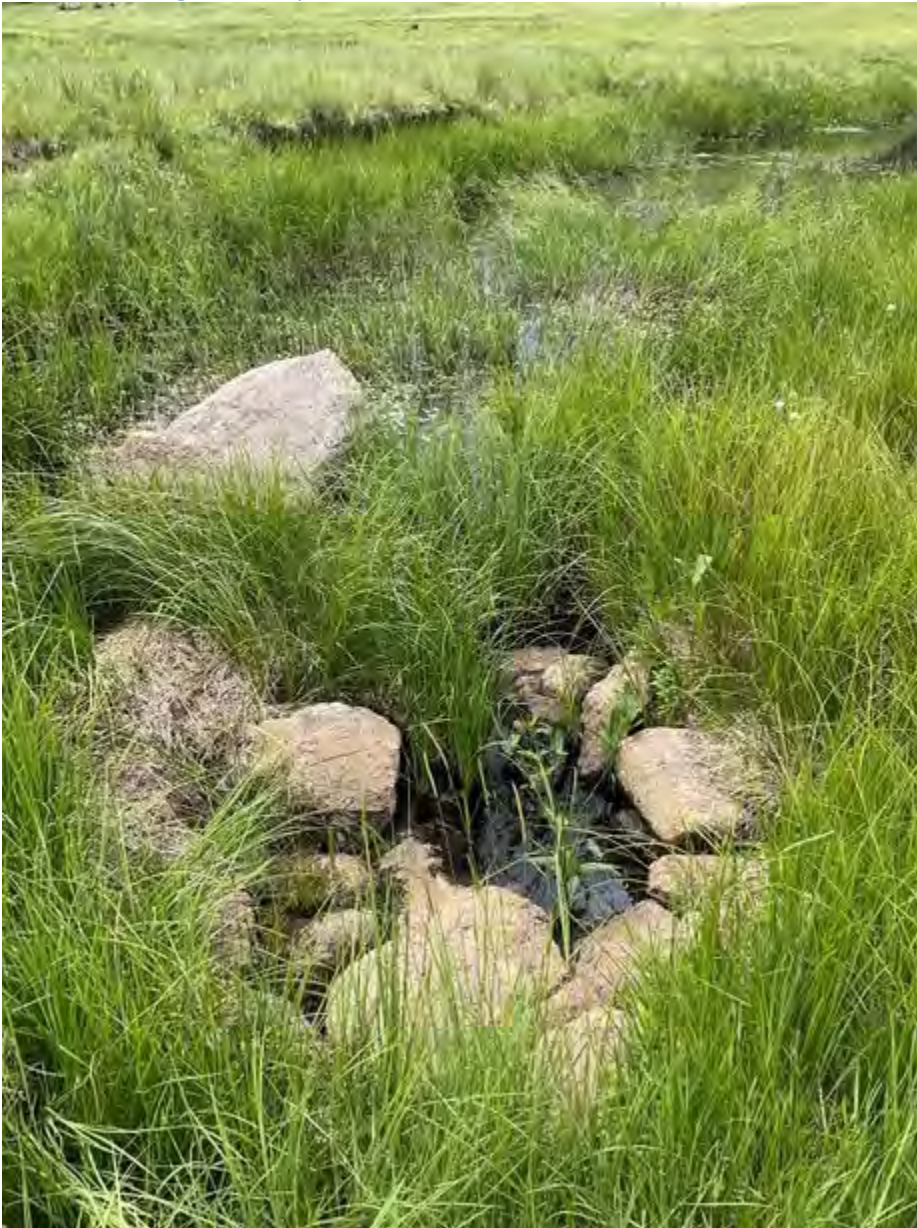
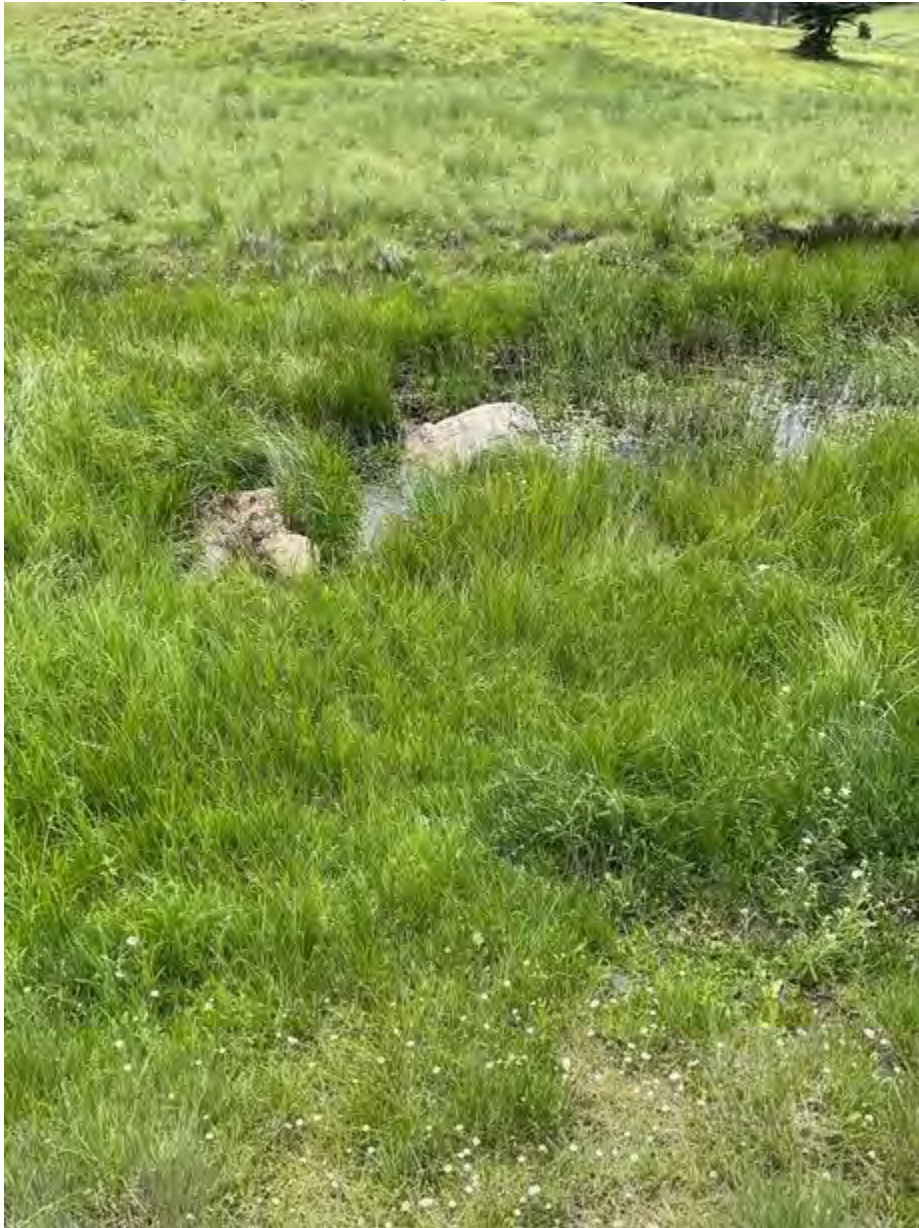
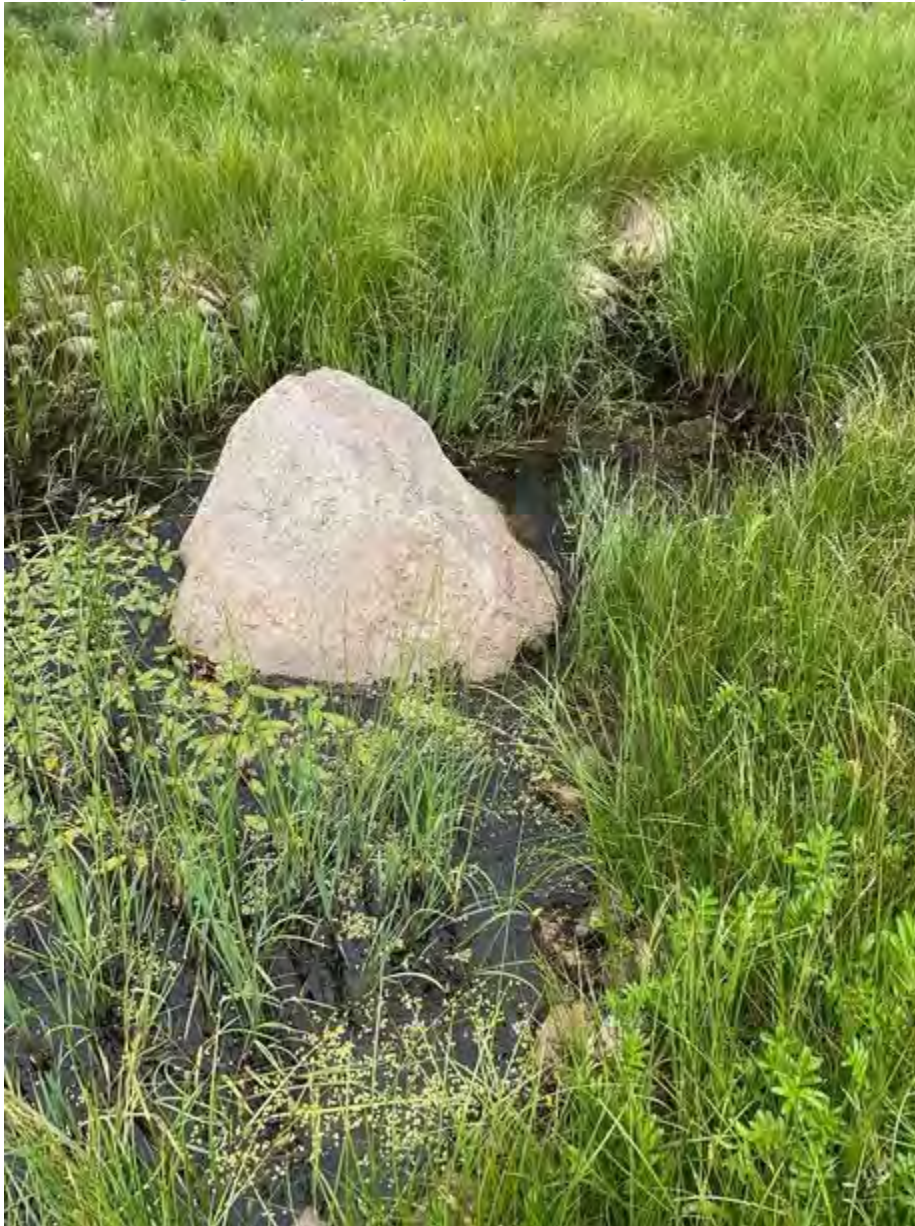
All rocks intact

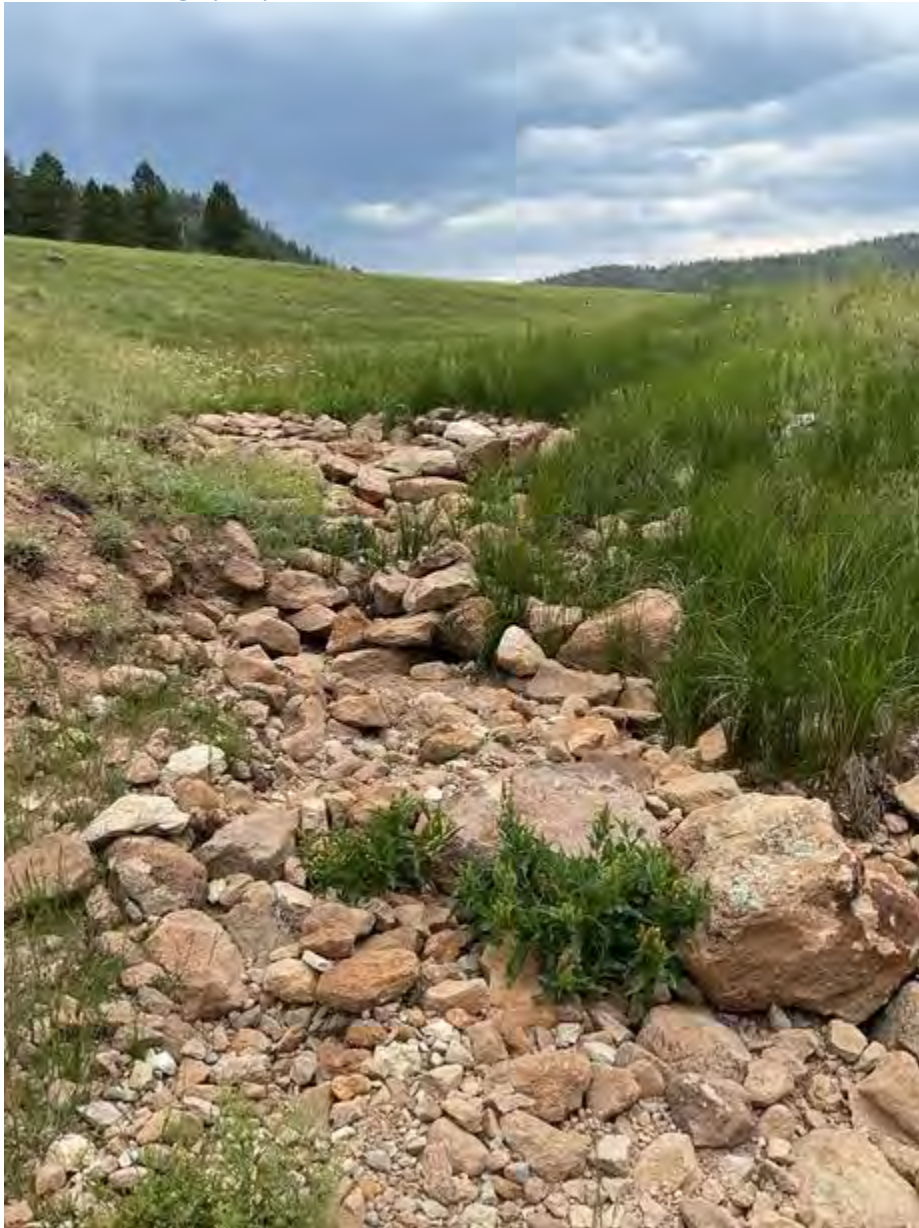
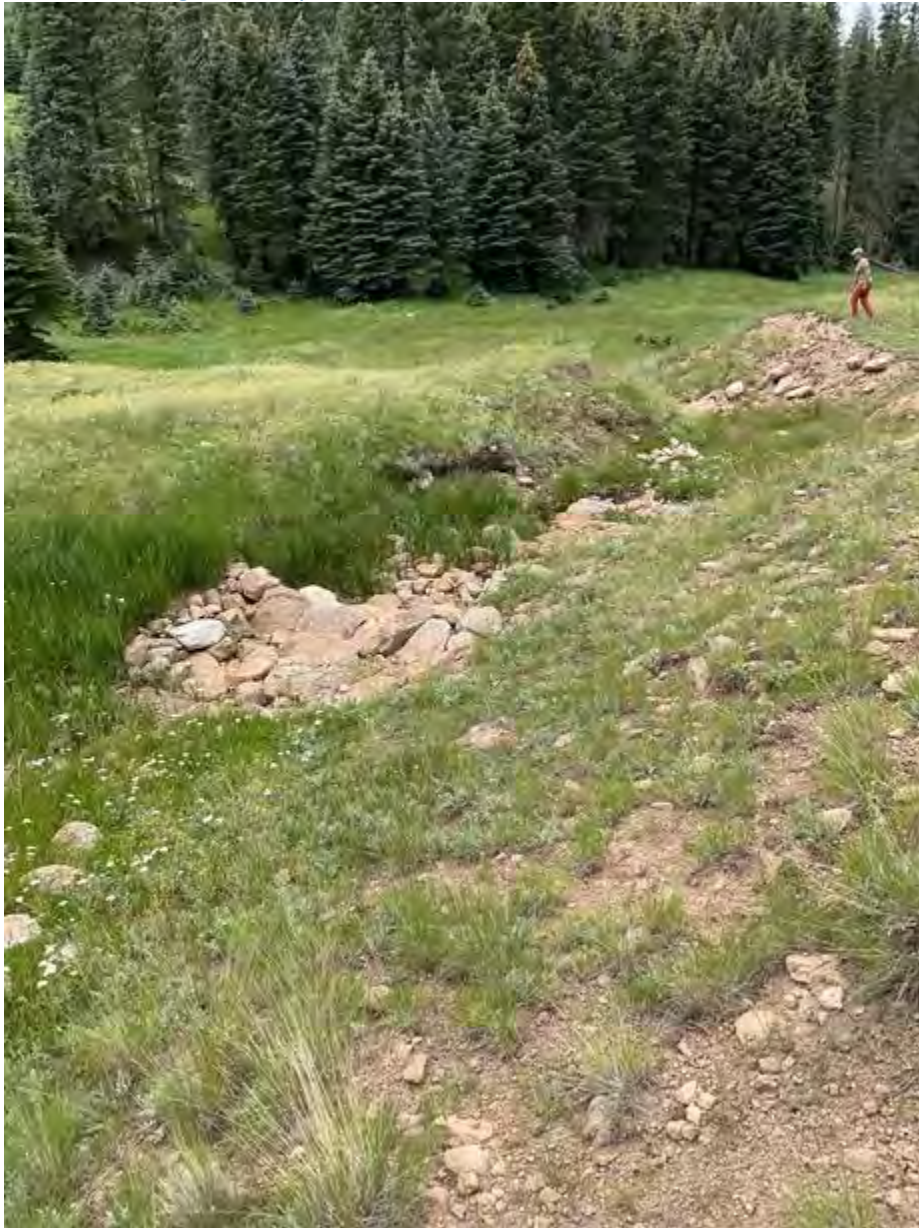
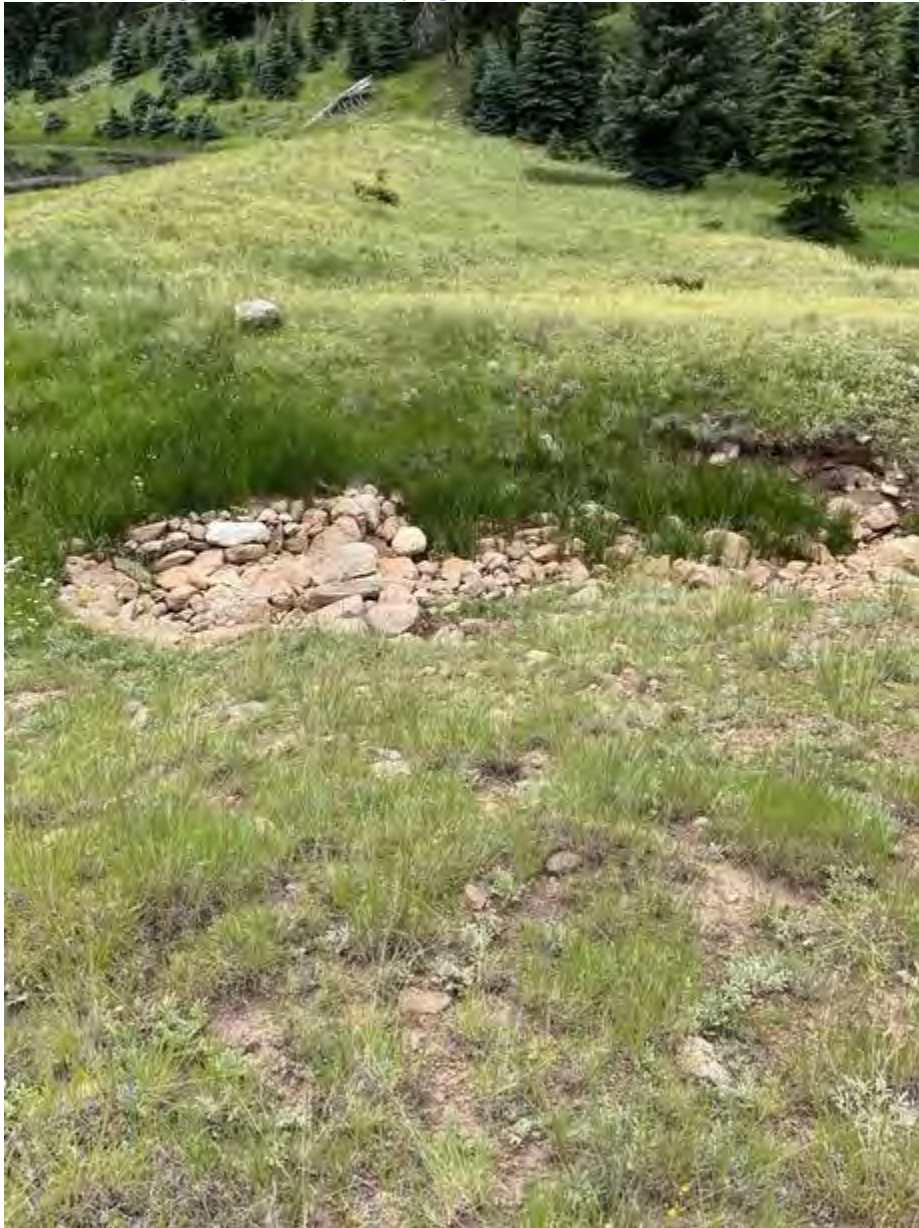
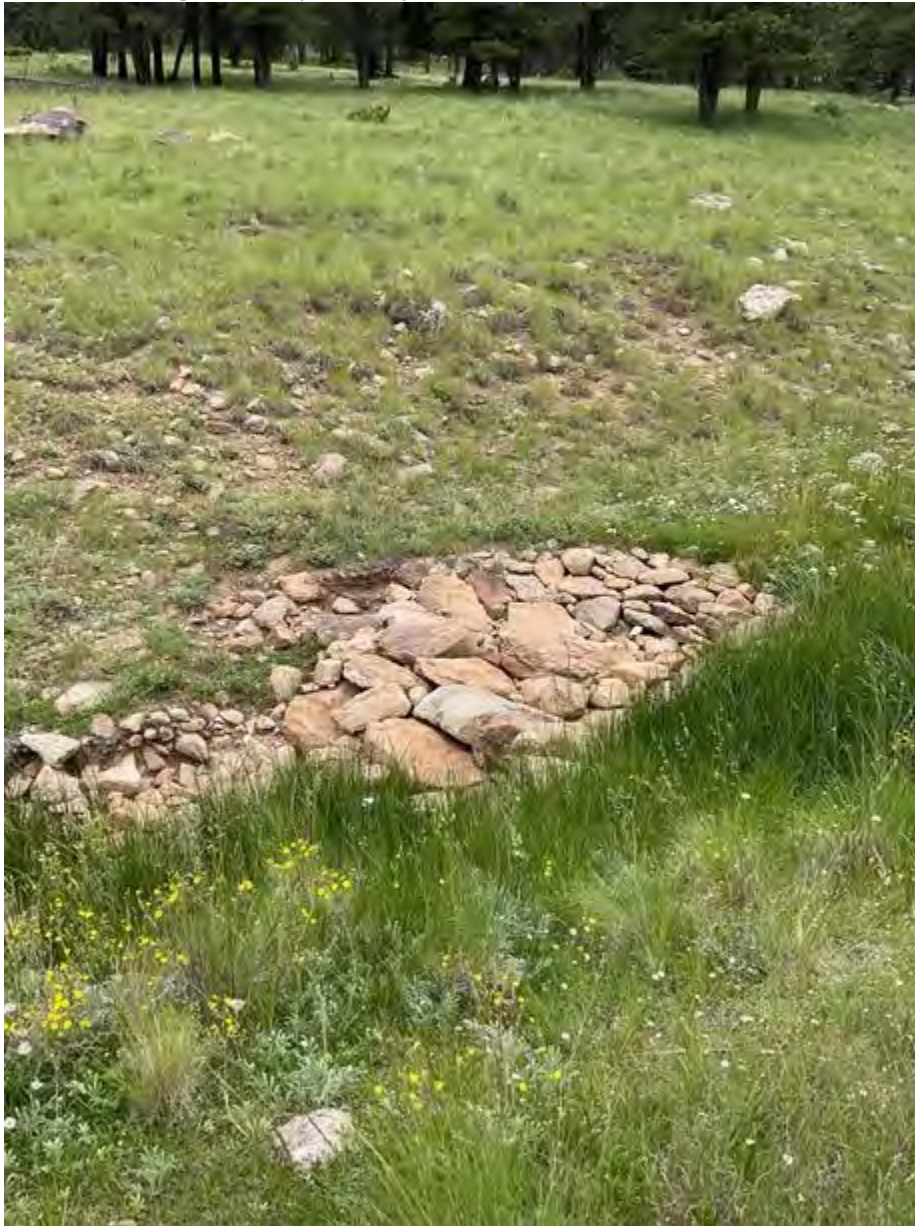
All rocks intact

Difference between ZB and ORD Condition
Middle half of ORD dislodged
