**Zuni Bowl and One Rock Check Dam Research –
Phase 1**

Final Report

December 2024

Rio Grande Return for the New Mexico Department of Transportation Research Bureau

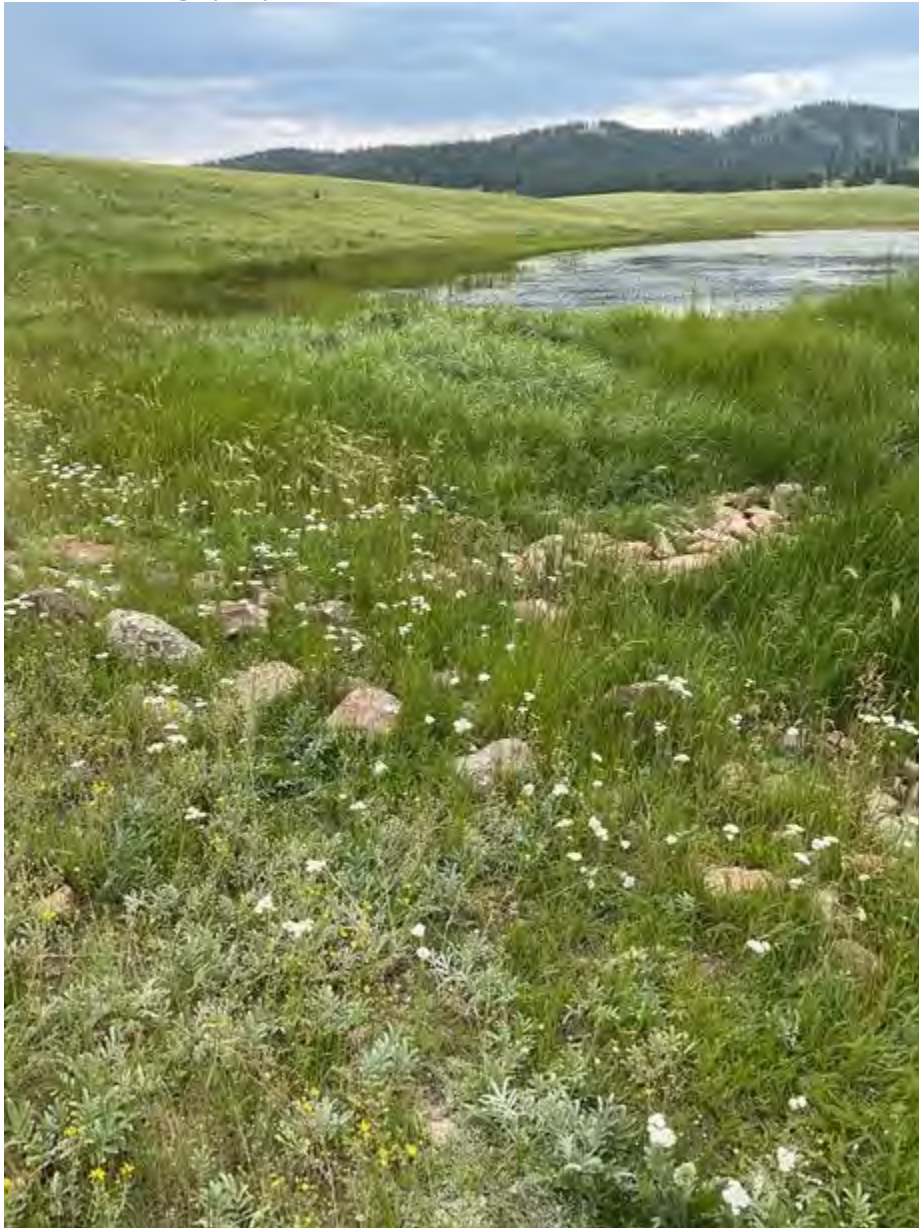
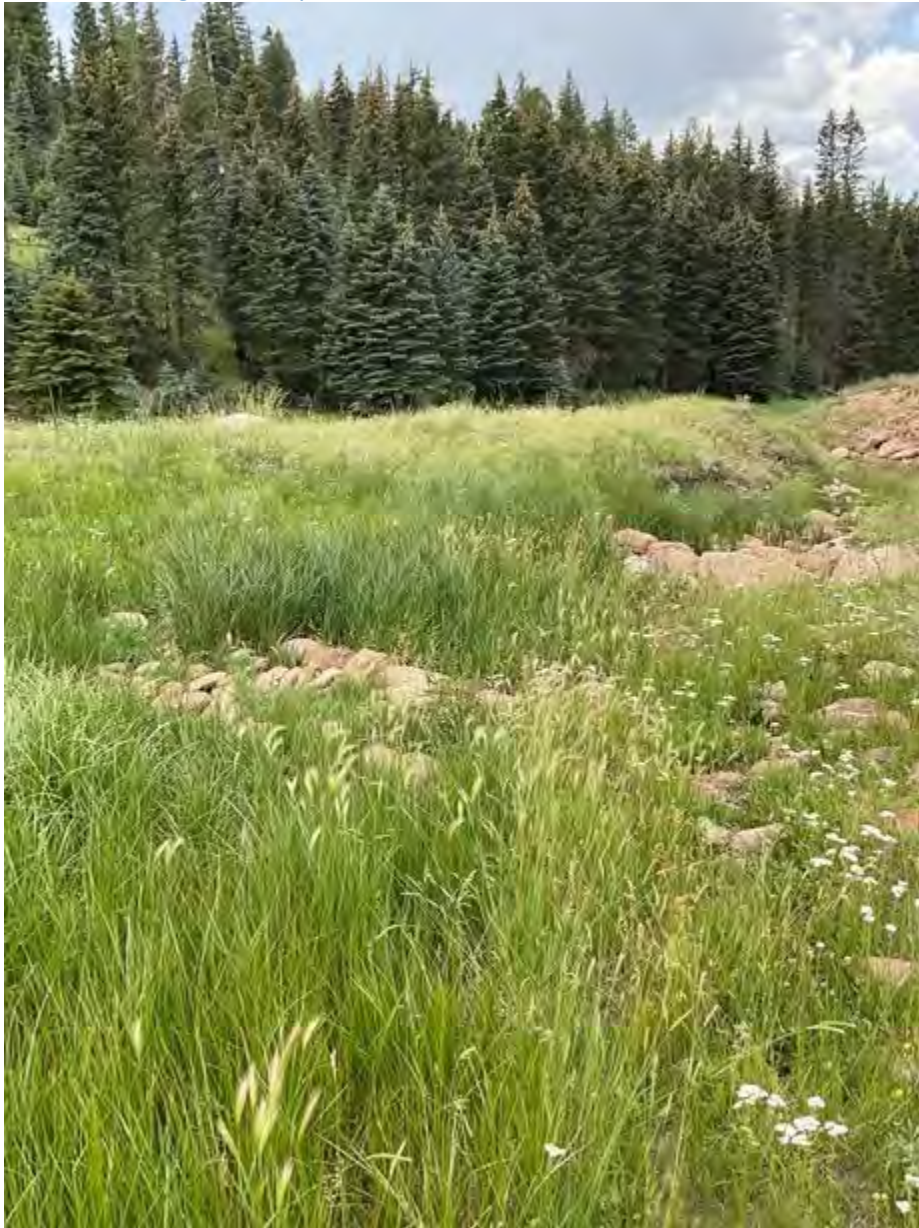
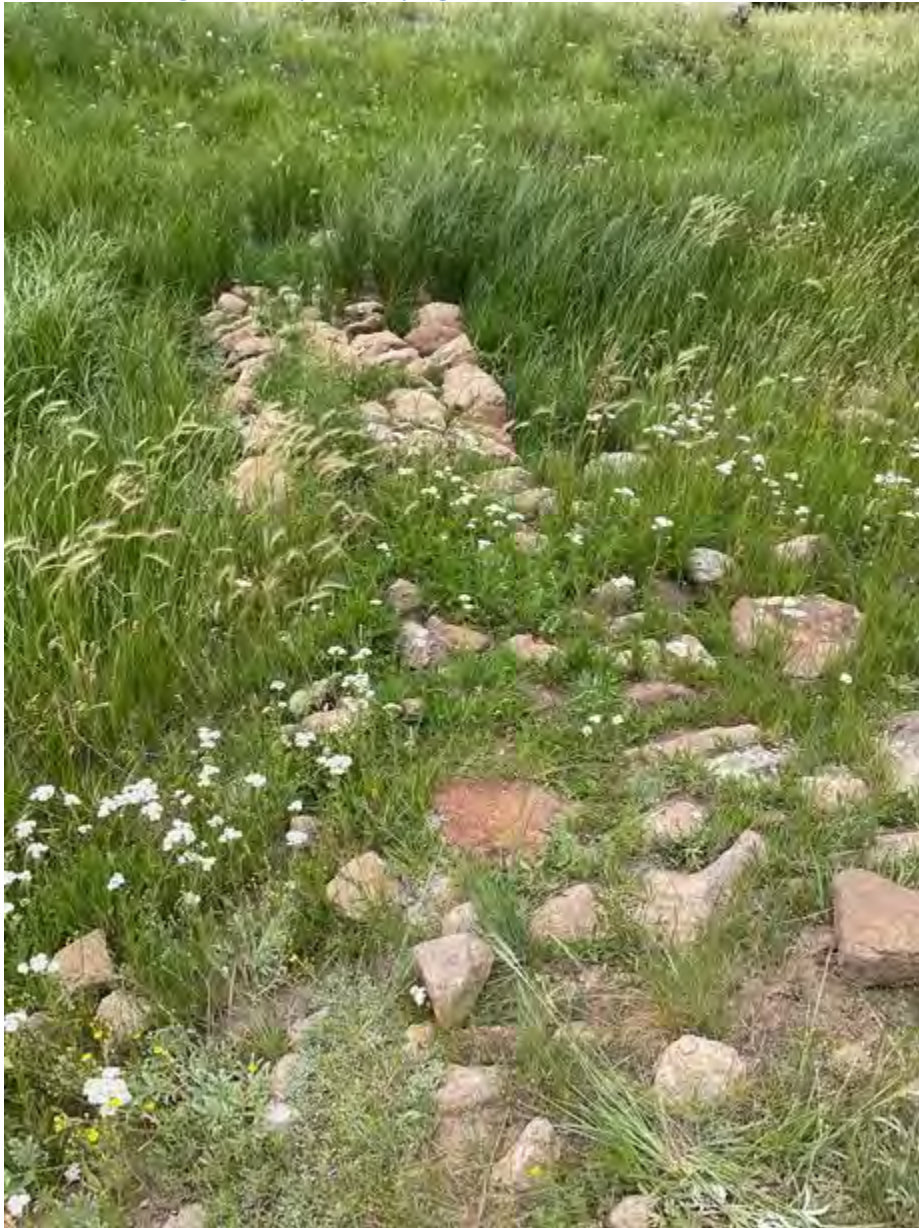
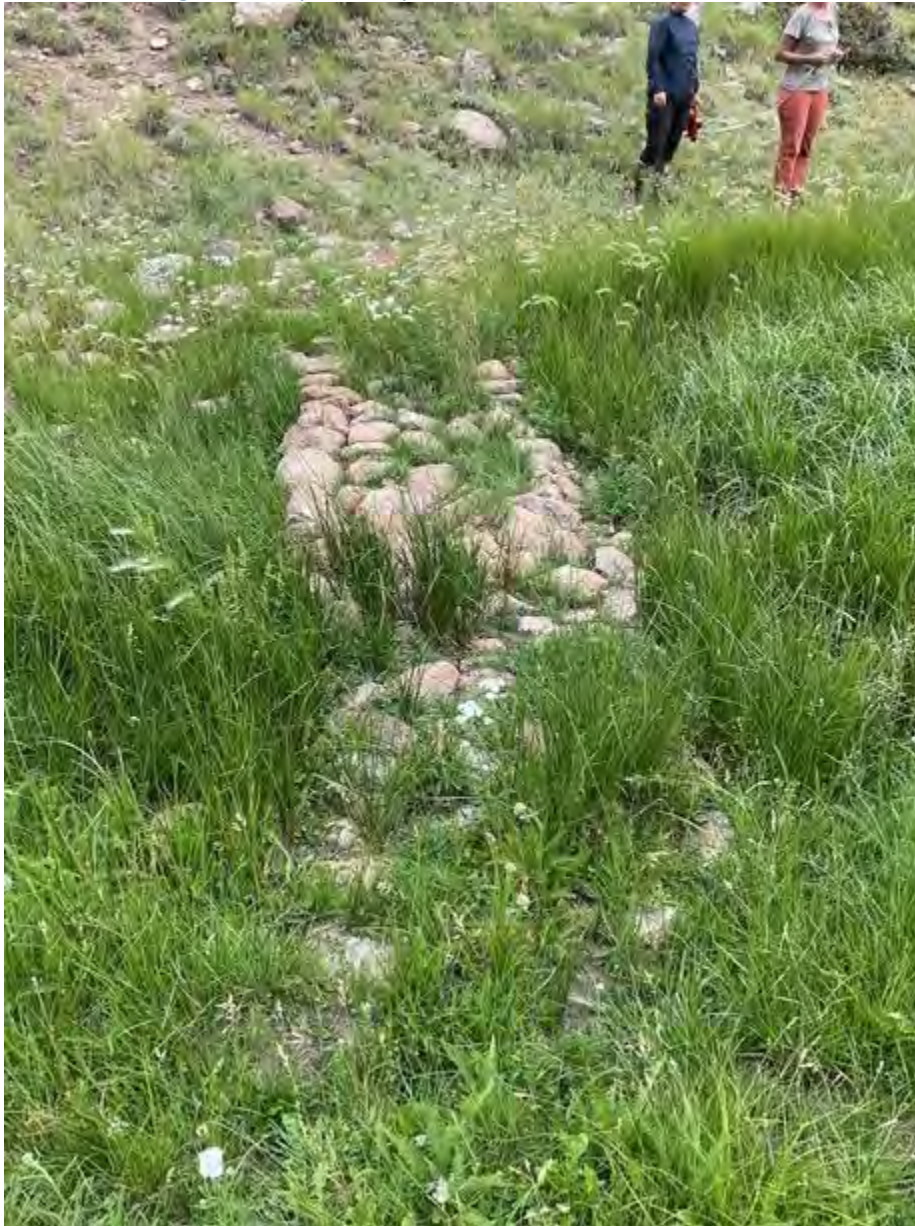
All rocks intact

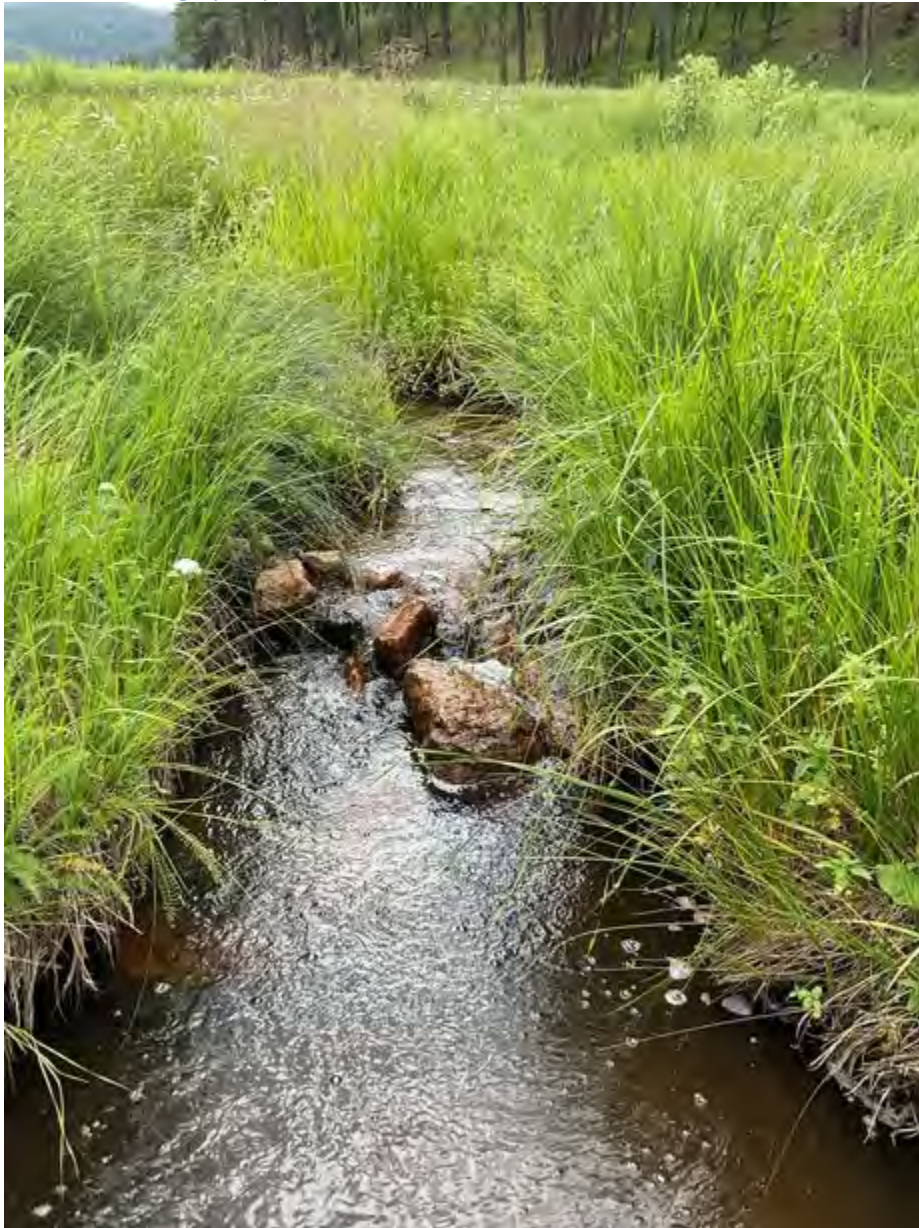
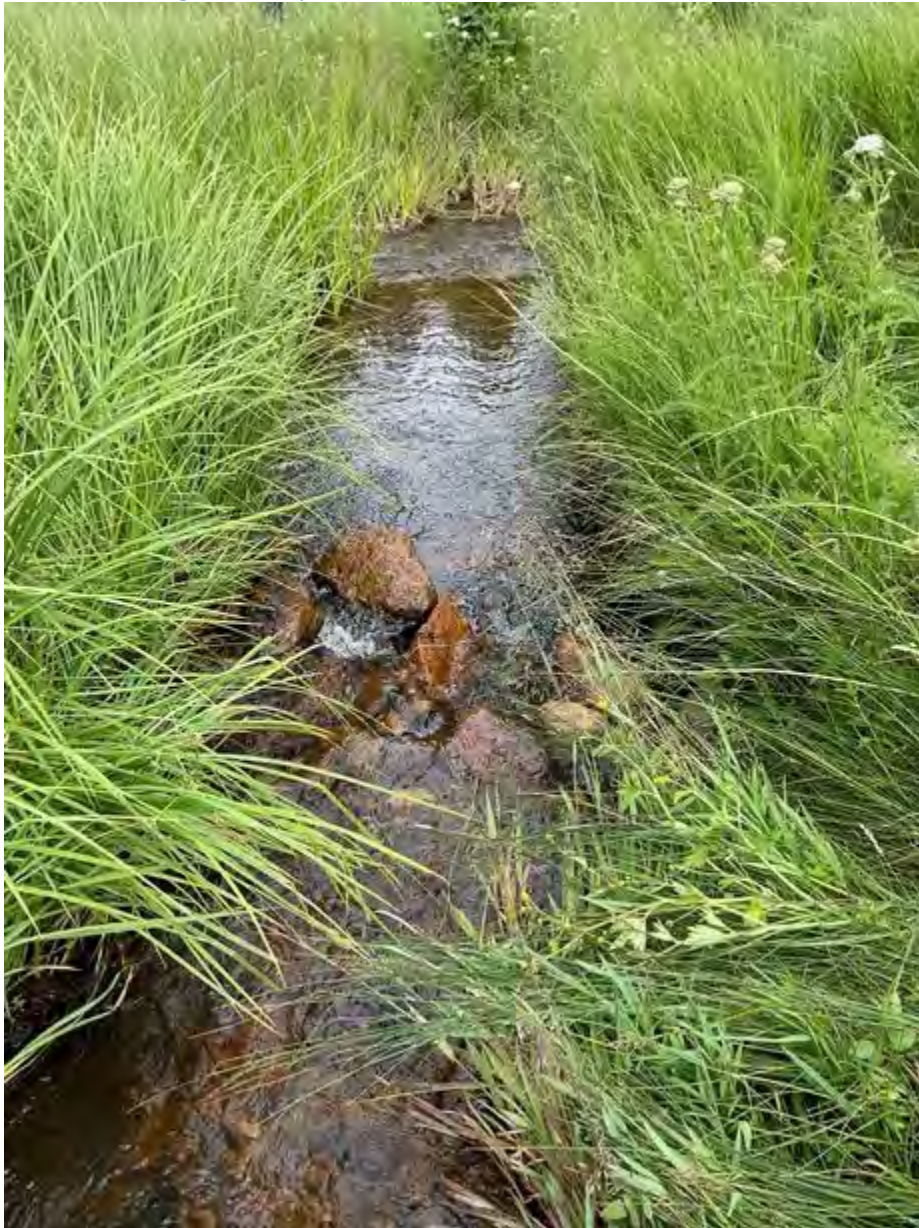
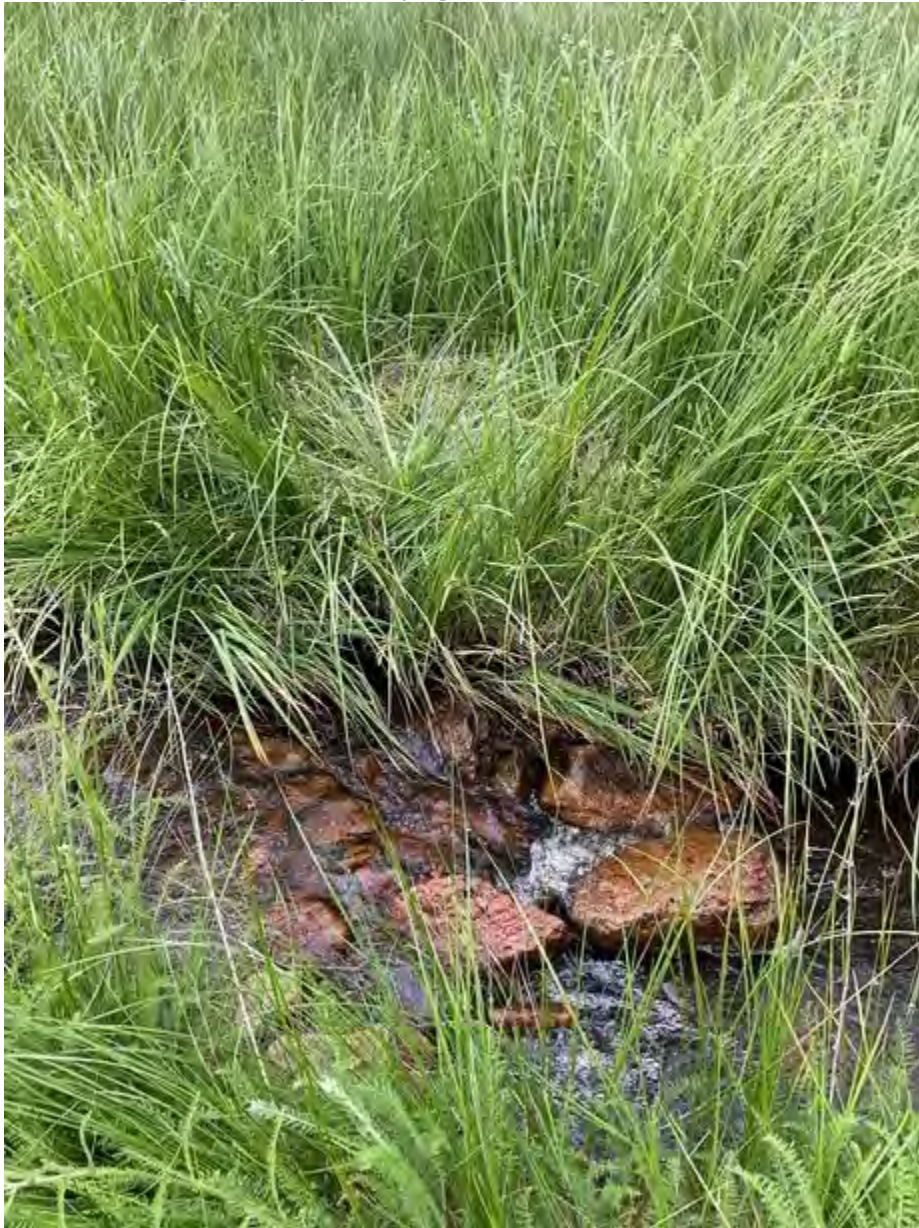
Some rocks dislodged or broken

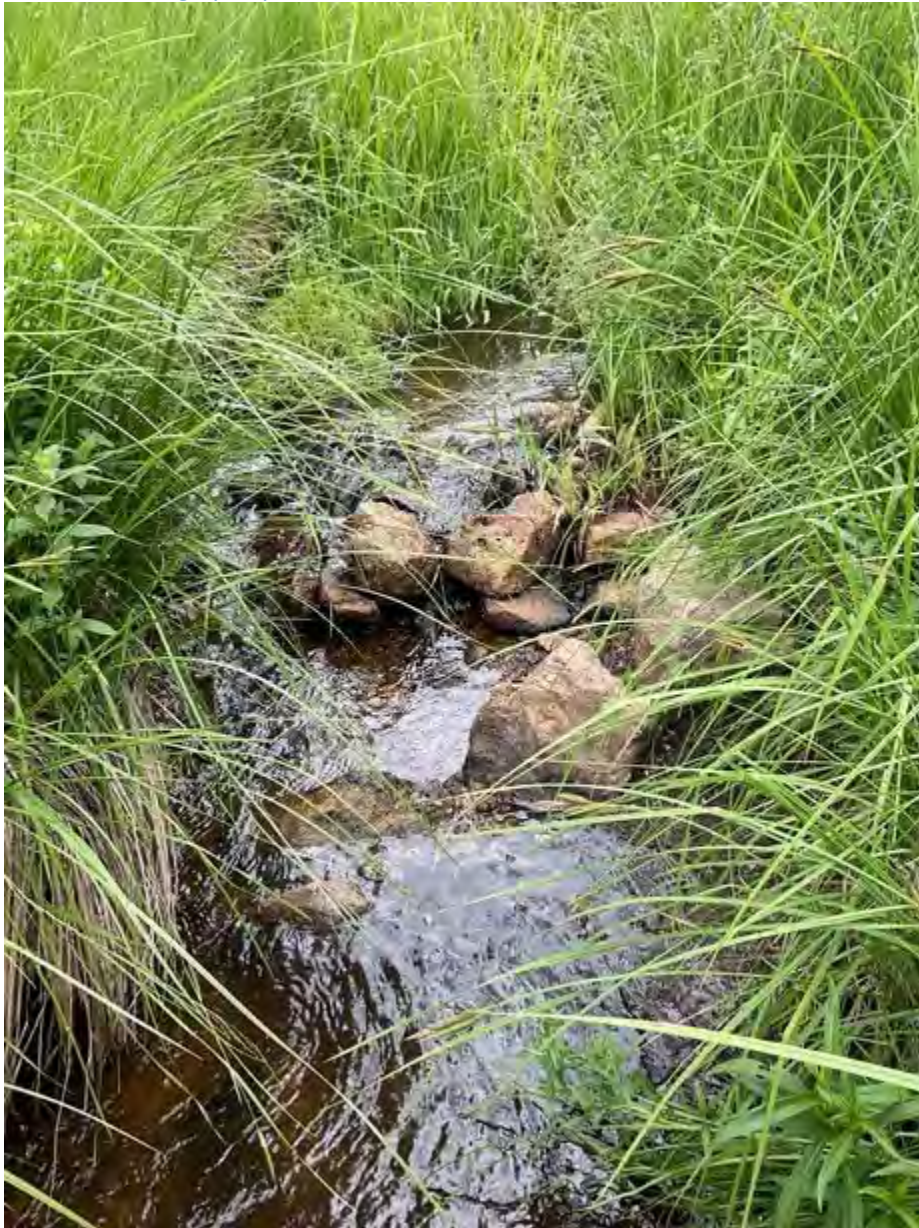
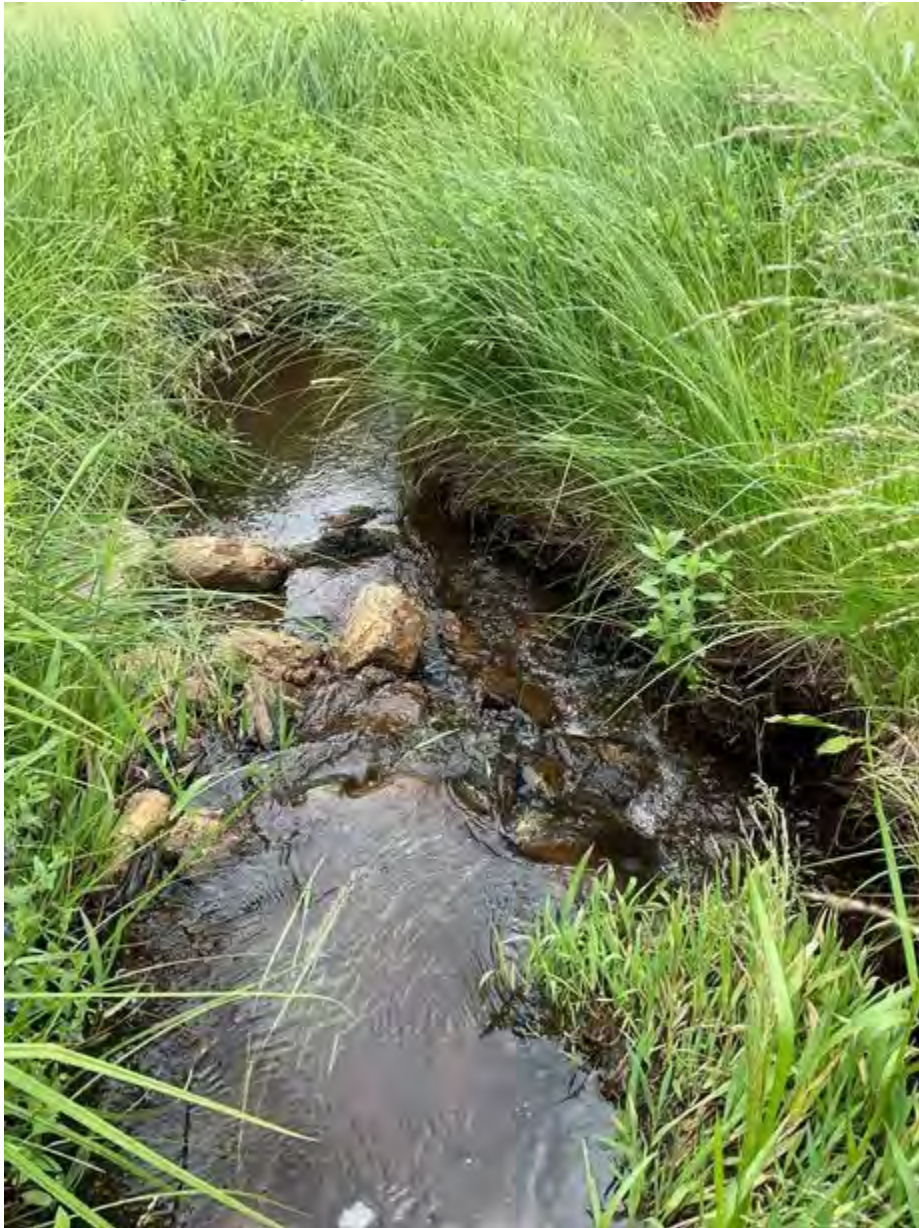
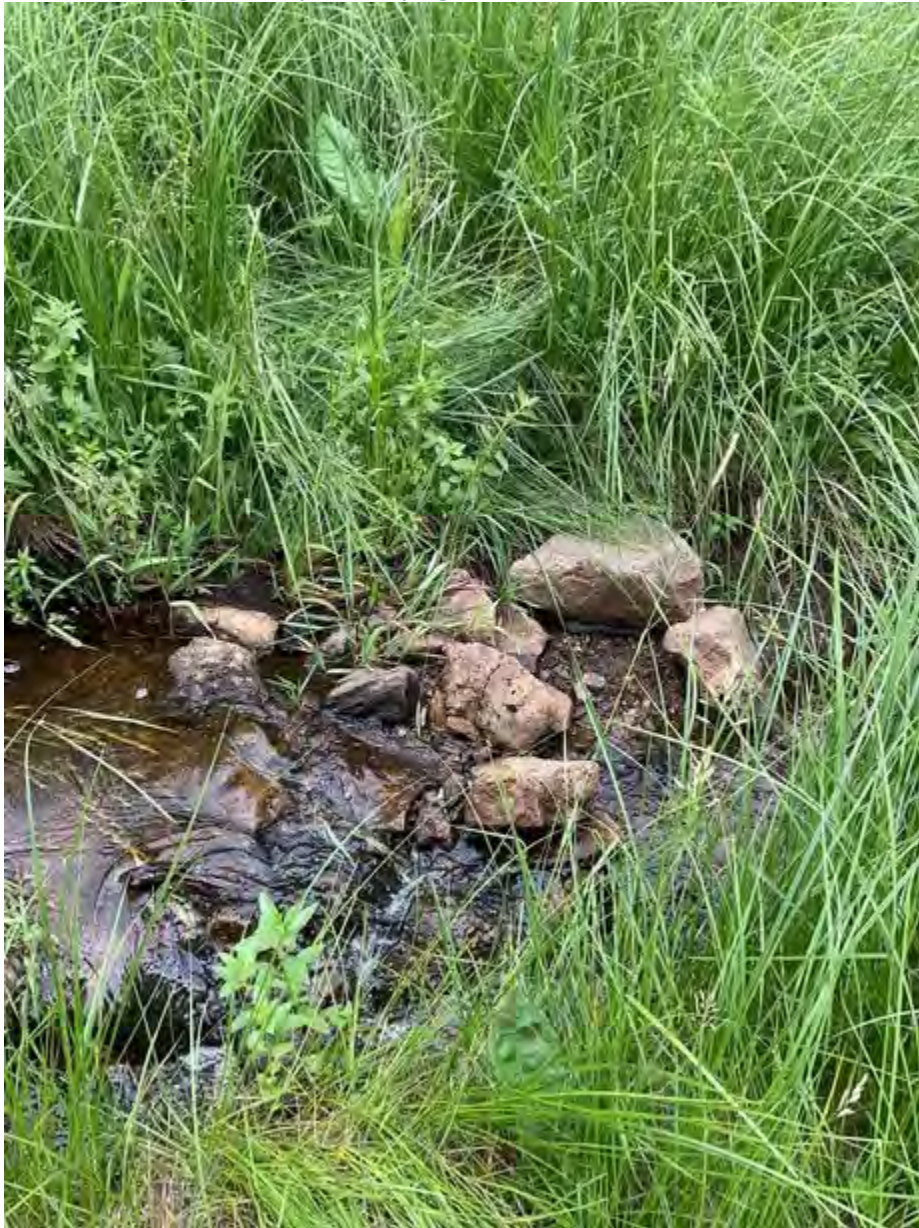
Some rocks dislodged or broken

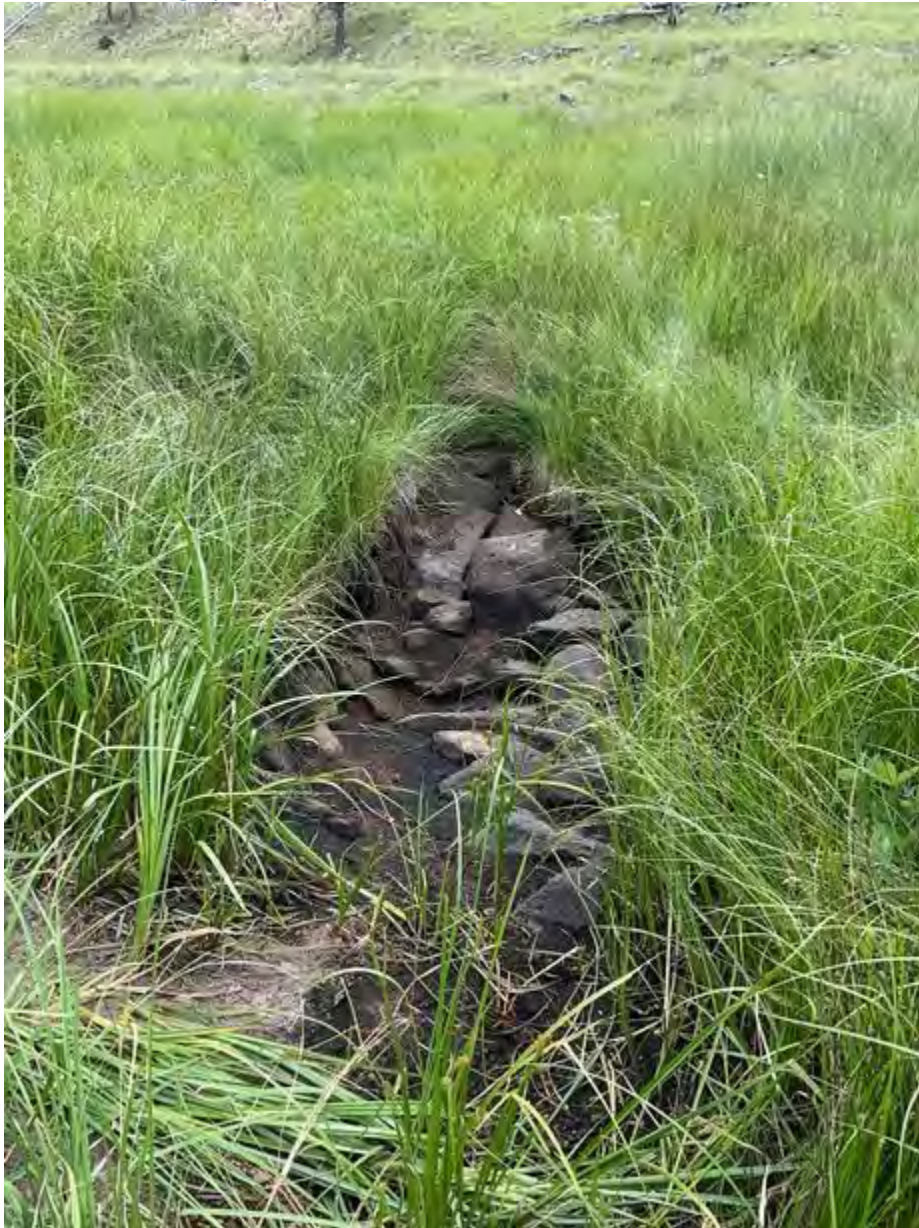
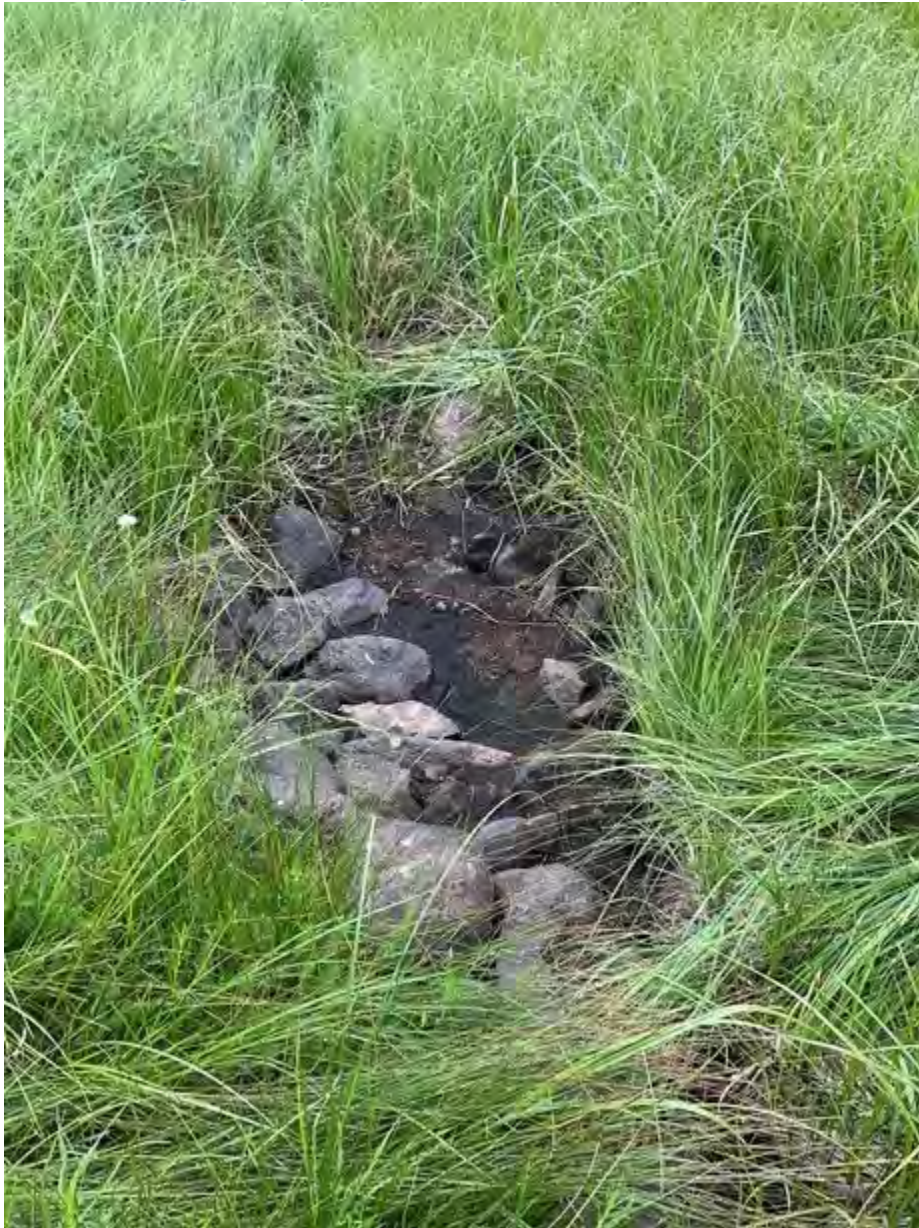
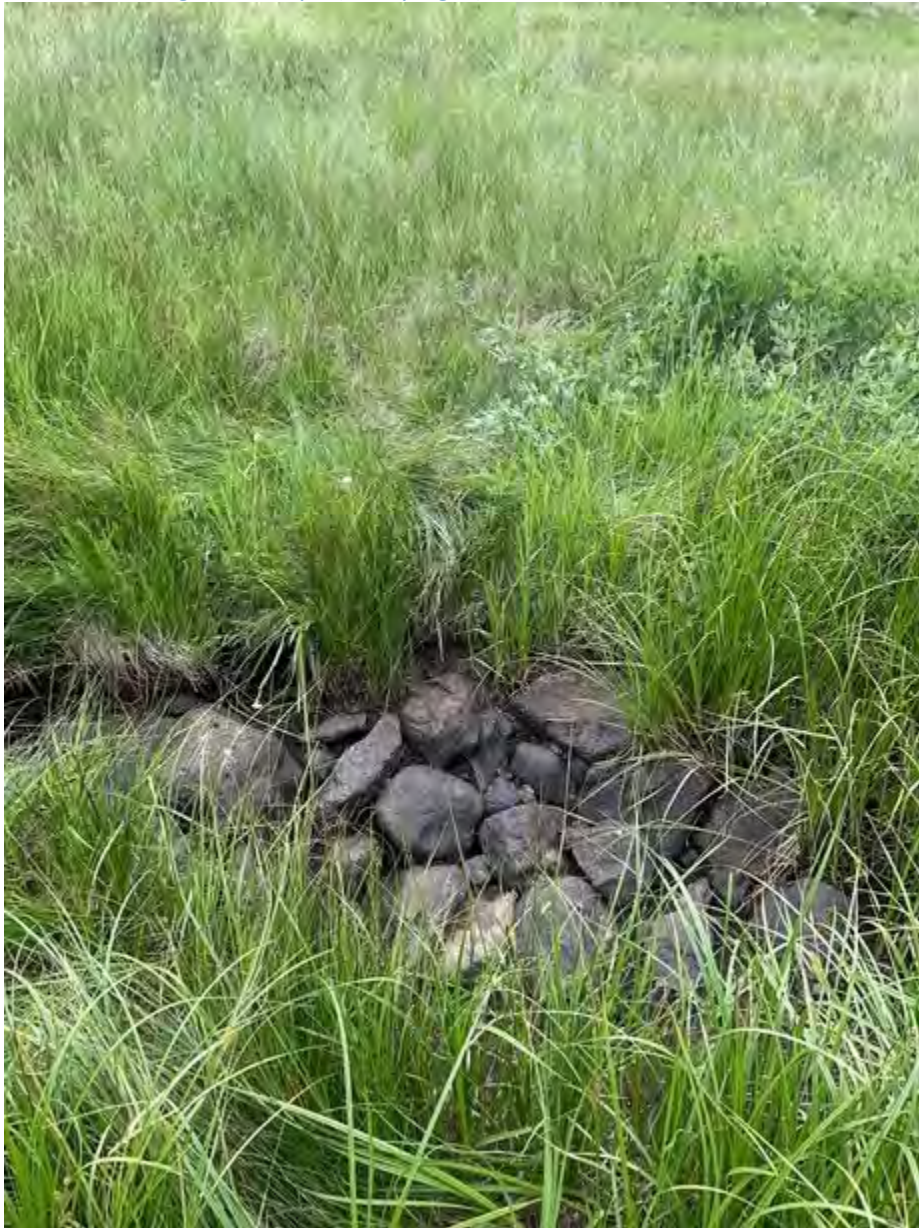
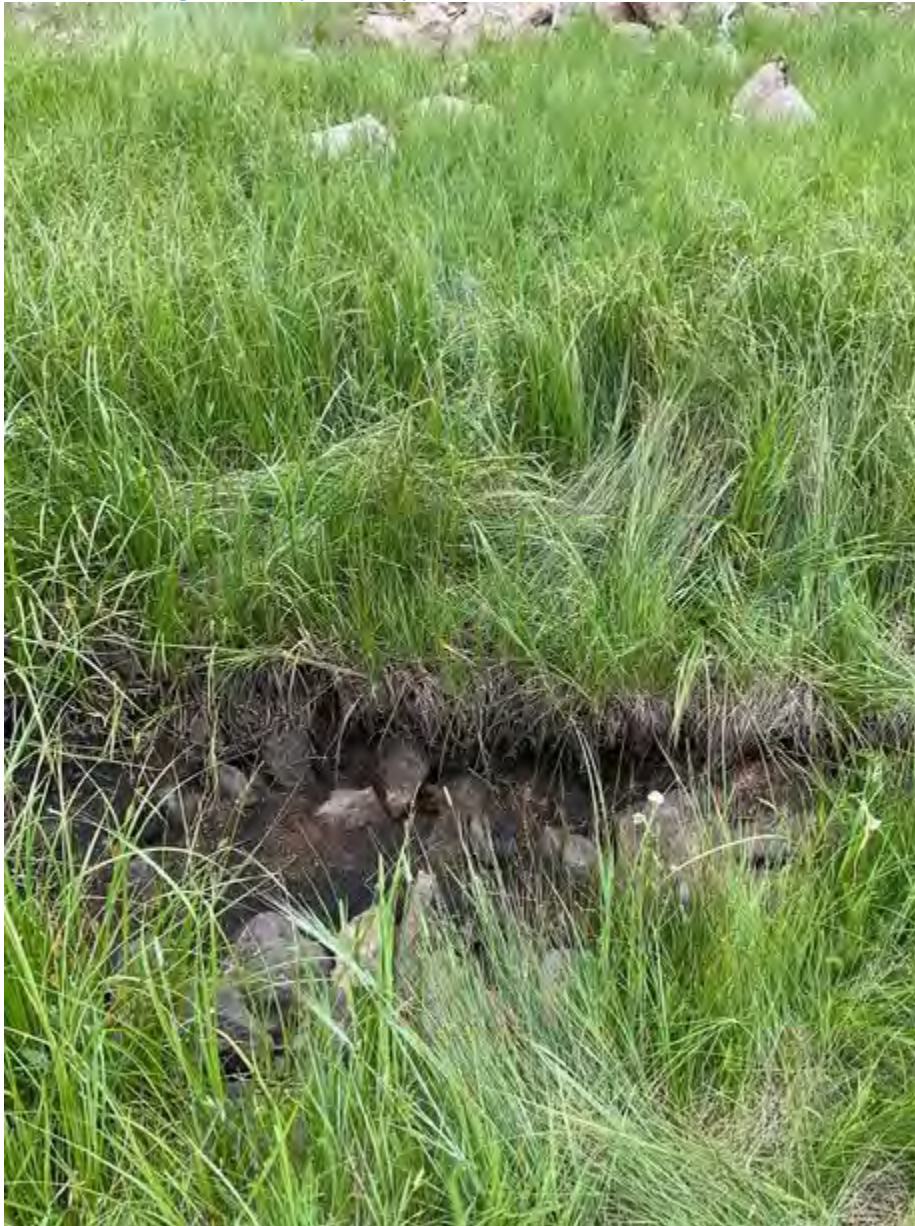
Some rocks dislodged or broken

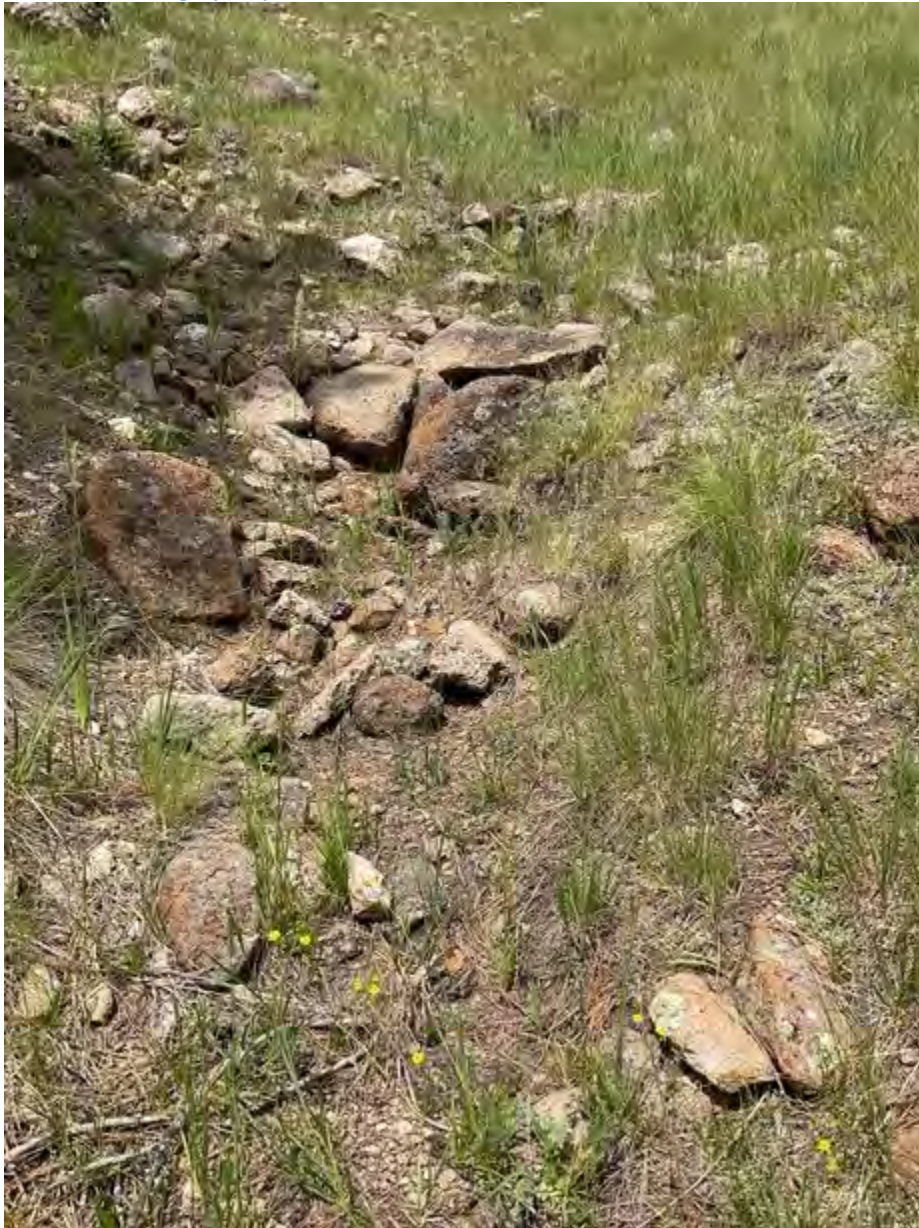
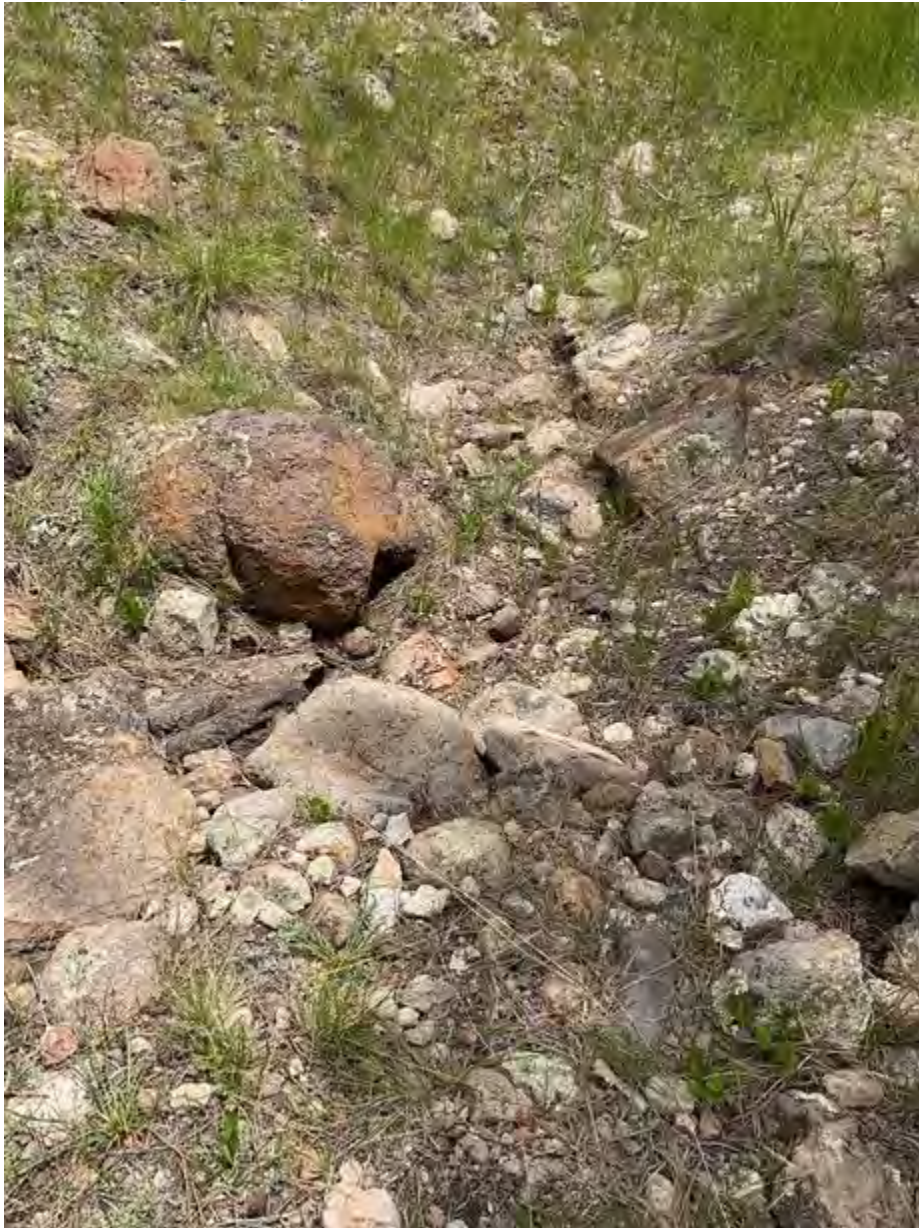
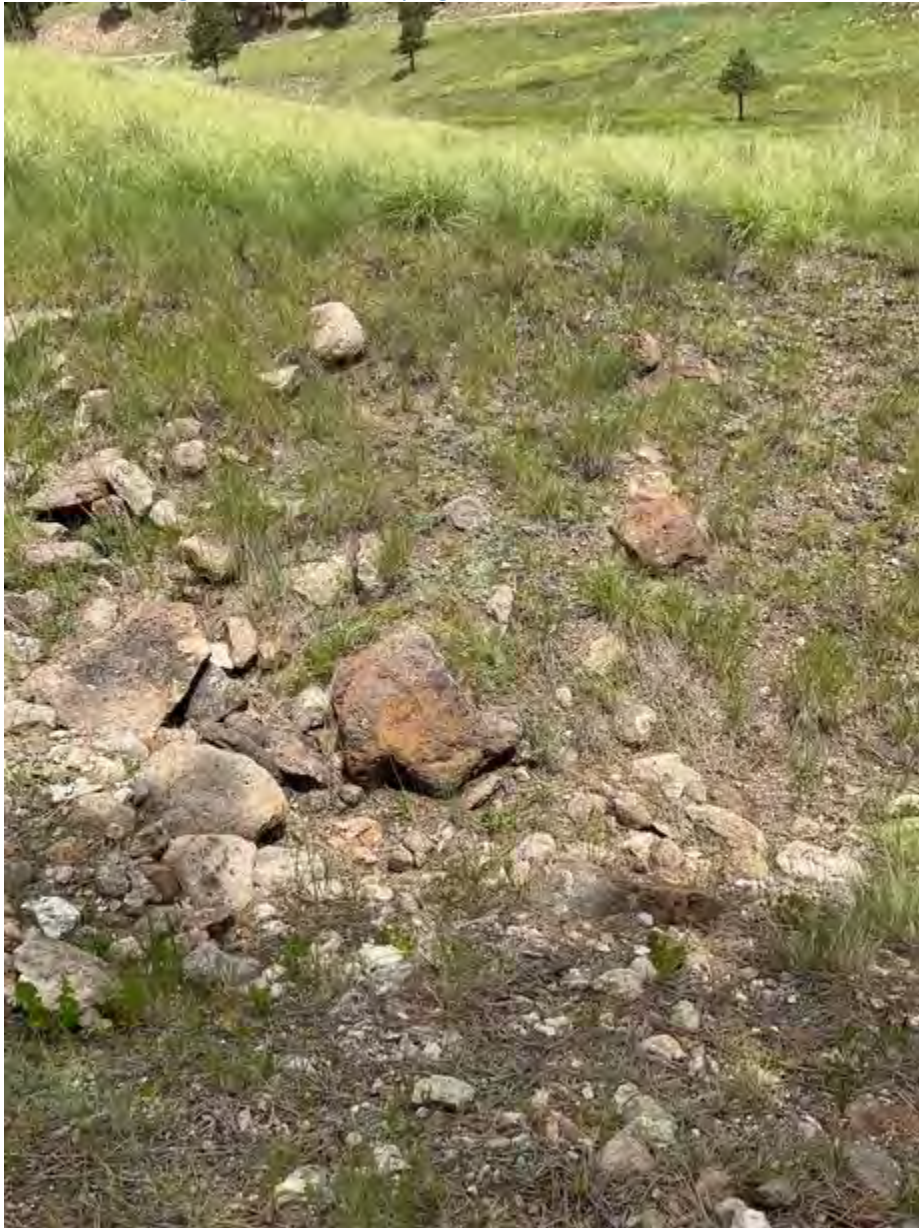
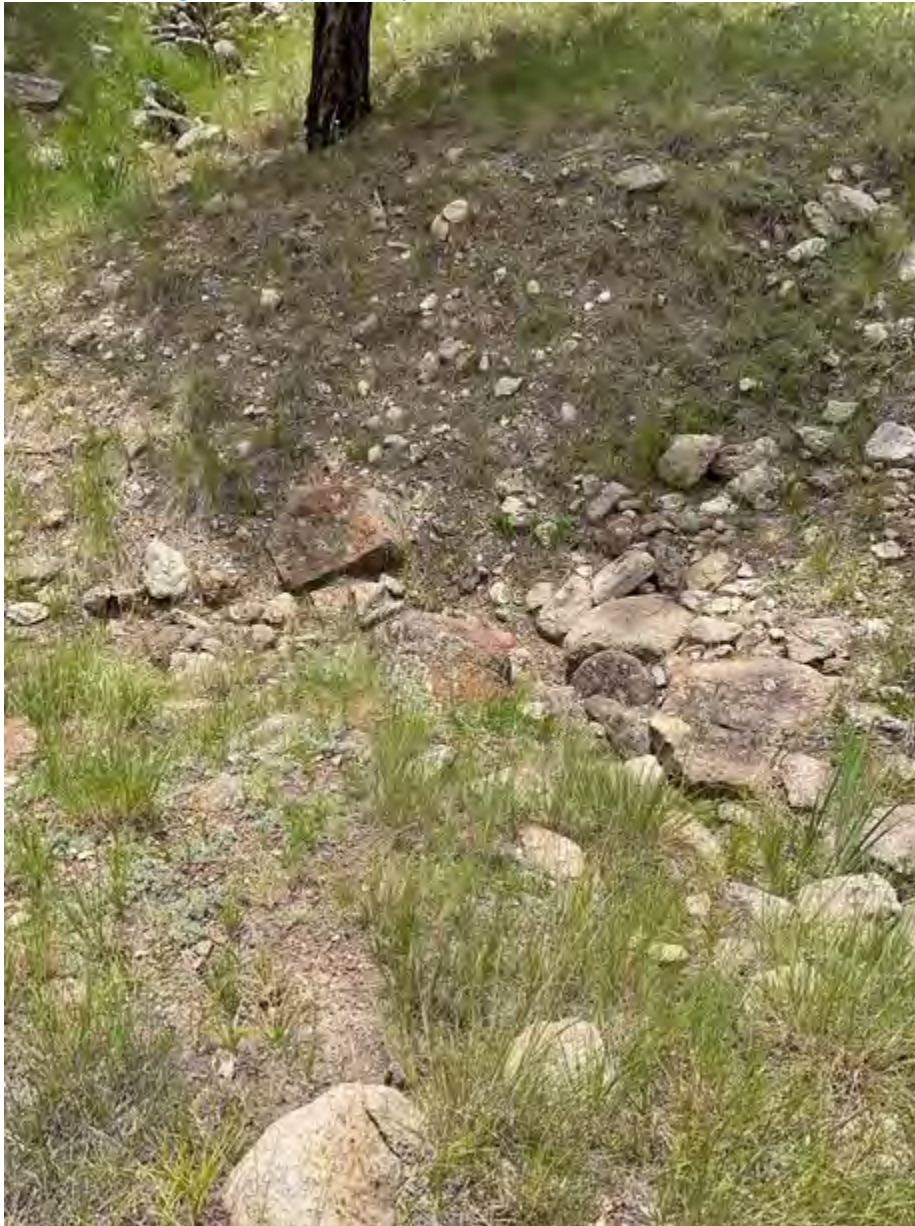
Some rocks dislodged or broken

Difference between ZB and ORD Condition
ORD is mostly dislodged ZB is missing a few rocks
