**Zuni Bowl and One Rock Check Dam Research –
Phase 1**

Final Report

December 2024

Rio Grande Return for the New Mexico Department of Transportation Research Bureau

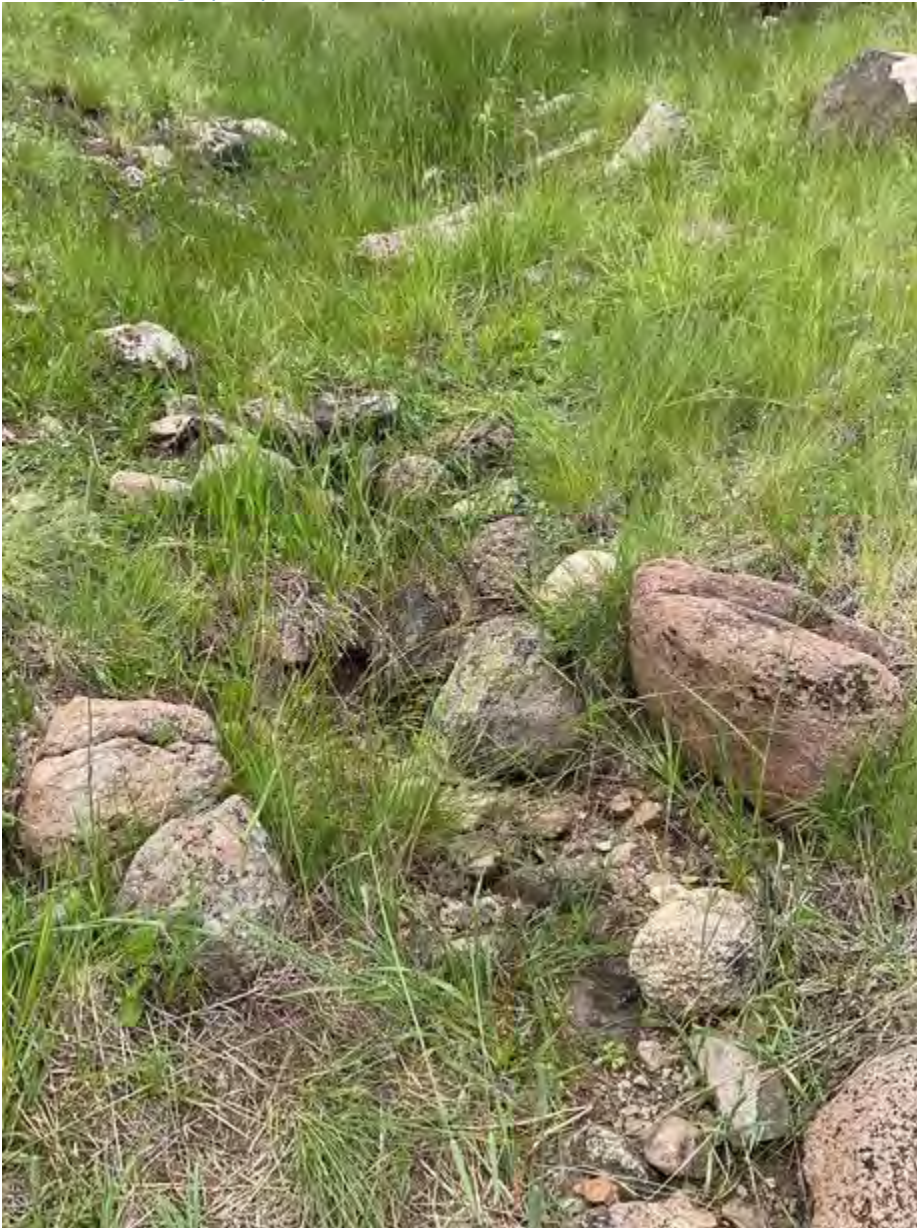
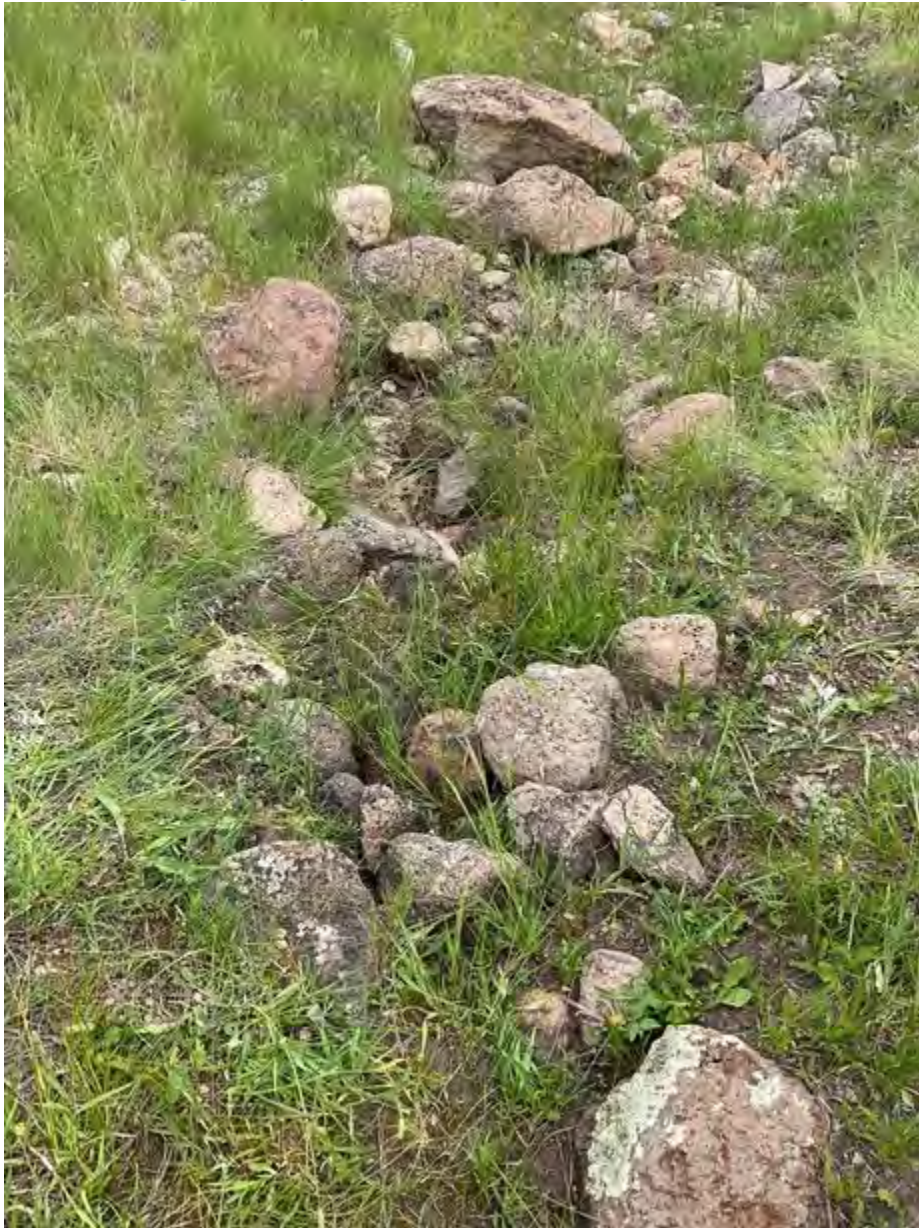
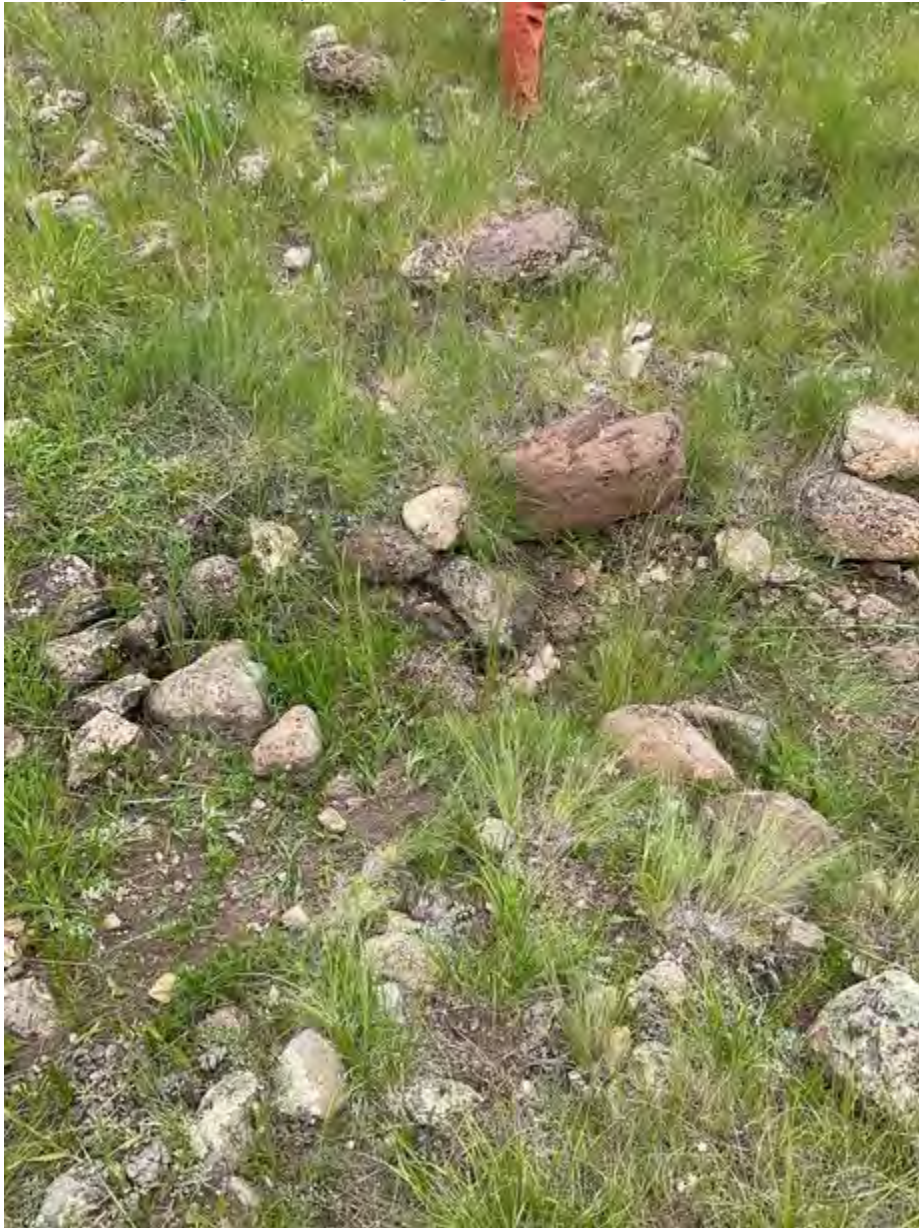
Some rocks dislodged or broken

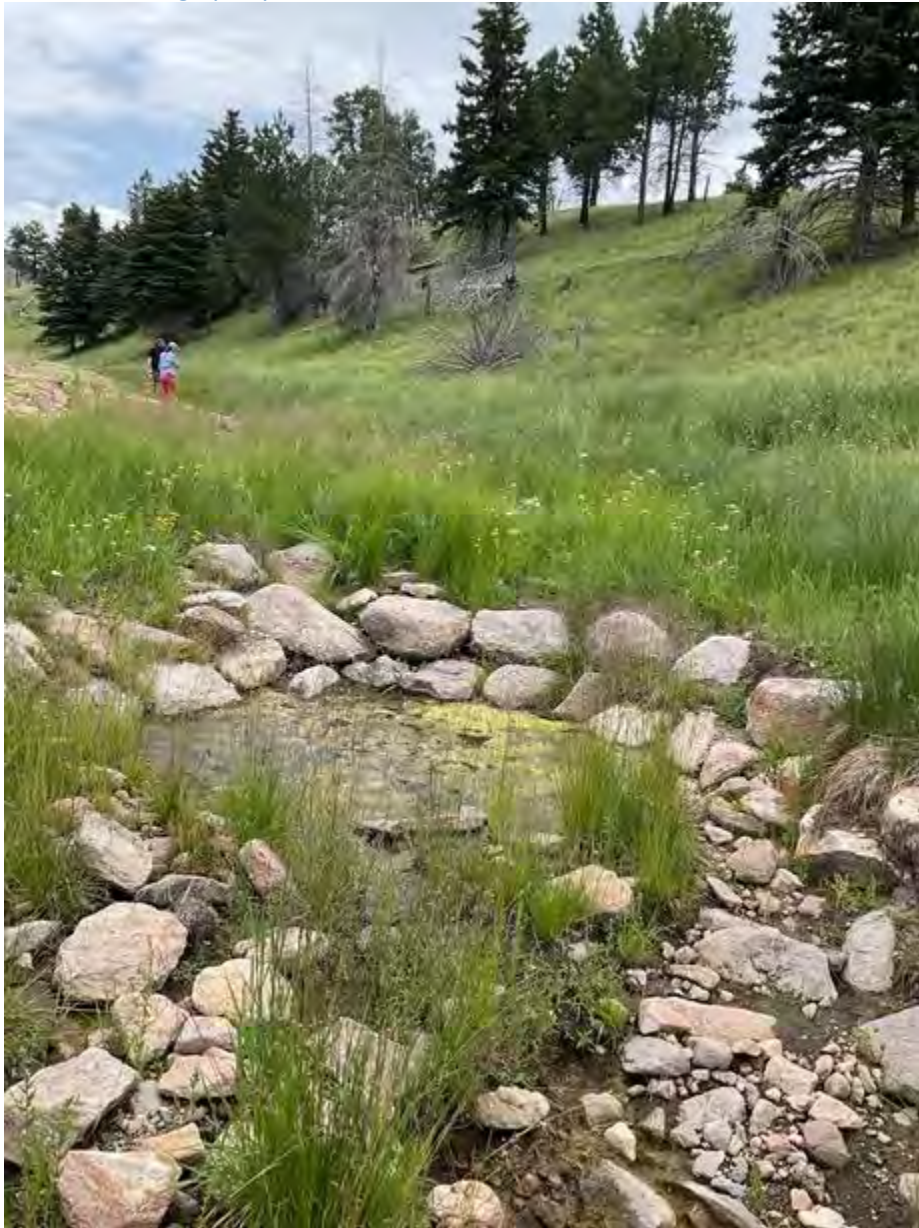
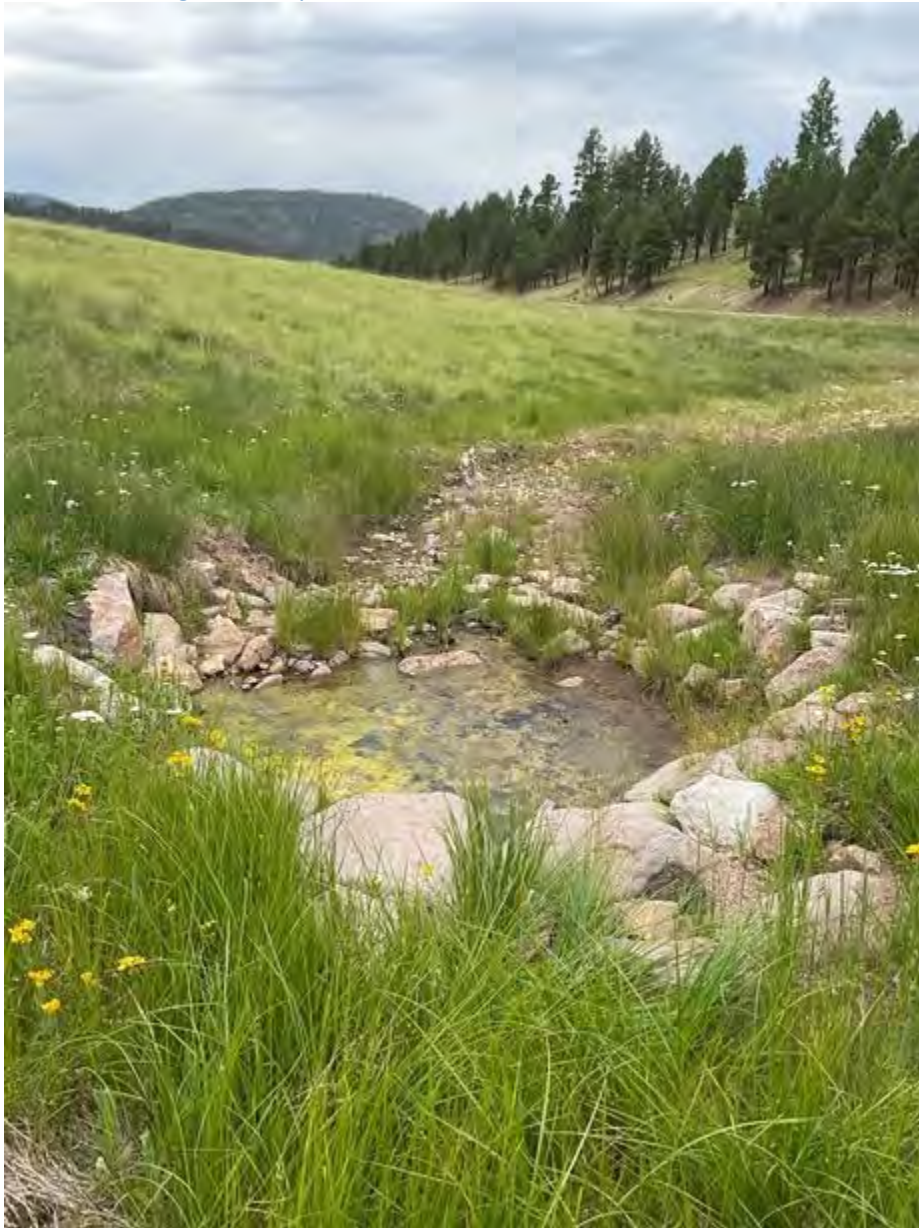
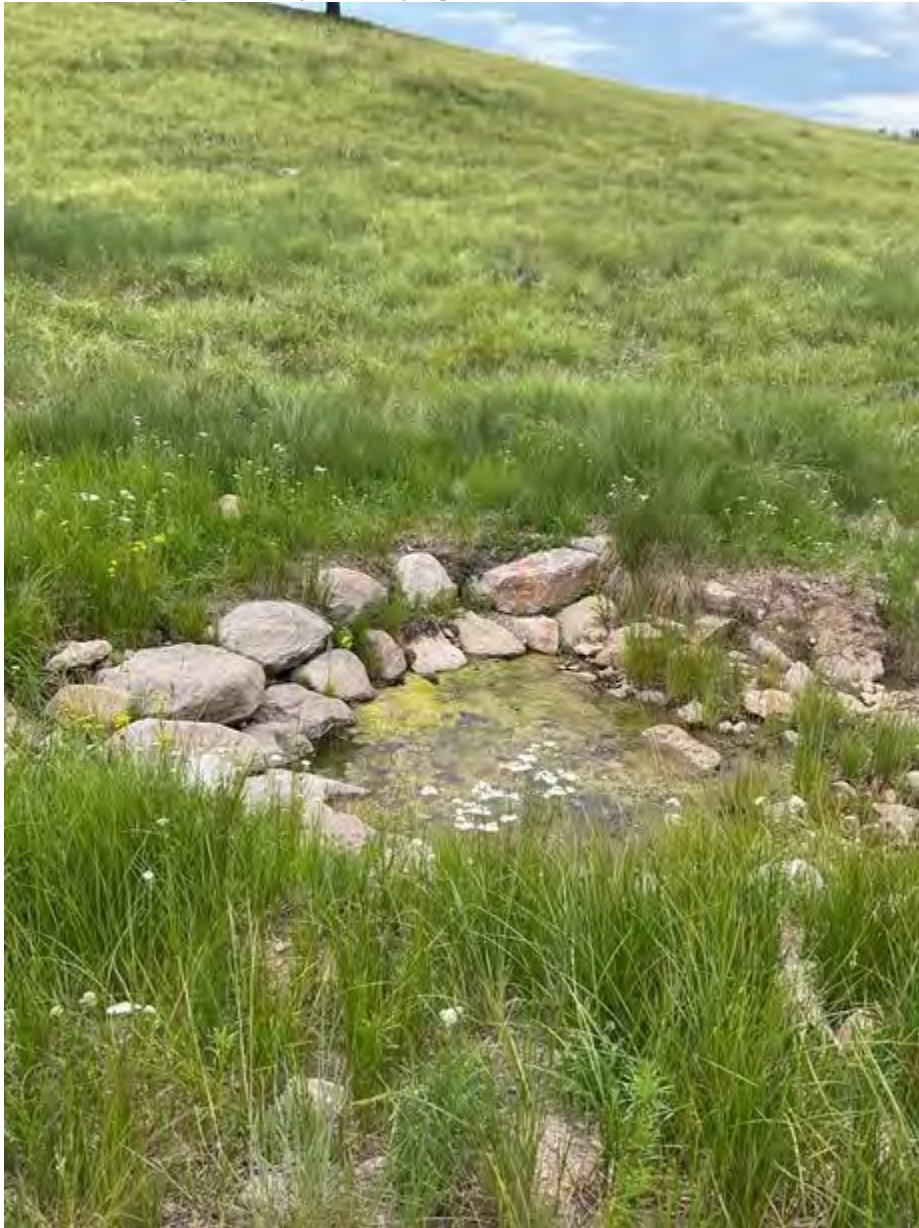
Some rocks dislodged or broken

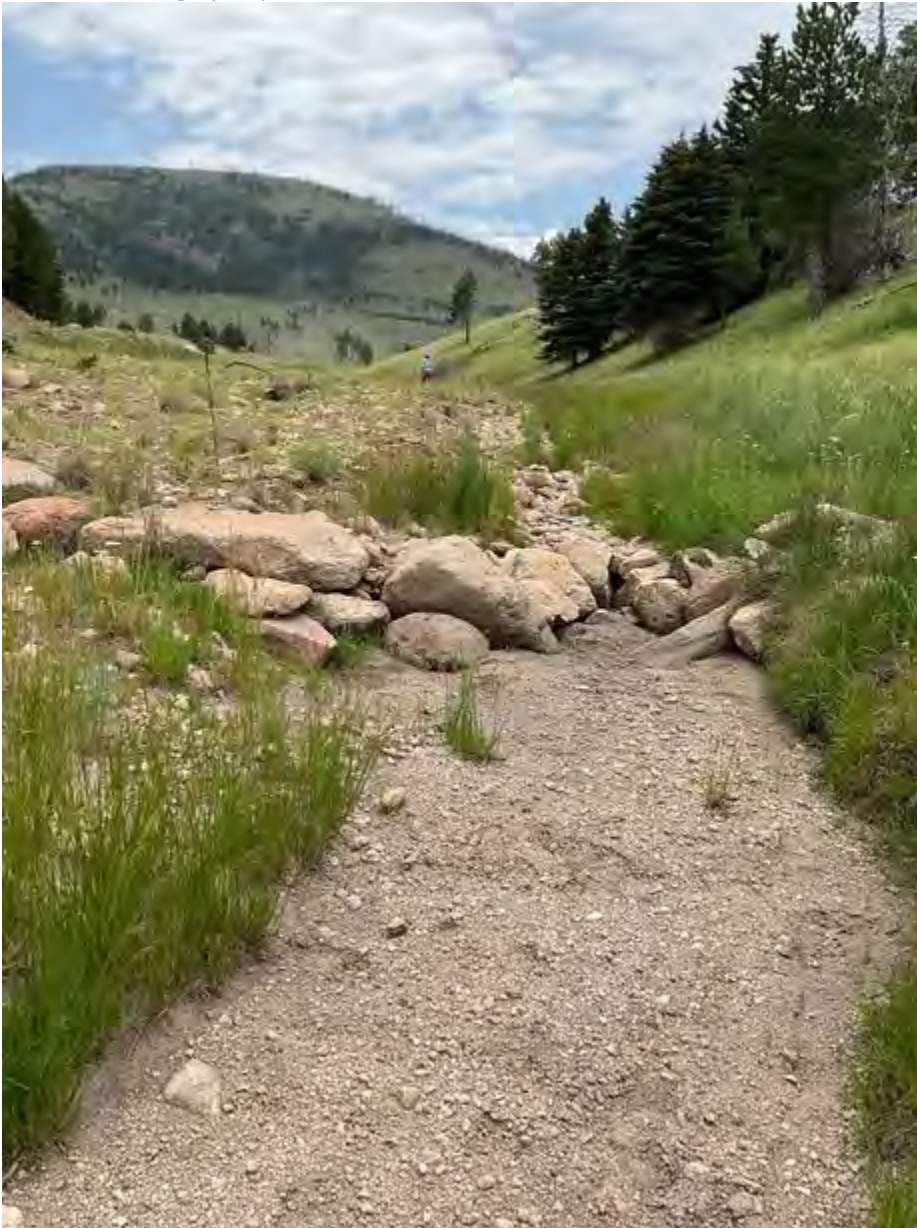
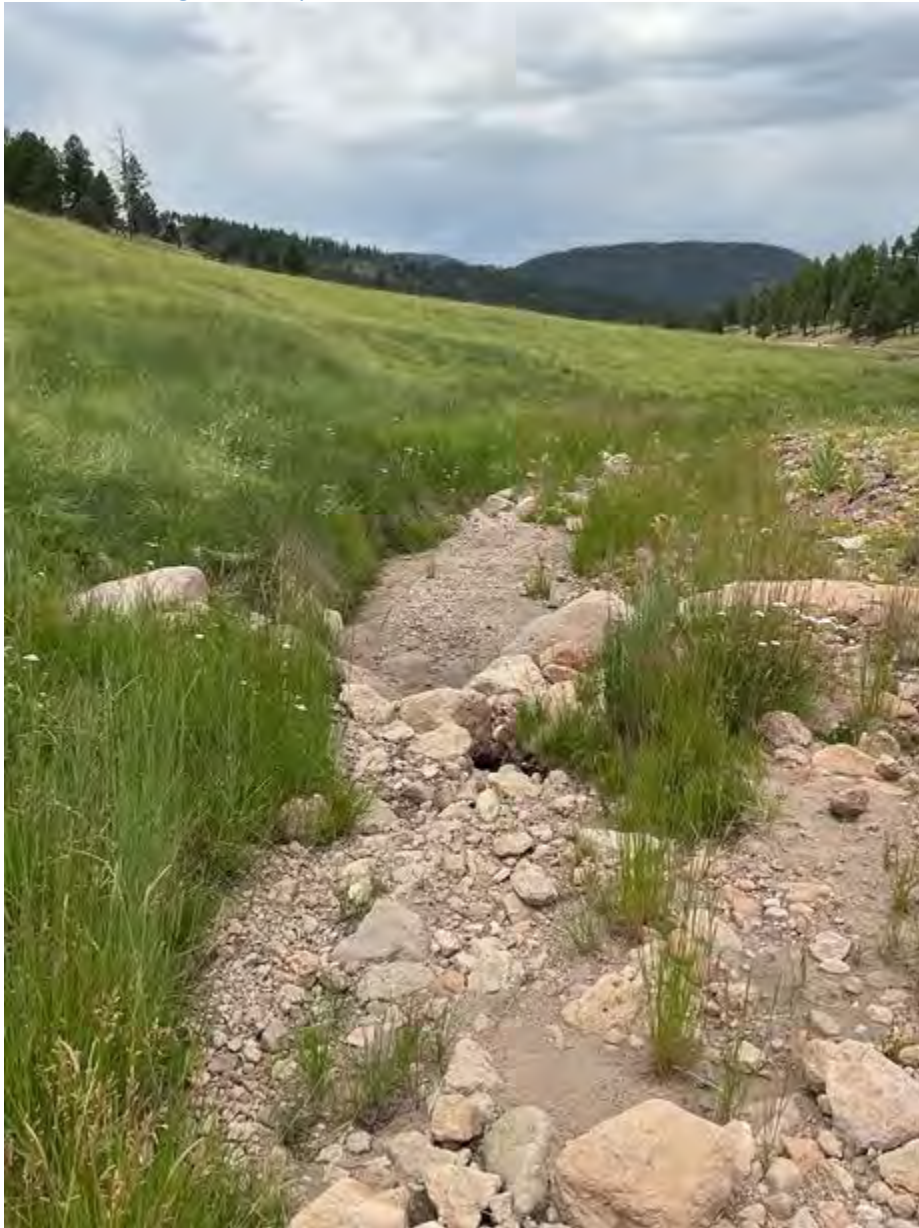
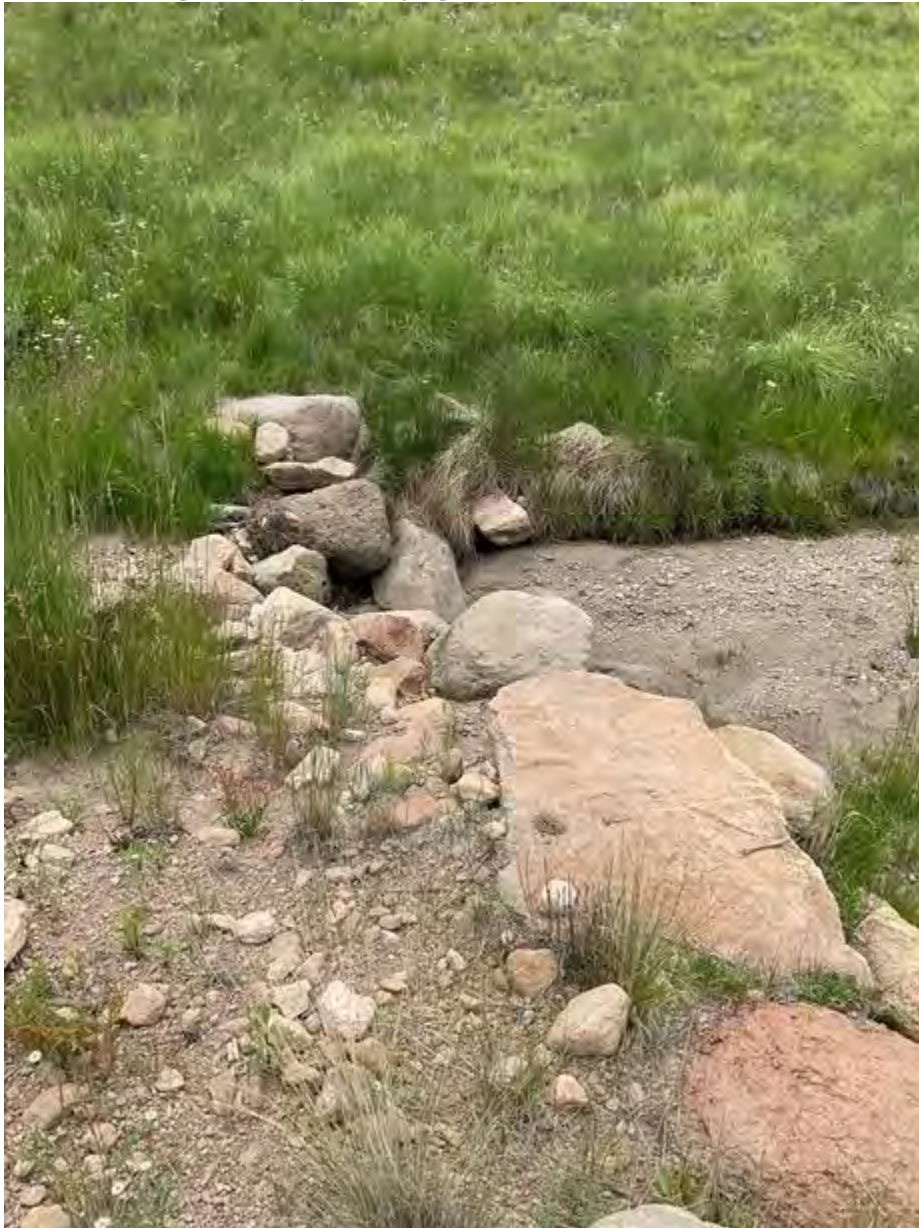
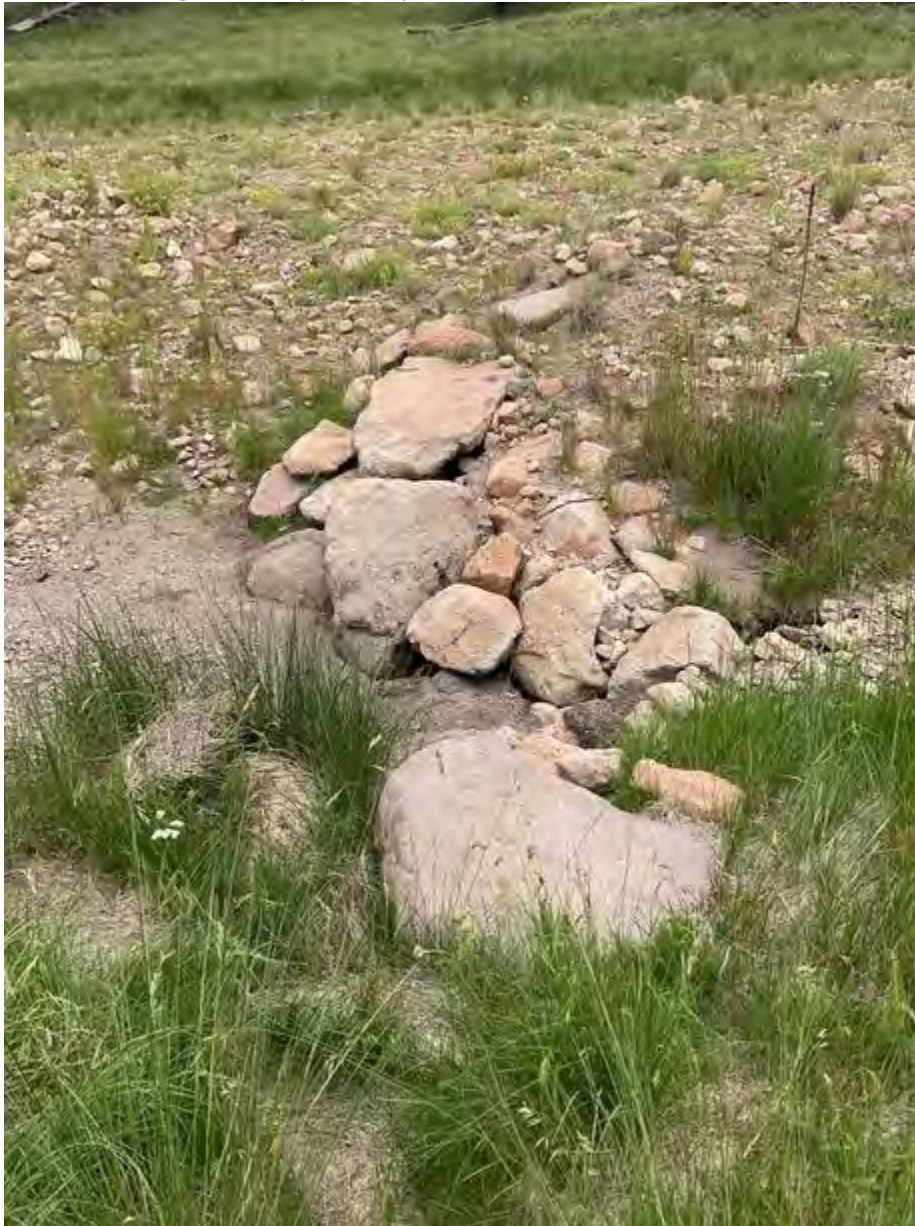
All rocks intact

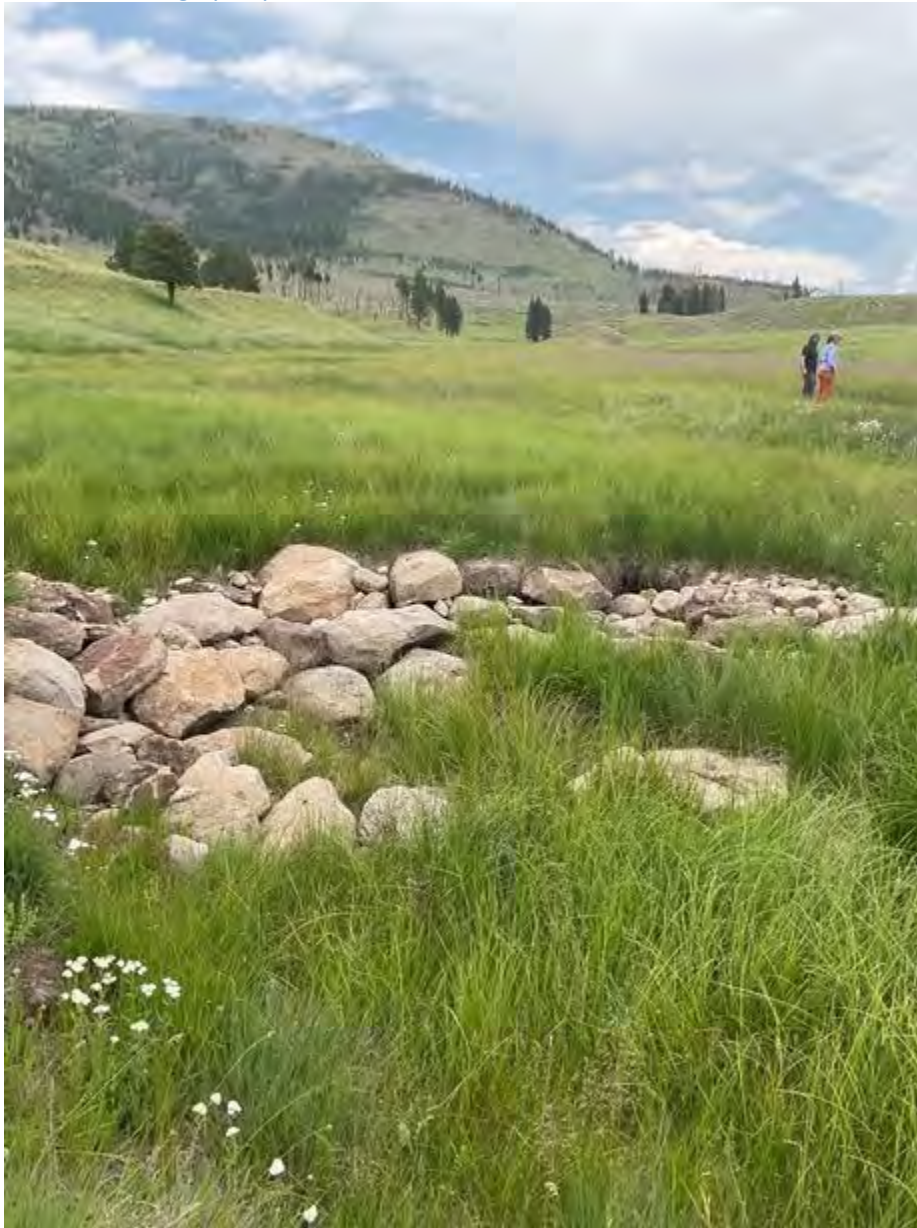
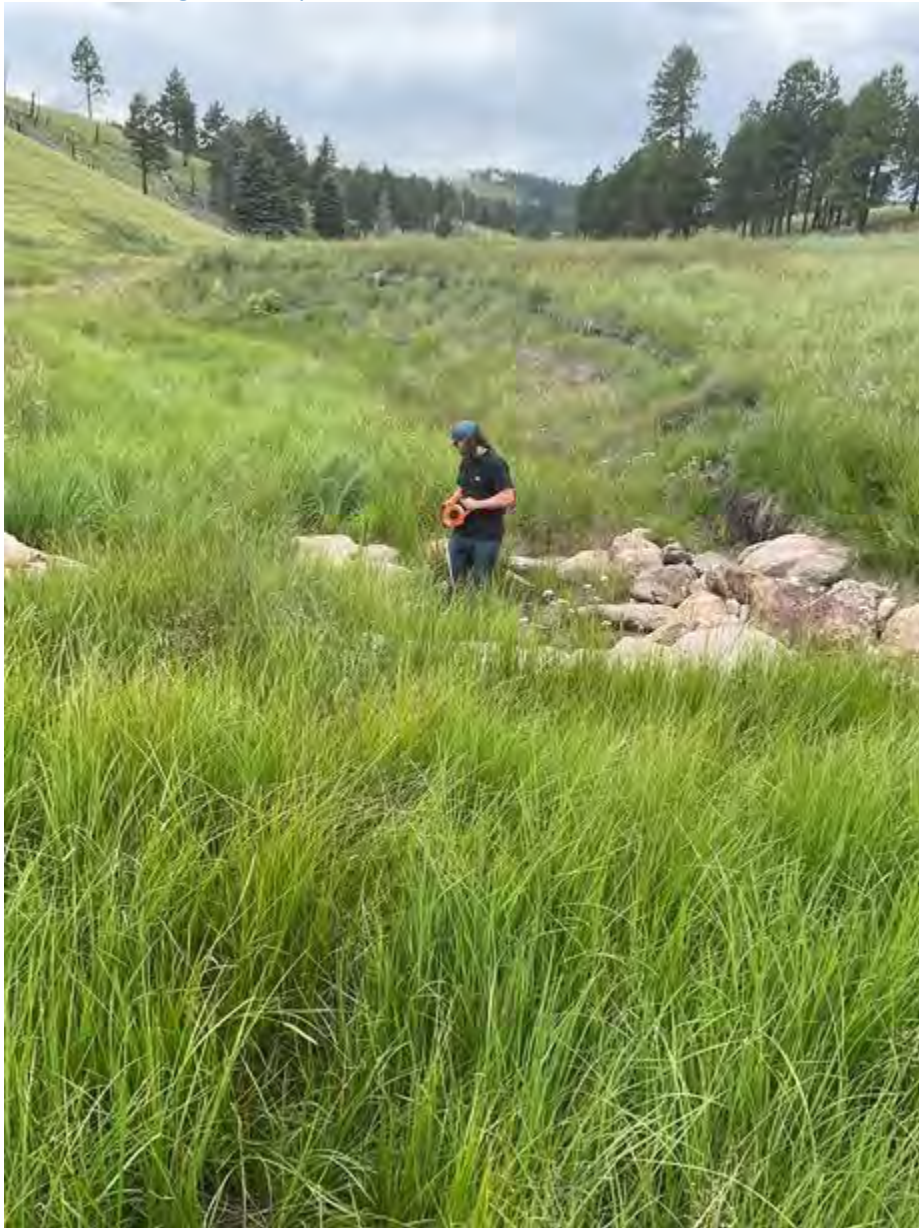
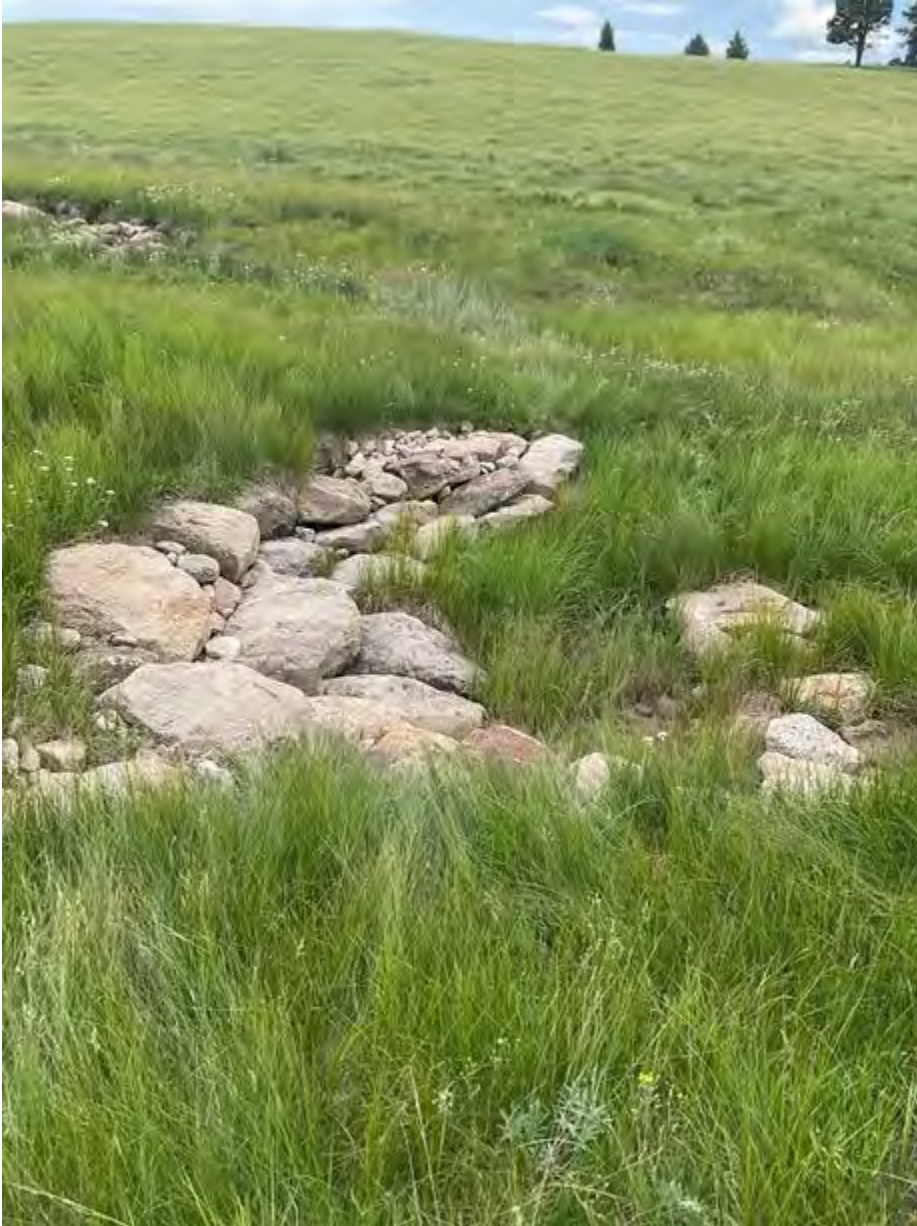
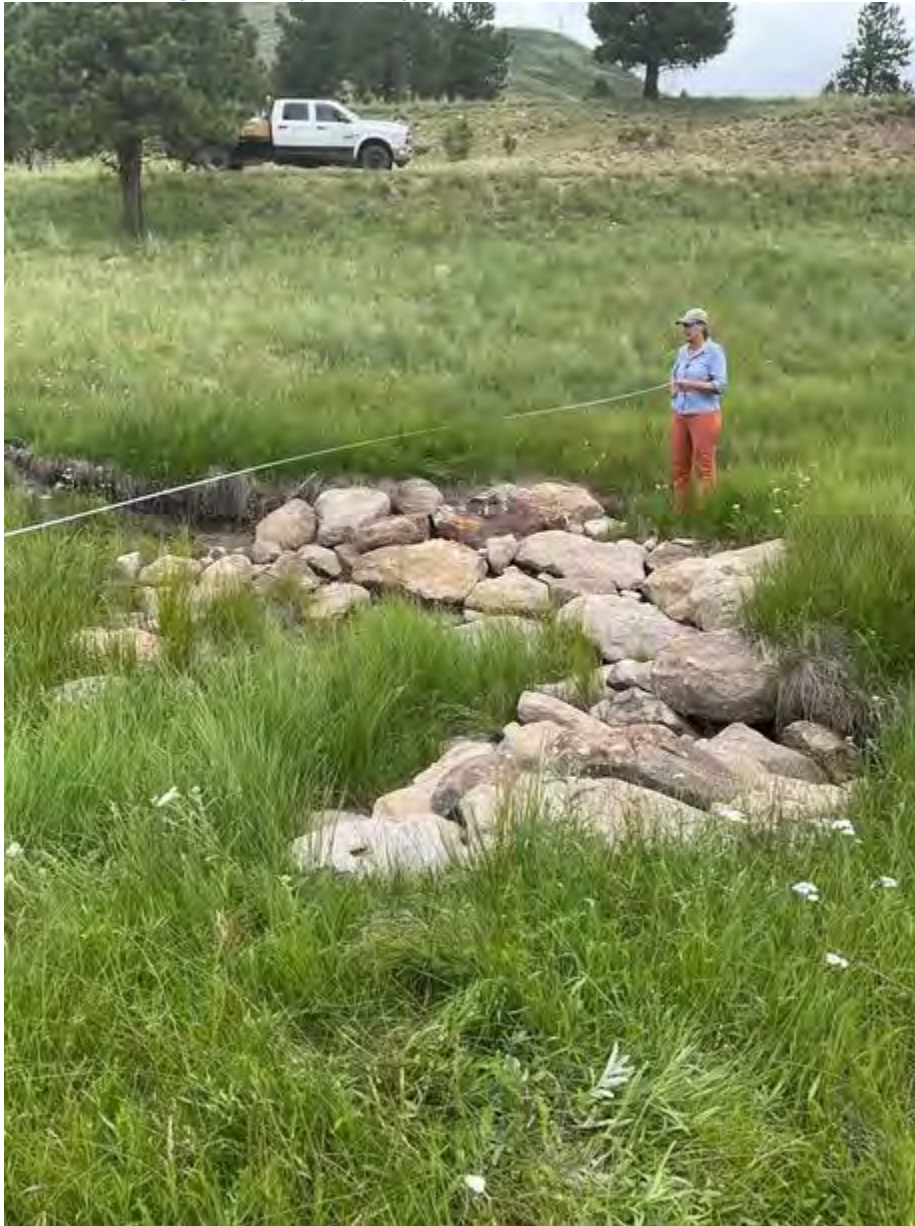
Some rocks dislodged or broken

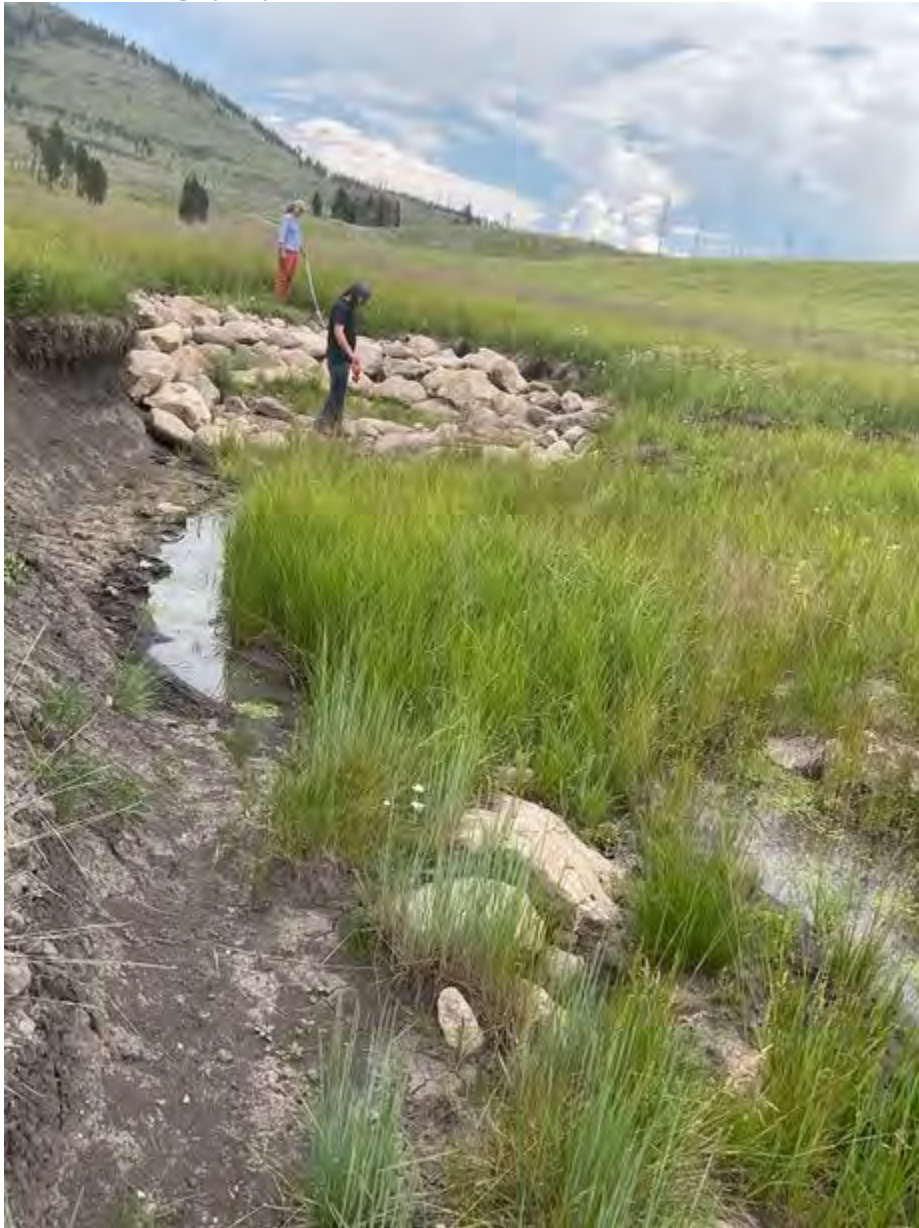
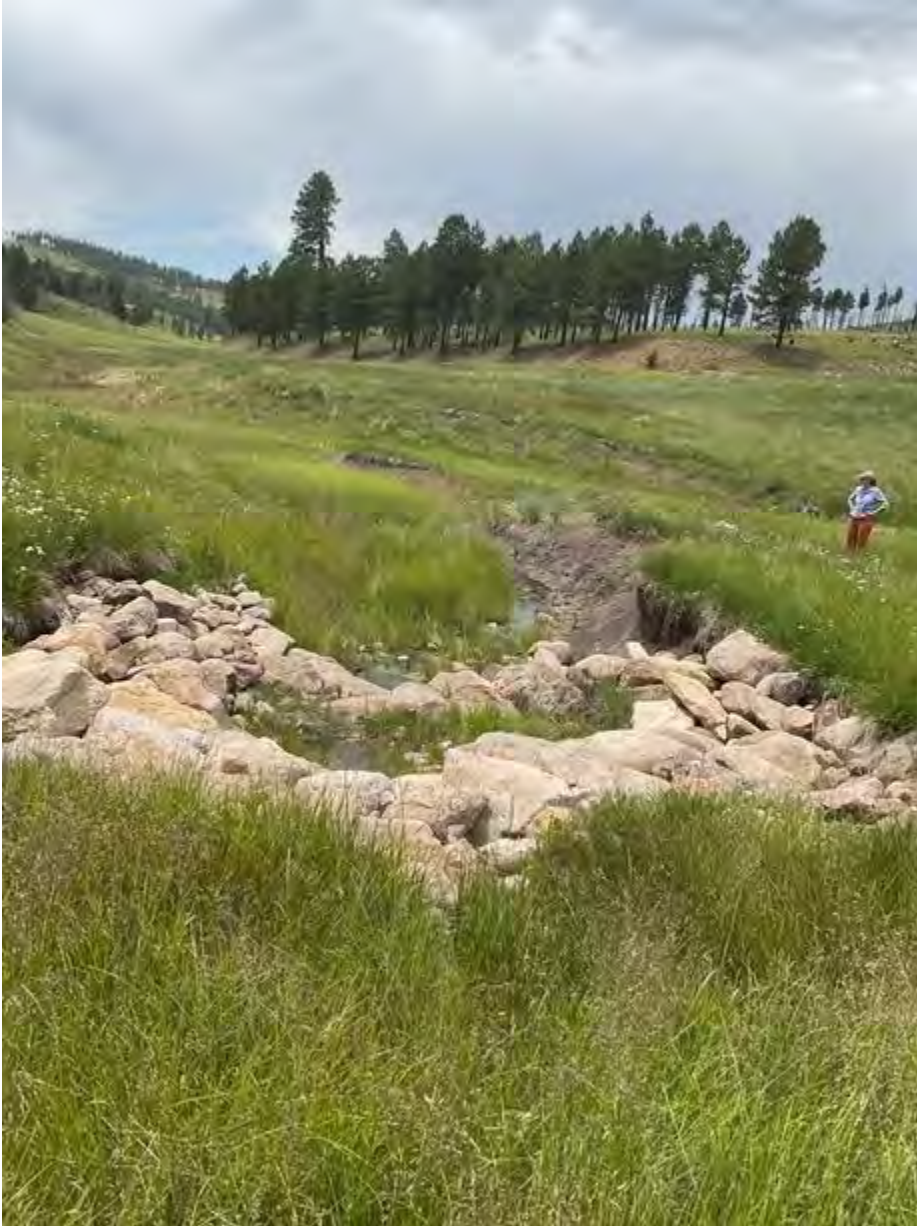
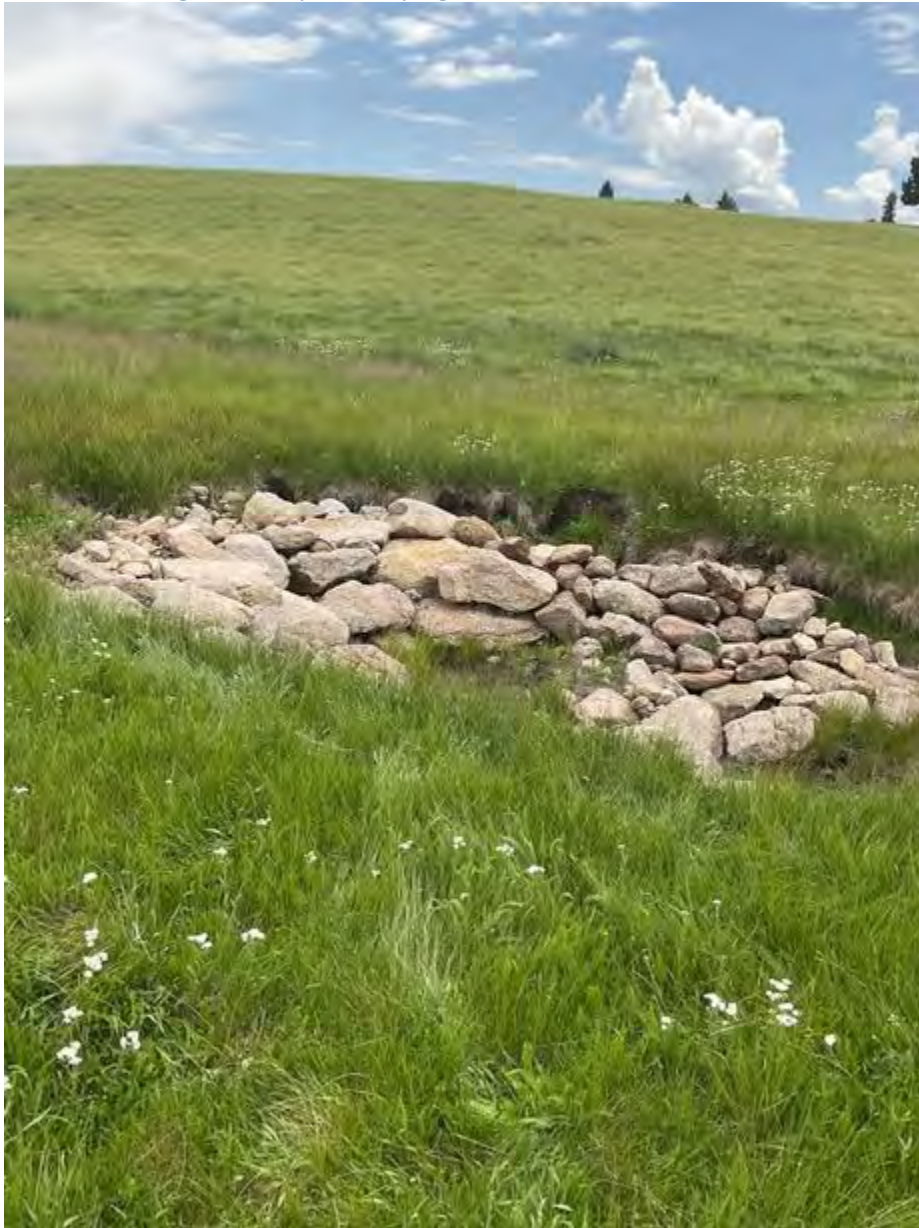
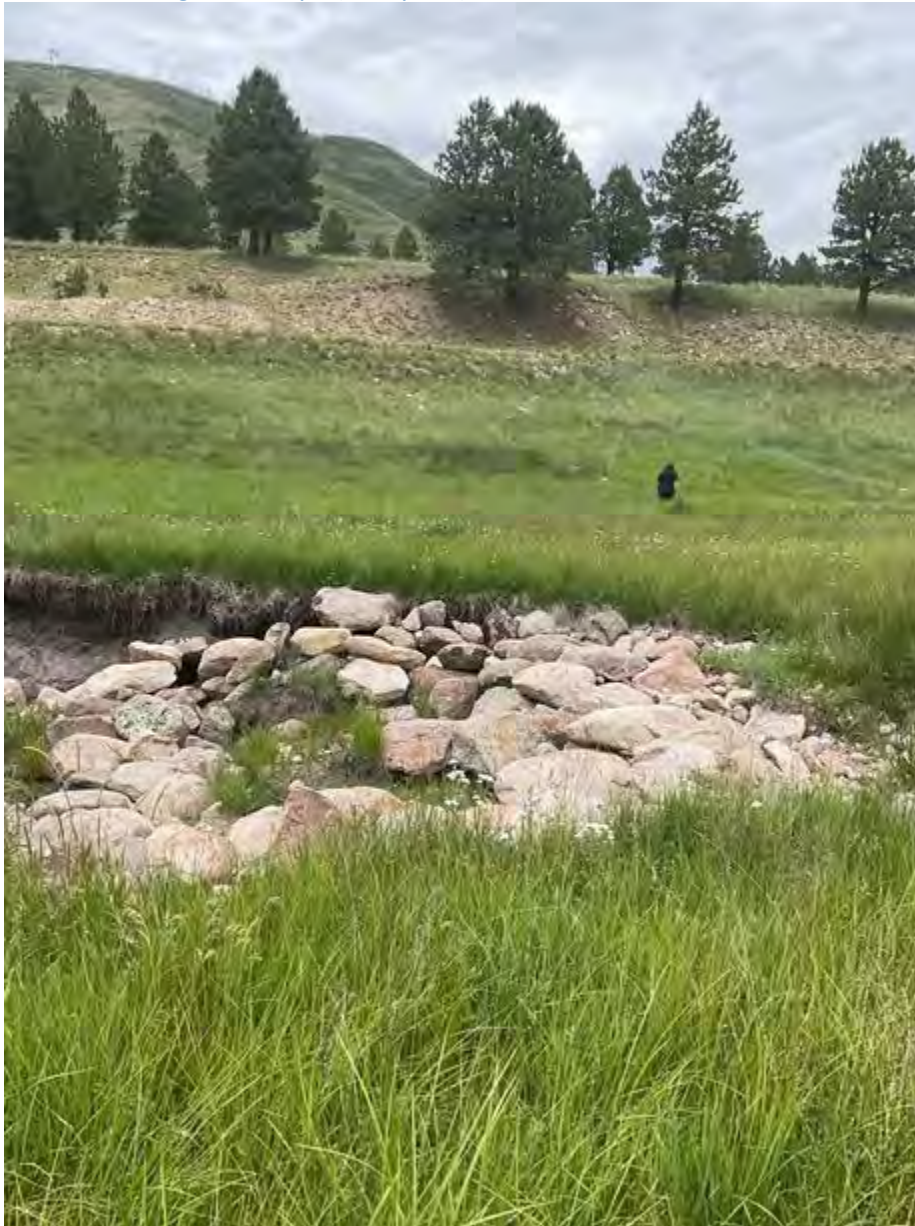
Some rocks dislodged or broken
