**Zuni Bowl and One Rock Check Dam Research –
Phase 1**

Final Report

December 2024

Rio Grande Return for the New Mexico Department of Transportation Research Bureau

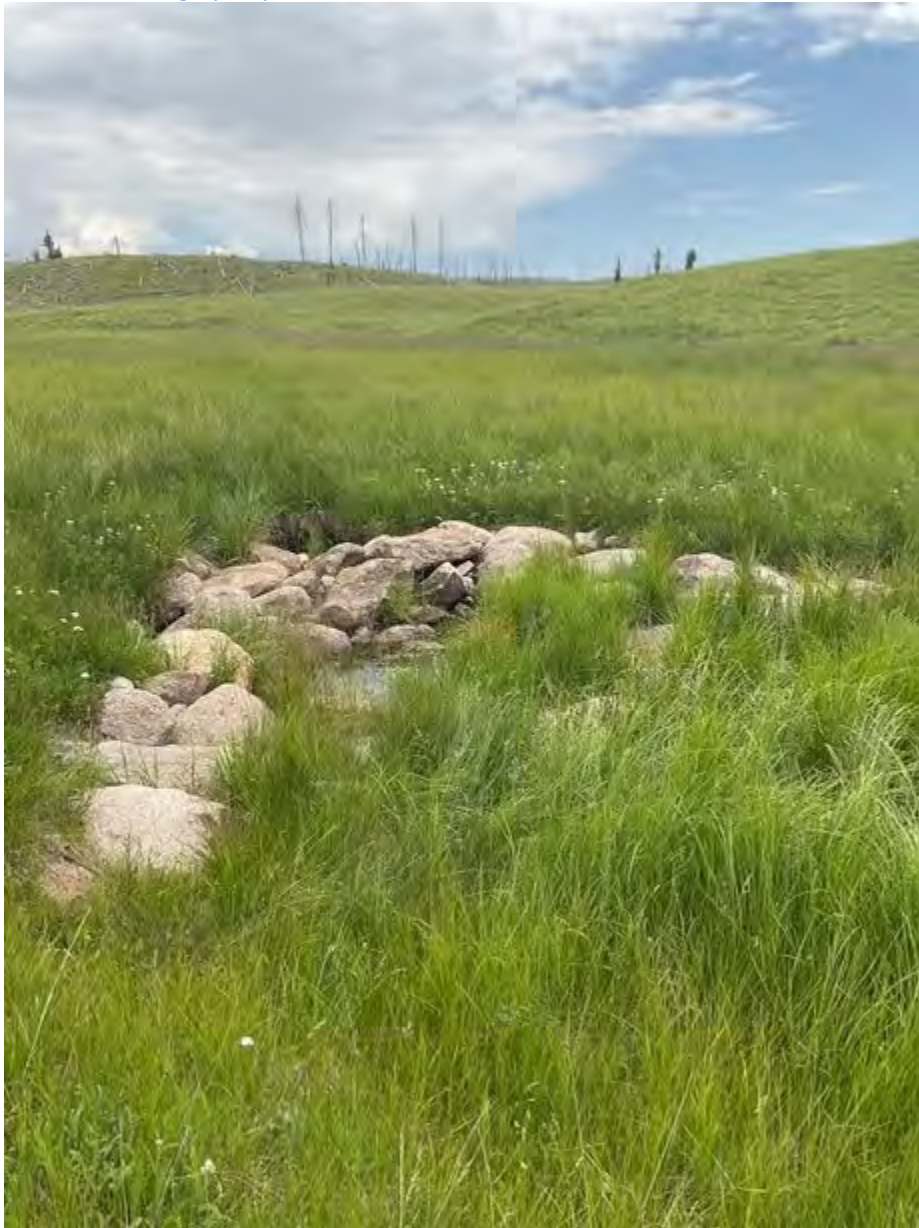
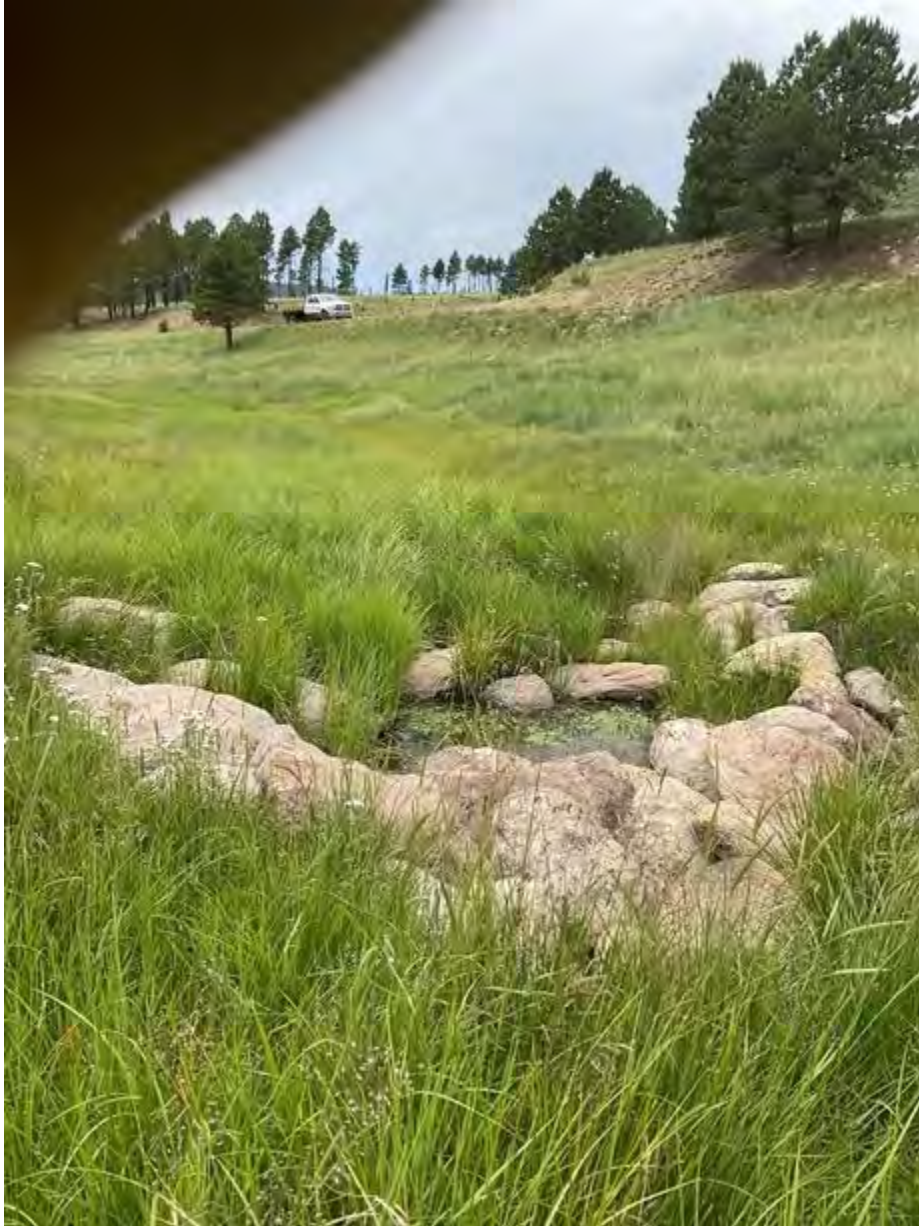
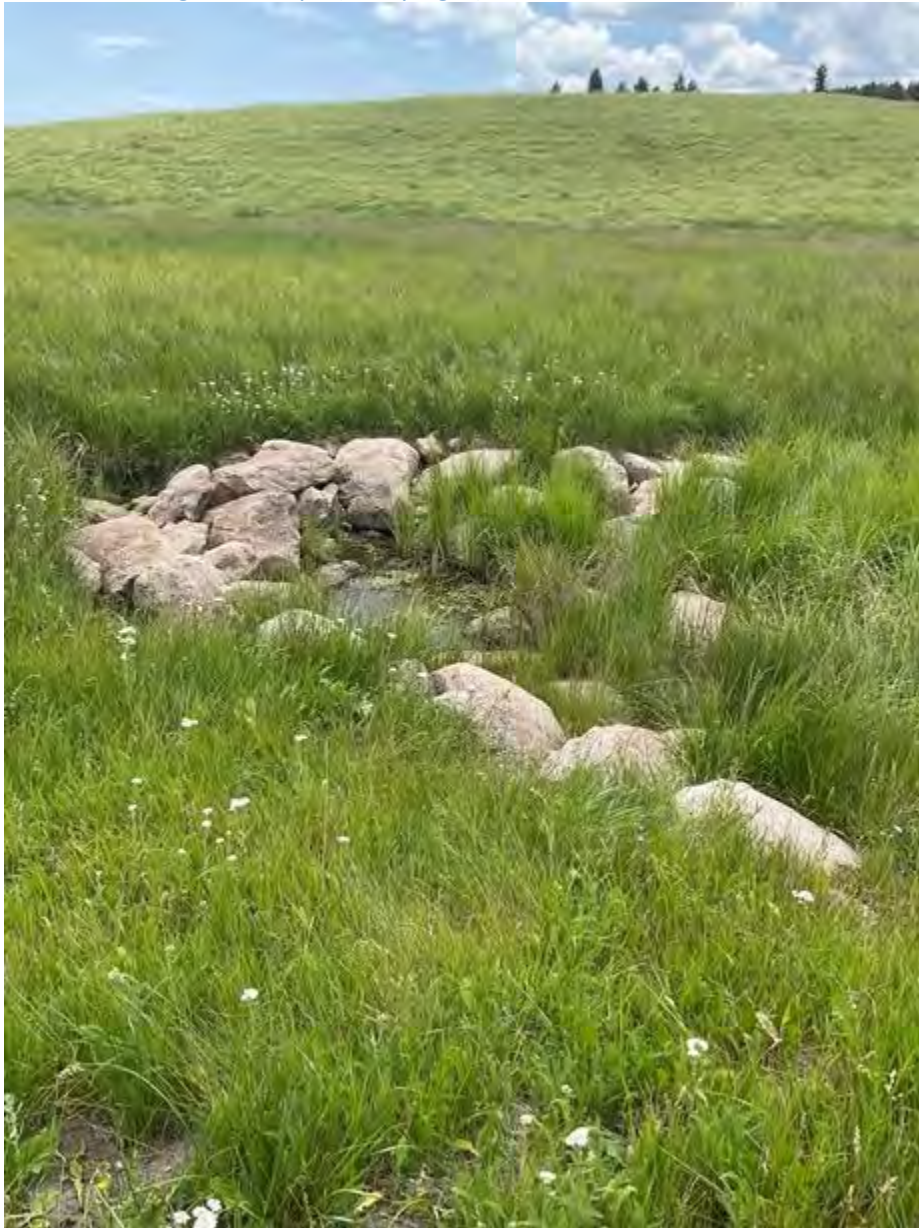
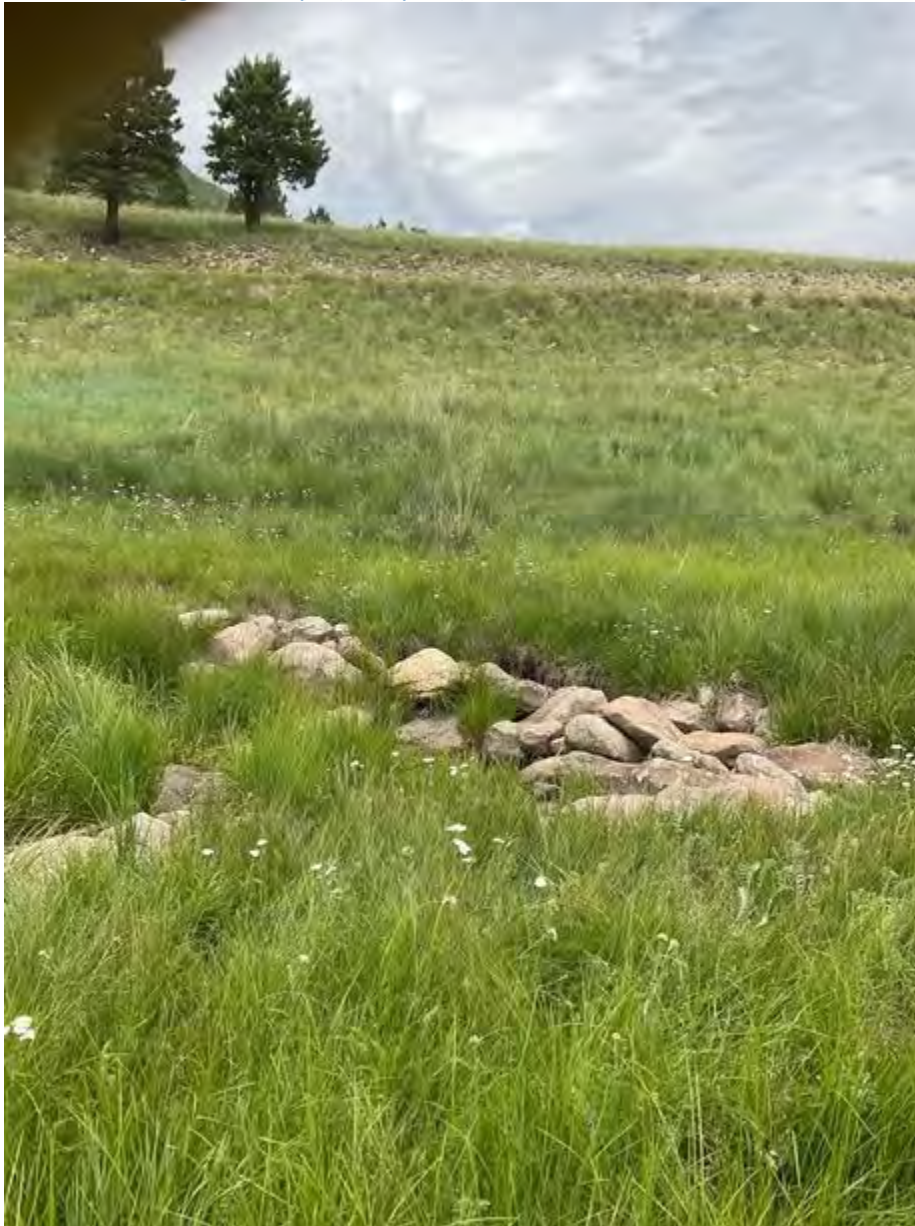
Some rocks dislodged or broken

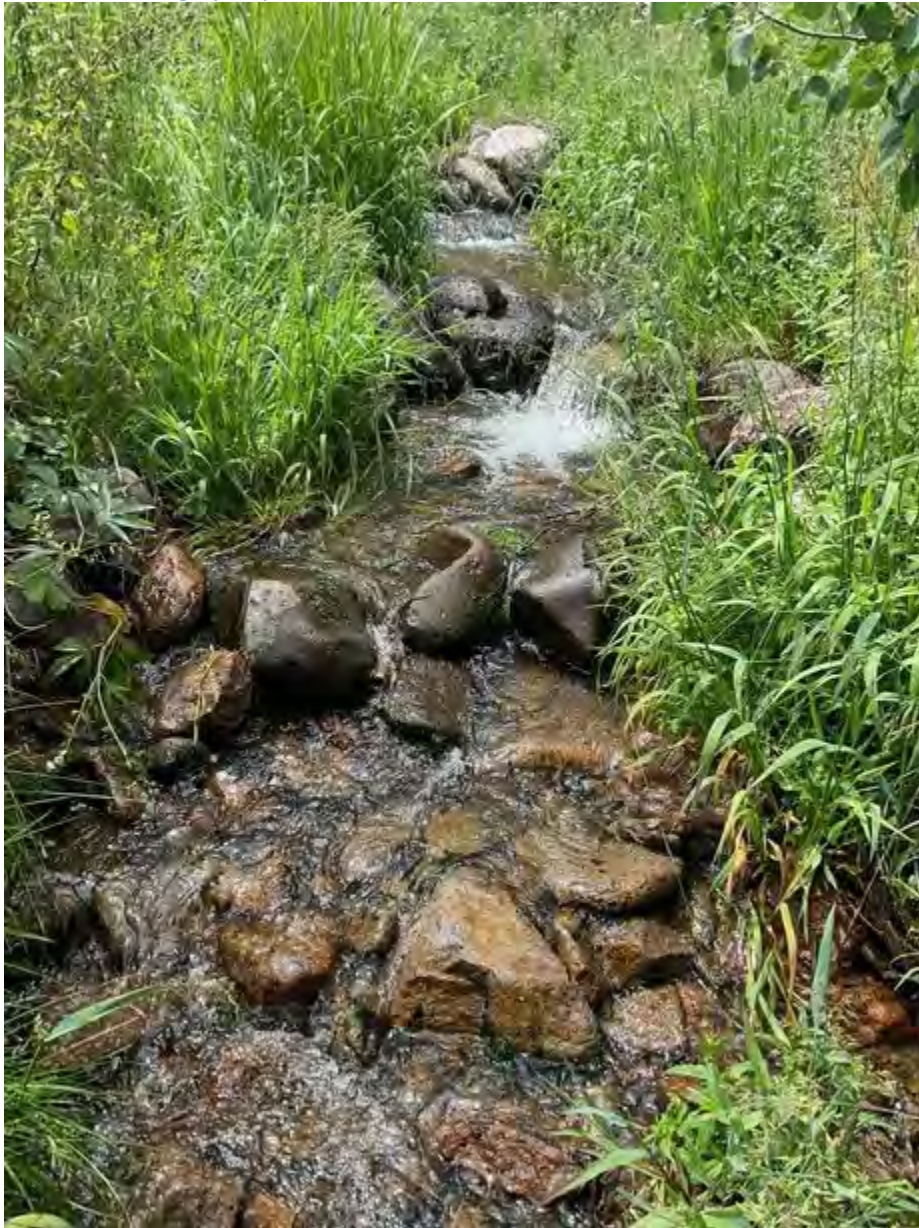
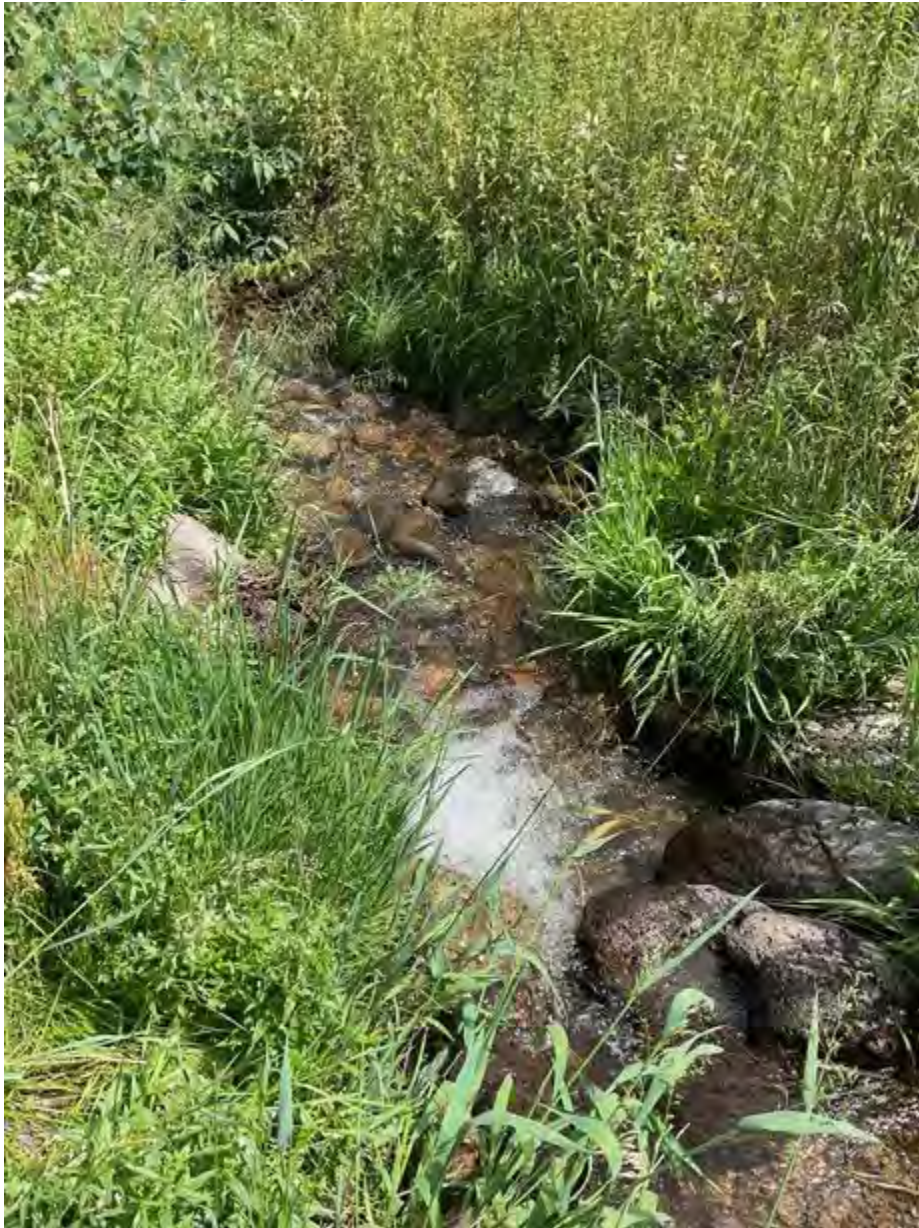
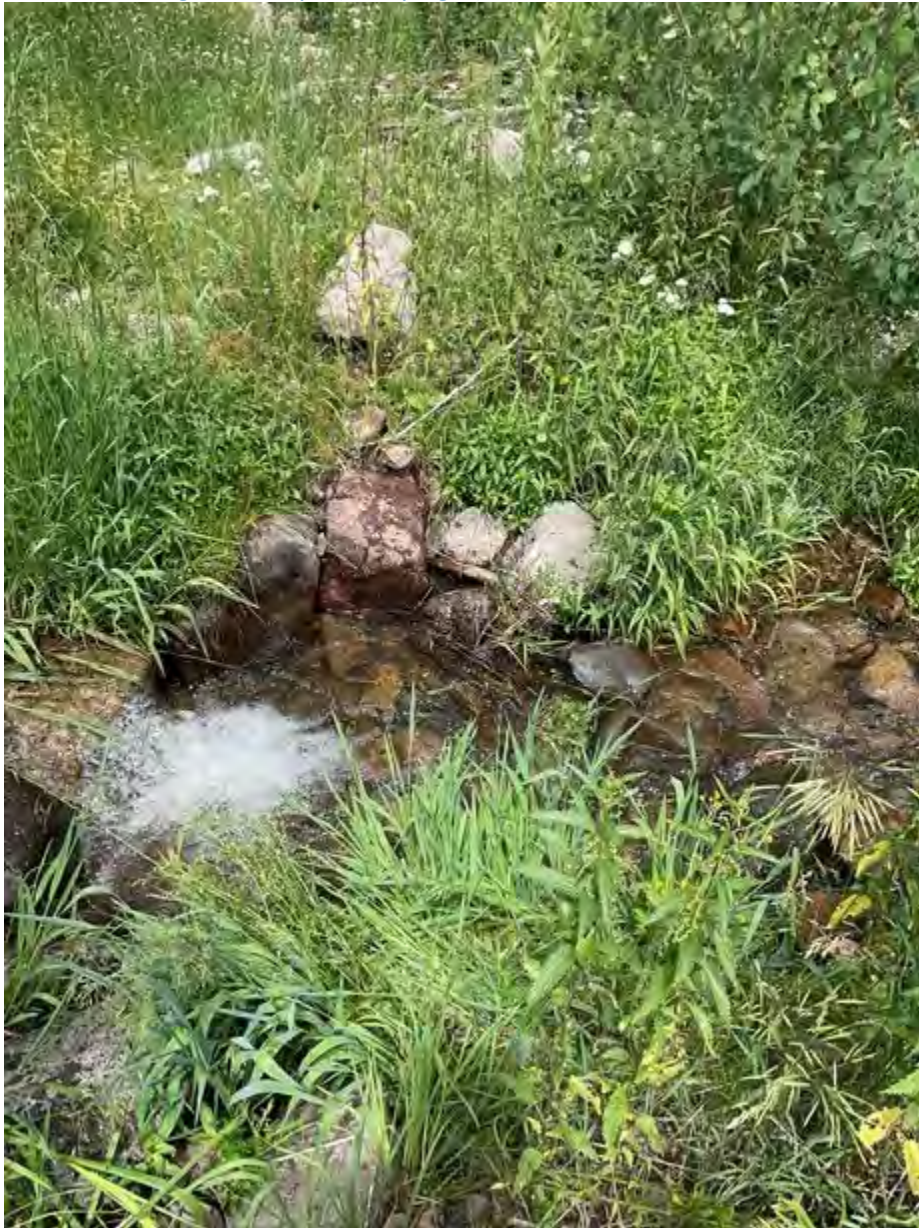
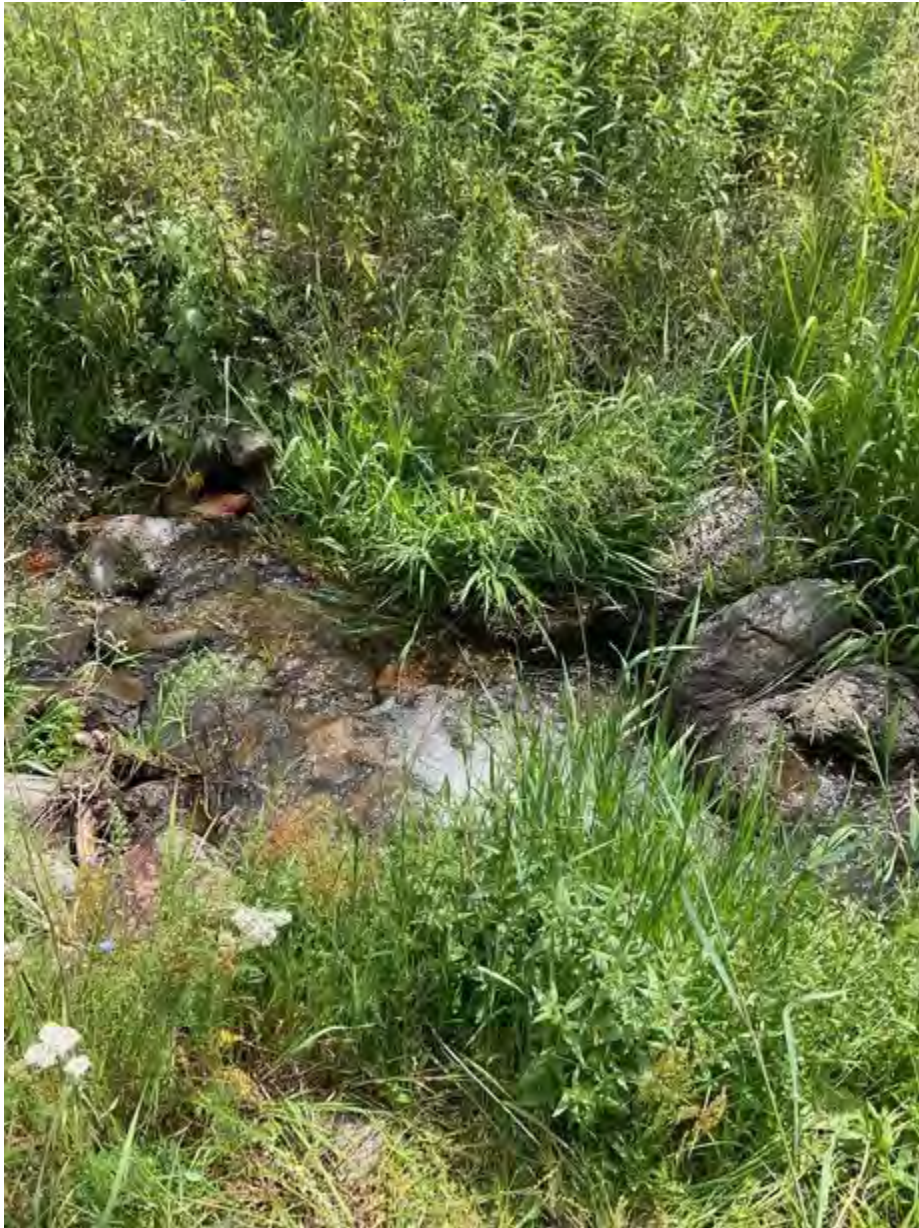
All rocks intact

Difference between ZB and ORD Condition
ORD center rocks dislodged

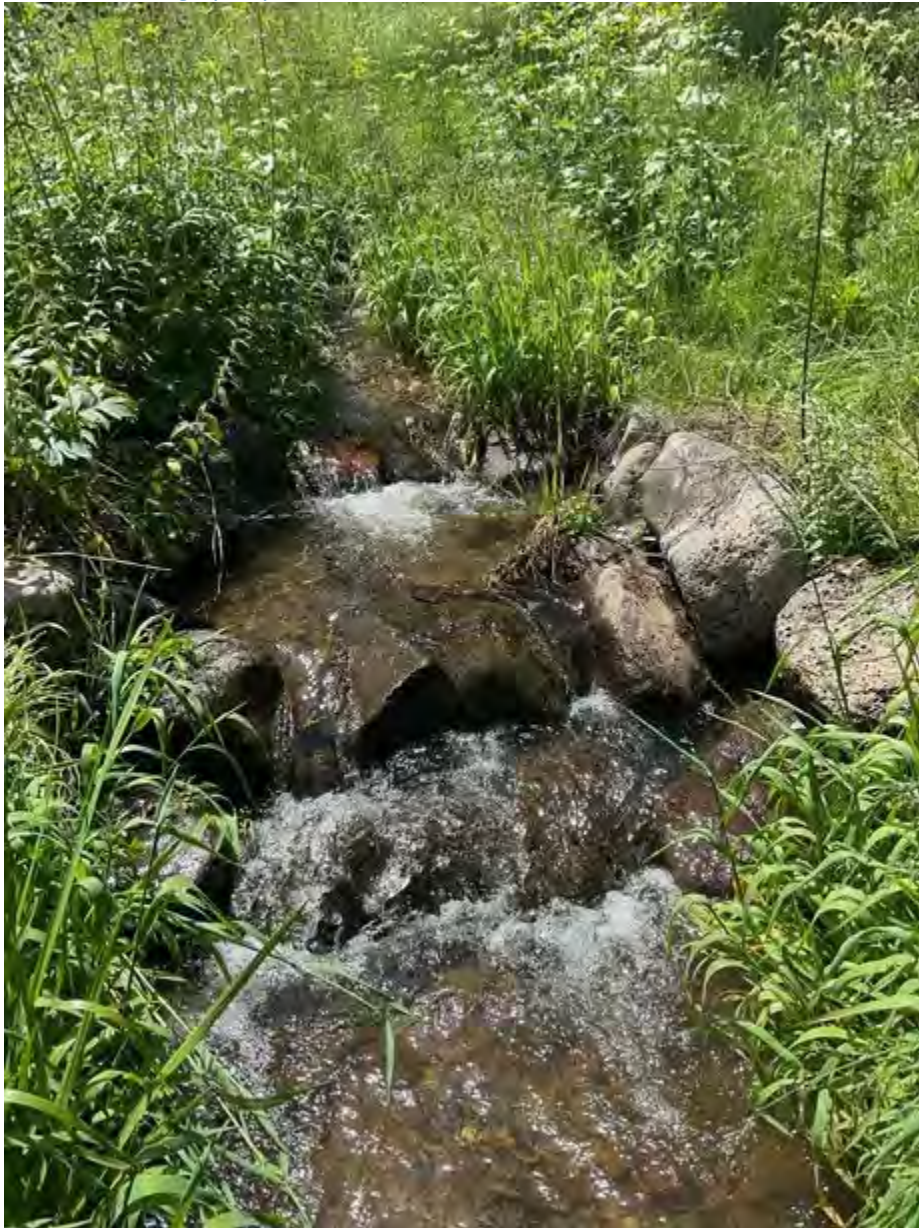
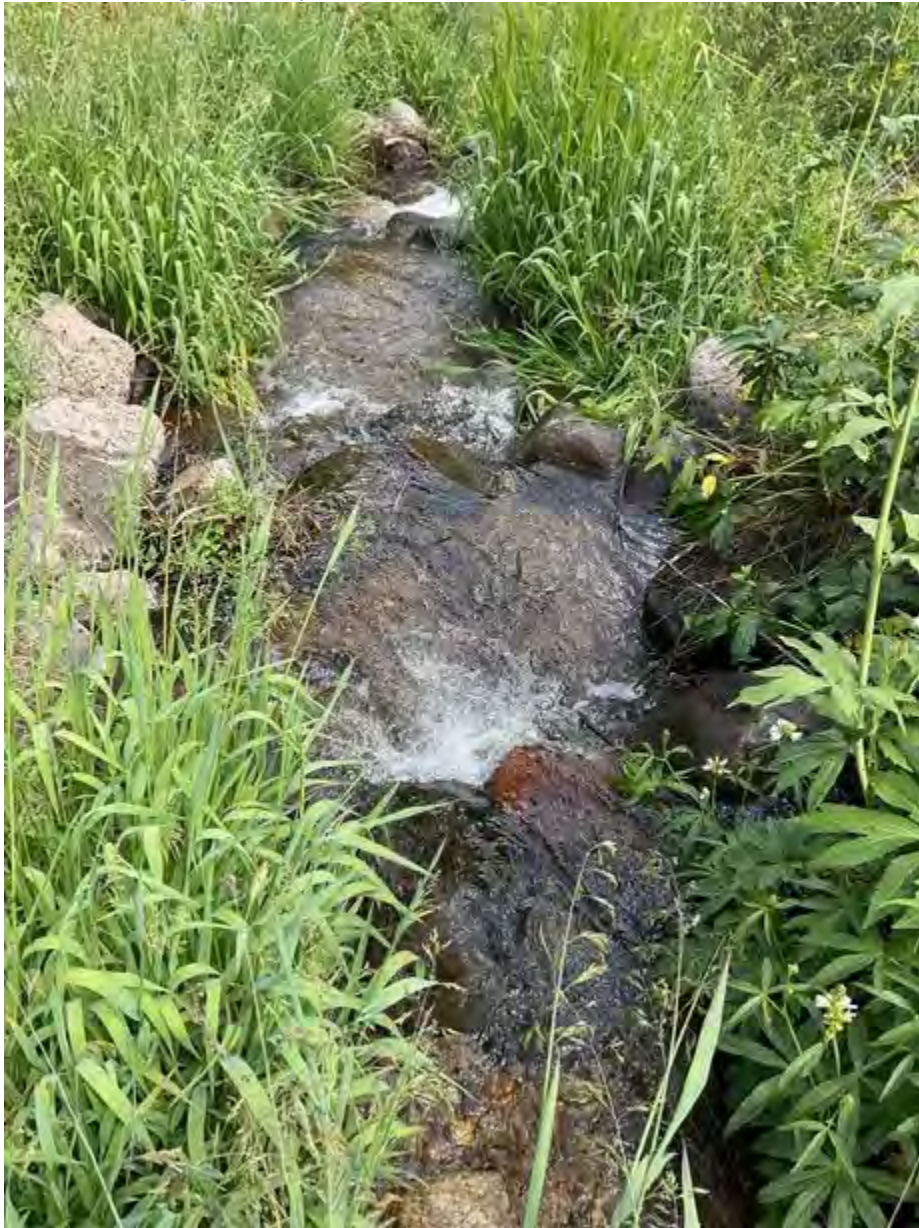
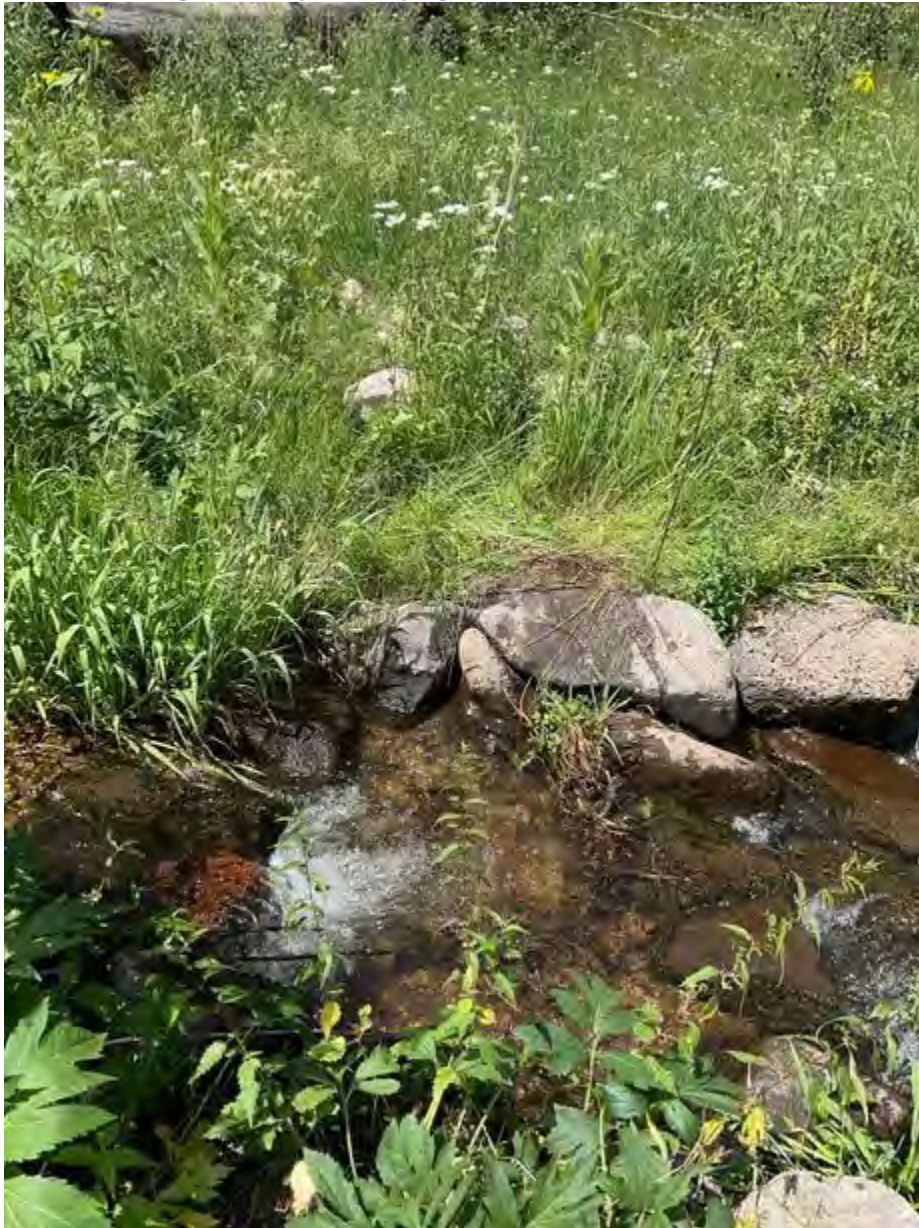
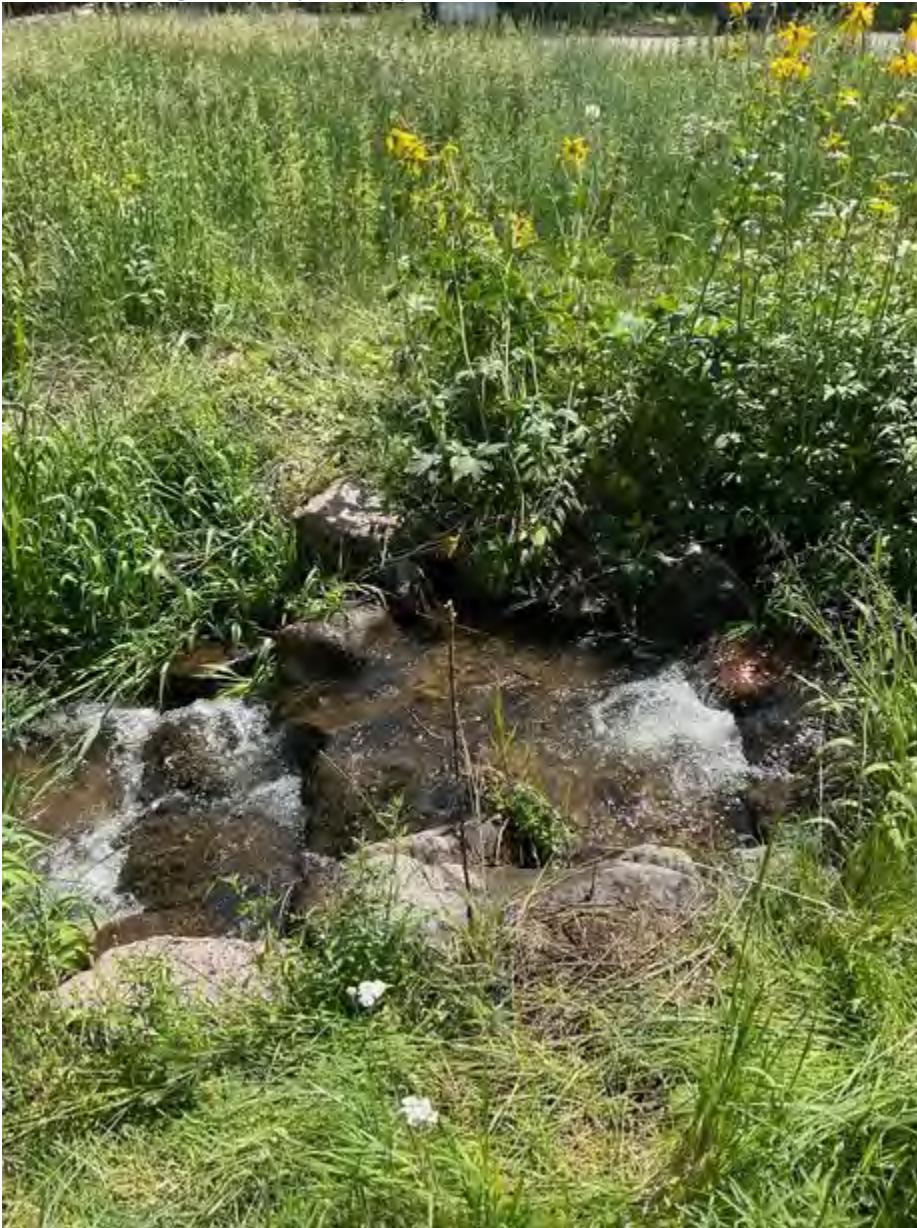
All rocks intact

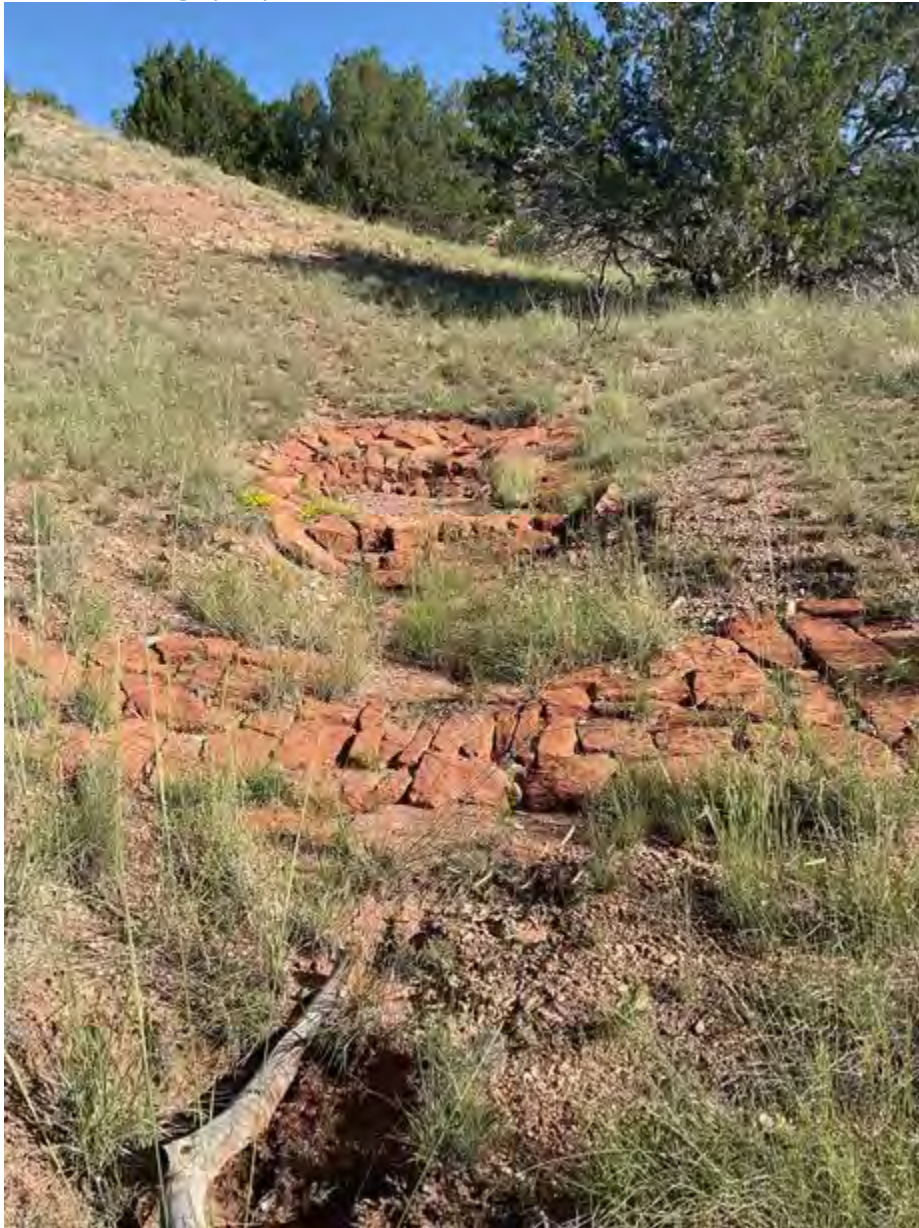
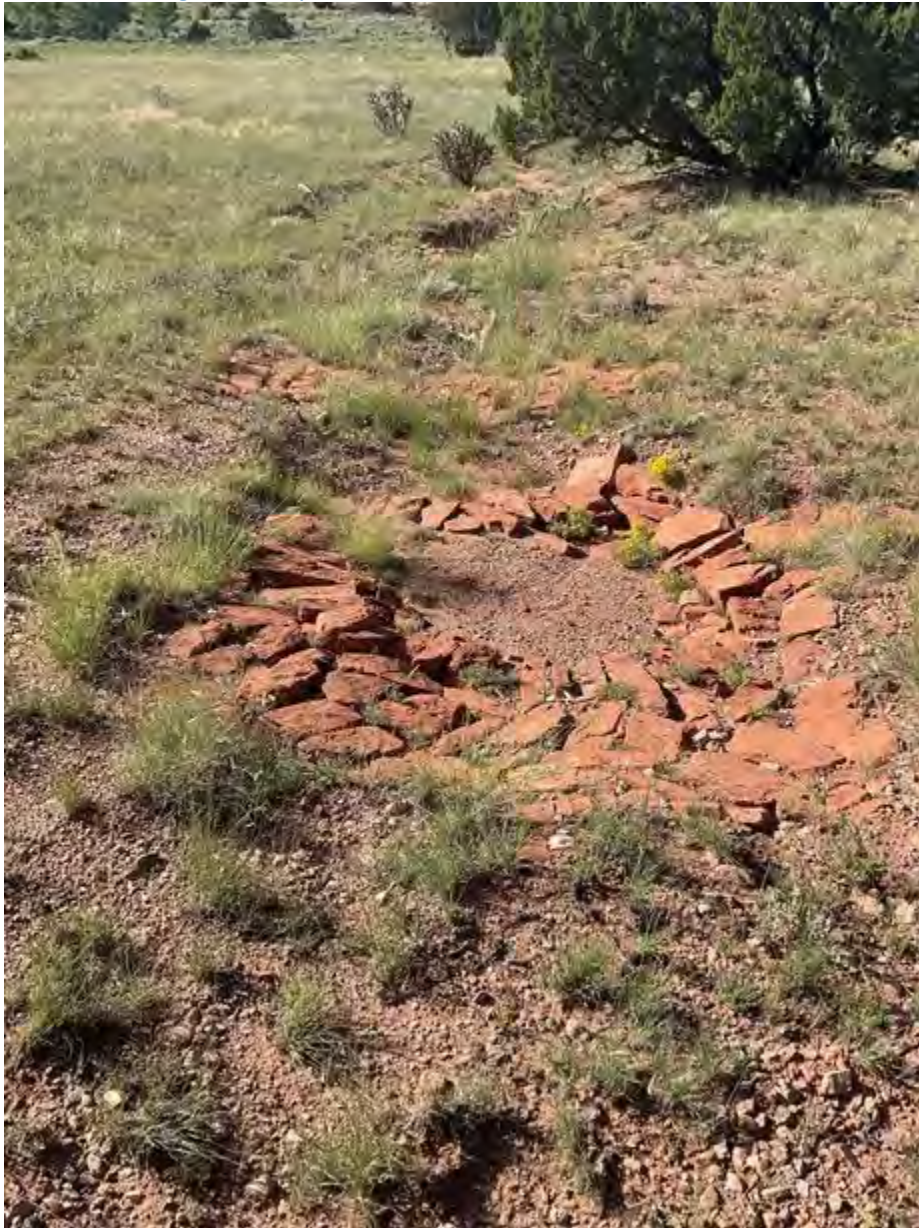
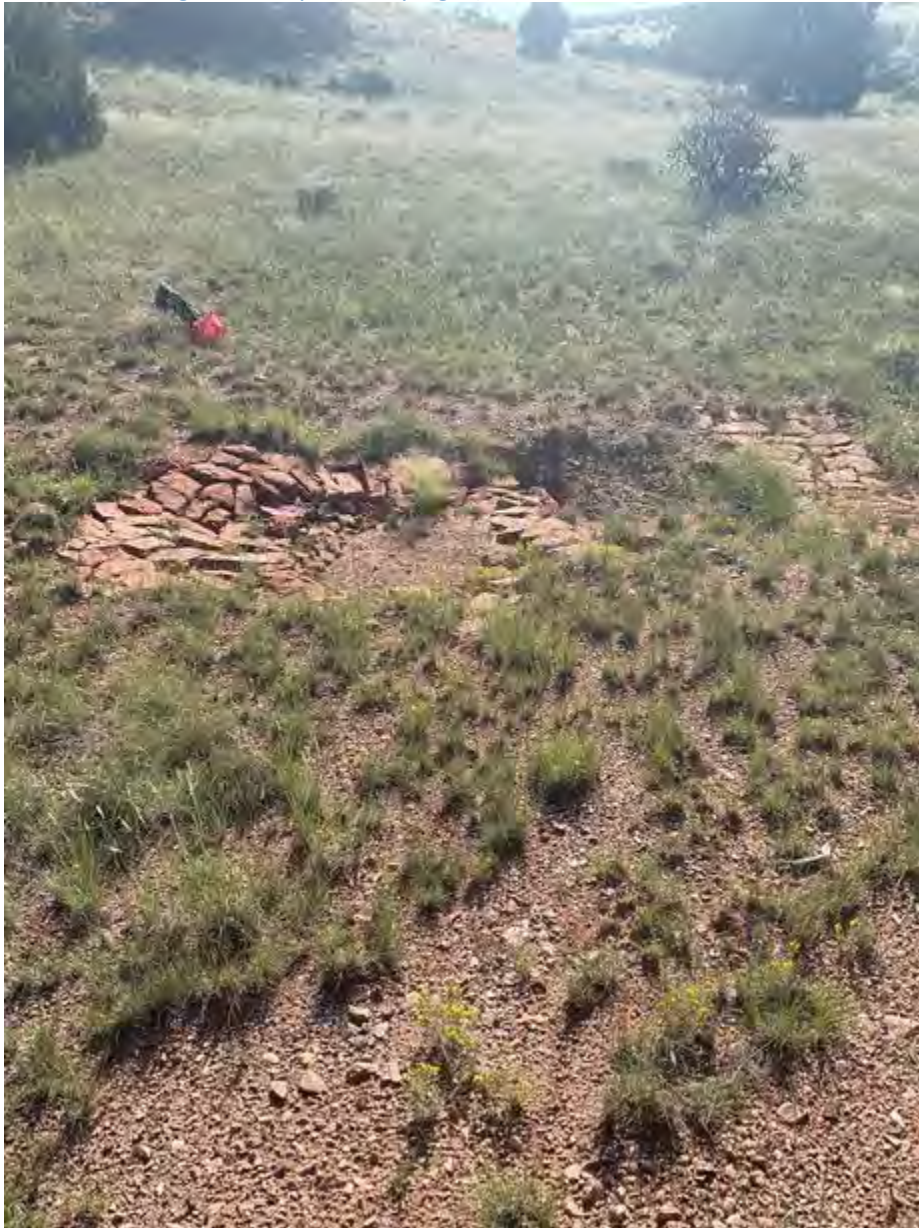
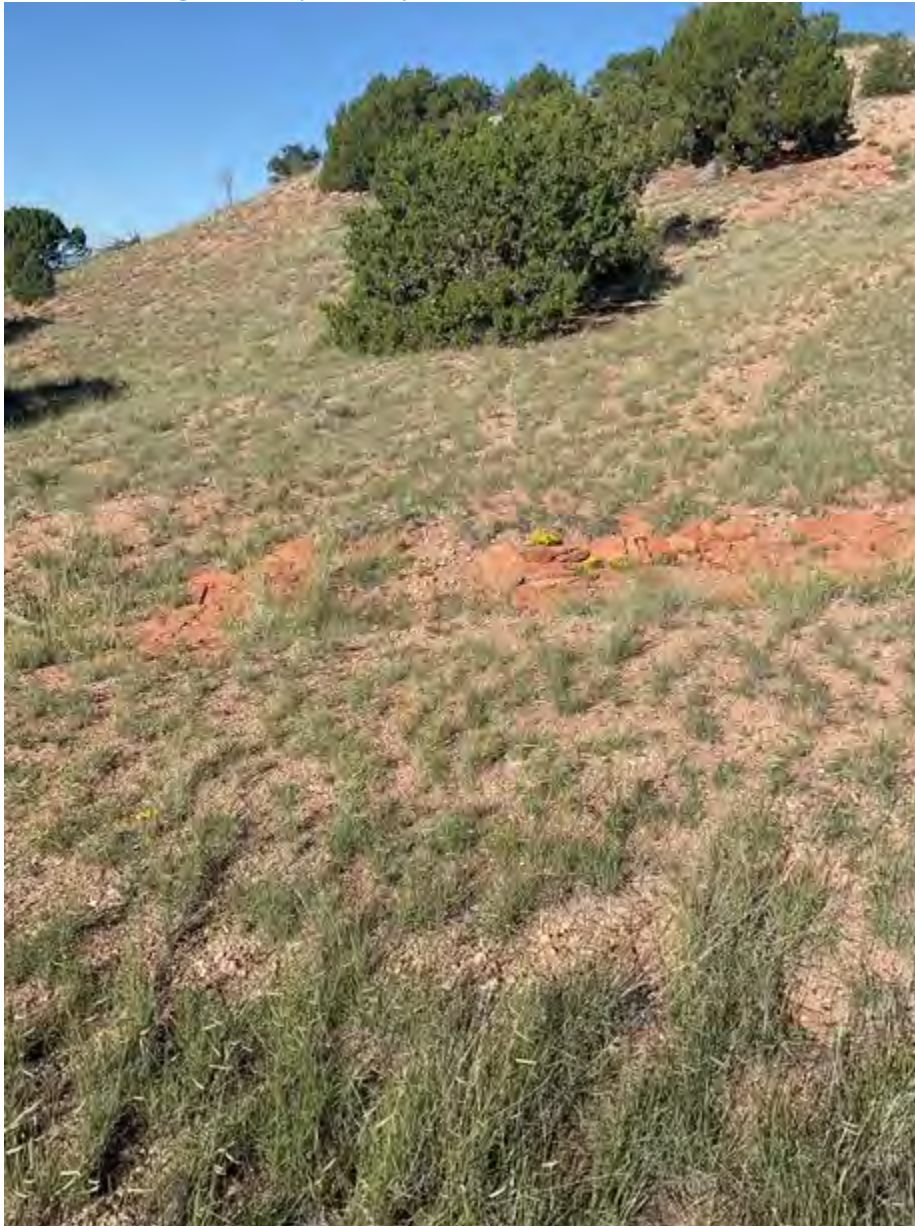
All rocks intact

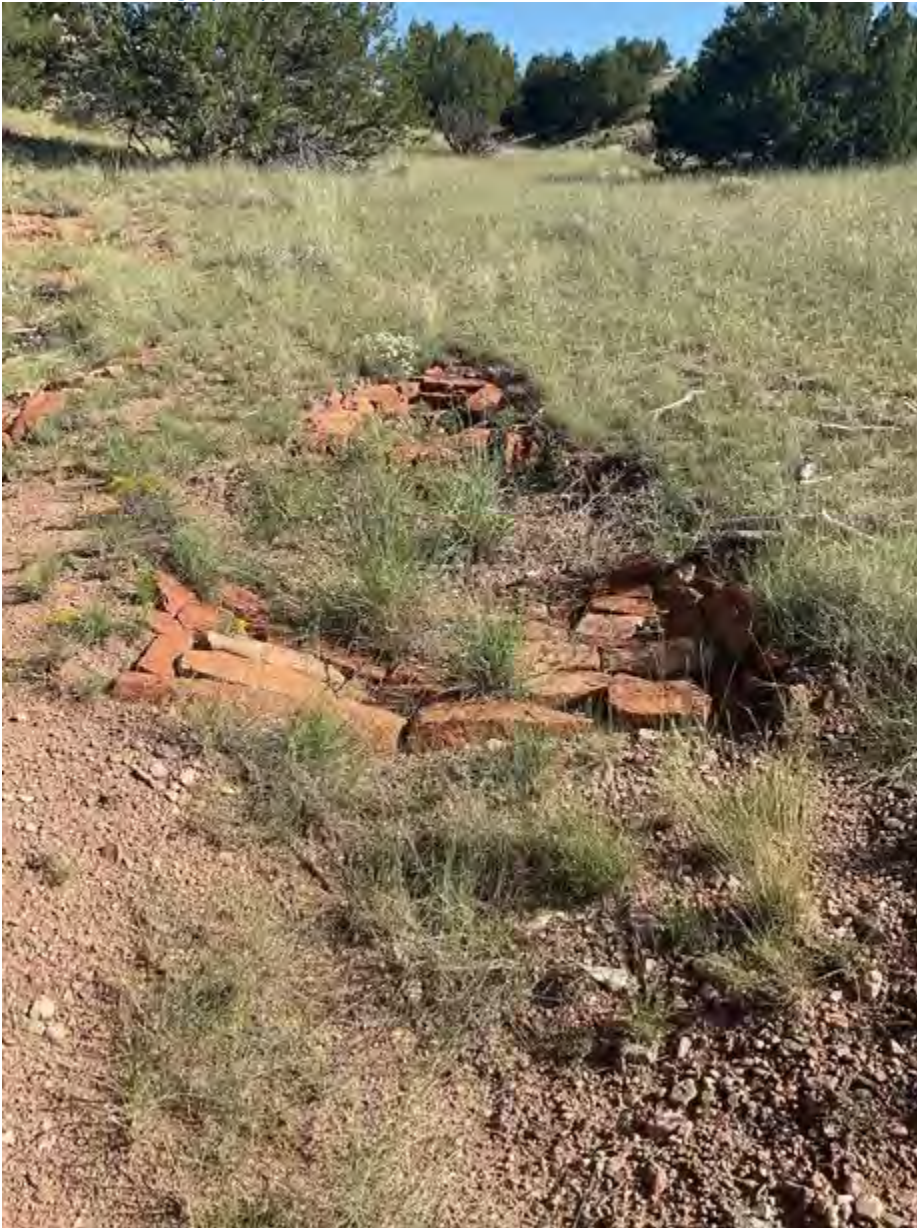
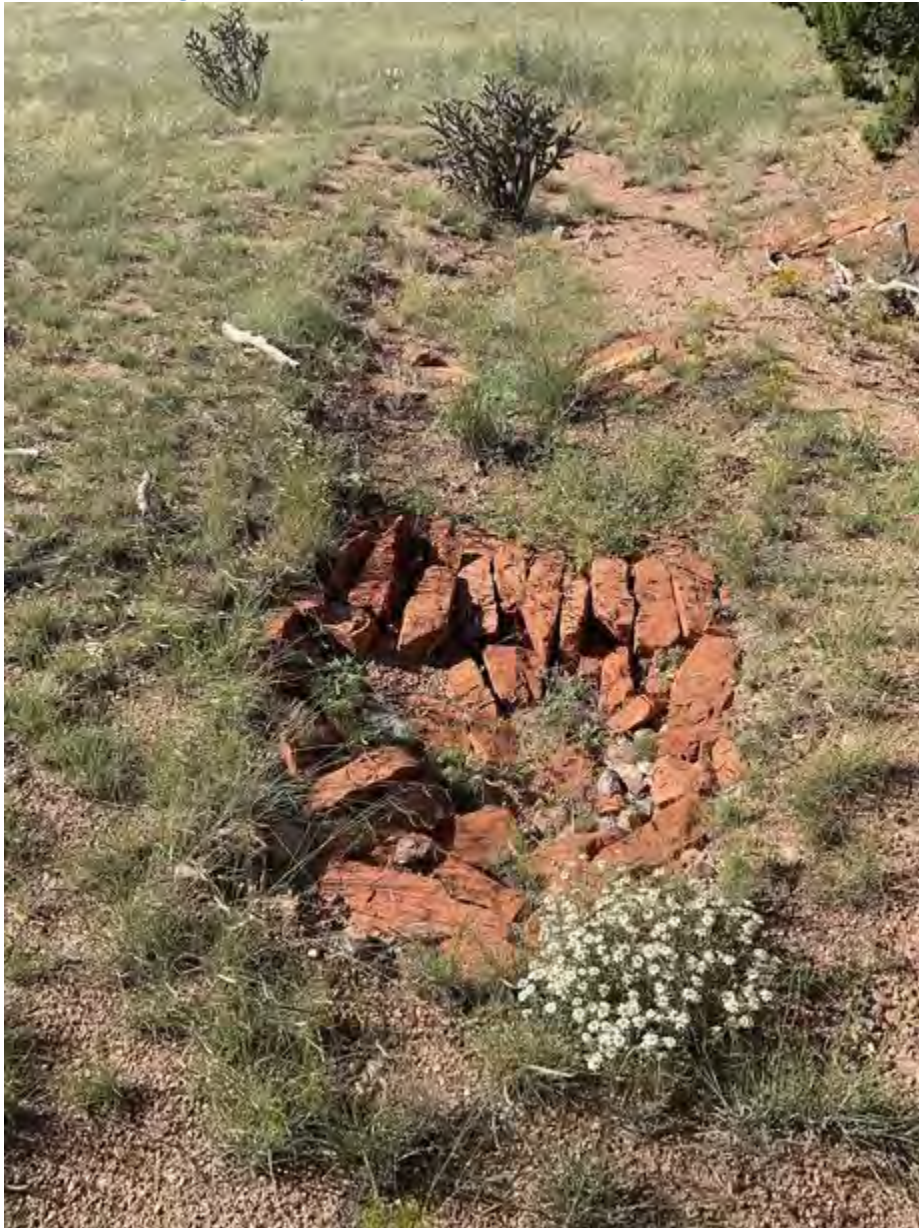
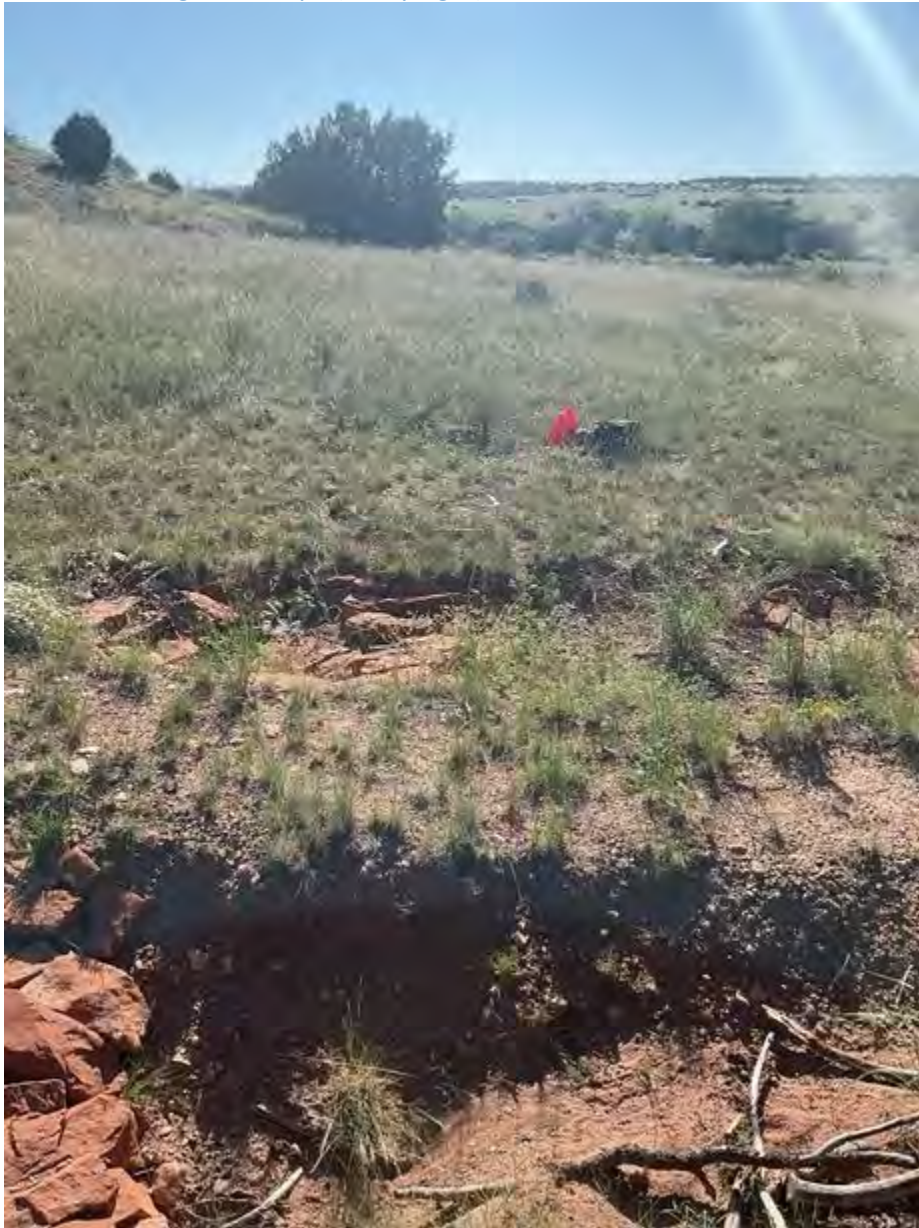
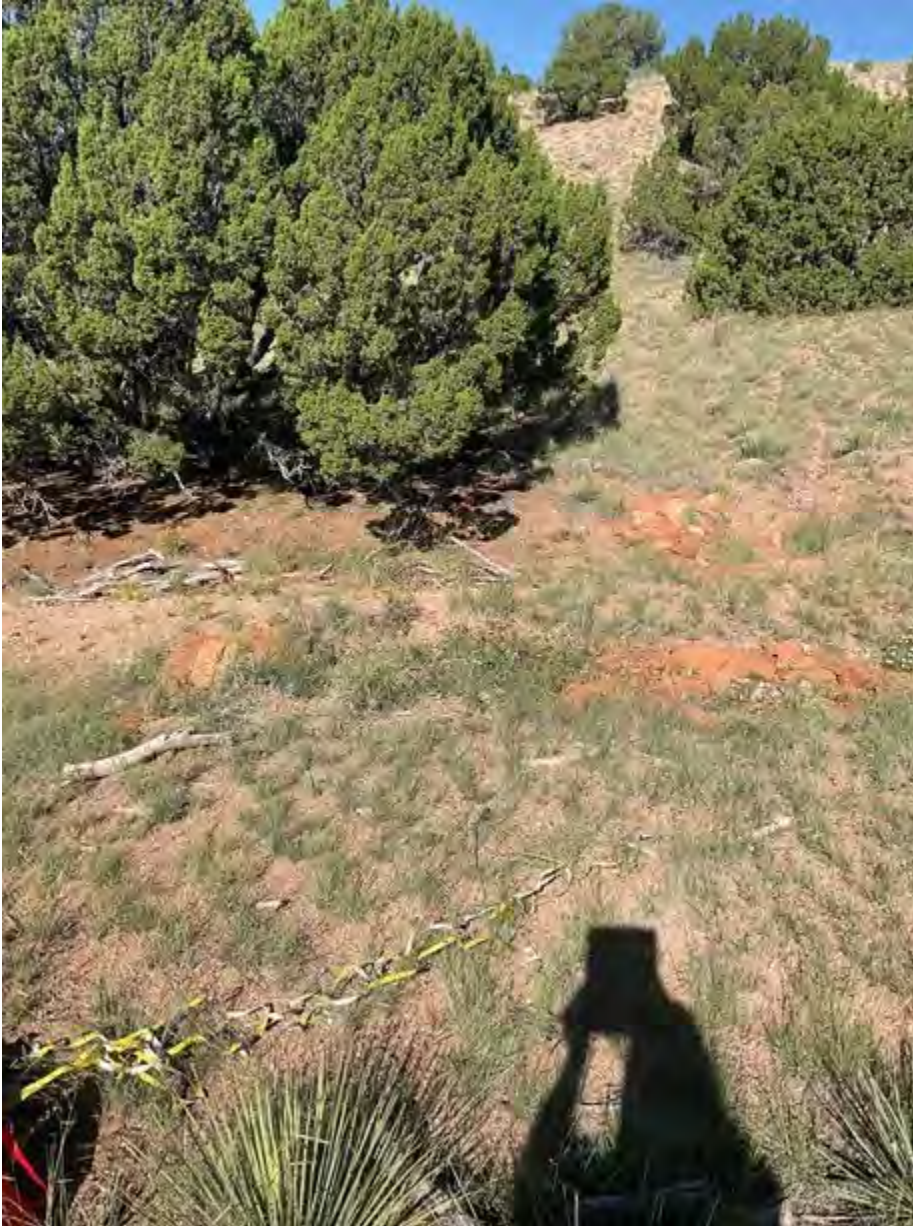
All rocks intact
