**Zuni Bowl and One Rock Check Dam Research –
Phase 1**

Final Report

December 2024

Rio Grande Return for the New Mexico Department of Transportation Research Bureau

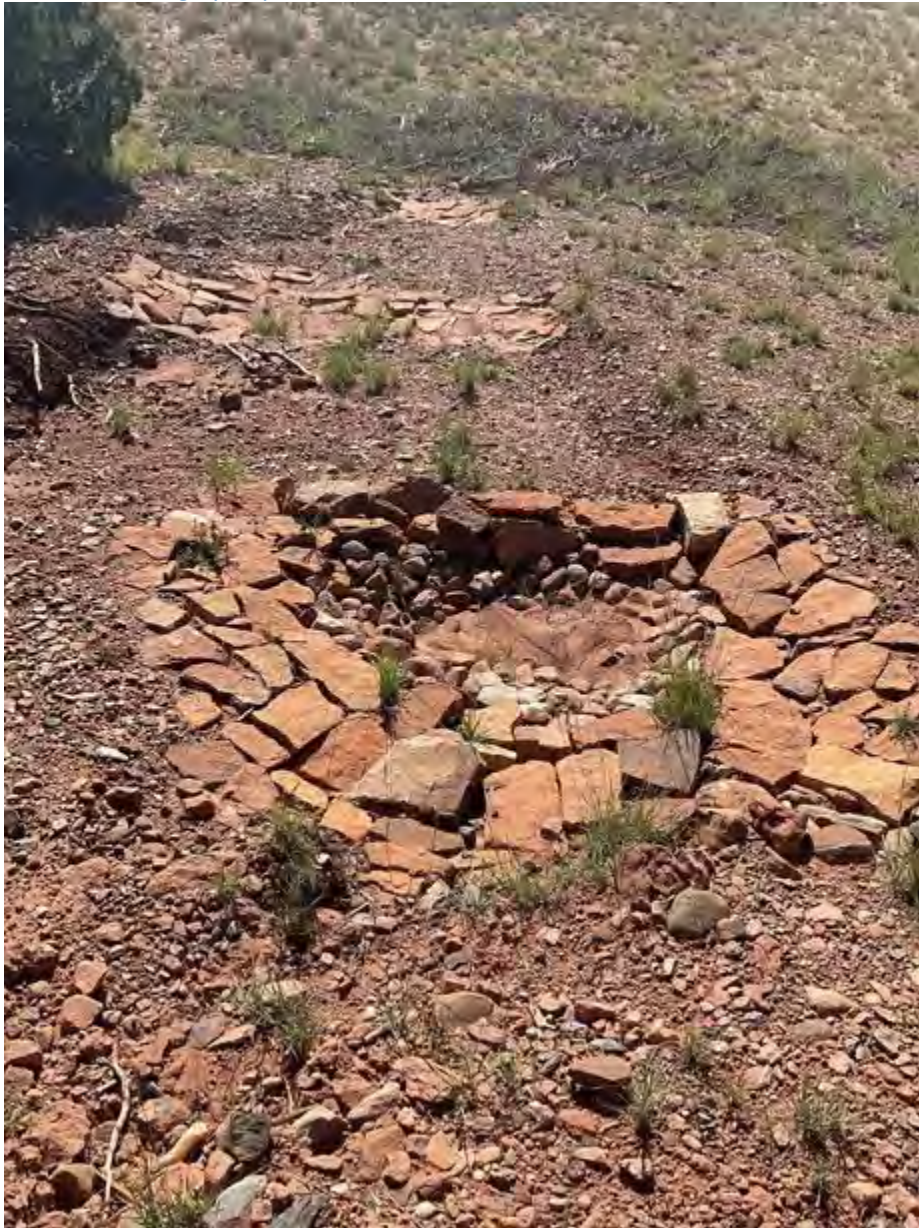
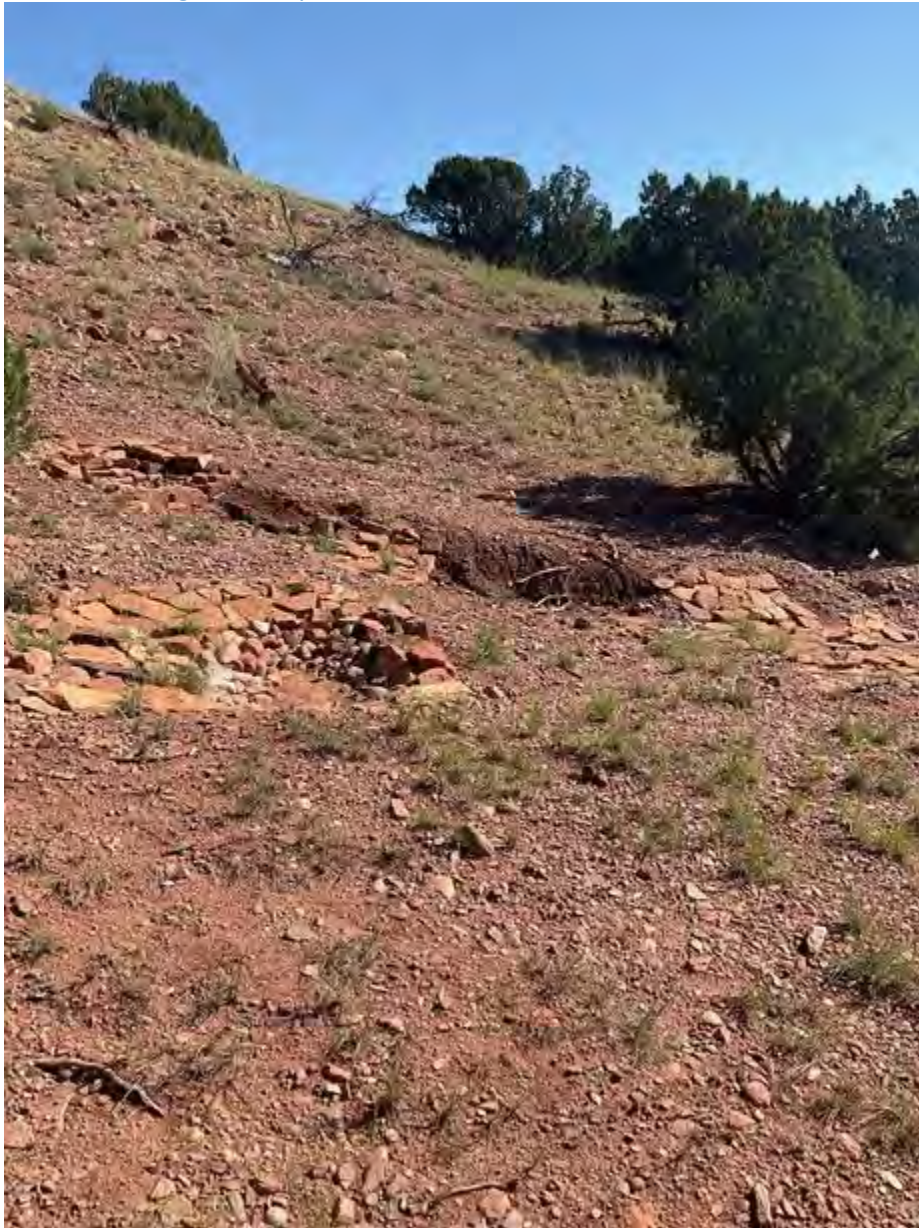
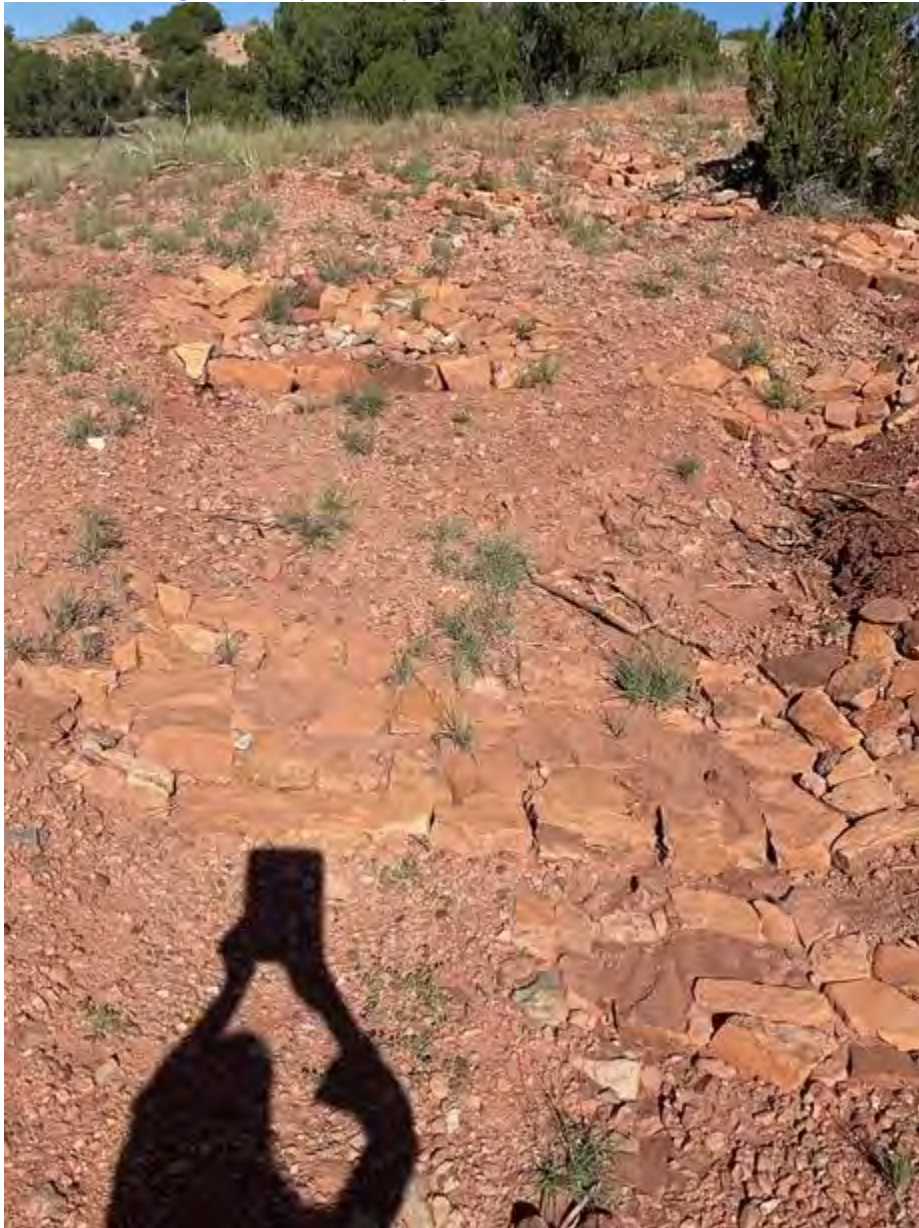
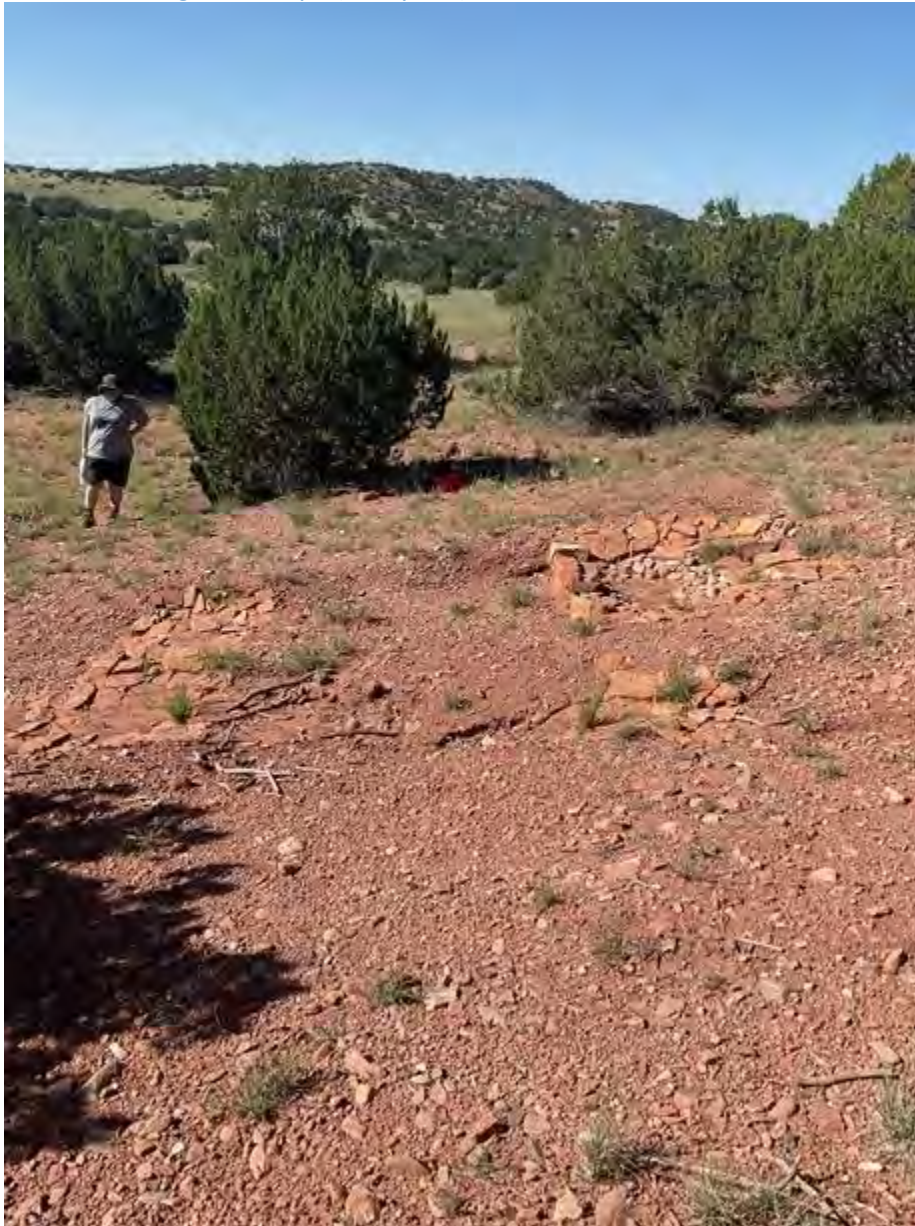
All rocks intact

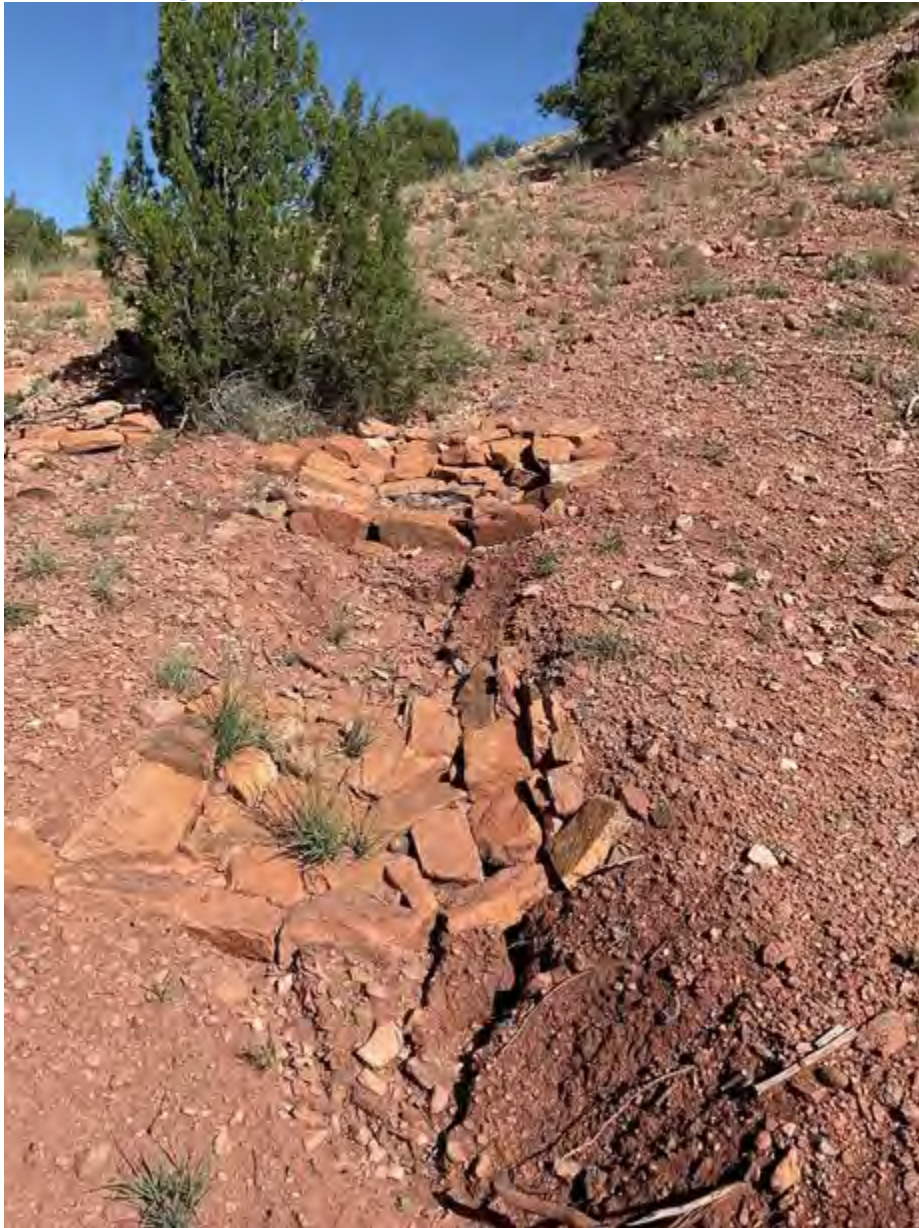
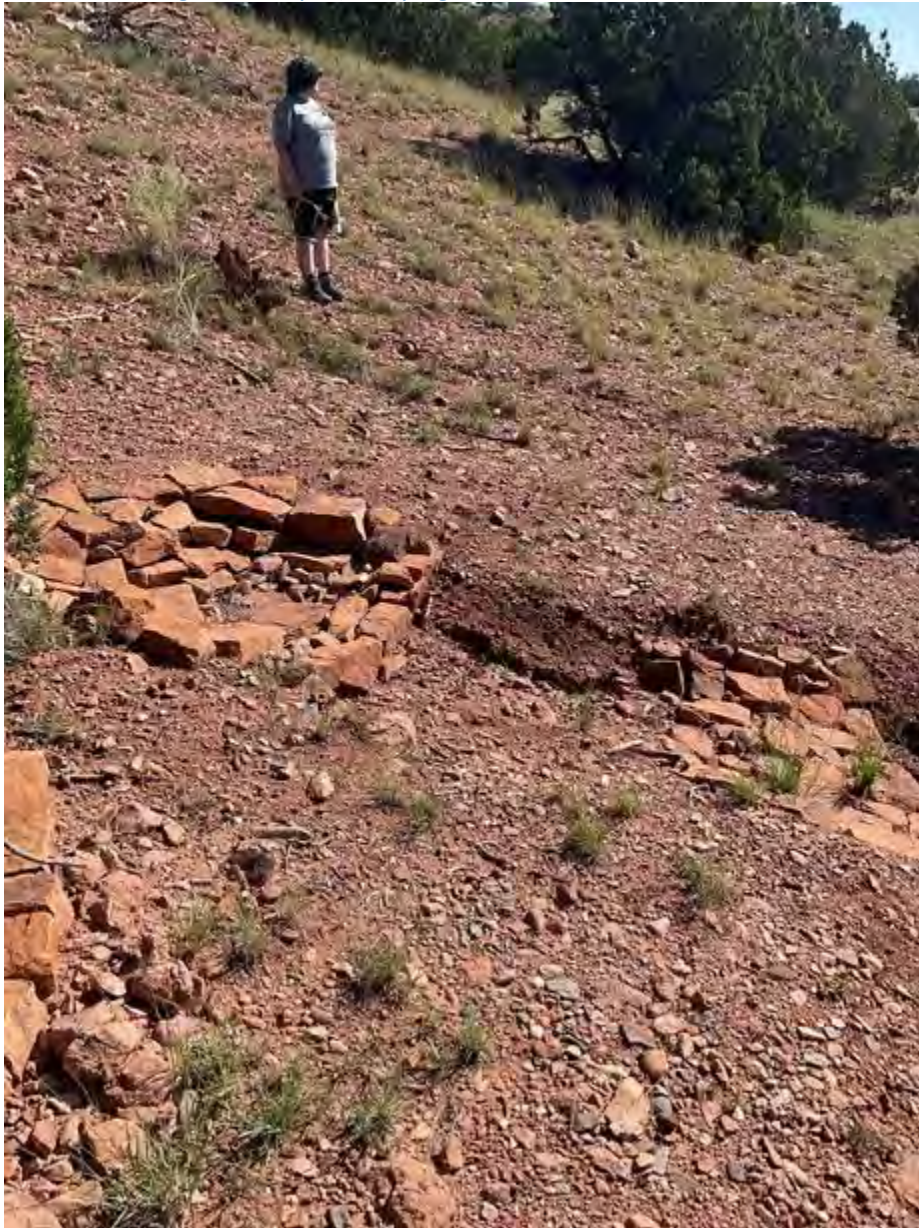
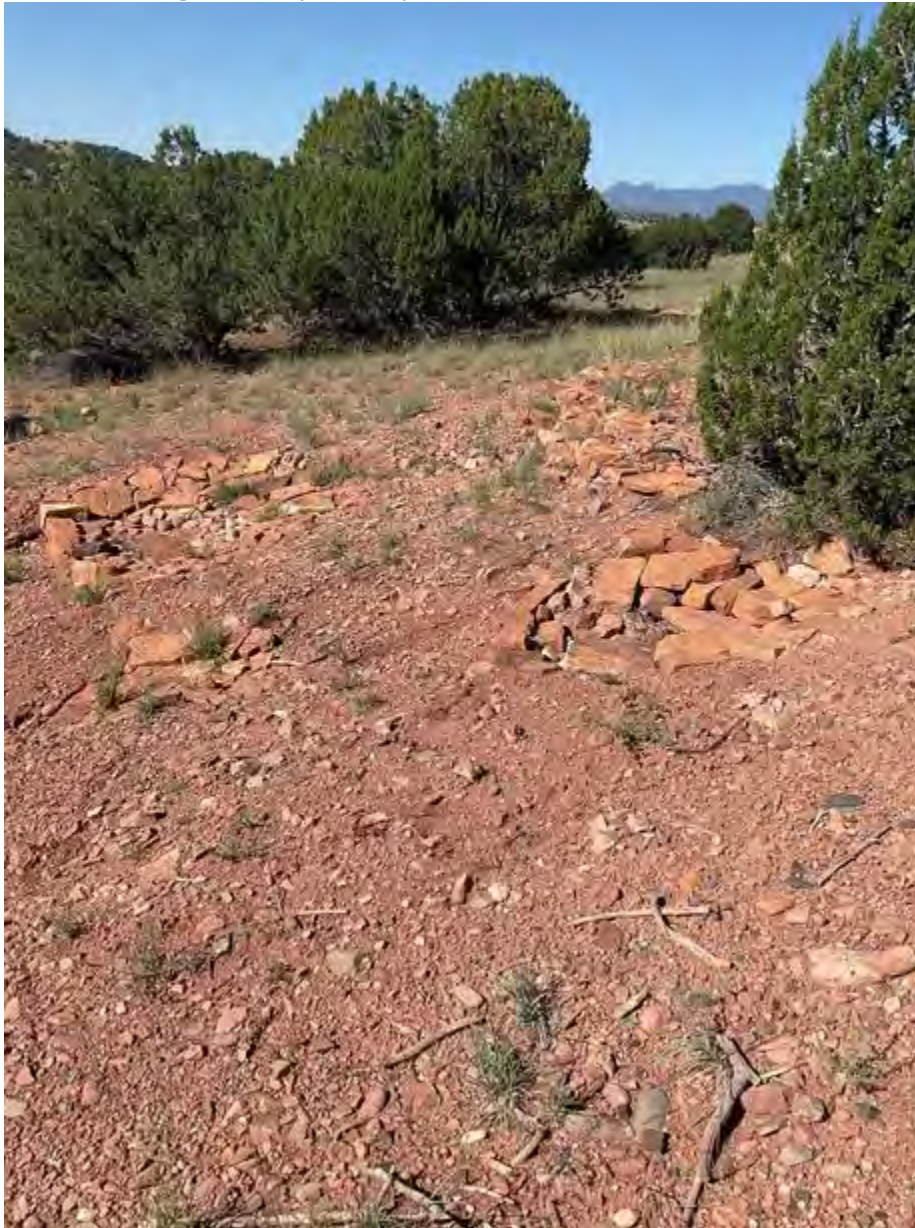
All rocks intact

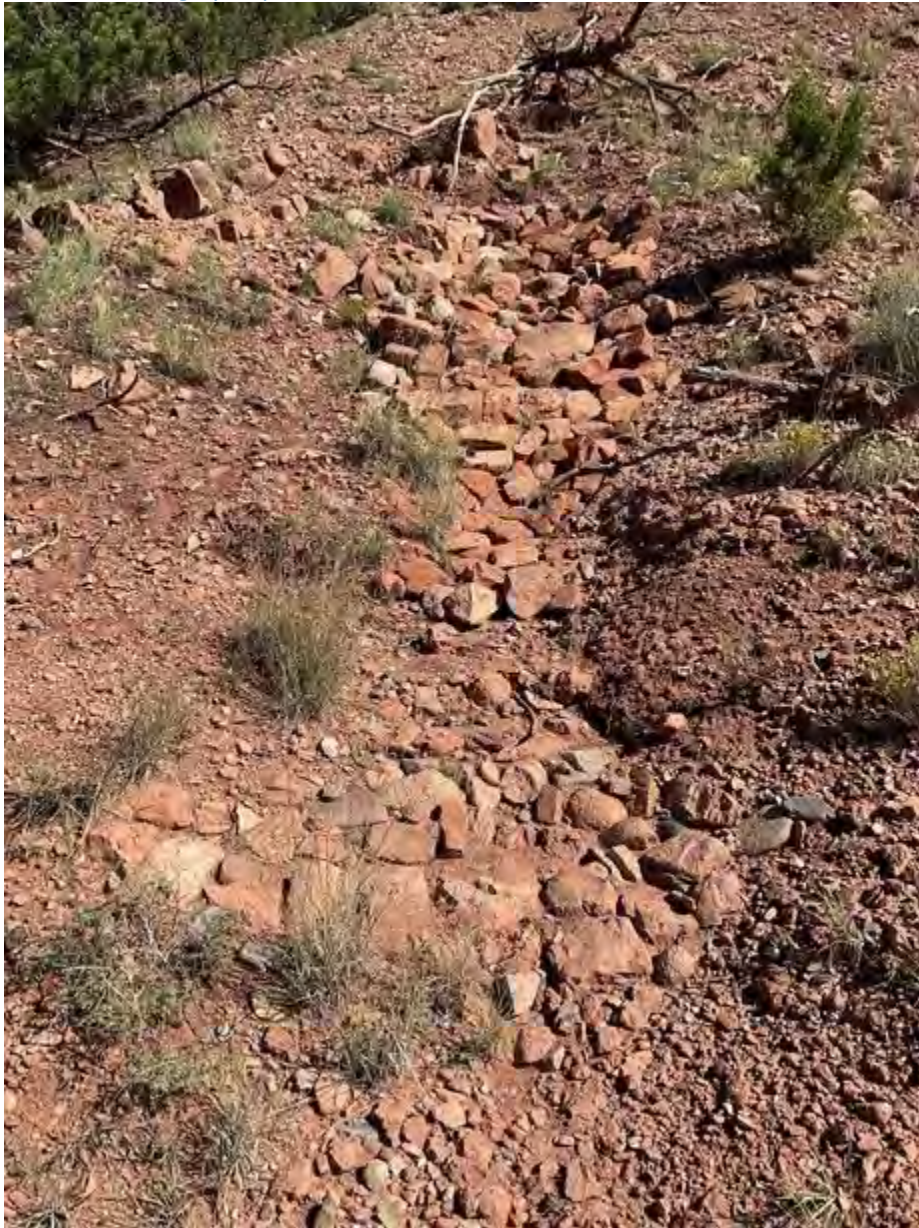
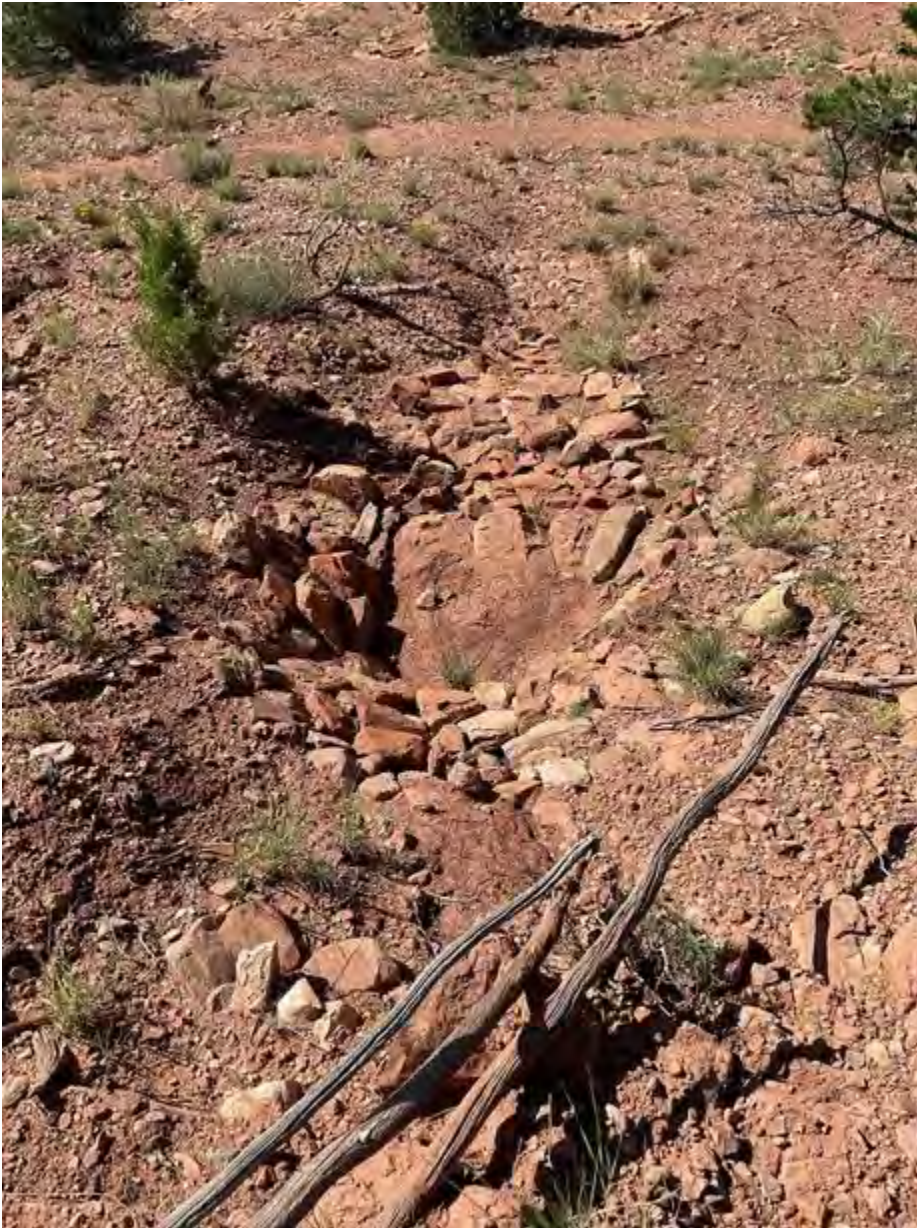
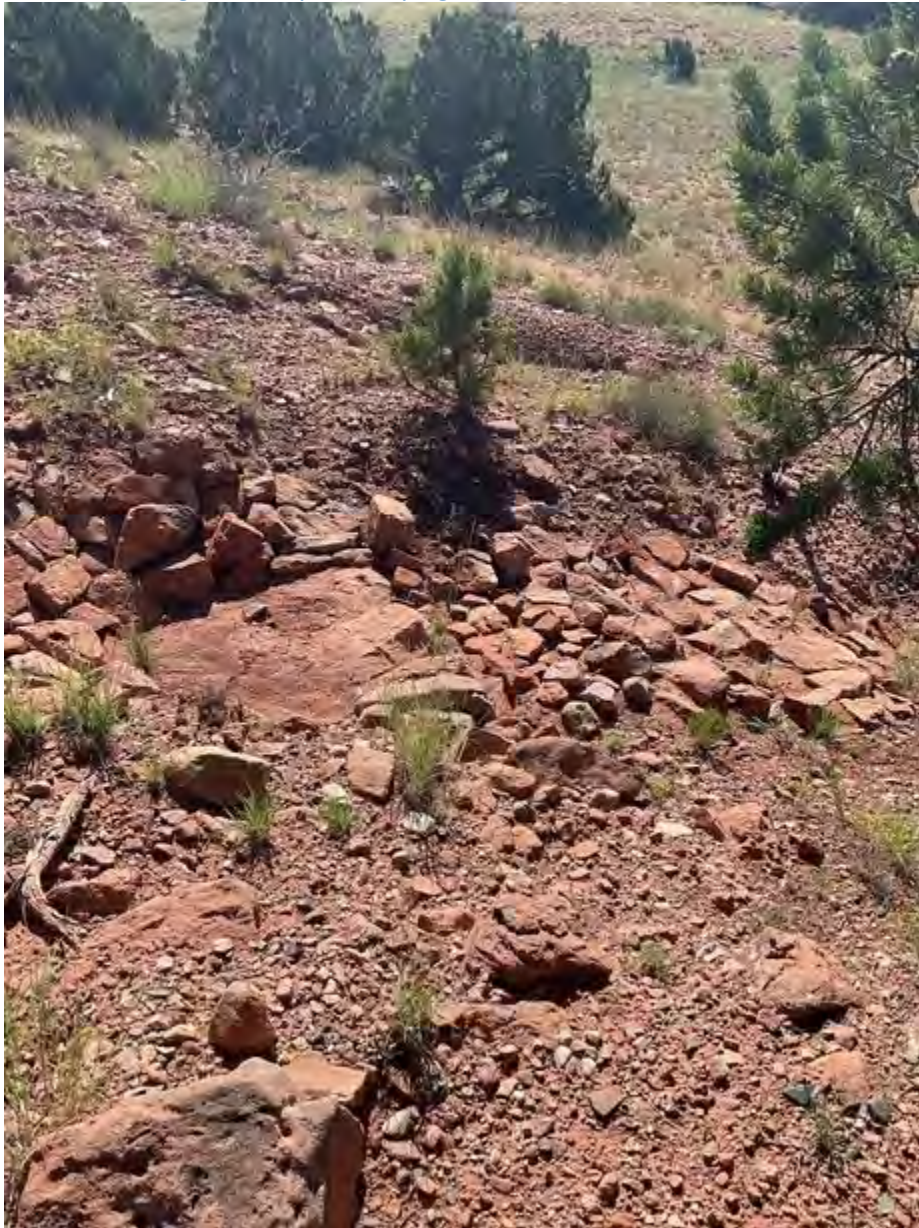
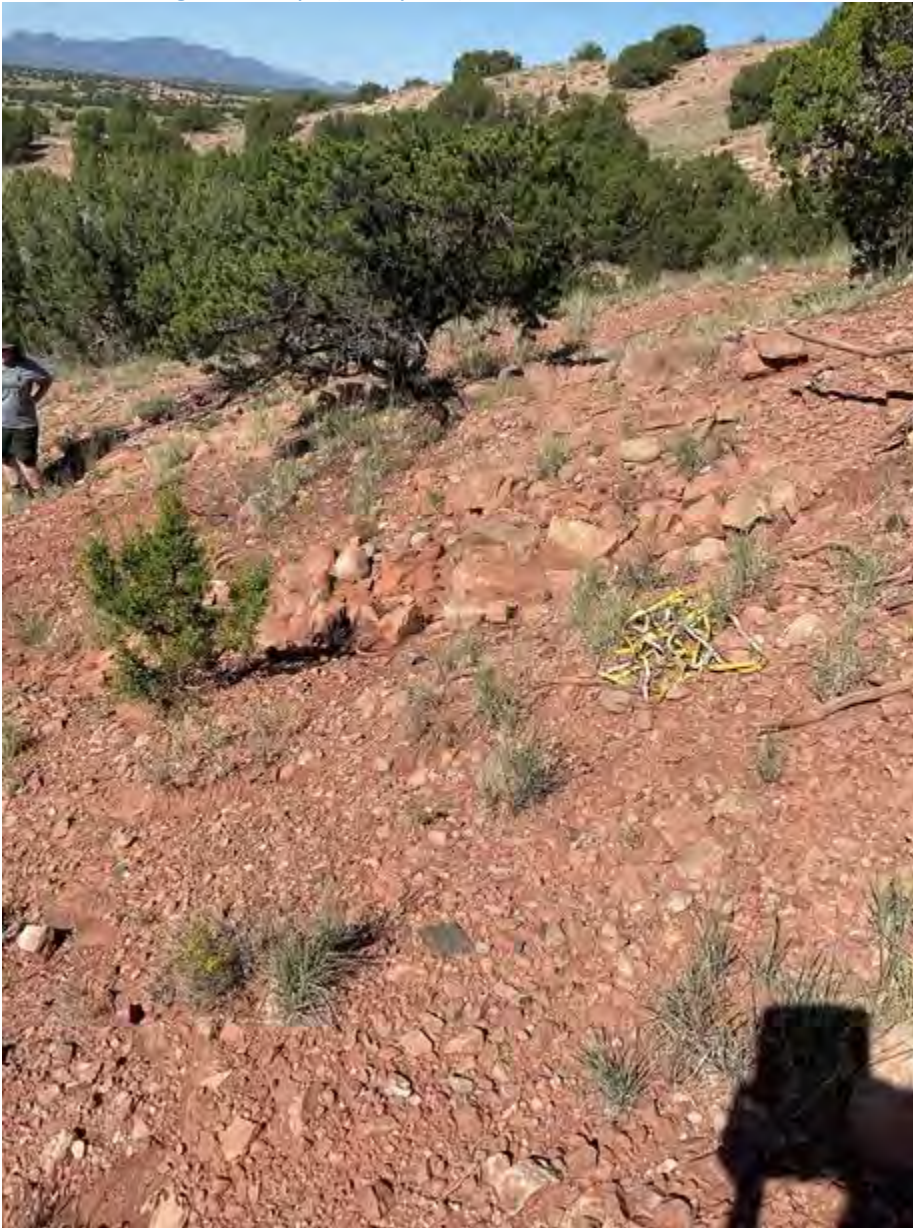
-105.9424171 35.44438518

Some rocks dislodged or broken

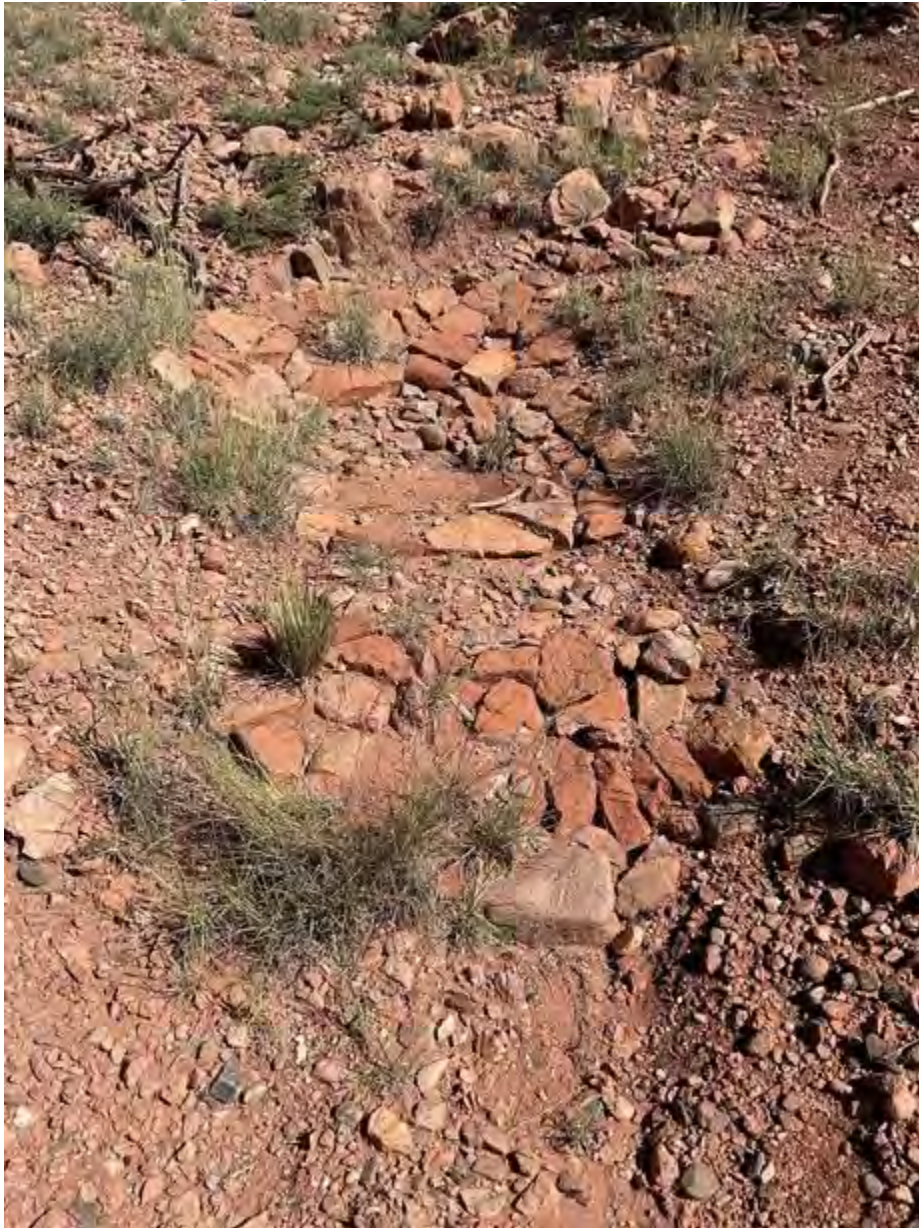
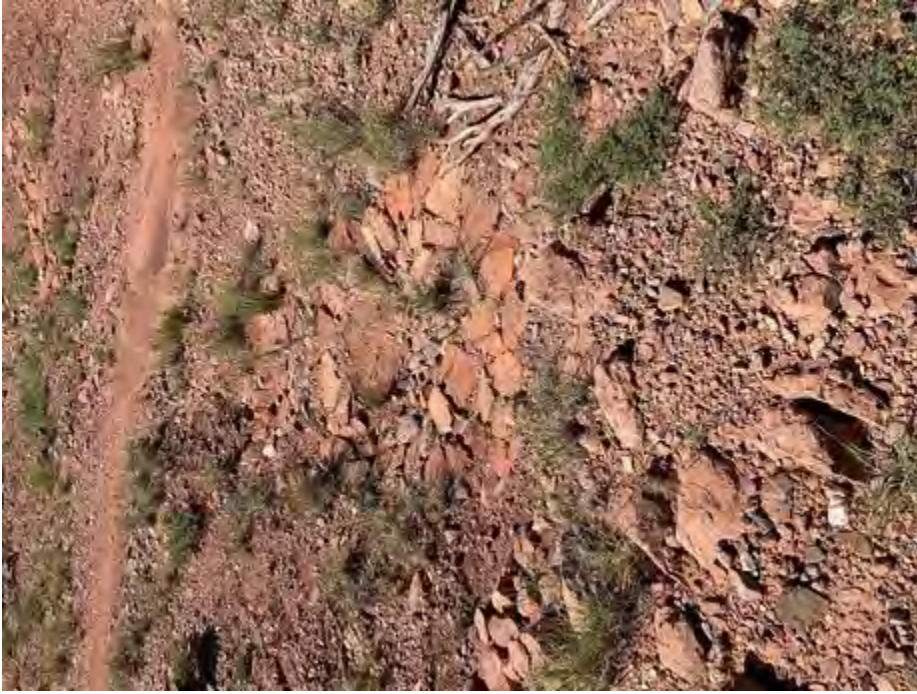
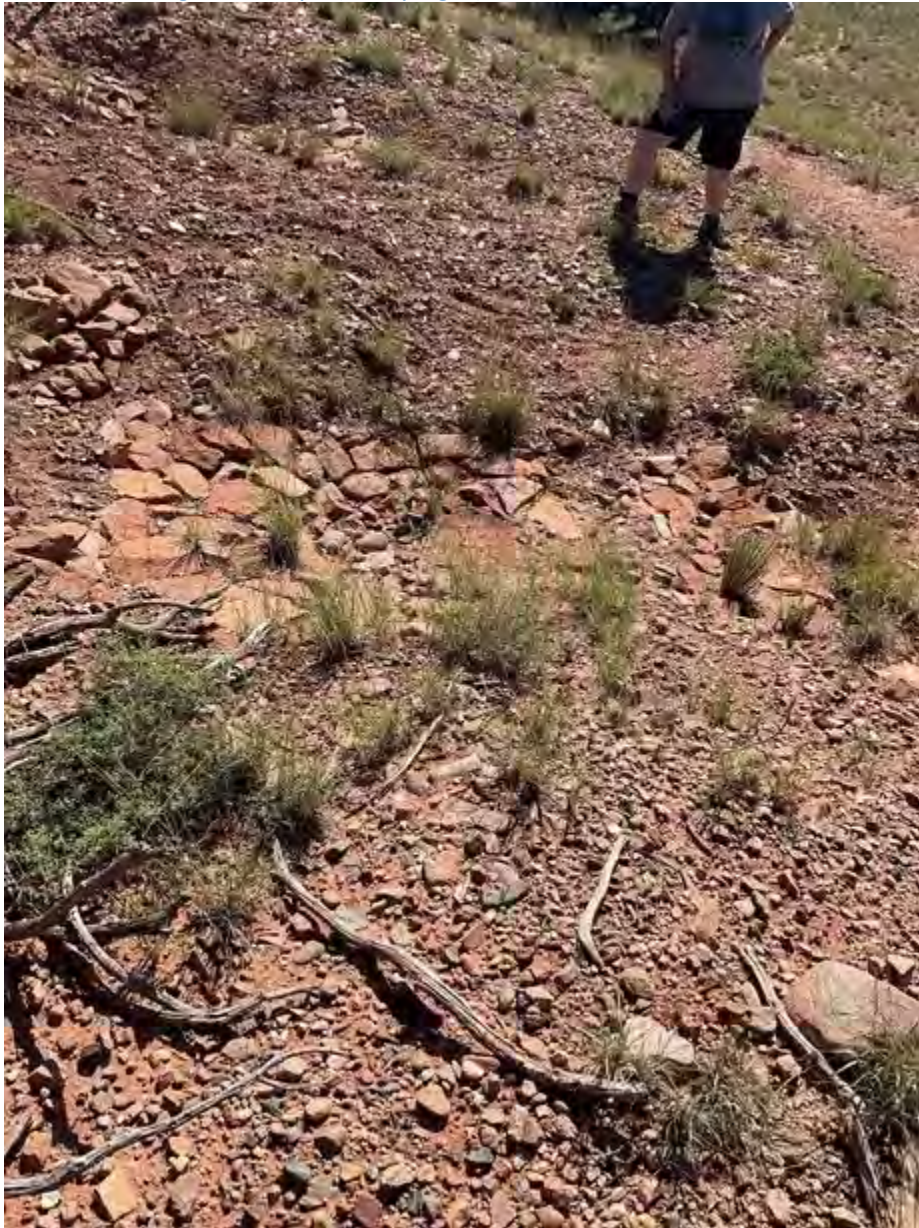
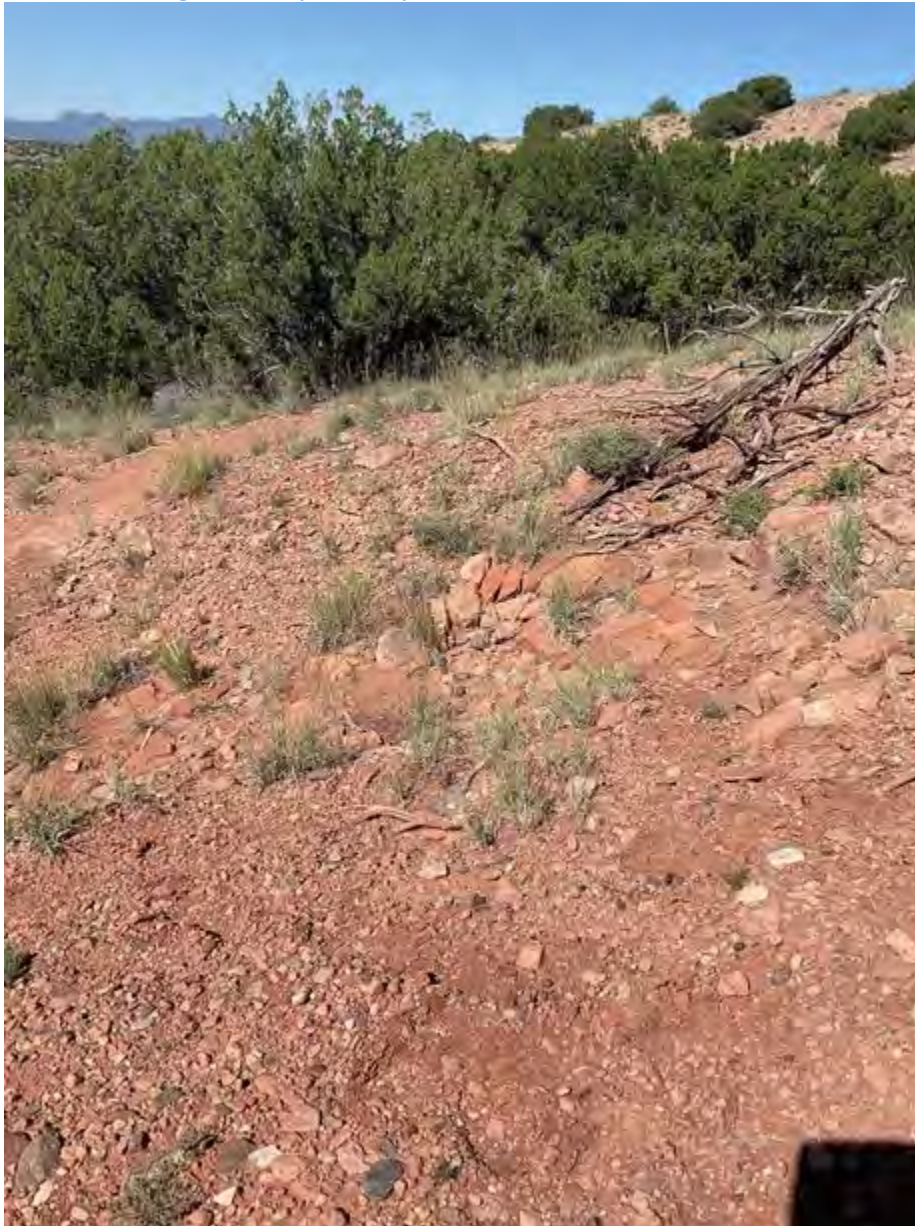
-105.942457 35.44432338

All rocks intact

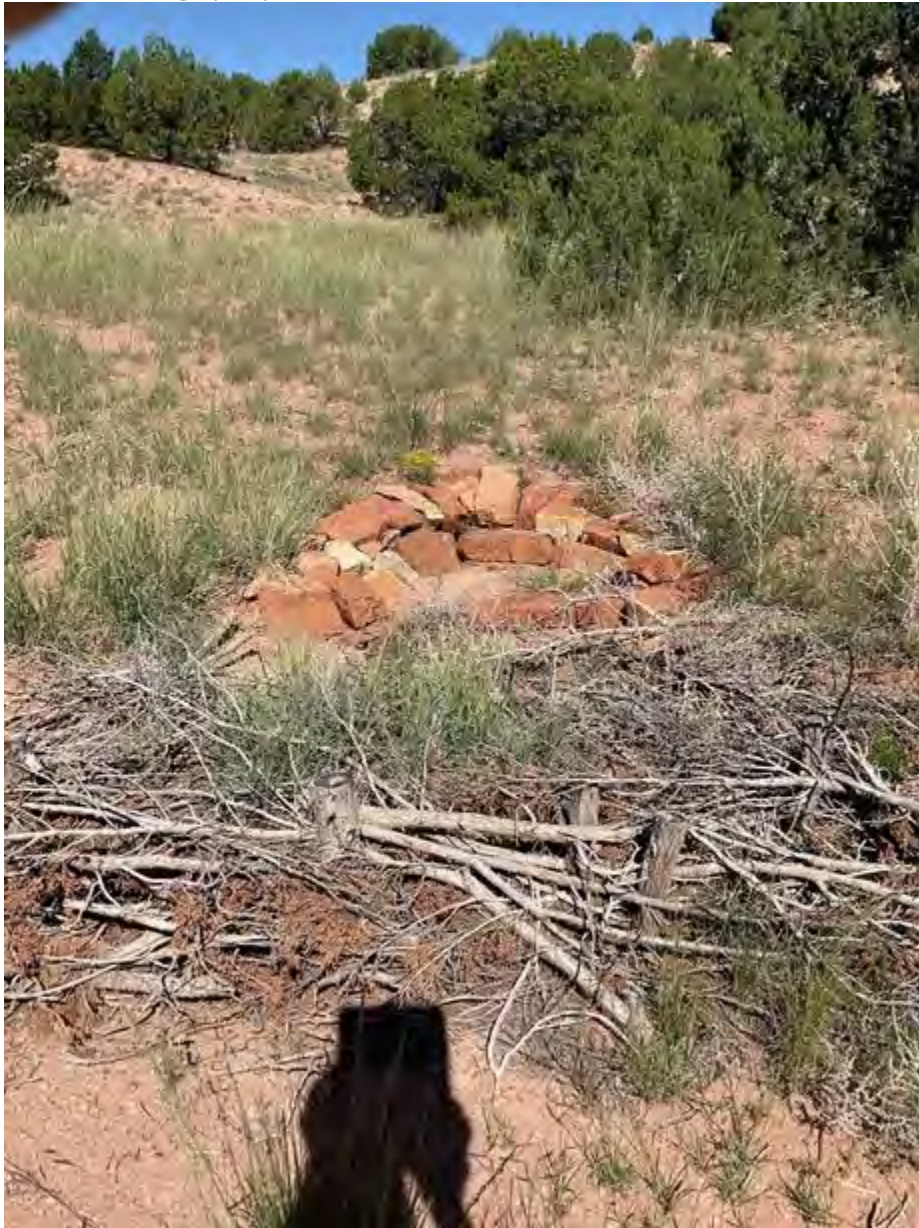
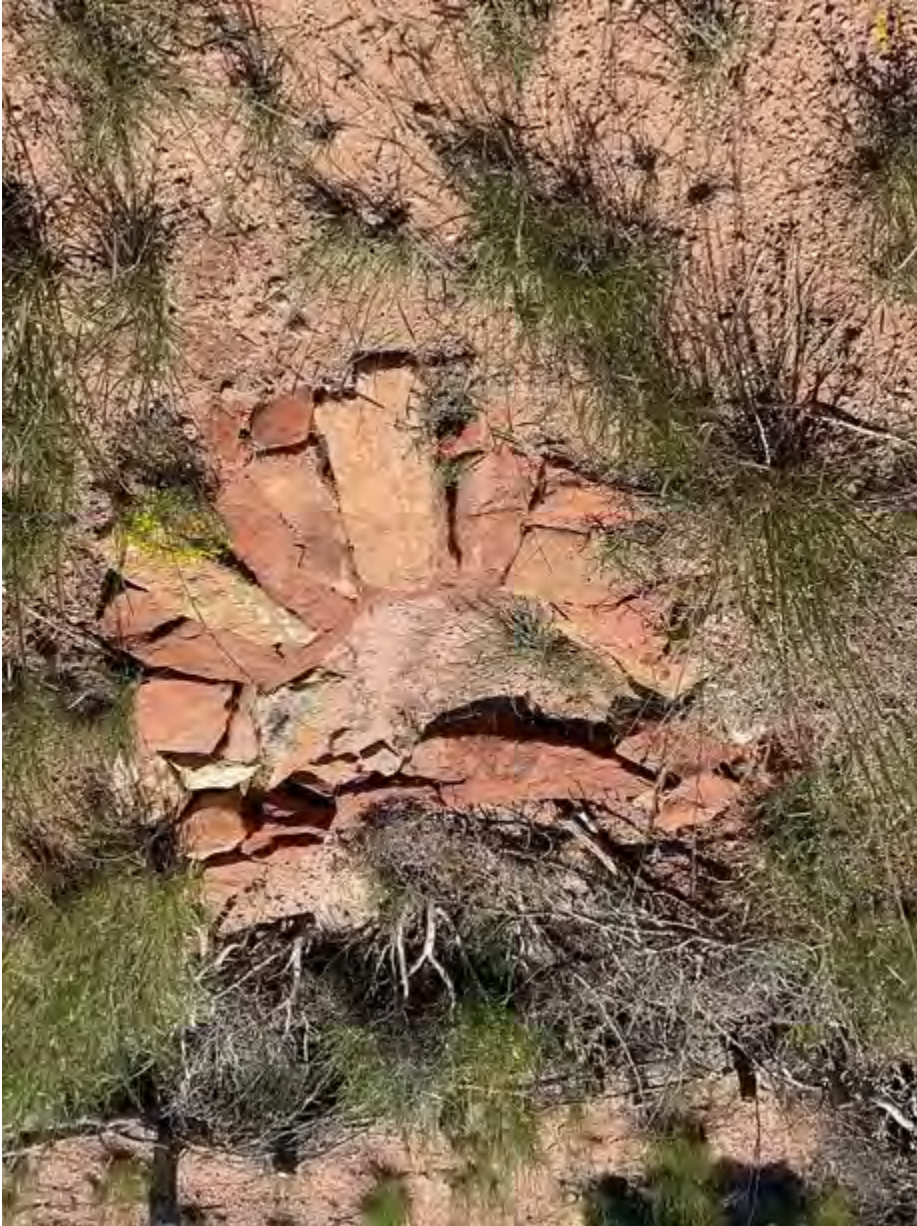
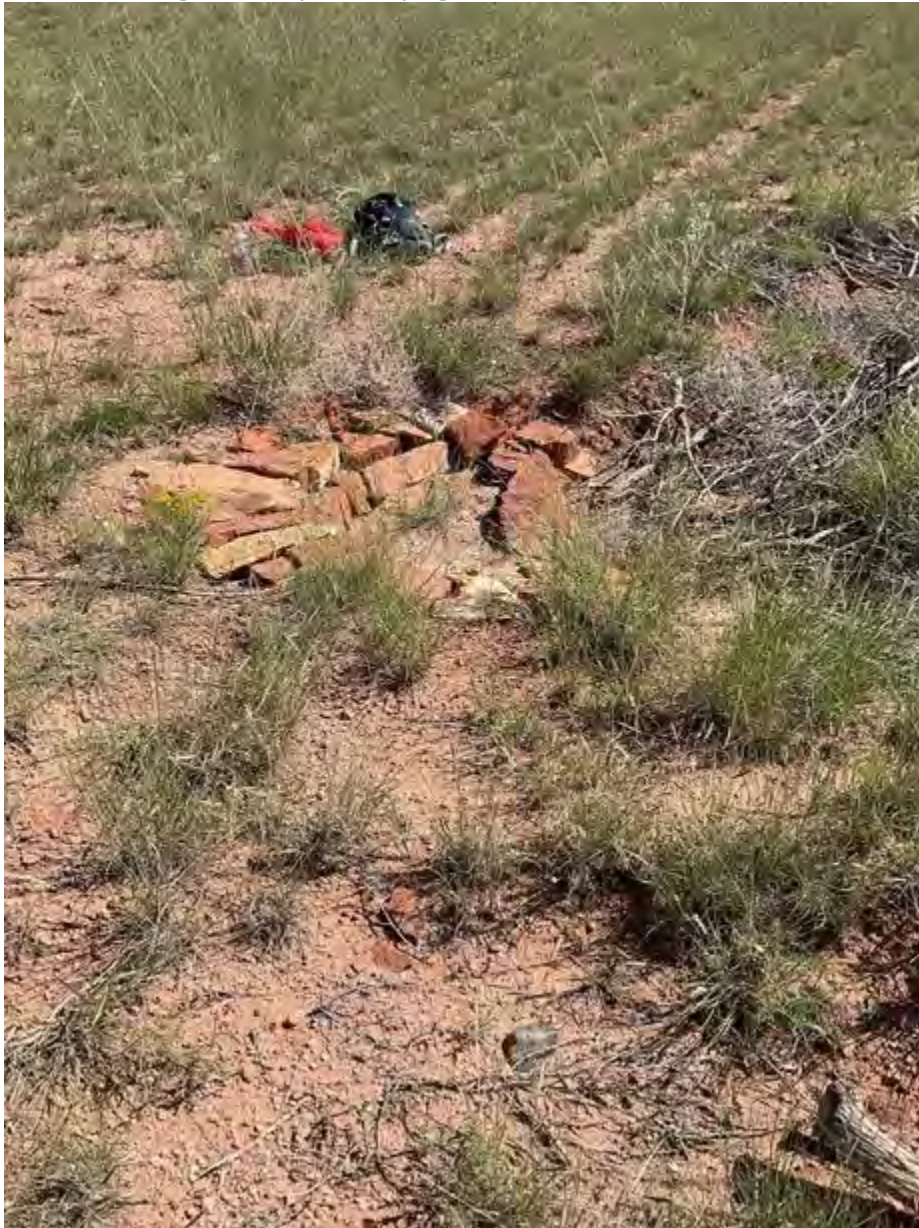
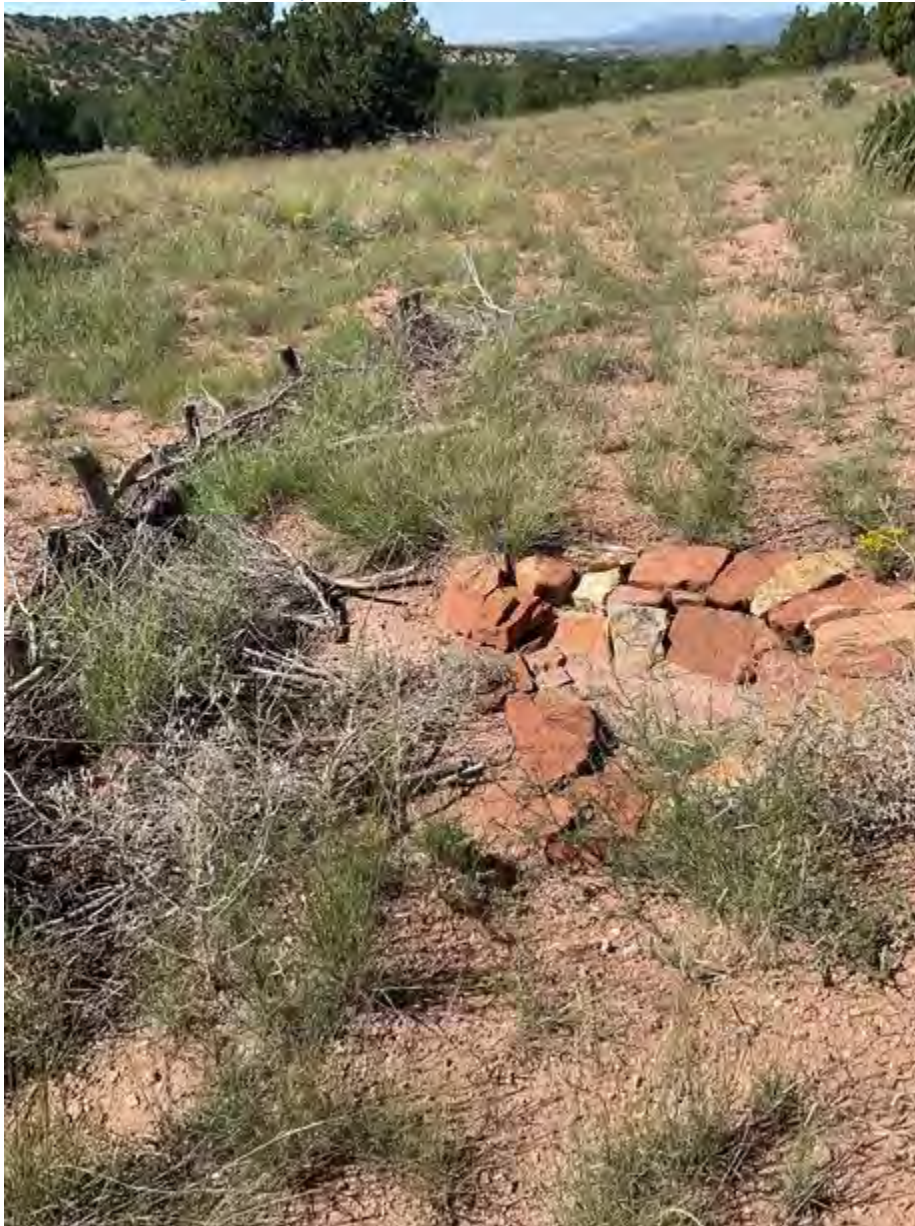
-105.9429858 35.44385002

All rocks intact
