**Zuni Bowl and One Rock Check Dam Research –
Phase 1**

Final Report

December 2024

Rio Grande Return for the New Mexico Department of Transportation Research Bureau

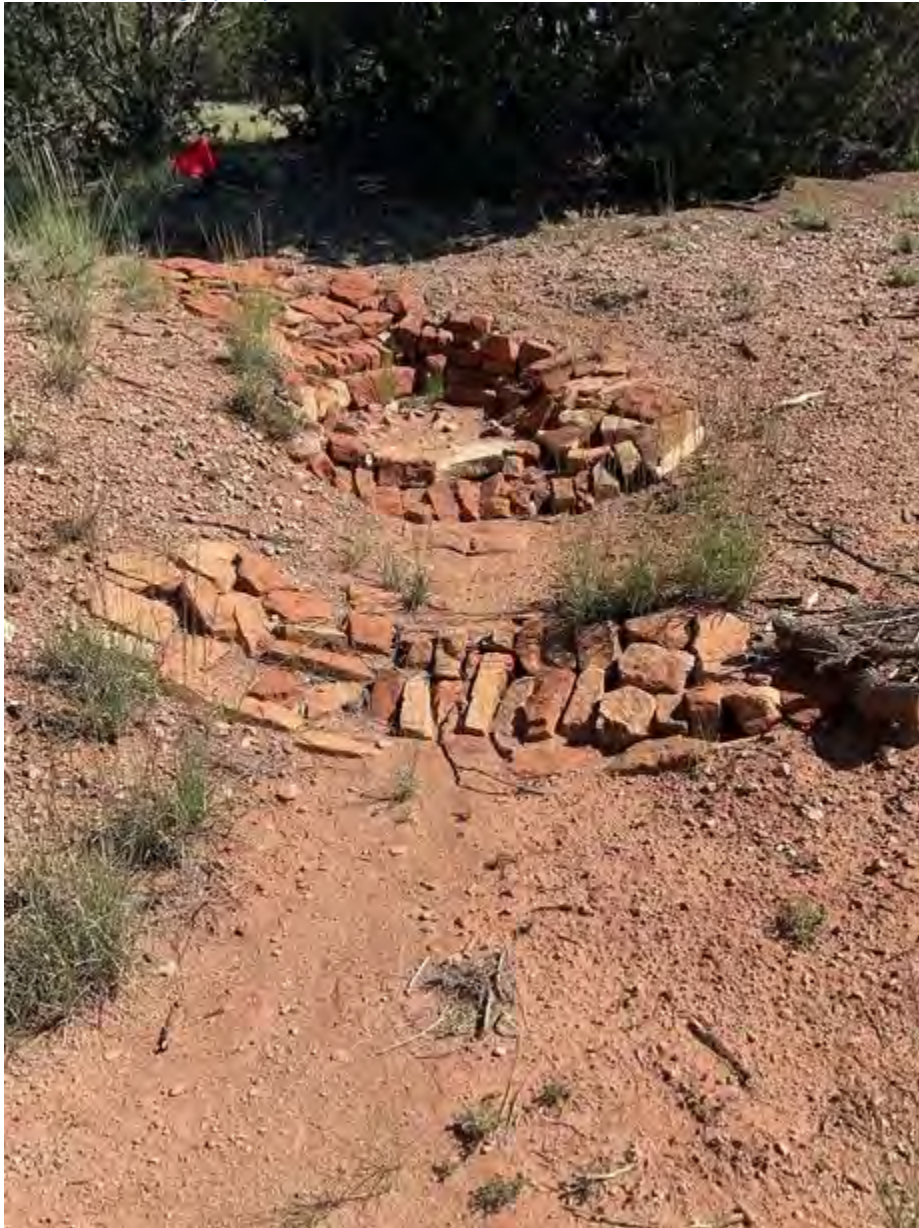
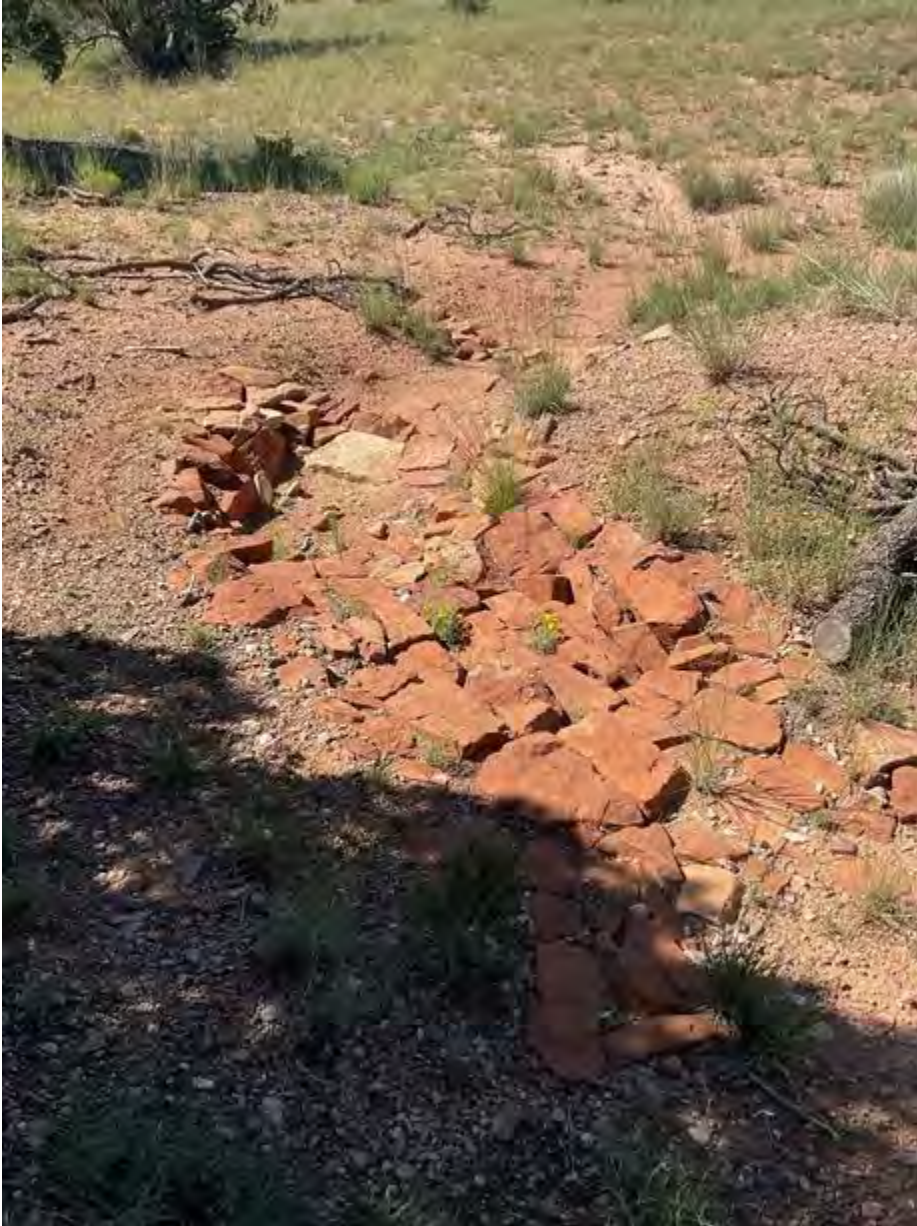
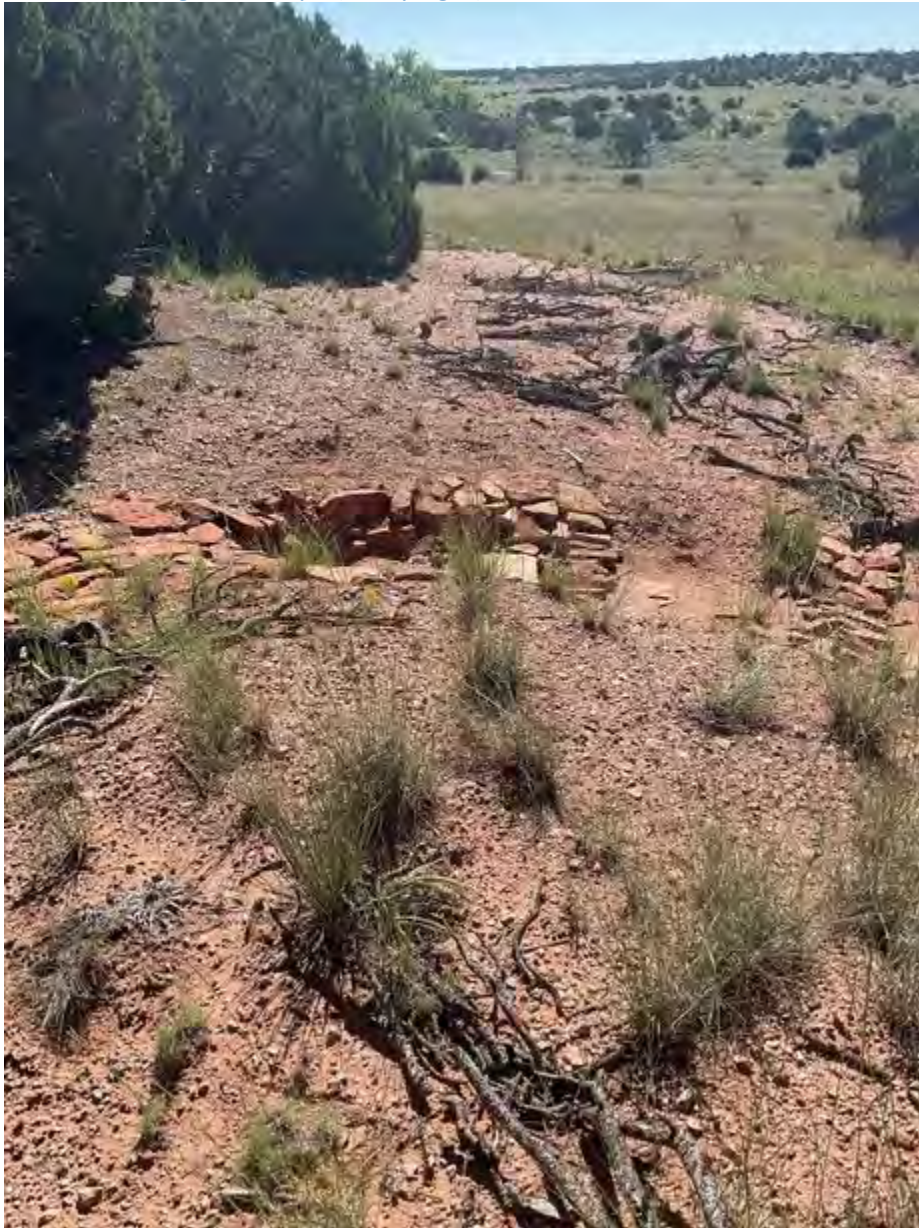
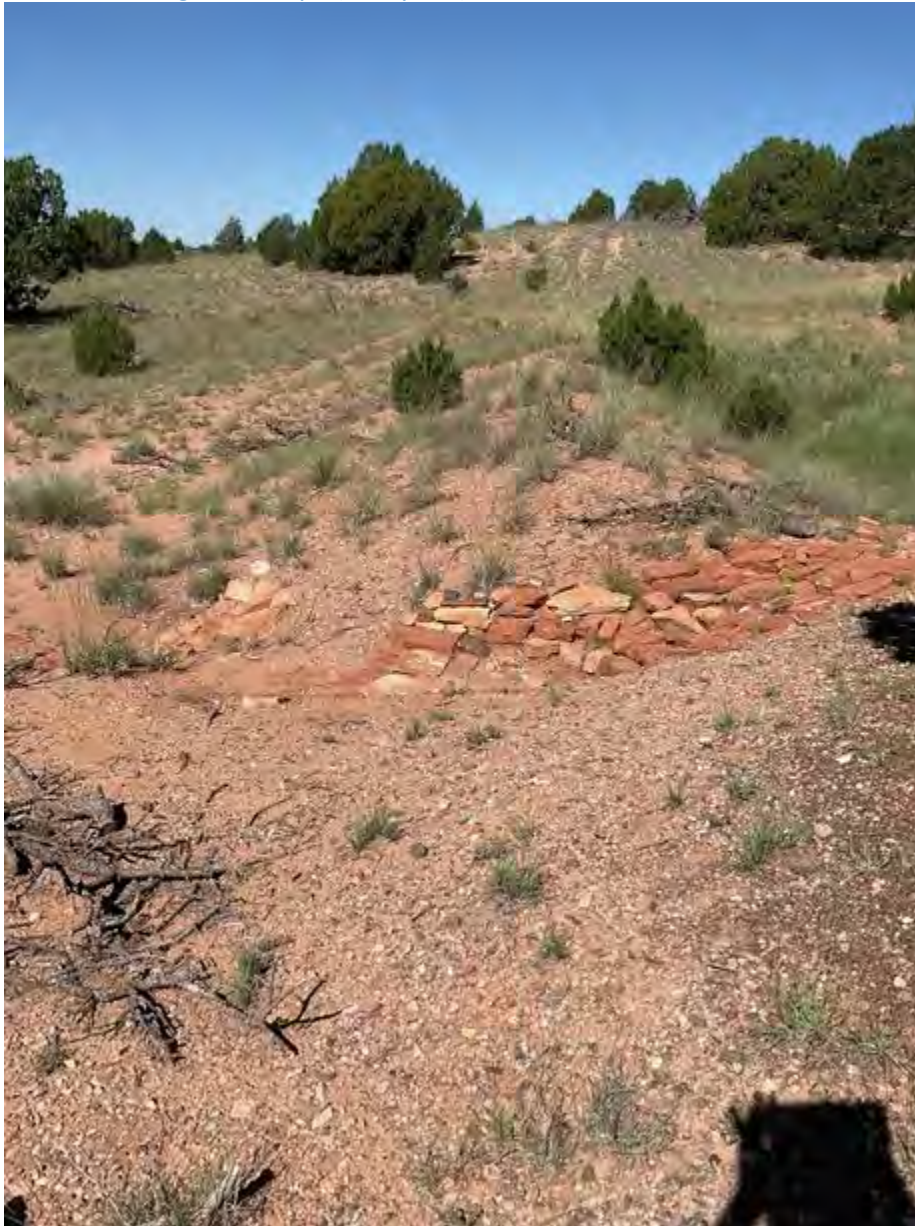
-105.9428874 35.44374573

All rocks intact

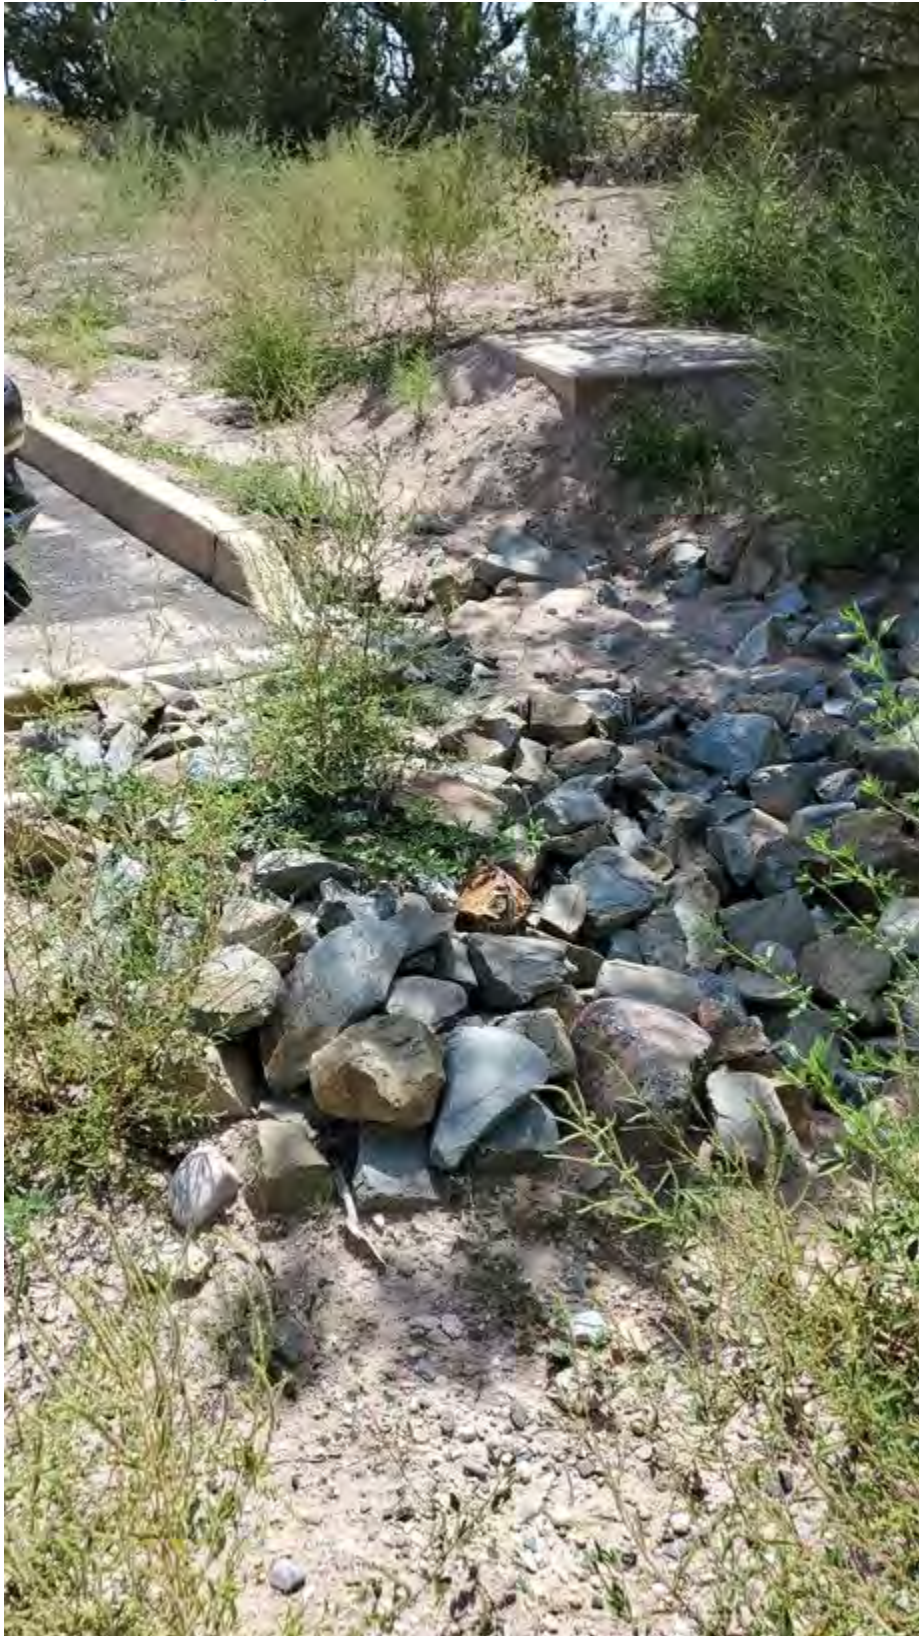
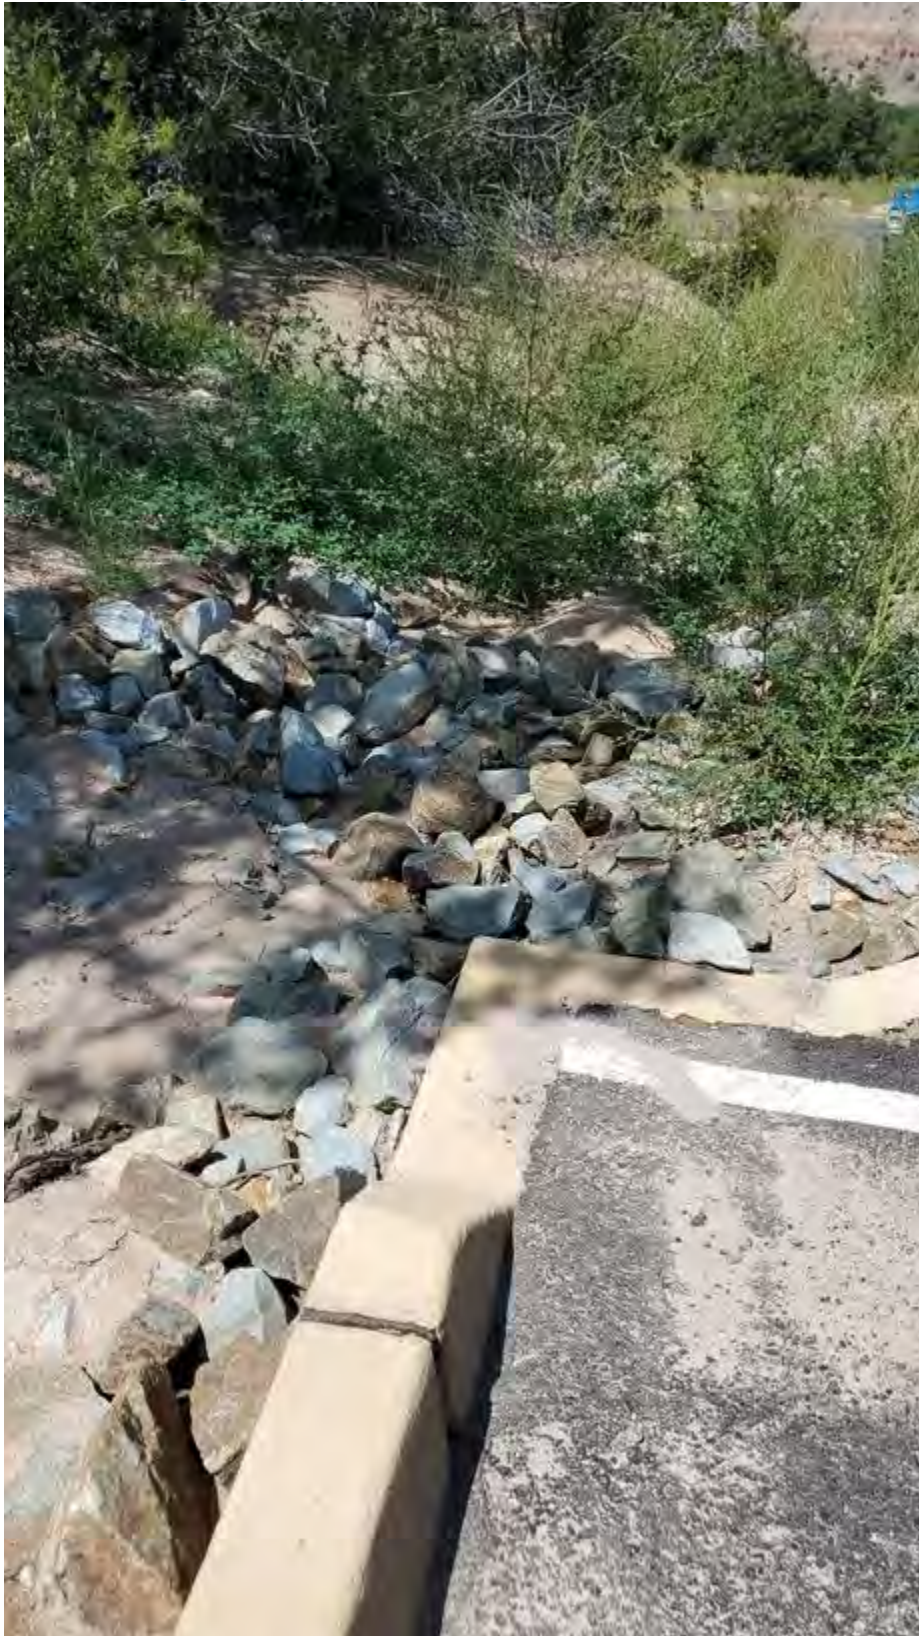
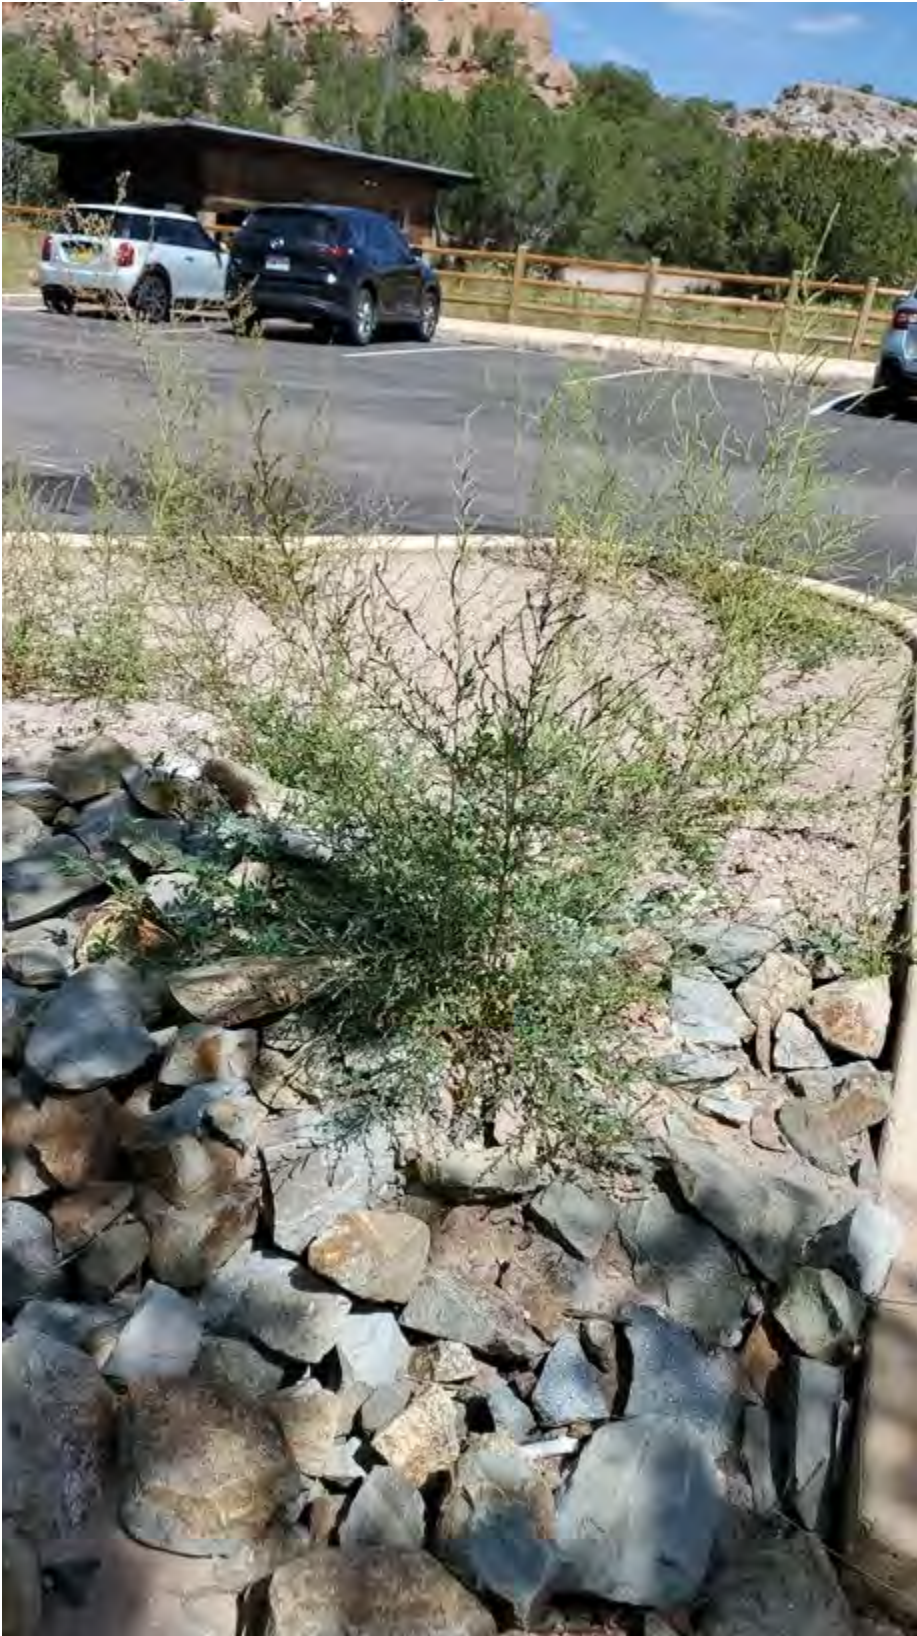
-106.2243189 35.85993323

Some rocks dislodged or broken

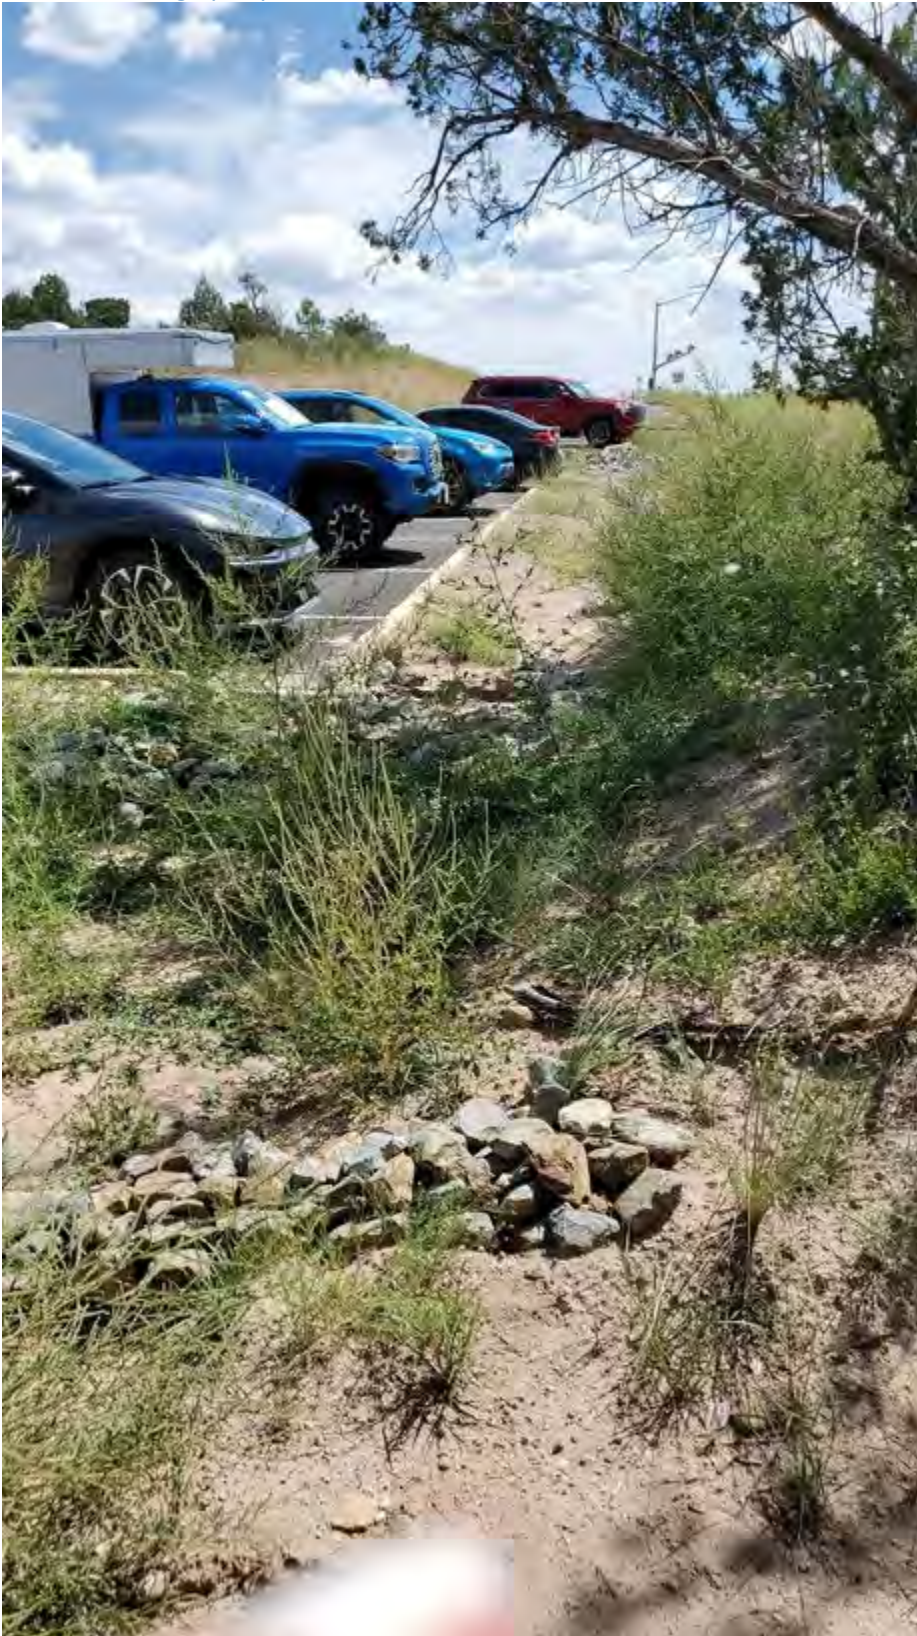
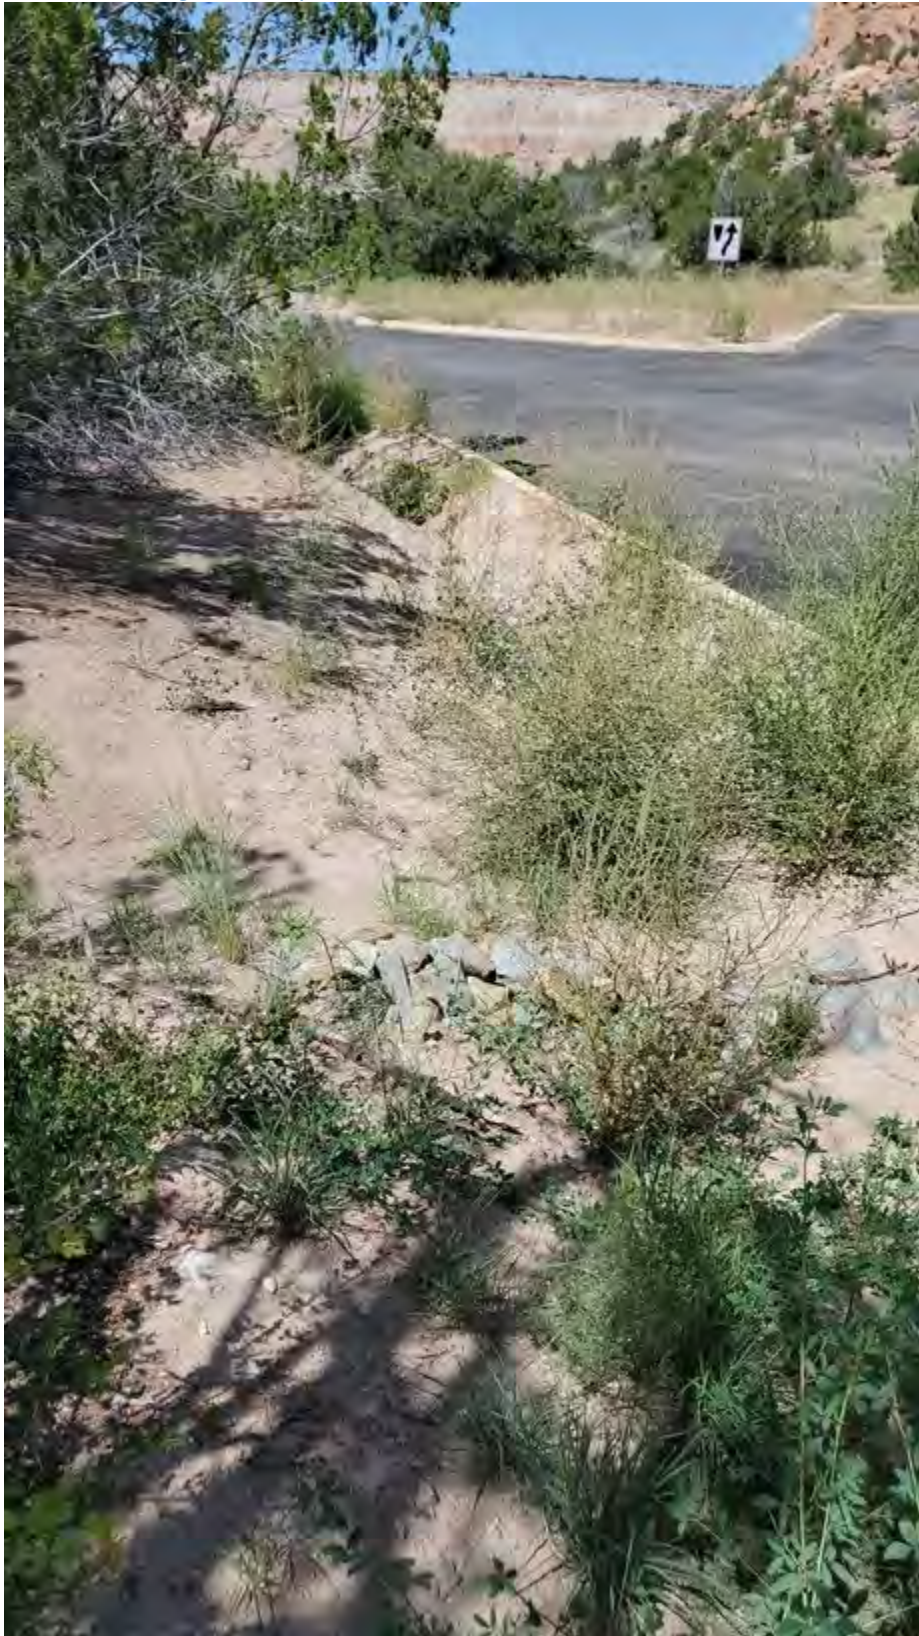
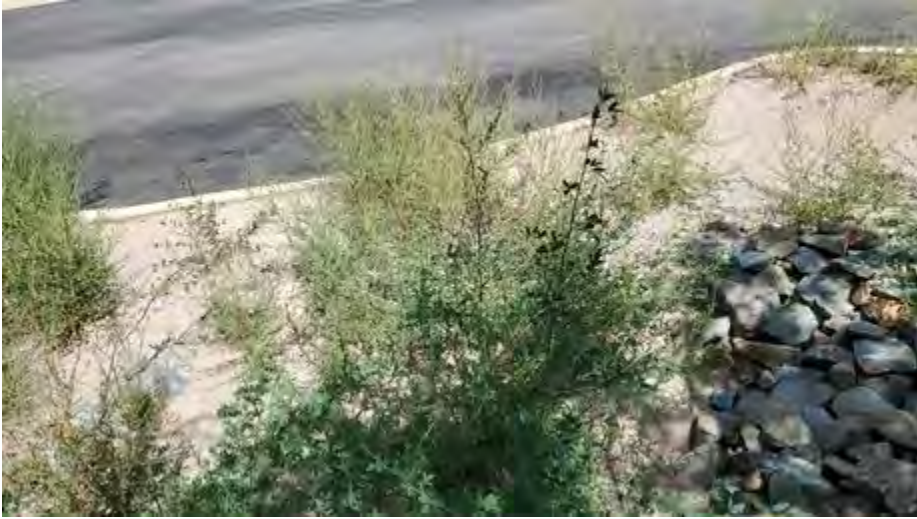
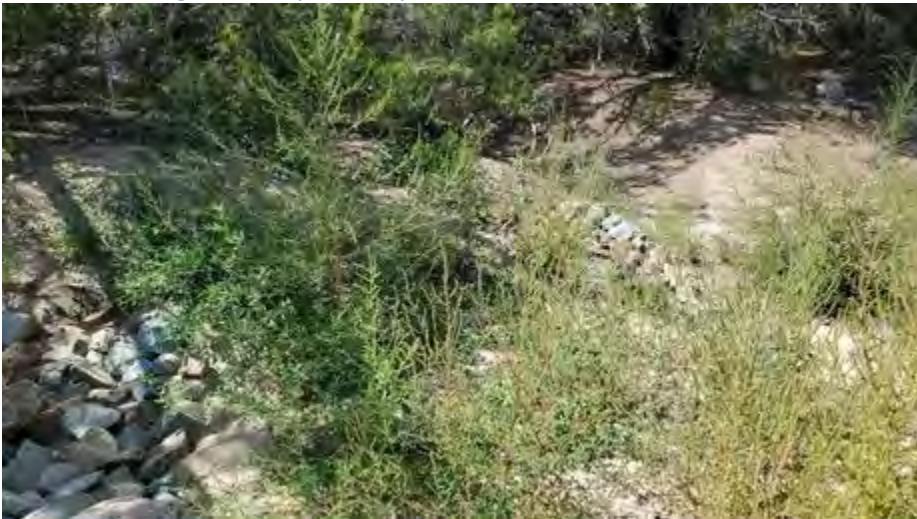
-106.2243784 35.85996151

Some rocks dislodged or broken

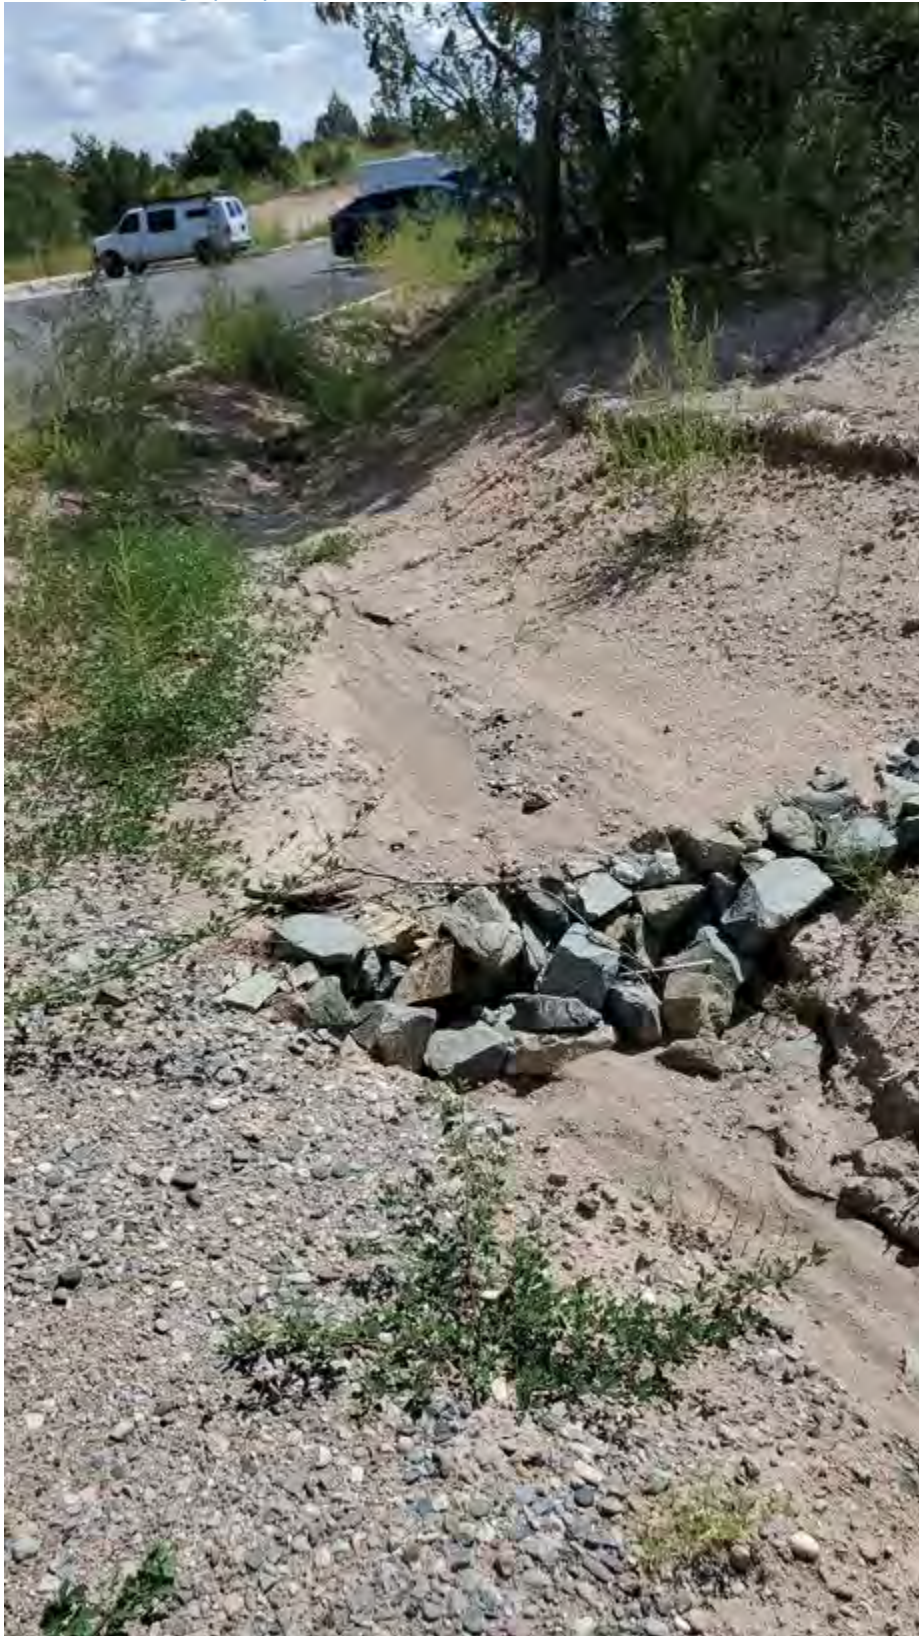
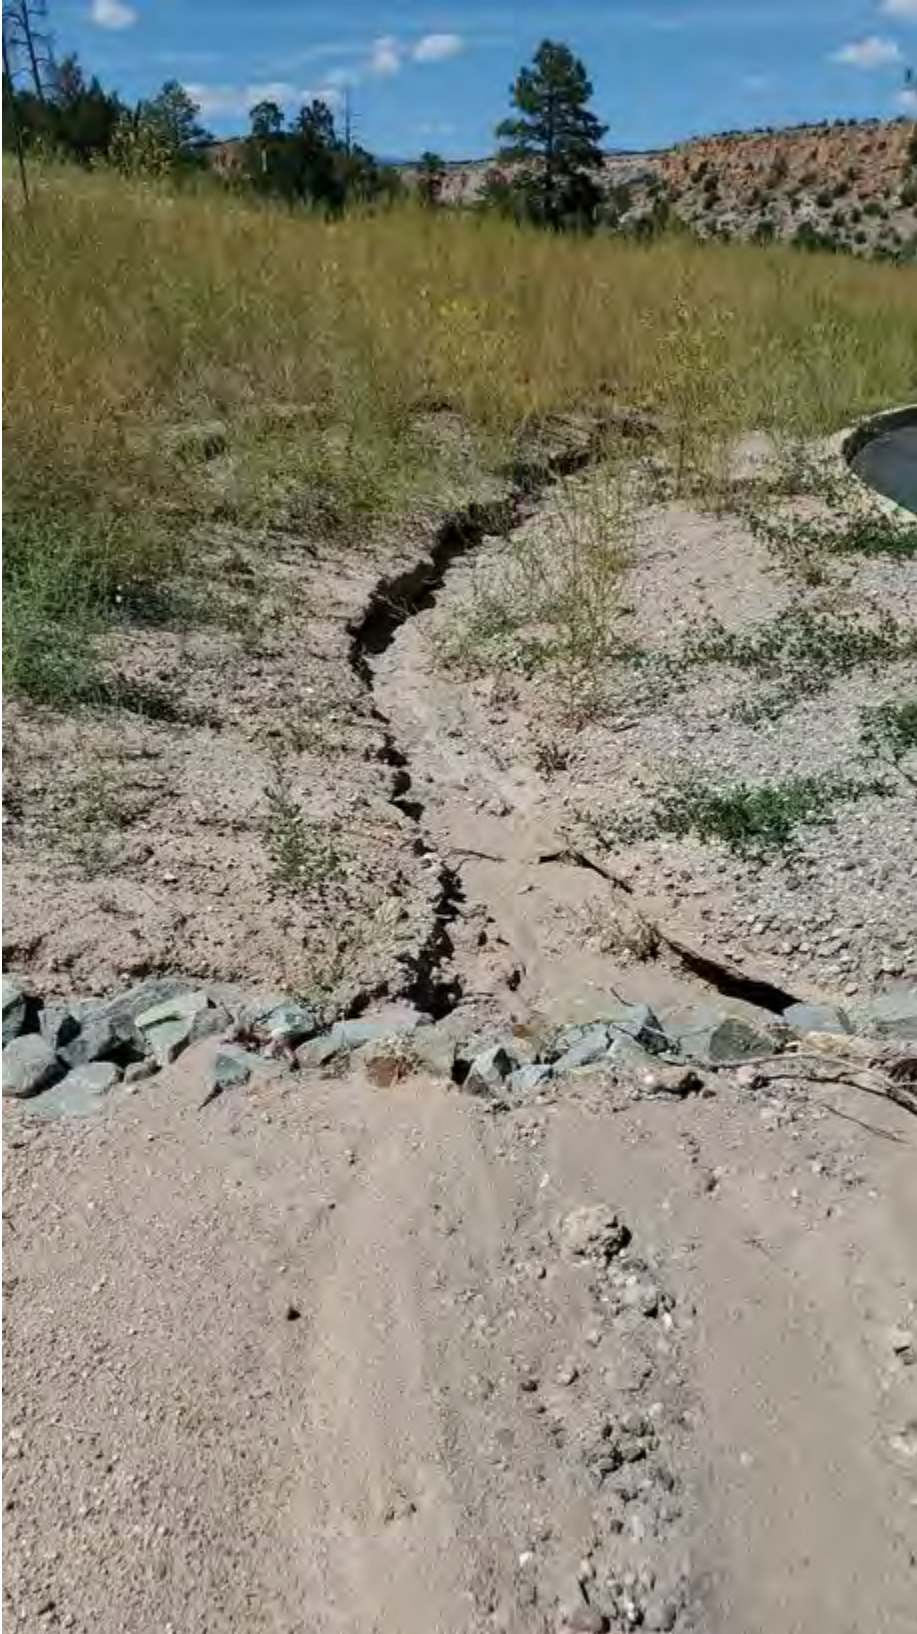
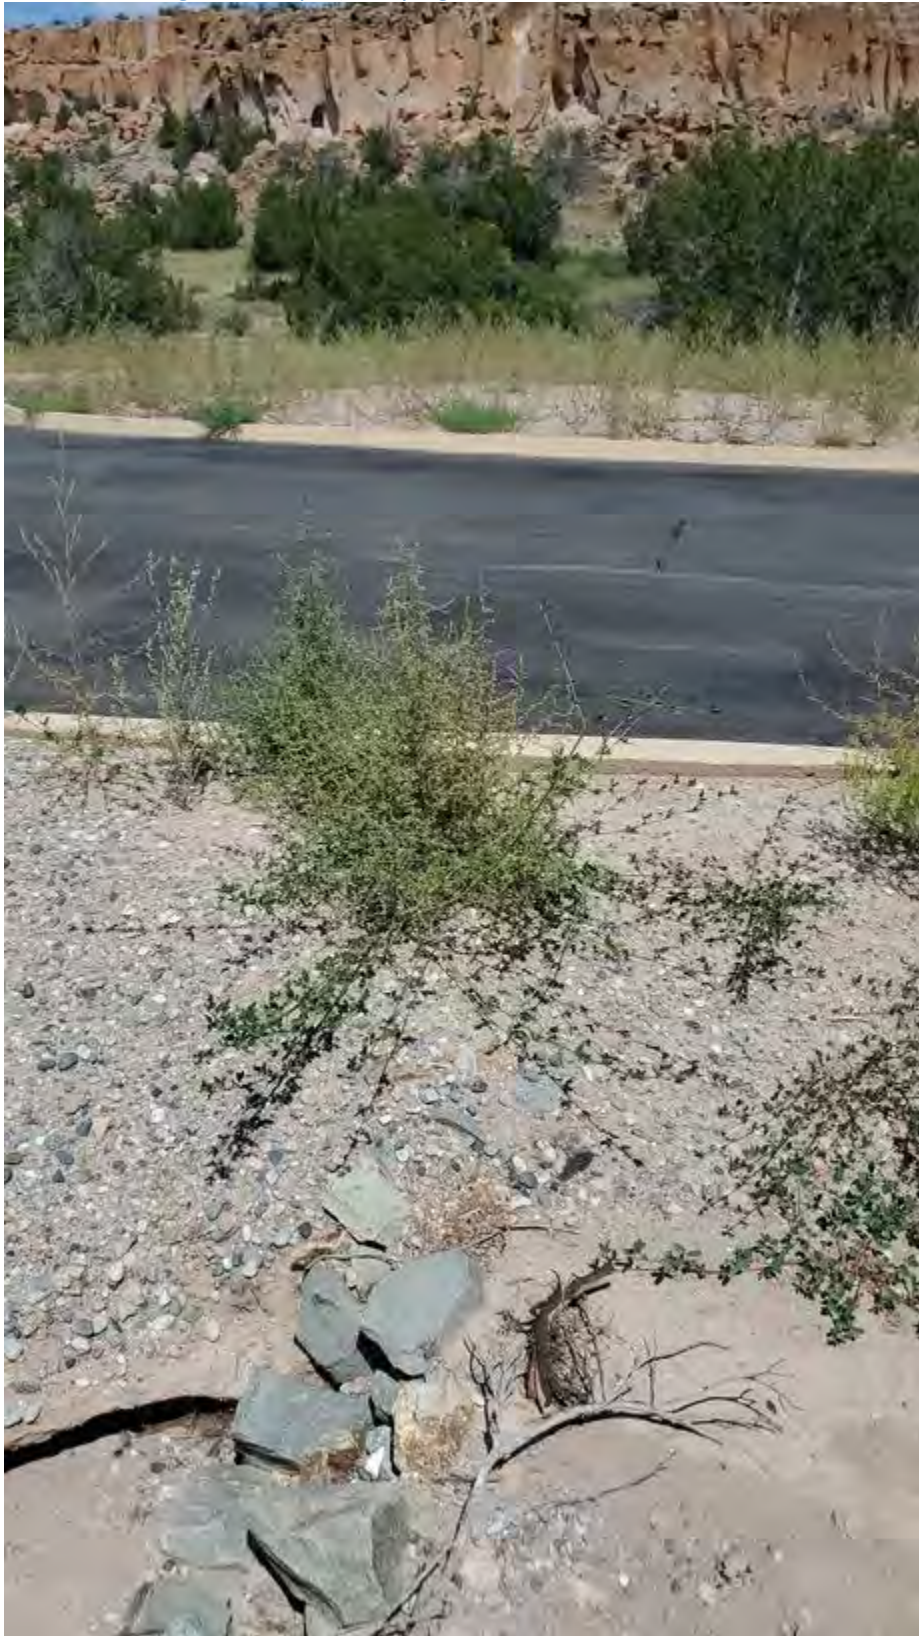
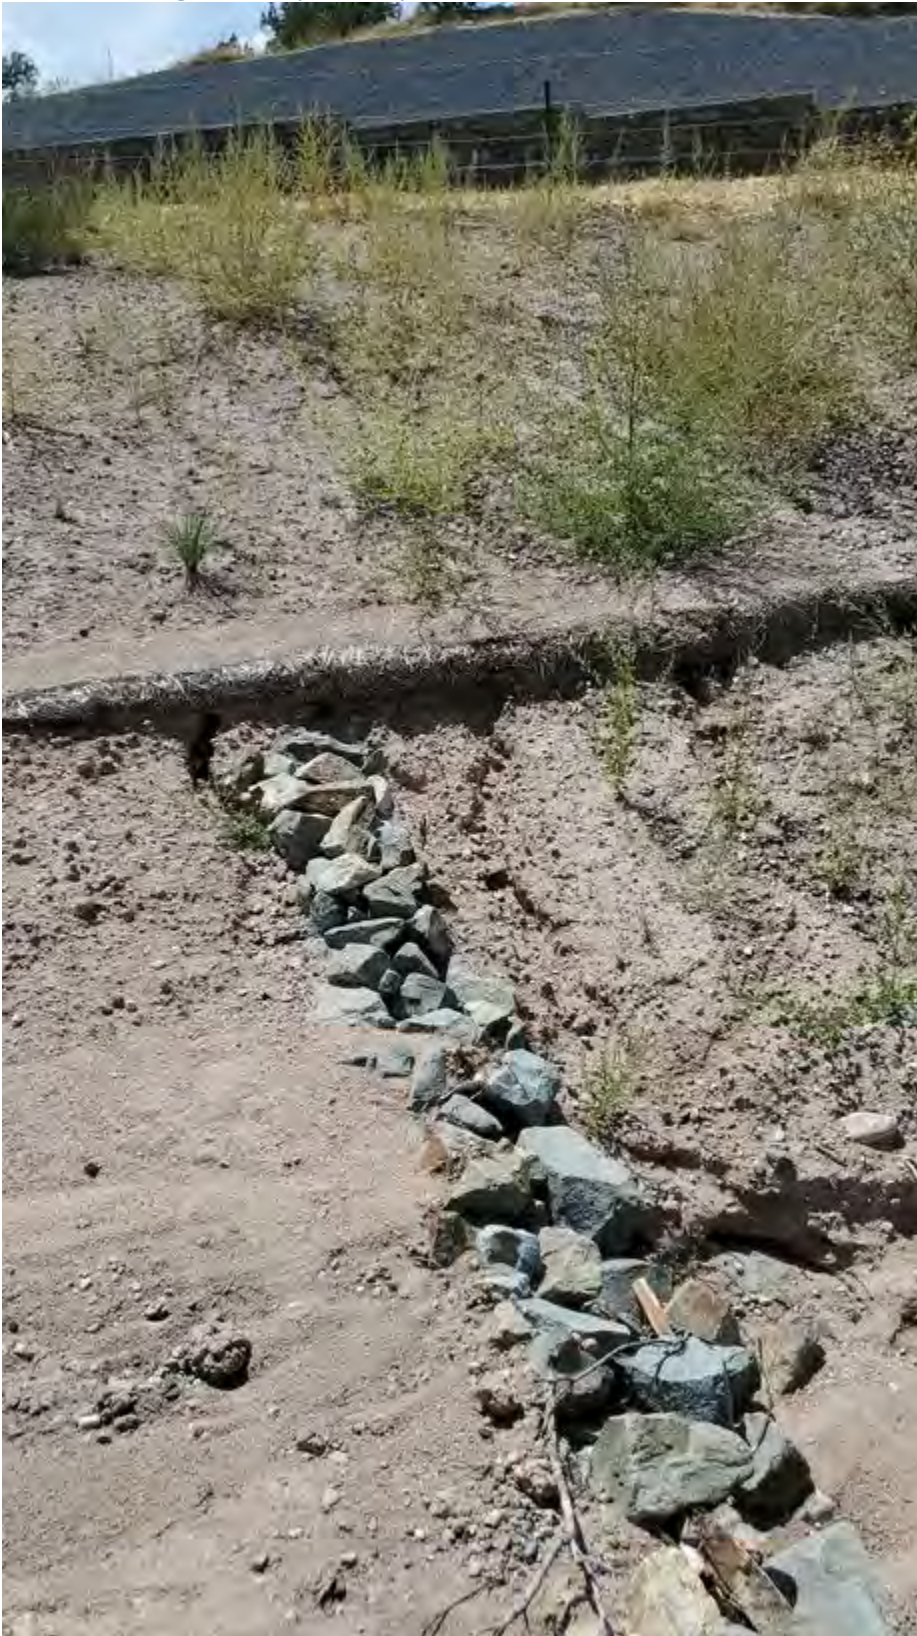
-106.2244515 35.86014432

All rocks intact

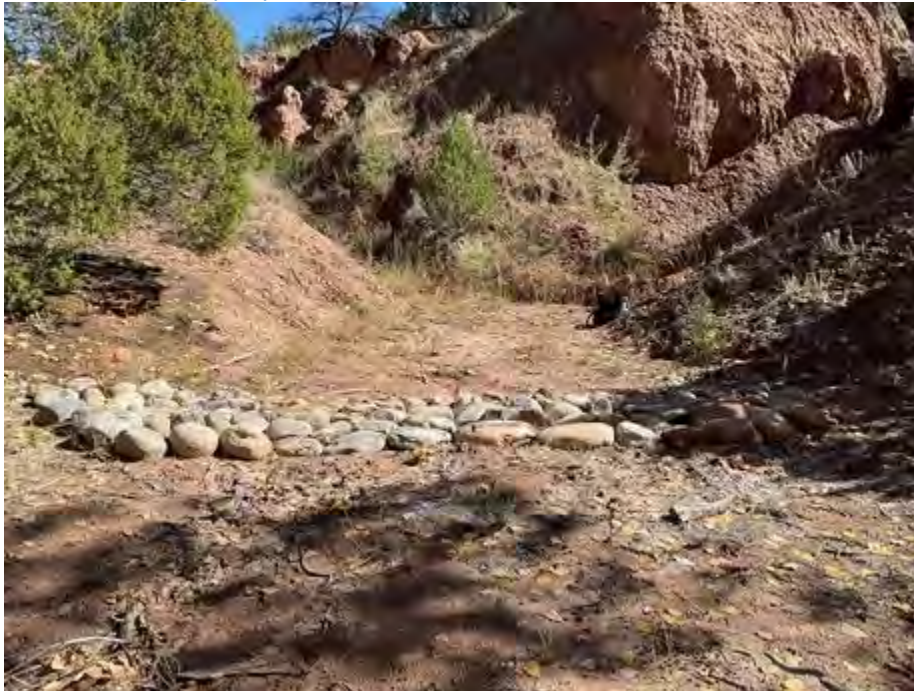
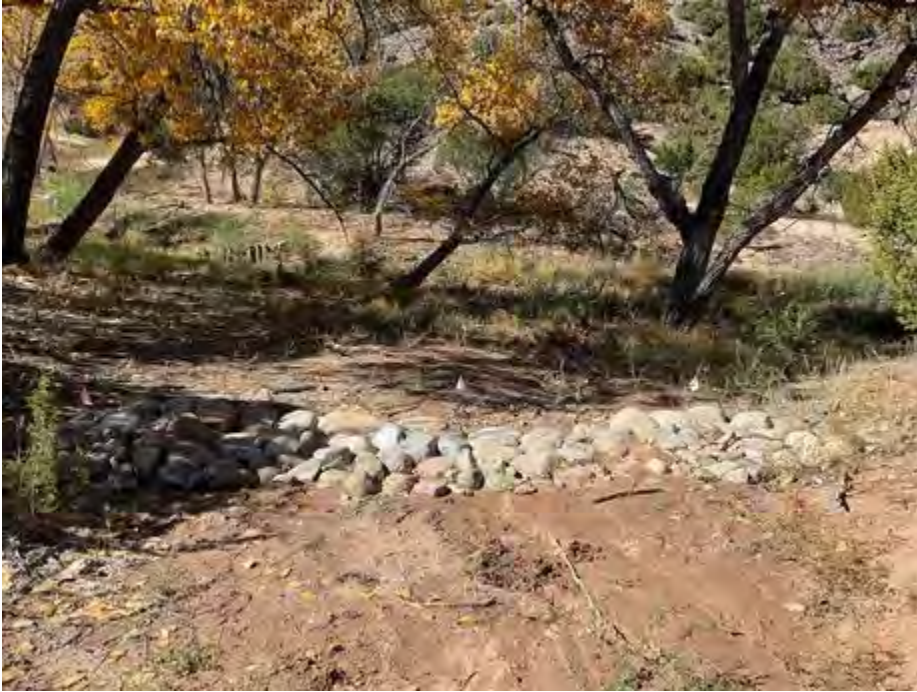
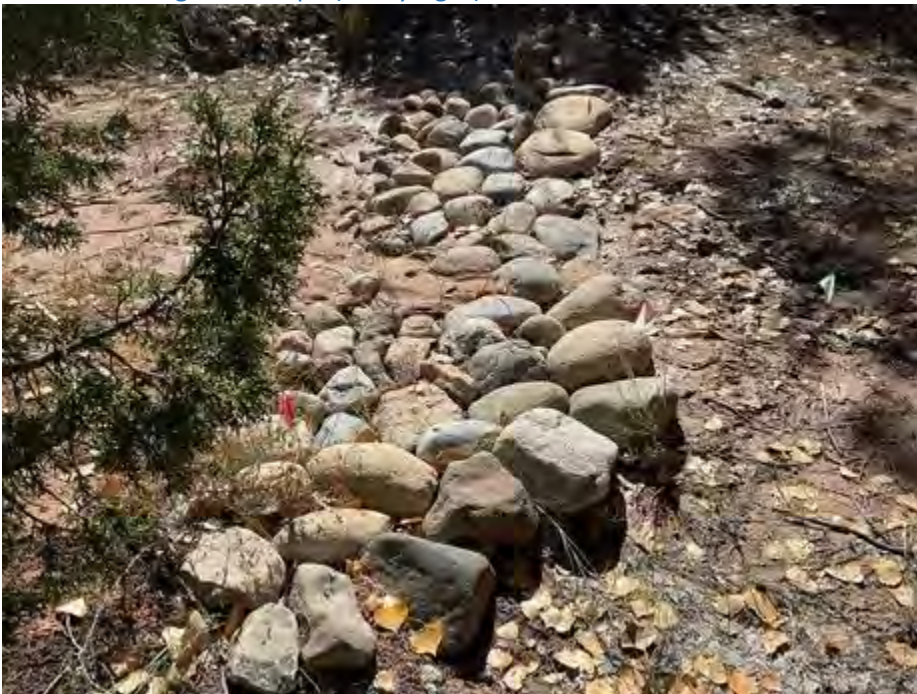
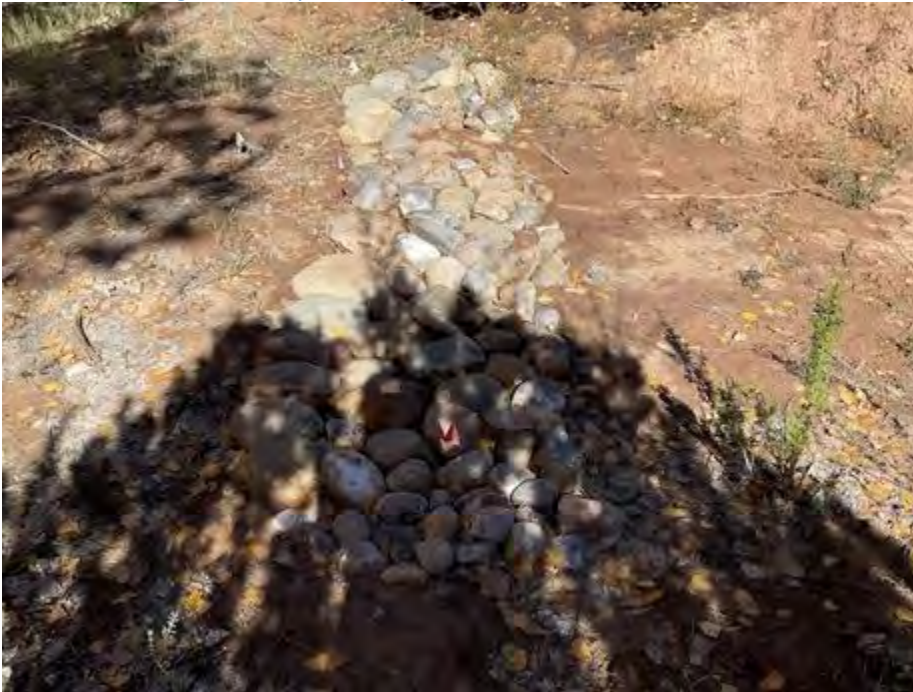
-105.9078511 36.18872842

All rocks intact
