**Zuni Bowl and One Rock Check Dam Research –
Phase 1**

Final Report

December 2024

Rio Grande Return for the New Mexico Department of Transportation Research Bureau

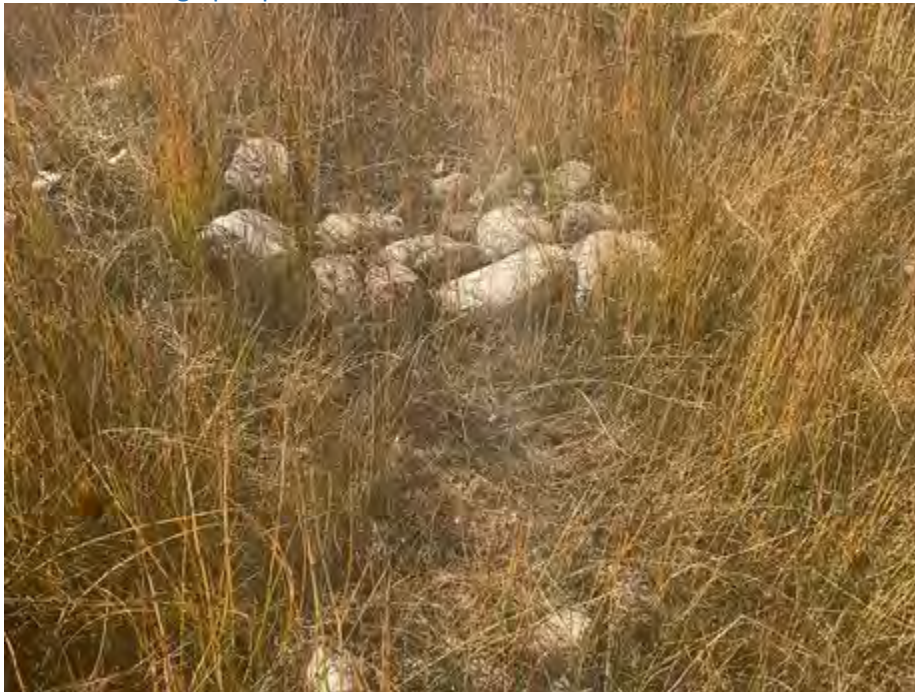
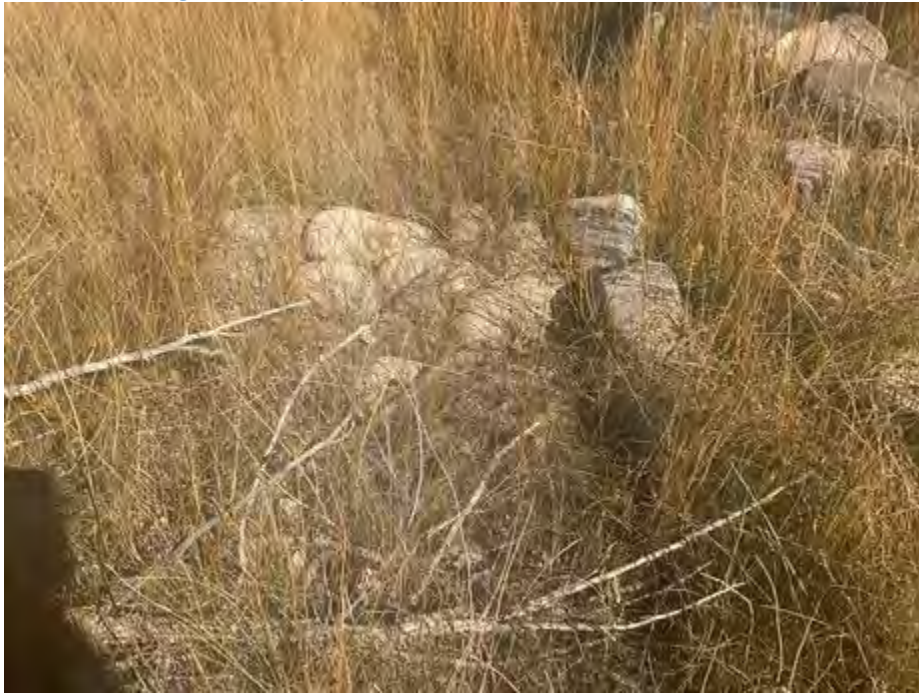
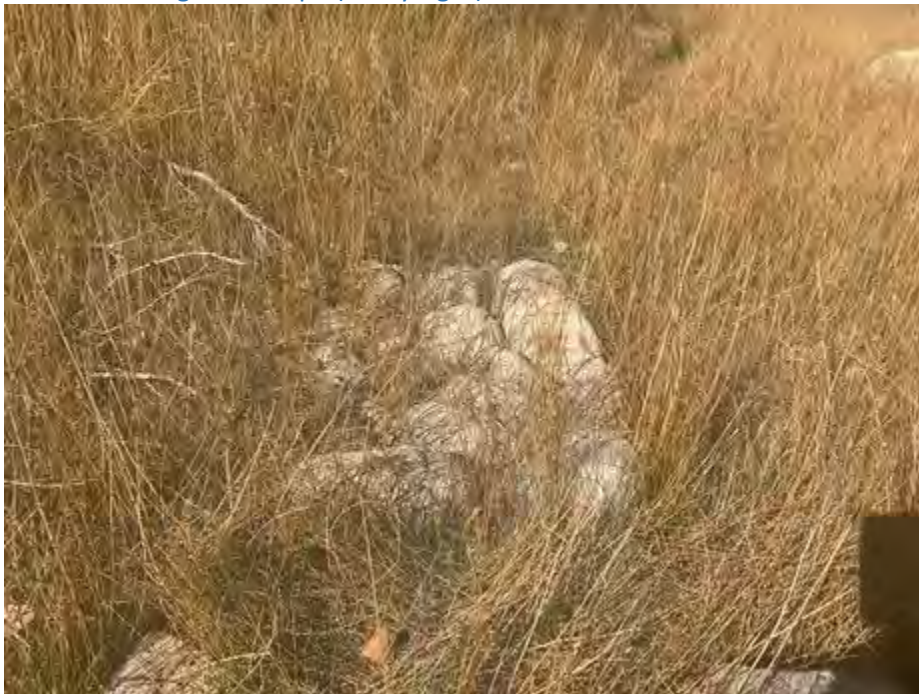
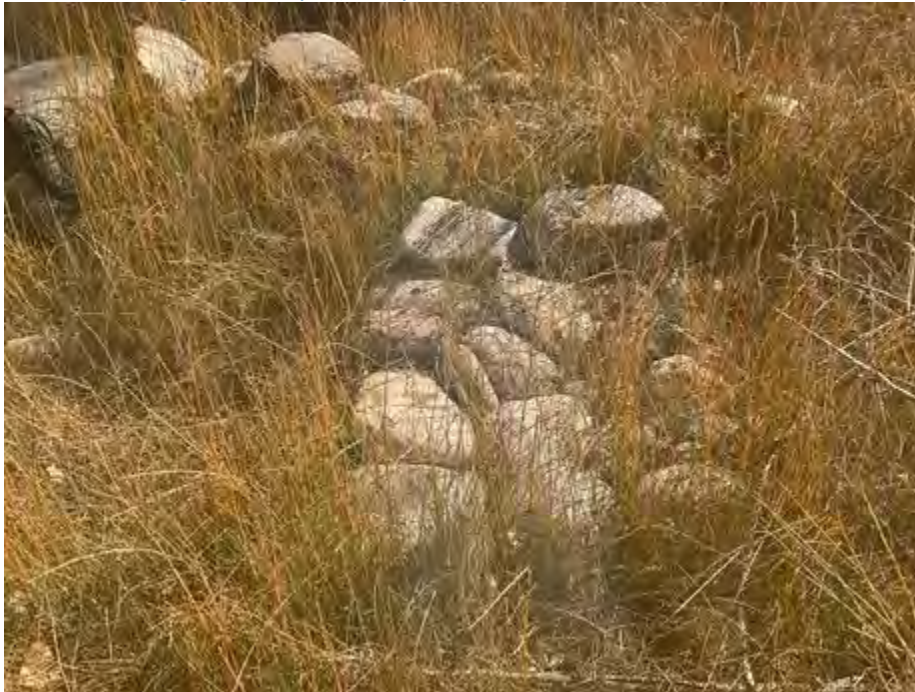
-105.9088917 36.18696822

All rocks intact

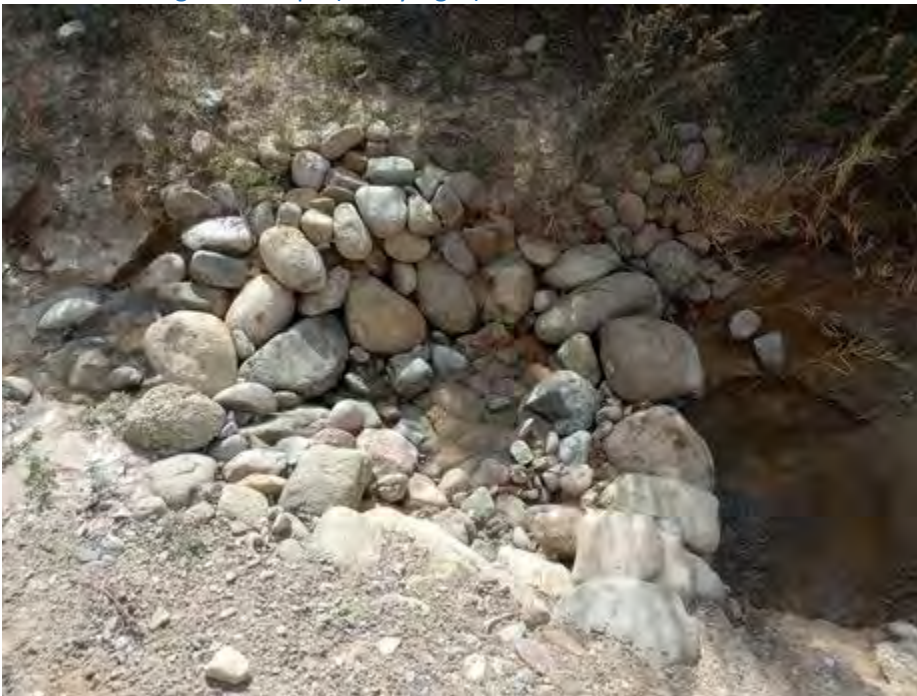
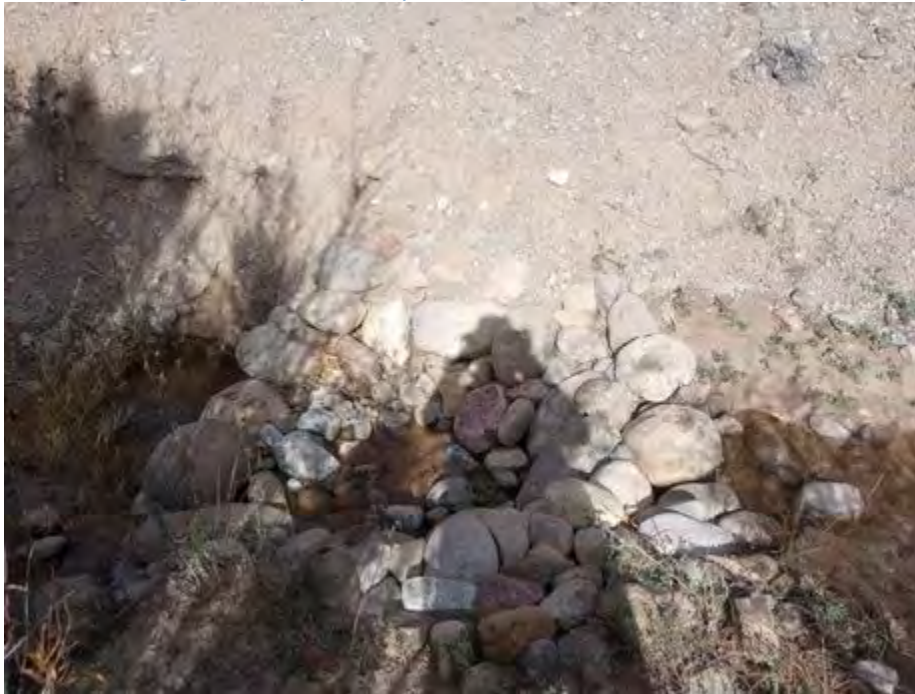
All rocks intact

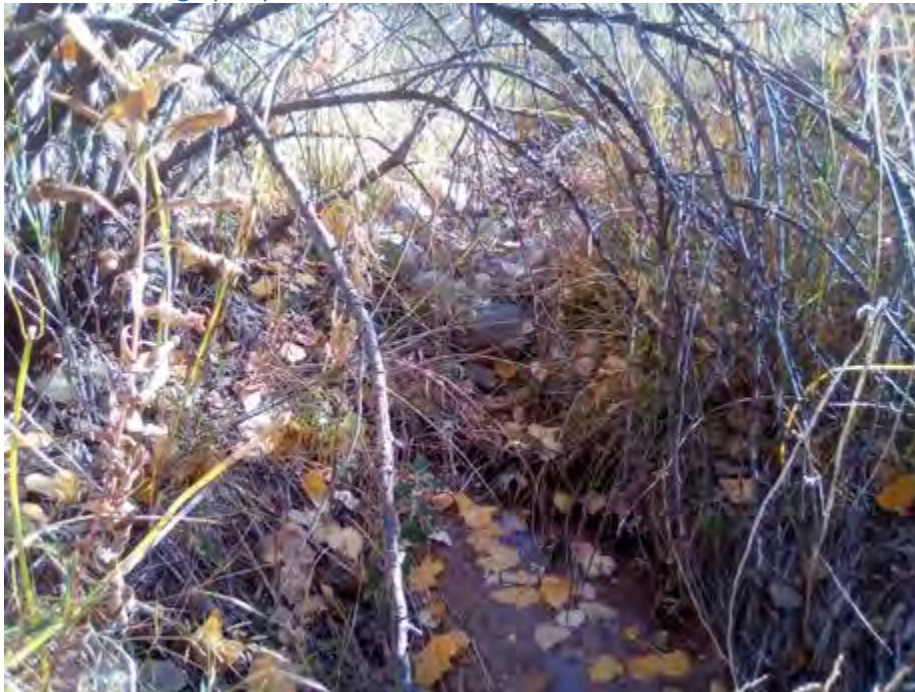
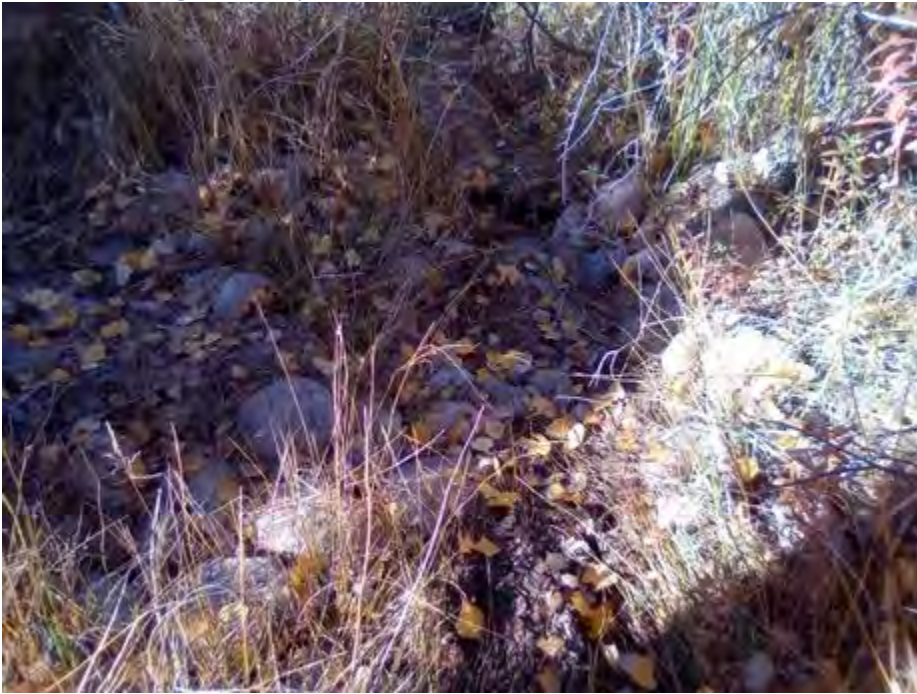
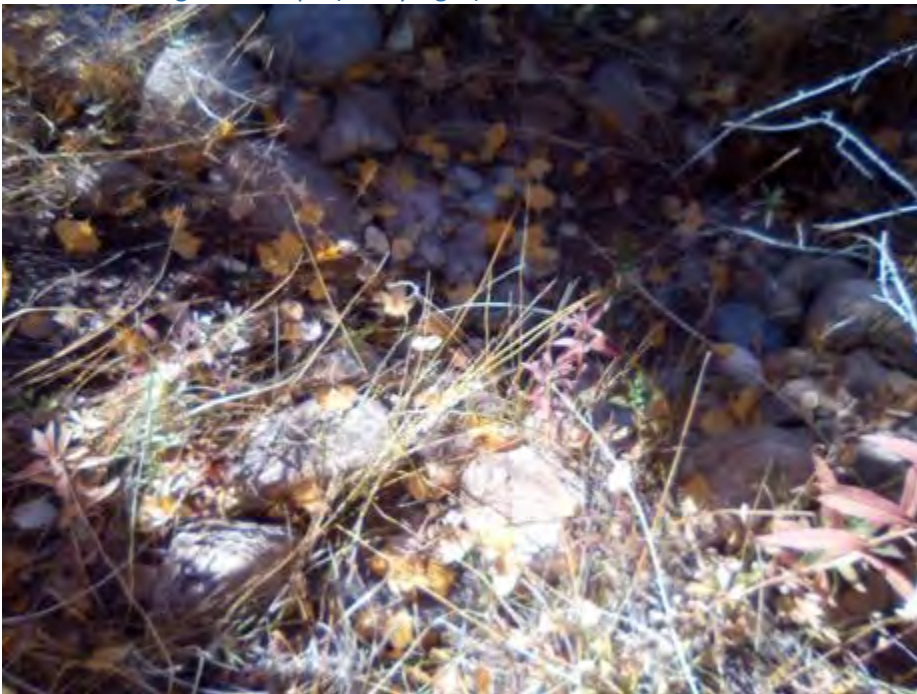
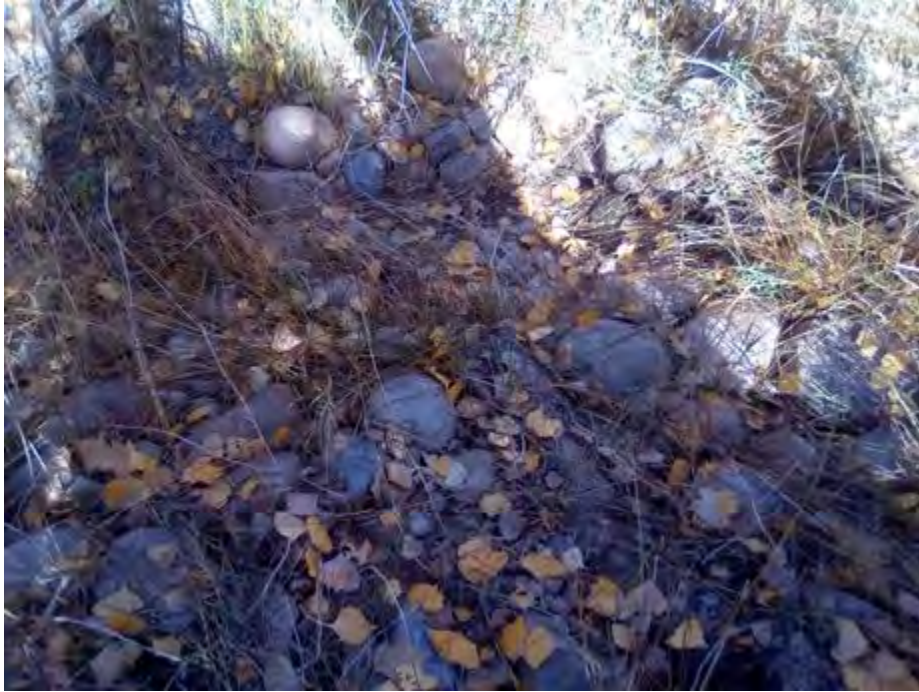
-105.892229 36.18216896

All rocks intact

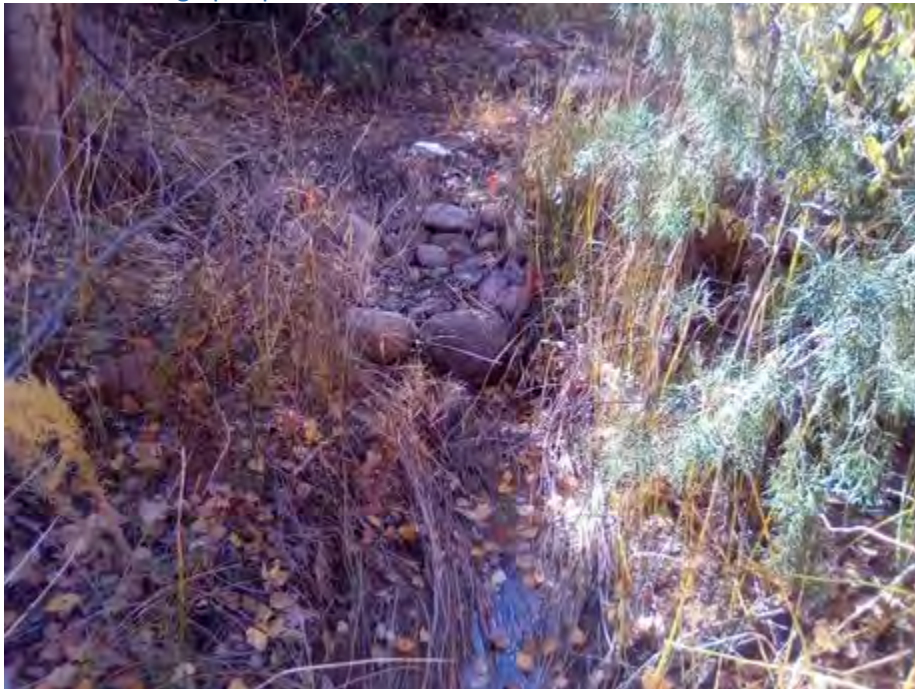
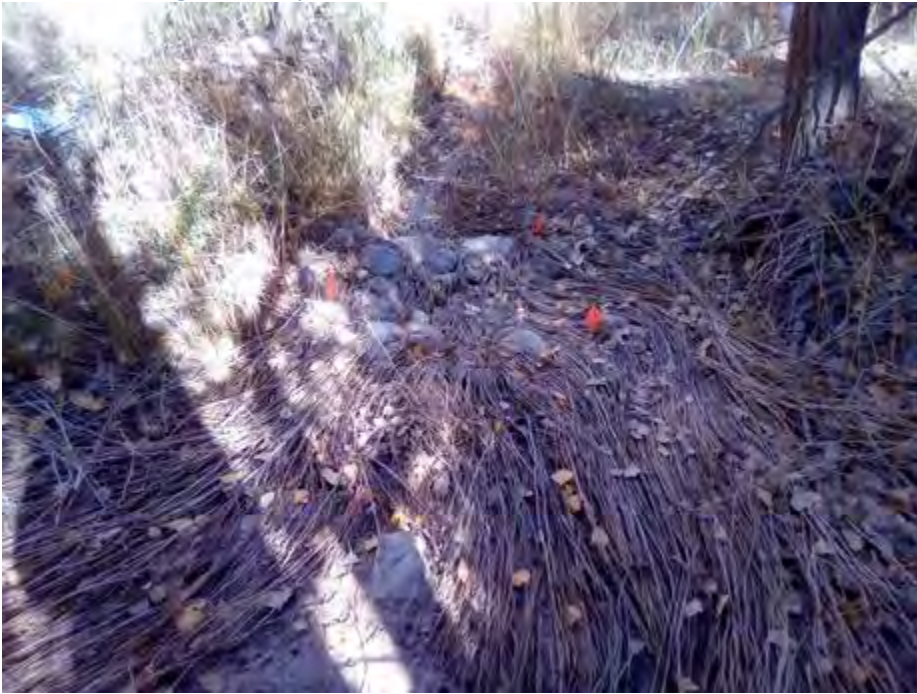
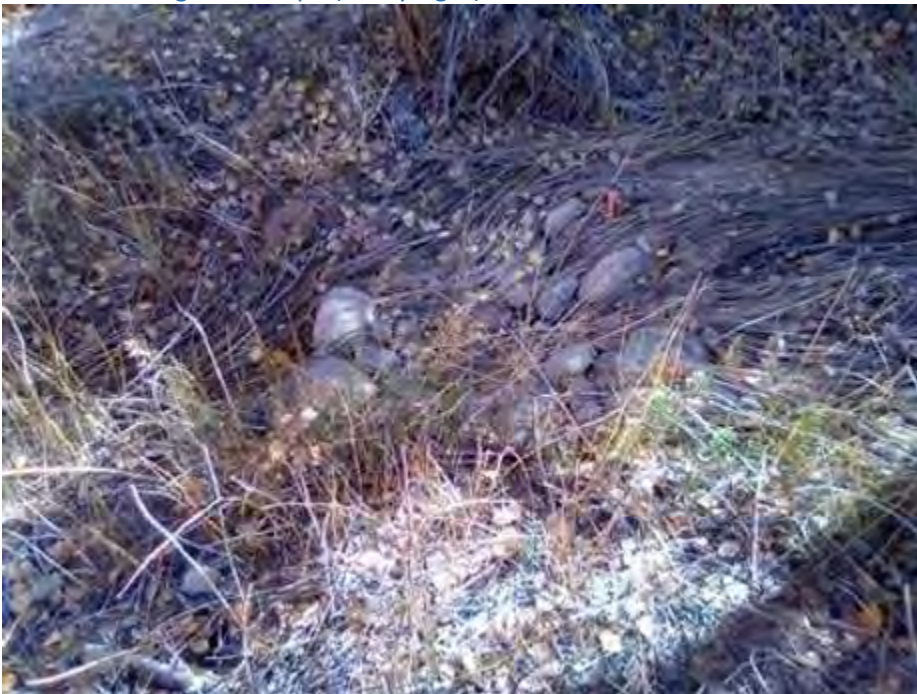
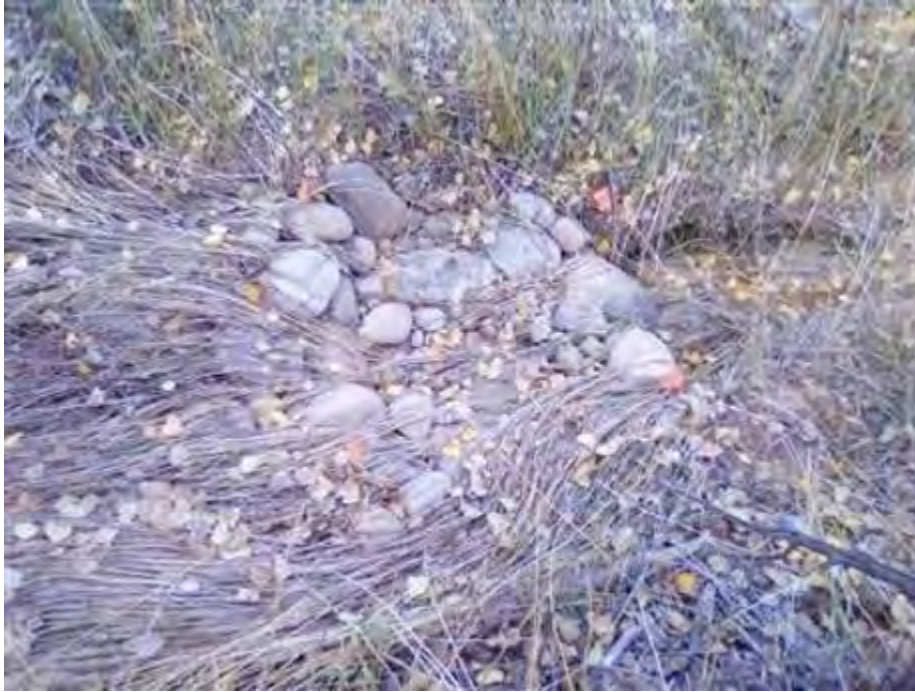
-105.90233 36.184721

All rocks intact

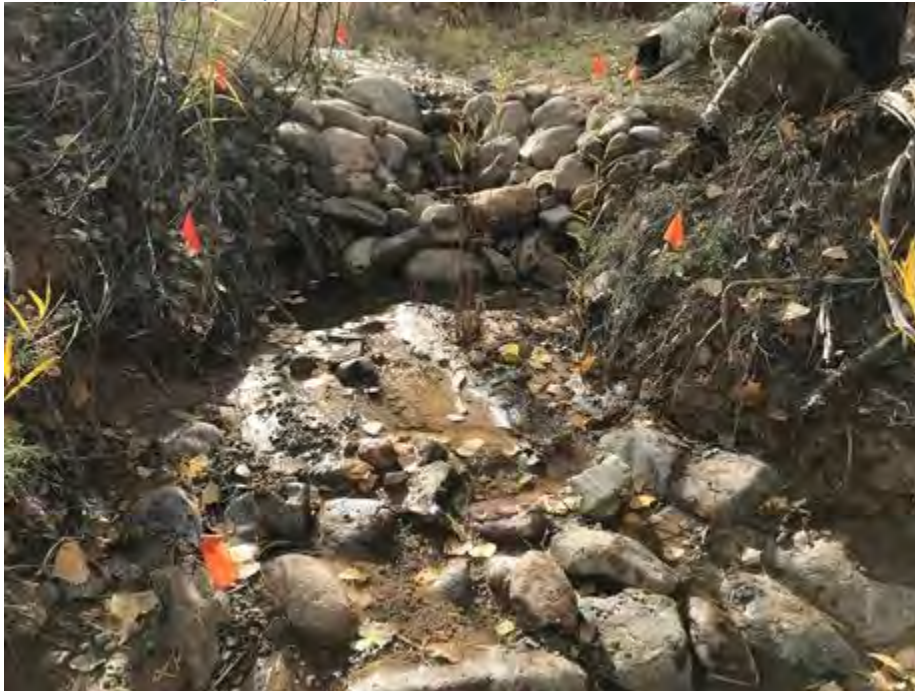
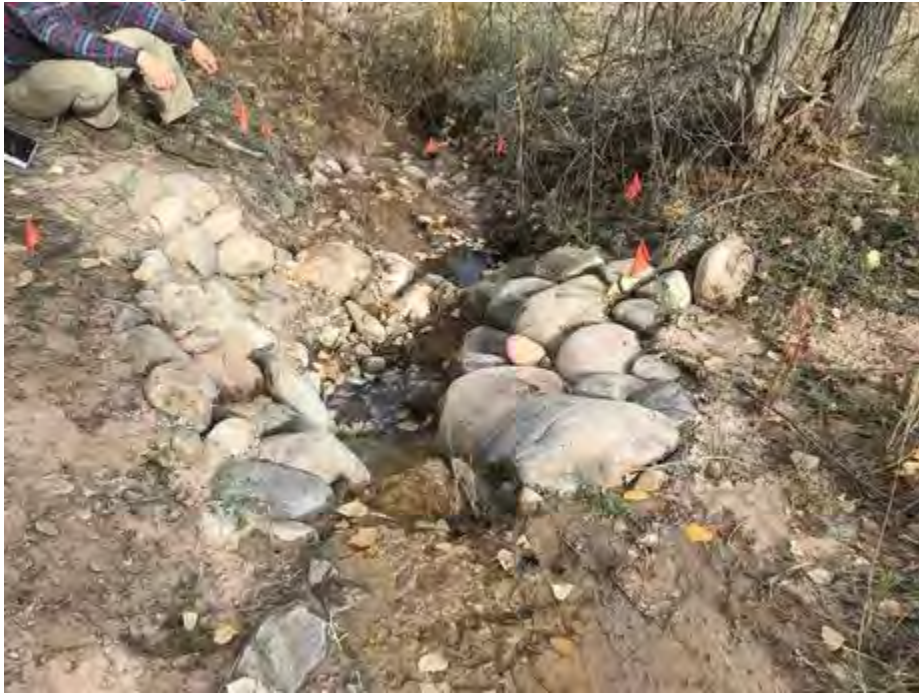
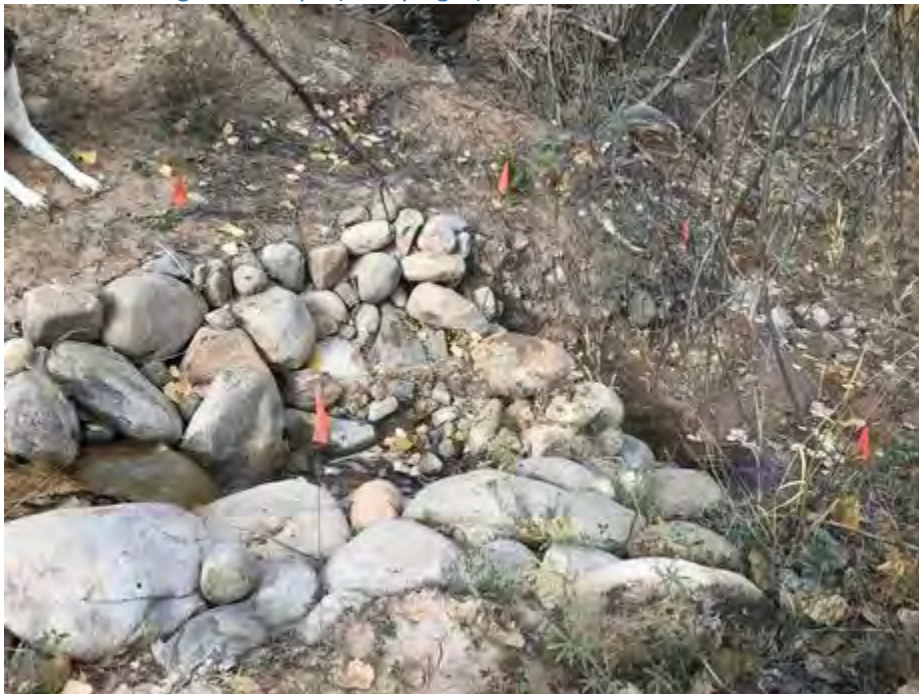
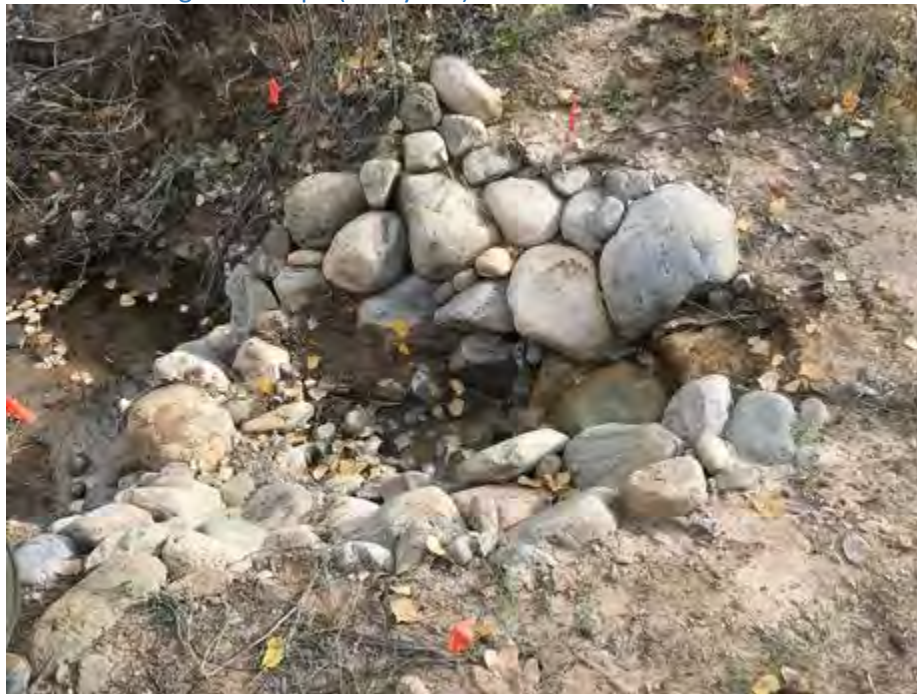
-105.901541 36.18692301

All rocks intact
